DERBYSHIRE COUNTY COUNCIL

# Beechcroft HOP

Six Facet Survey

1st November 2018

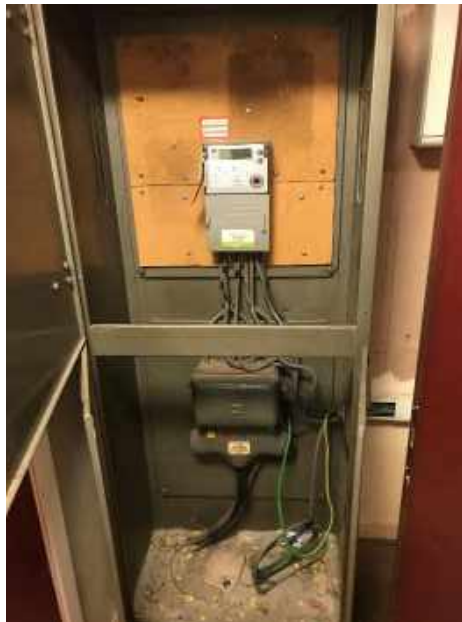
Photograph No 7 – Incoming electrical utility supply.

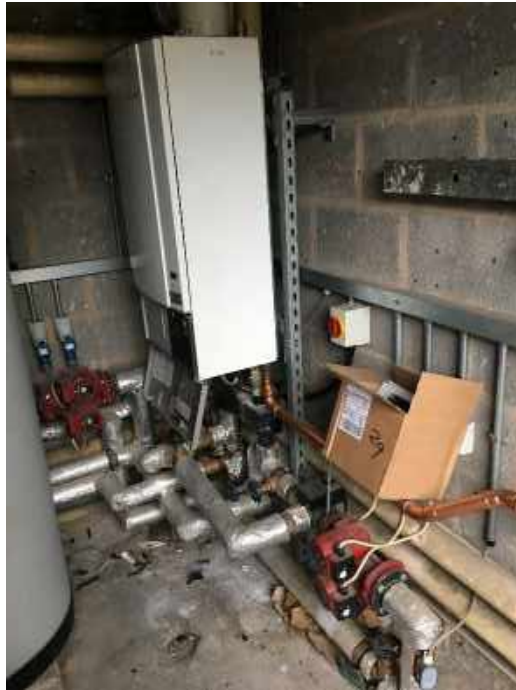
Photograph No 9 – Typical Boiler within the boiler plantrooms

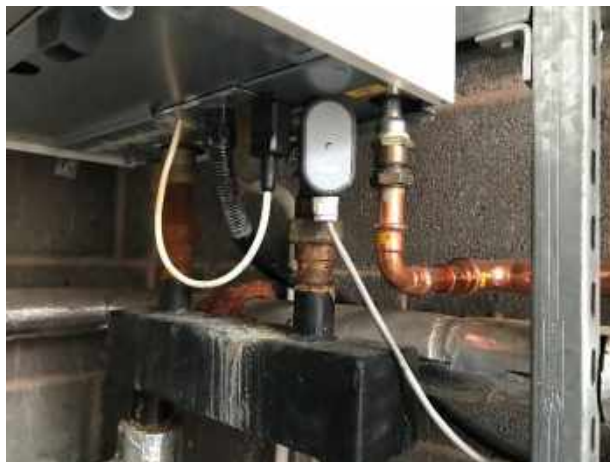
Photograph No 14 – Typical low loss header to older boilers without shunt pump, note corrosion to pipework

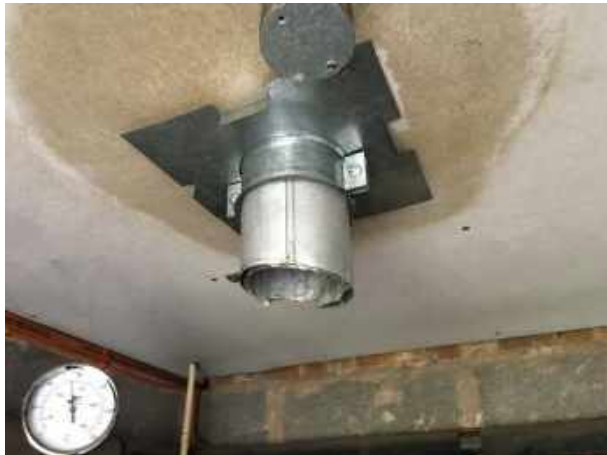
Photograph No 15 – Typical existing redundant flue passing through roof, not sealed and left open ended letting water into plantroom.

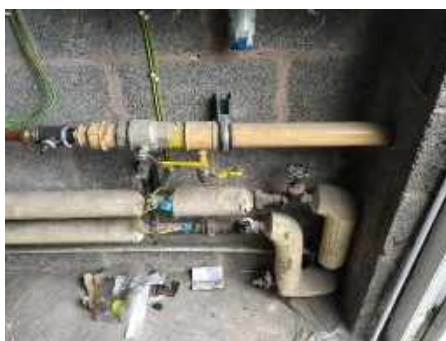
Photograph No 17 – Original existing pipework installation and insulation still present around the boilerhouse. Insulation damaged in places.

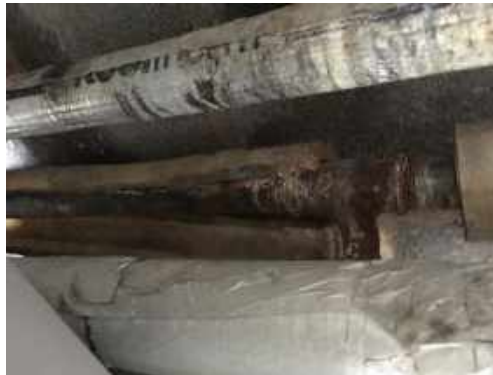
Photograph No 18 – Damaged pipework insulation and badly corroded pipework beneath.

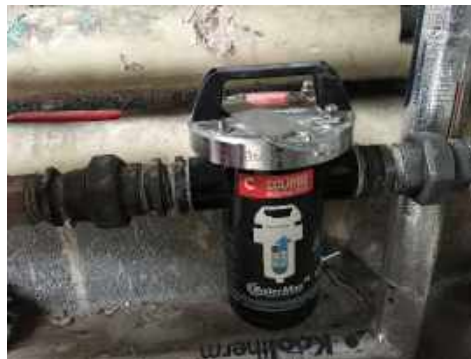
Photograph No 19 – Magnetic filter on new boiler for the Cedar Wing. No magnetic filters on remaining 3 No. boiler installations.

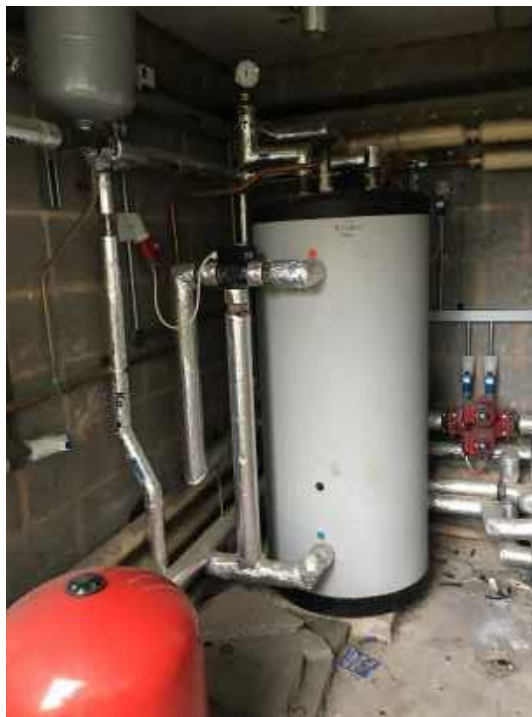
Photograph No 20 – Typical ACV “Smart” Calorifier for the domestic HWS generation

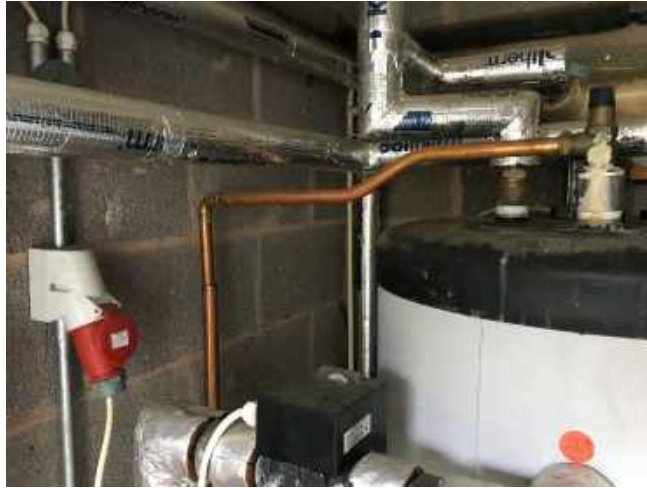
Photograph No 21 – Typical Calorifier pressure relief pipework.

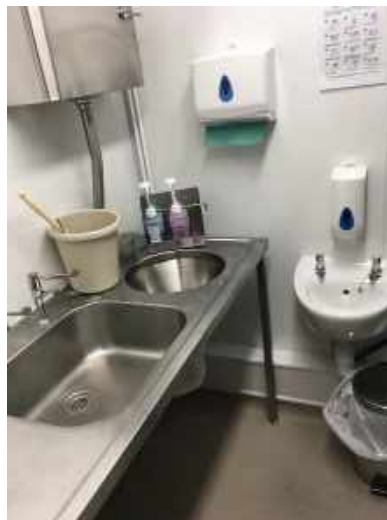
Photograph No 26 – Typical stainless steel sluice in sluice rooms.

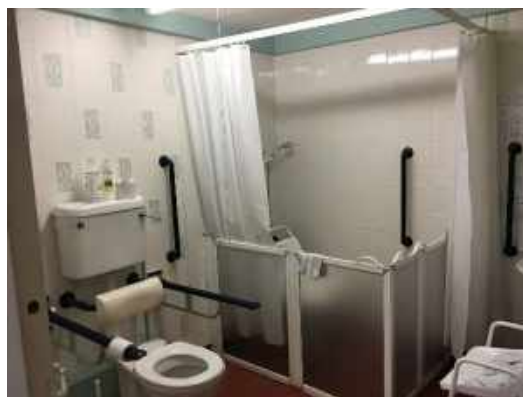
Photograph No 27 – Typical shower room in bedroom blocks.

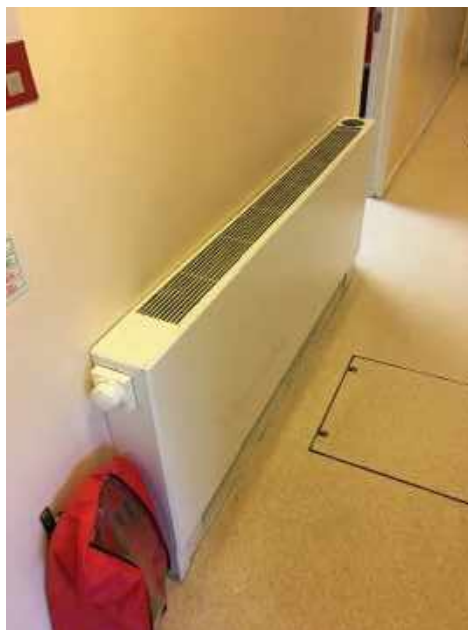
Photograph No 31 – Typical wall mounted LST radiator, newer type

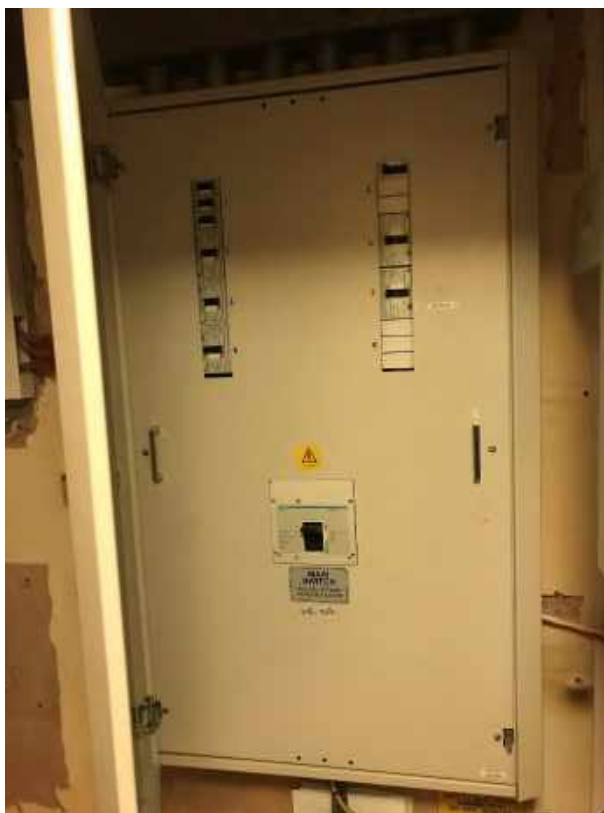
Photograph No 46 – Main Hager 8 way TPN MCCB board with integral main isolator

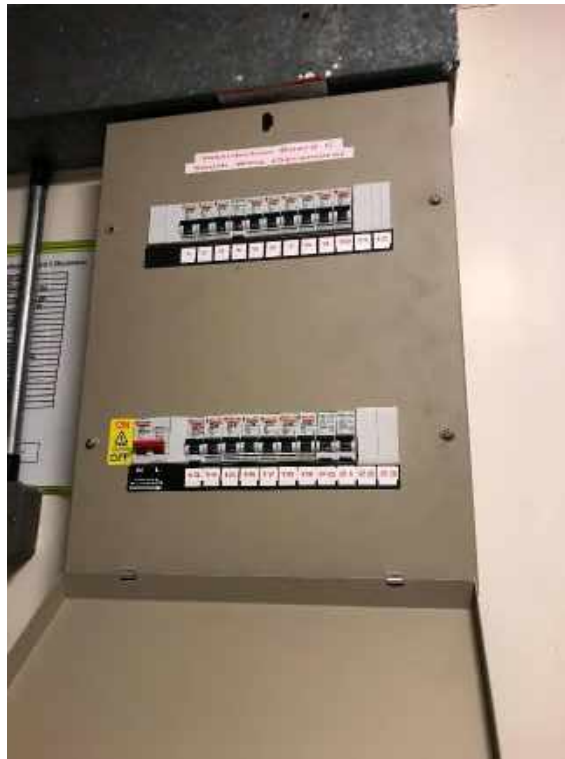
Photograph No 47 – Typical Merlin Gerin Distribution Board Serving a Bedroom Wing

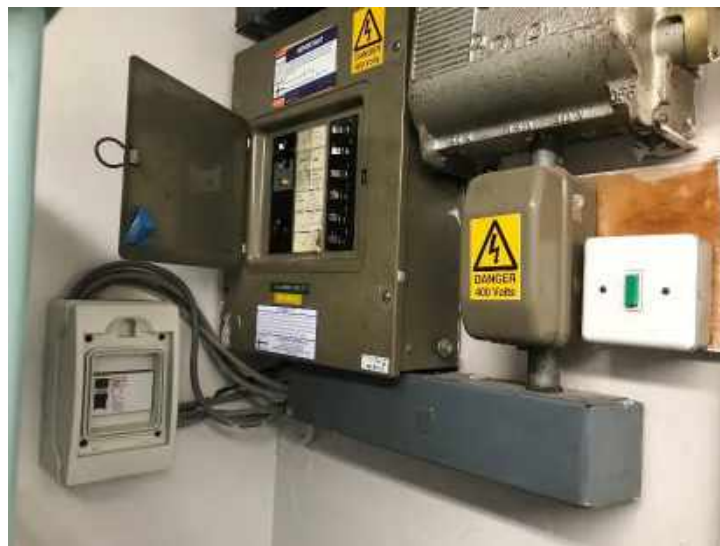
Photograph No 48– Existing Distribution Board “EE” Installed In and Serving Kitchen Requires Replacing

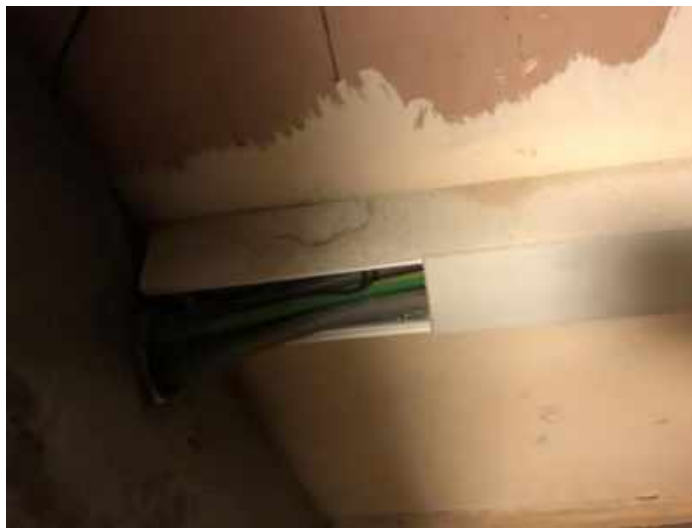
Photograph No 49 – Example of Final Cabling

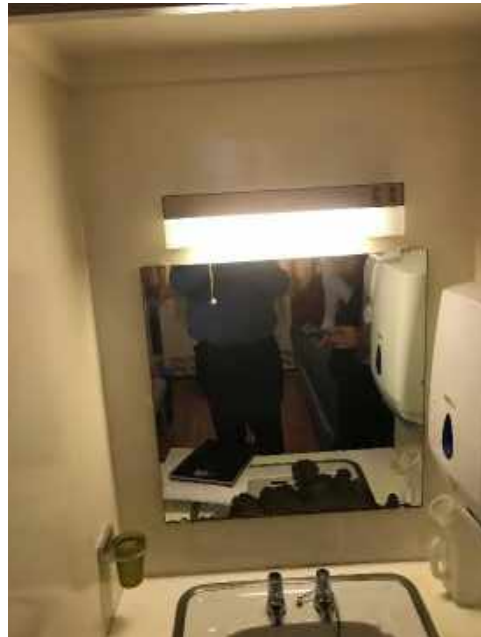
Photograph No 51 – Typical bedroom mirror luminaire.

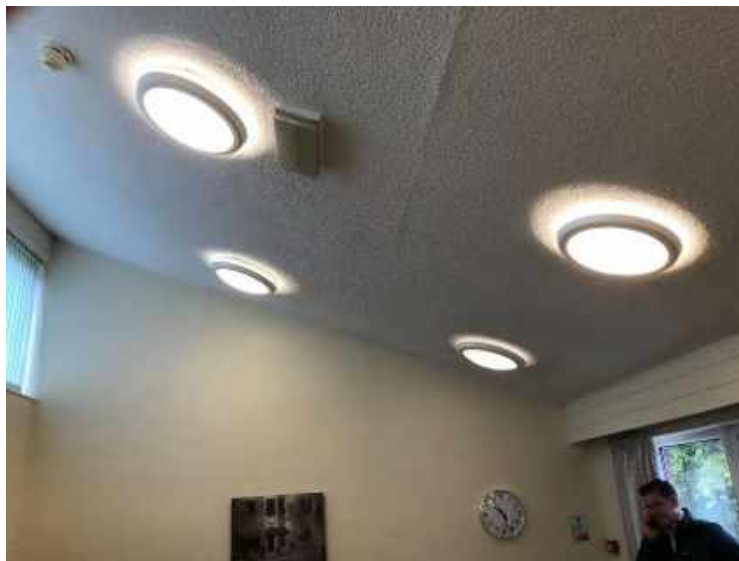
Photograph No 52 – Amenity lighting

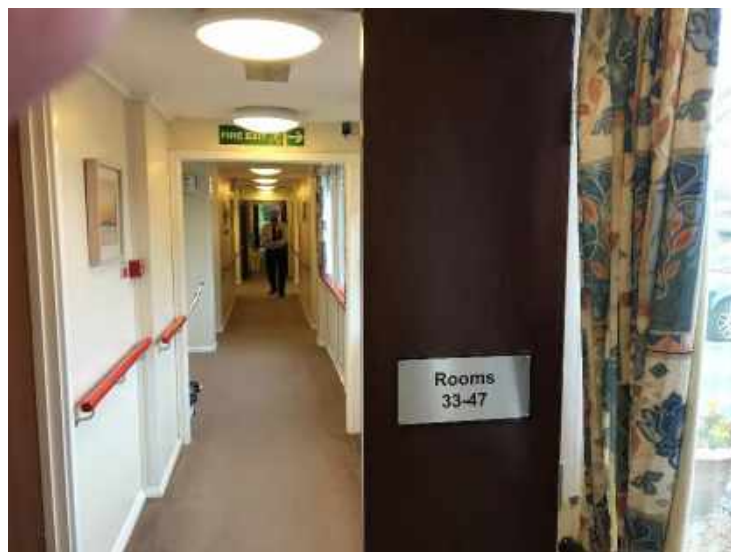
Photograph No 53 – Typical Bedroom Corridor lighting.

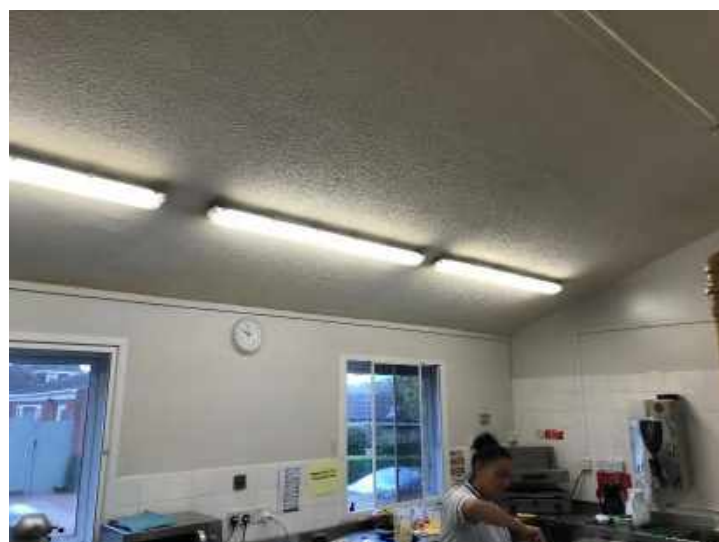
Photograph No 54 – Main Kitchen Lighting

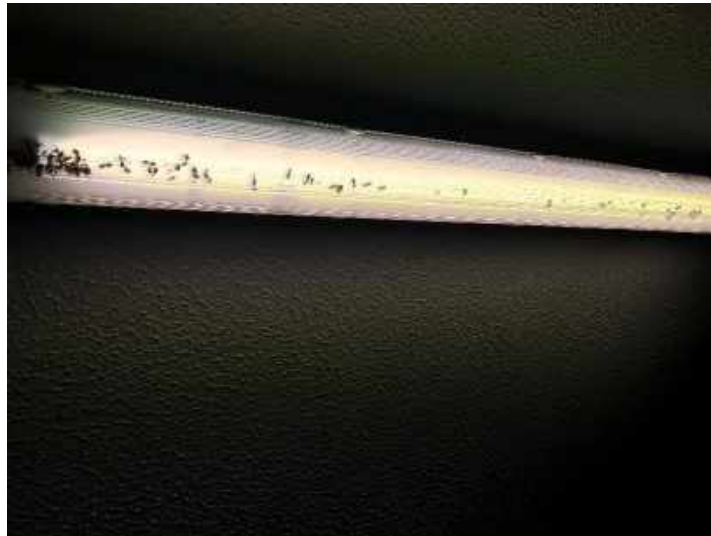
Photograph No 55 – Laundry luminaire full of dead flies.

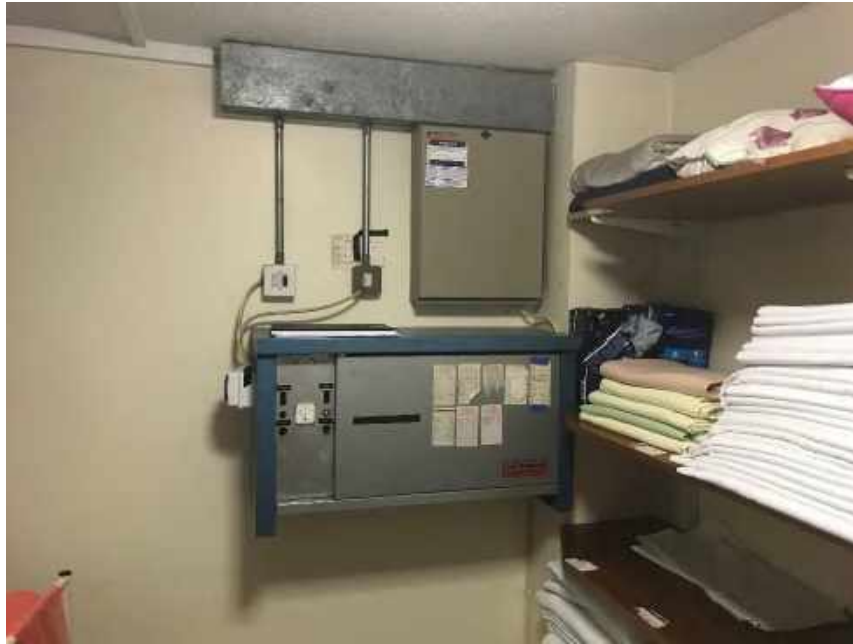
Photograph No 56 – Typical central battery unit

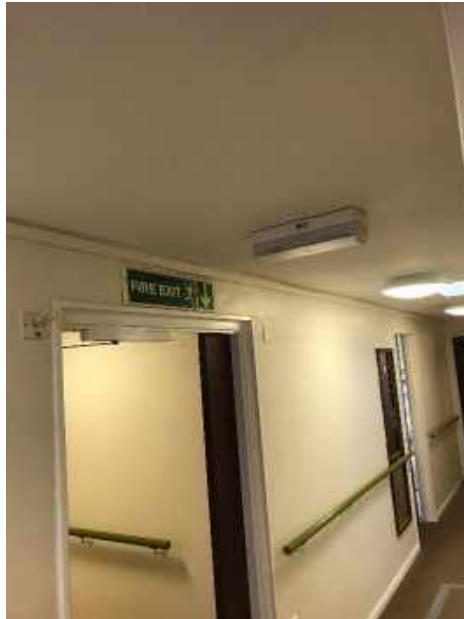
Photograph No 57 – Correct positioning of emergency lighting required

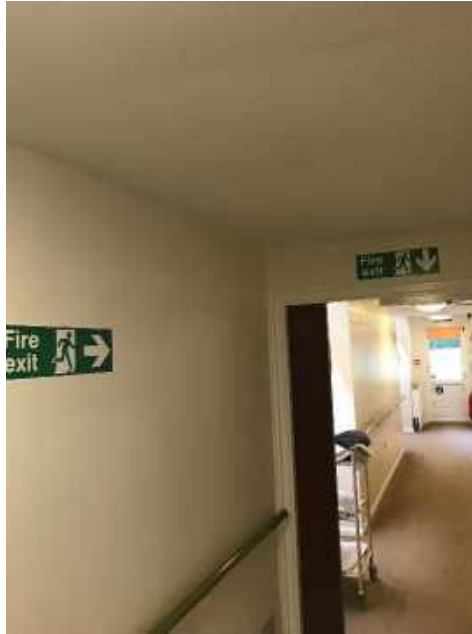
Photograph No 58 – Supplementary emergency lighting required

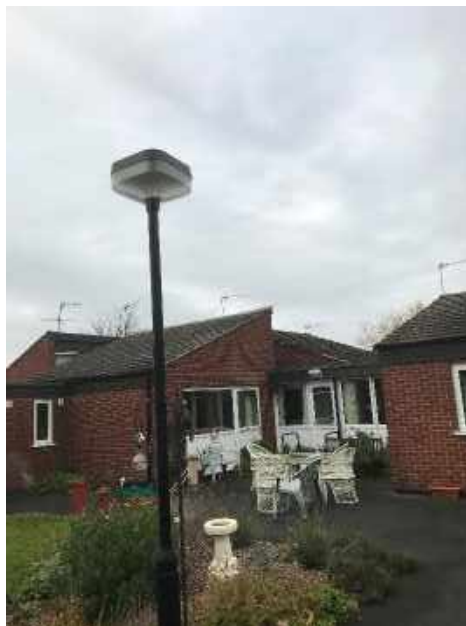
Photograph No 59 – There are a few lighting column on the site illuminating the main garden areas.

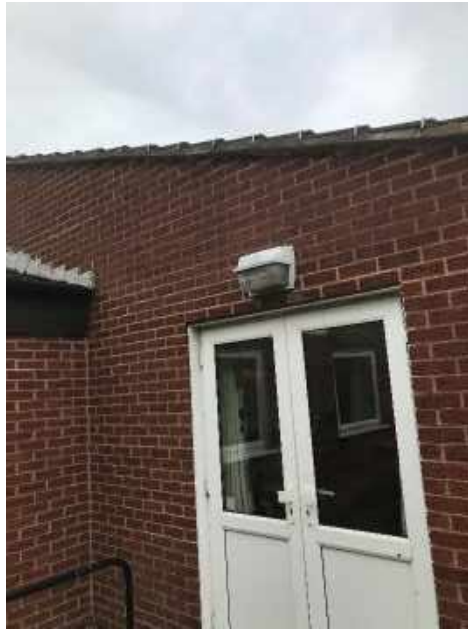
Photograph No 60 – Typical wall mounted bulkhead luminaire a fire exit door. It was not clear if these were emergency luminaires.

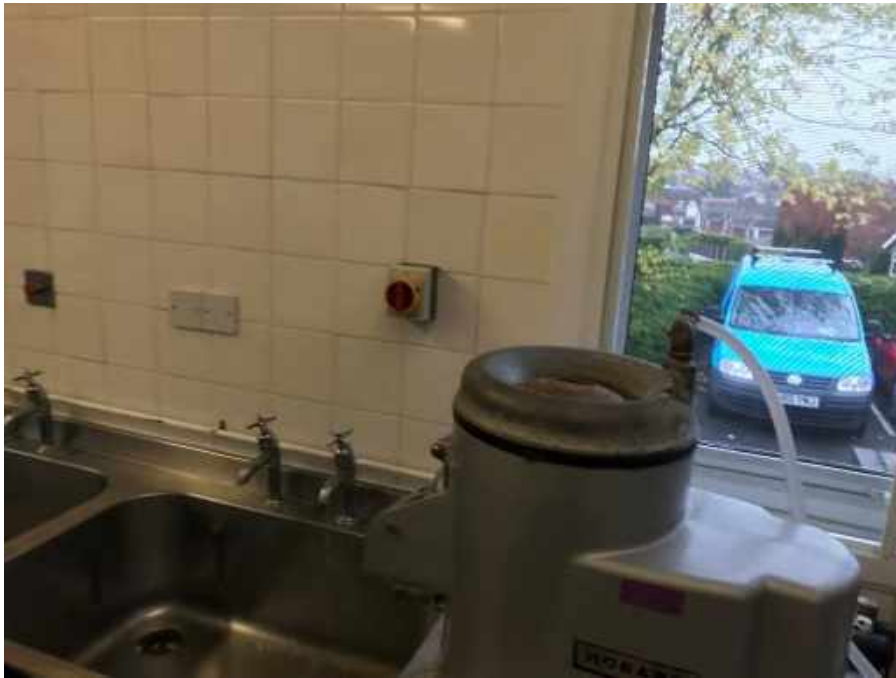
Photograph No 62 – Kitchen equipment via local isolator with emergency stop button

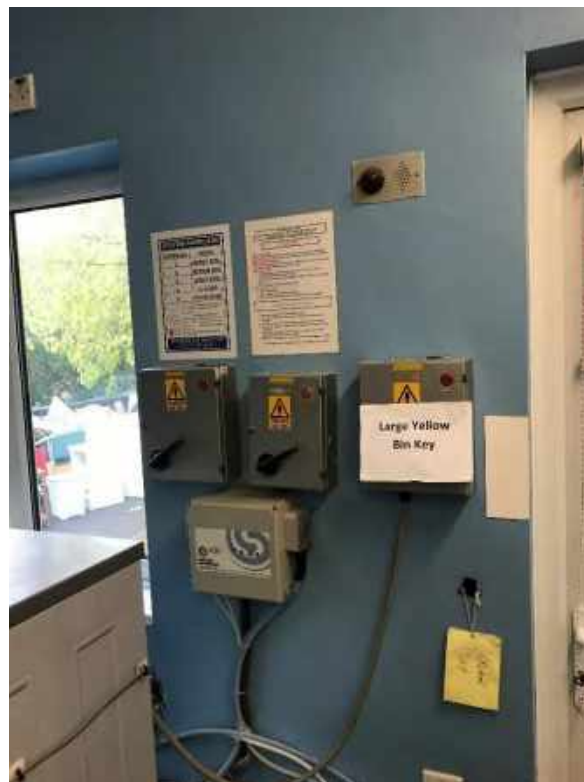
Photograph No 63 – 3 Phase isolators supplying laundry equipment

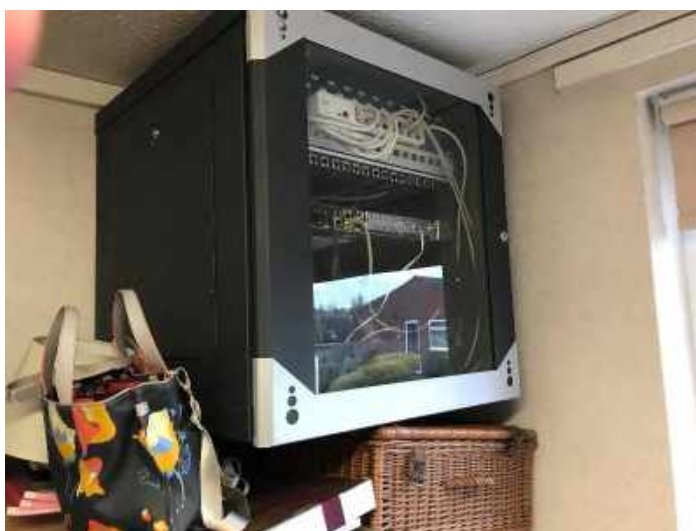
Photograph No 64 – Data rack installed in office.

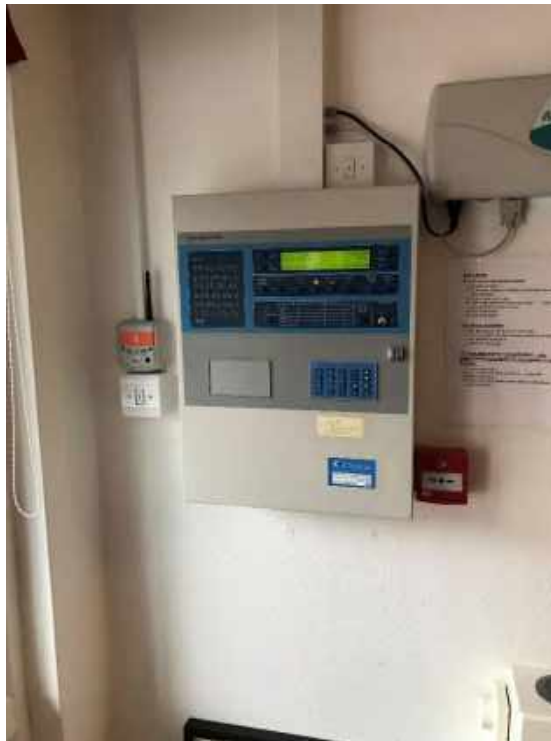
Photograph No 65 – New addressable fire alarm panel located in the main entrance.

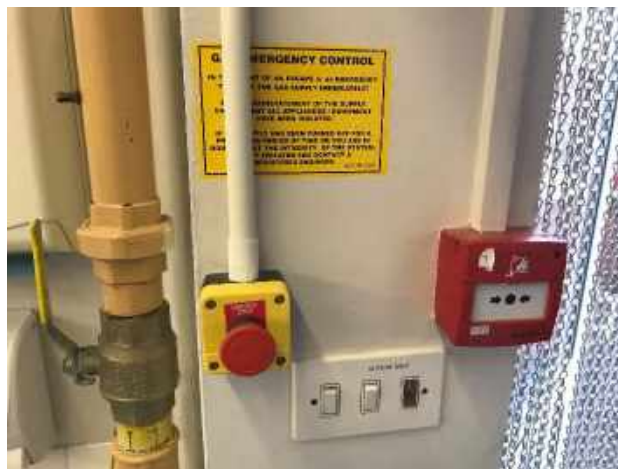
Photograph No 68 – Manual call points are not fitted with covers

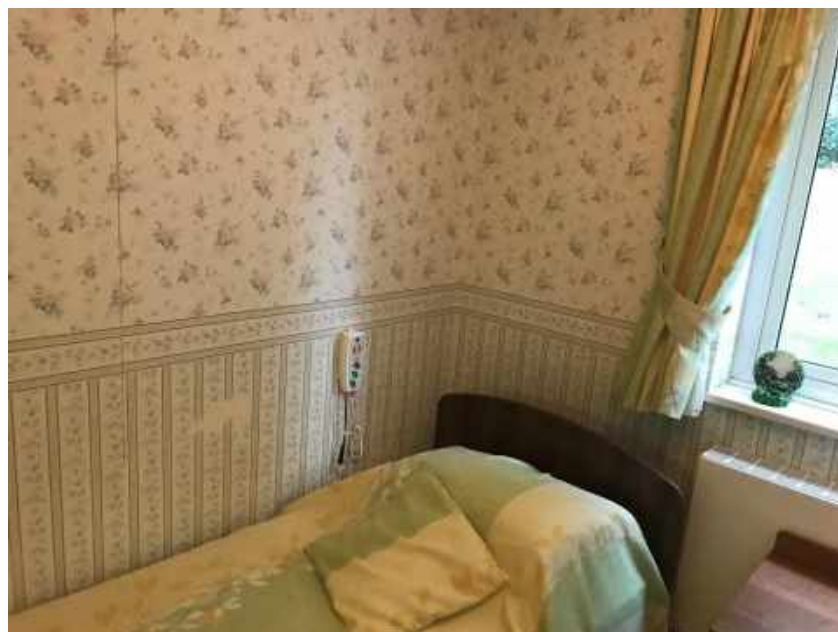
Photograph No 70 – Typical bedroom showing nurse call system.

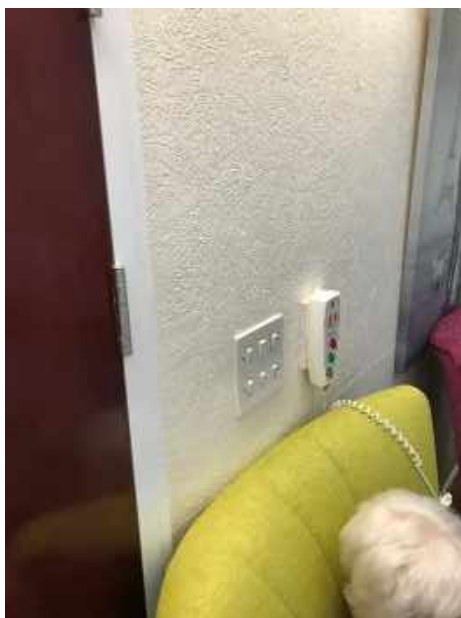
Photograph No 71 – Nurse call point within day area

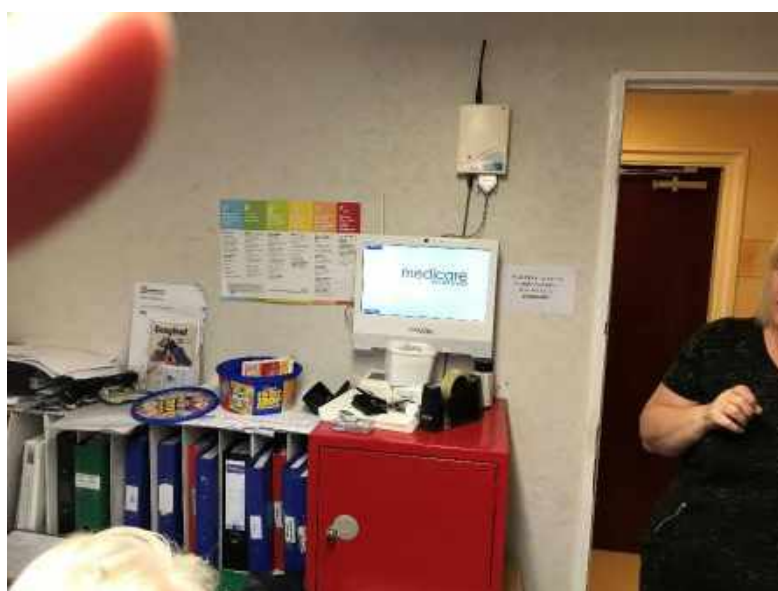
Photograph No 72 – Master Nurse Call system monitor located within office.

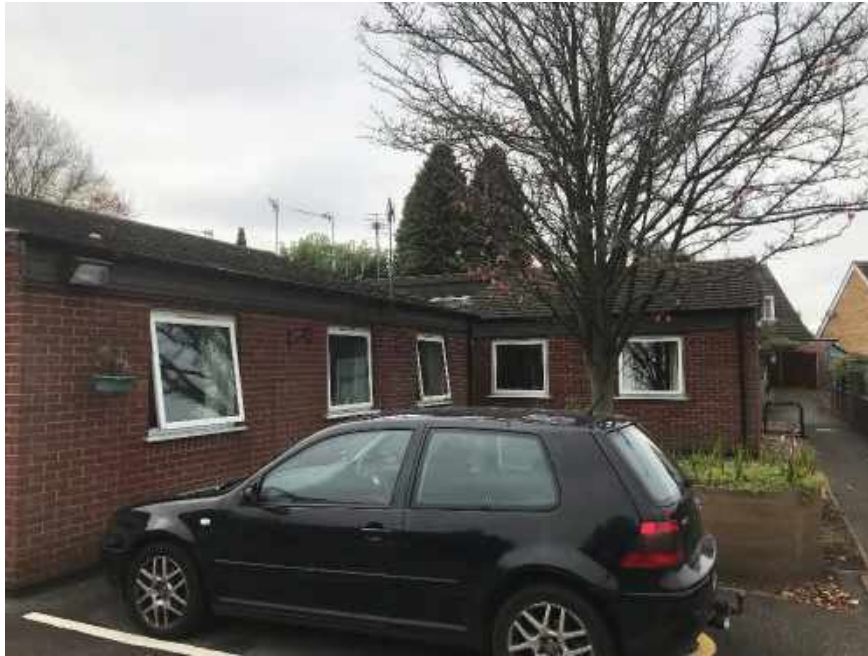
Photograph No 73 – Terrestrial TV aerials at roof level.
