DERBYSHIRE COUNTY COUNCIL

# East Clune HOP

## Condition Survey

January 2019

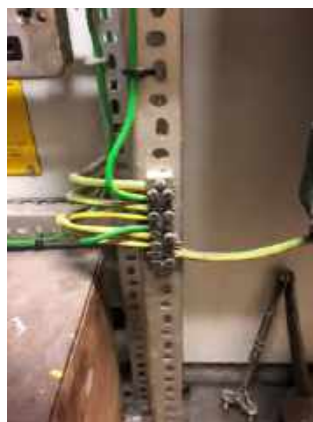
Photograph No 6 – The main earth bar is not up to current standards and needs to be replaced but it is not clear if all of the main earth bonds have been installed as the cabling has not been labelled.

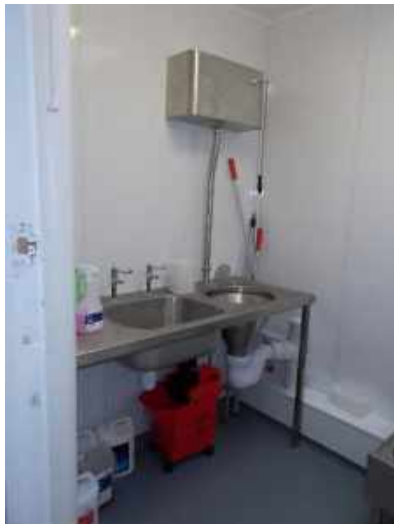
Photograph No 19 – Typical stainless steel sluice in sluice rooms.

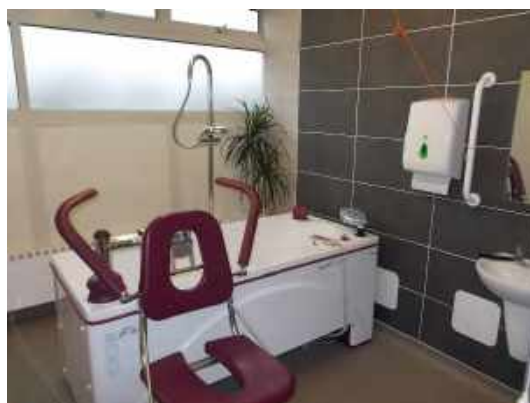
Photograph No 20 – Refurbished assisted bathroom with new bath fitted on 1<sup>st</sup> floor (room No 121). There is one existing bathroom with a new bath (room No 037) and one existing bathroom with an old bath (room No 021)

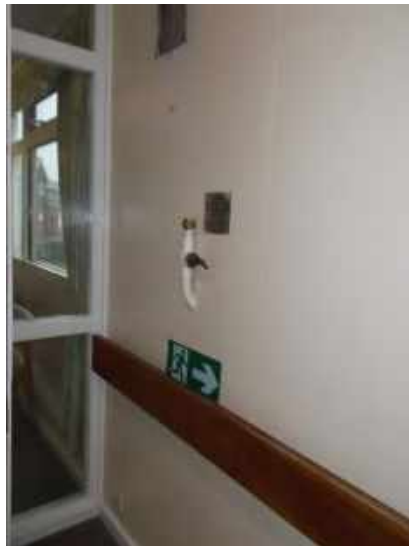
Photograph No 26 – Redundant hose reel installed at 1<sup>st</sup> floor level, it is not known if this or additional hose connections is still connected to the incoming main cold water system. If so this could cause issues with legionella and dead legs.

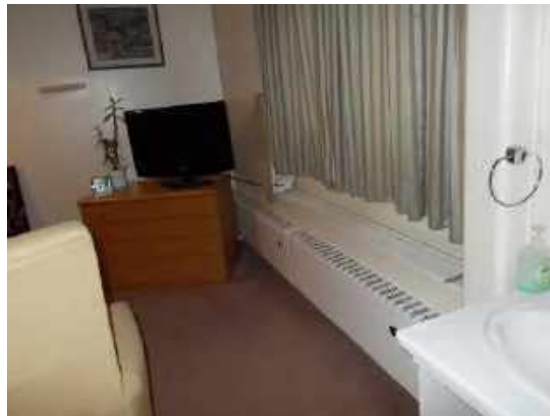
Photograph No 30 – Typical bedroom wall mounted LST radiators, these do not appear to have thermostatic valves fitted.

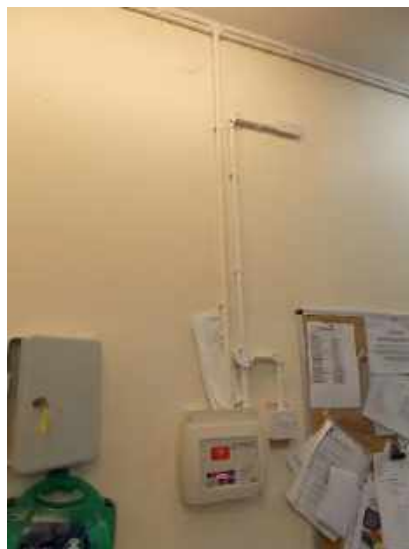
Photograph No 36 – Kitchen gas/ventilation interface control panel.

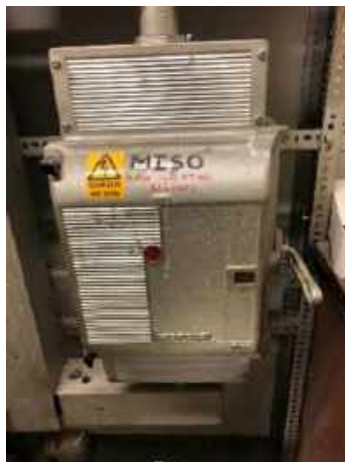
Photograph No 49 – Bill Red Spot Main Switch.

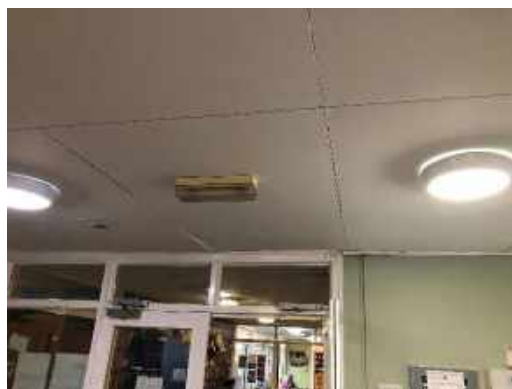
Photograph No 73 – Typical slave emergency lighting module, these are currently being replaced with a 24V LED luminaire.

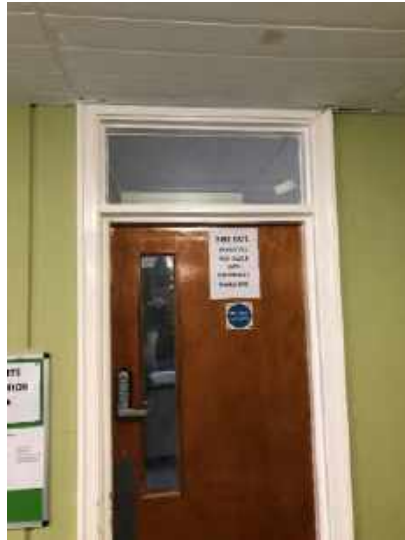
Photograph No 74 – This door is labelled as a fire exit but there is no Exit sign installed over the door.

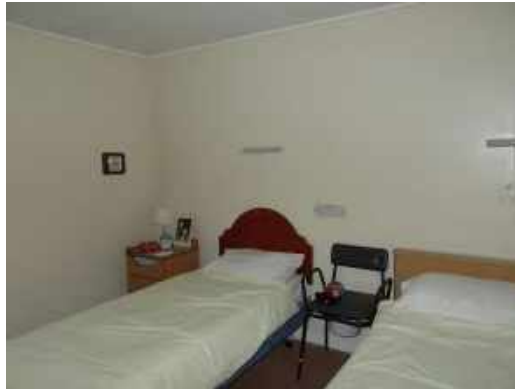
Photograph No 82 – Twin bedded bedroom with a twin socket between beds. This room had a single occupant with a hospital bed. Note there is a light over the bed head.

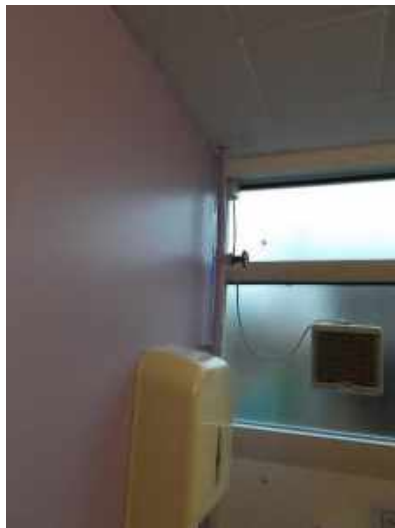
Photograph No 83 – Typical assisted bathroom extract fan power supply.

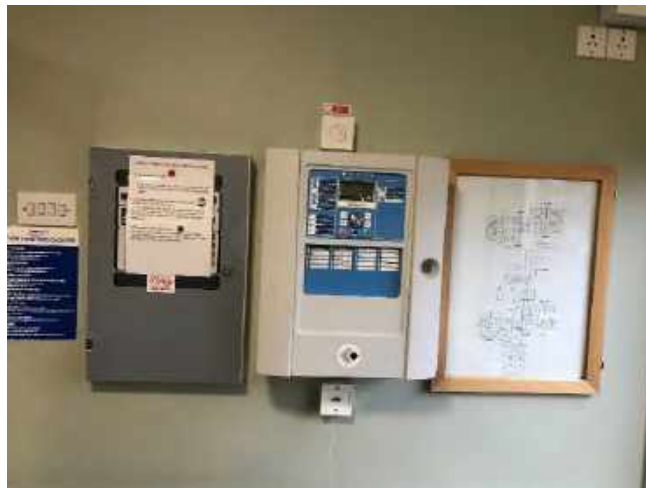
Photograph No 87 – New addressable fire alarm panel located in the main entrance. Note the original fire alarm panel has been left in place.

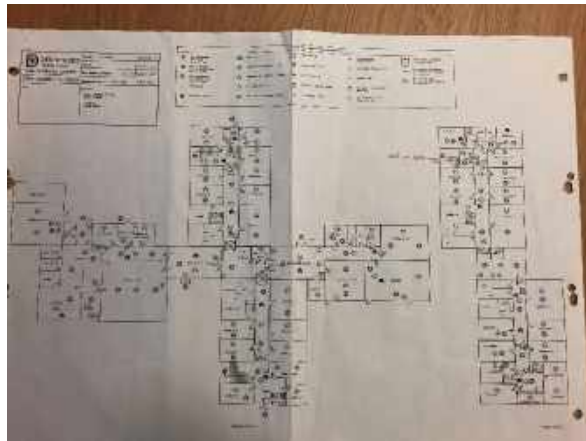
Photograph No 88 – Life safety drawing showing all detection. This drawing may not be accurate as the fire alarm system has been replaced. This drawing needs to be replaced with an updated drawing, the zonal diagram needs to be replaced with new.

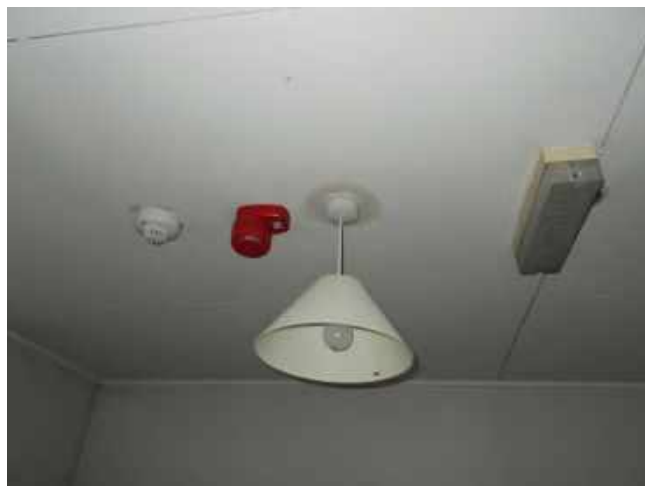
Photograph No 89 – Flat smoke detector with a visual alarm device (VAD) installed. Not all areas covered with VAD's.

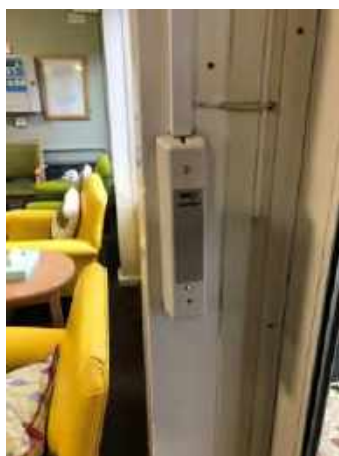
Photograph No 91 – Main entrance door with FirstQ watchguard system installed. It is assumed that this has been replaced by the ARM nurse call system.

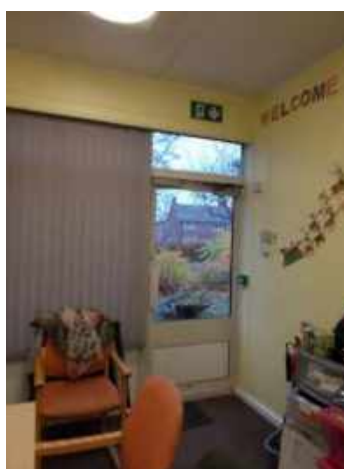
Photograph No 92 – Fire exit door with automatic door controls fitted. It was not clear if this door has been linked to the fire alarm system.

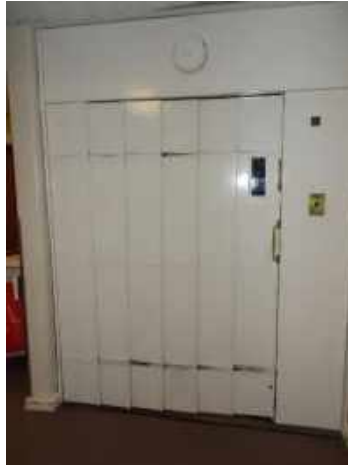
Photograph No 99 – Existing Passenger lift.

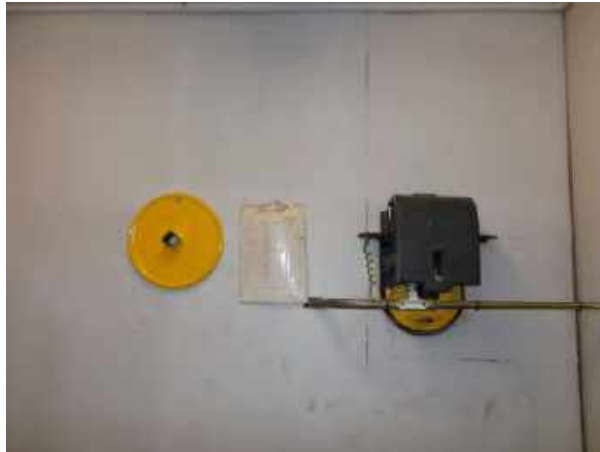
Photograph No 105 – Existing Passenger lift over speed protection device with no rope fitted, it is not clear if this has been replaced with a modern system.

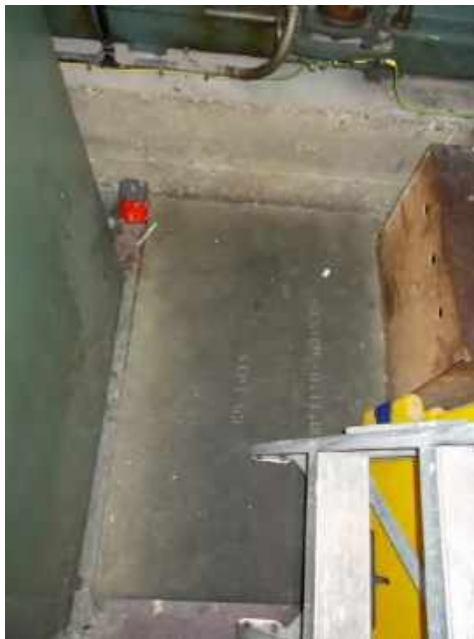
Photograph No 106 – Existing Passenger lift rubber mat in the lift machine room, this mat is dated September 1993. This mat needs to be replaced with a new mat.
