DERBYSHIRE COUNTY COUNCIL

Gernon Manor HOP

Six Facet Survey

22nd November 2018

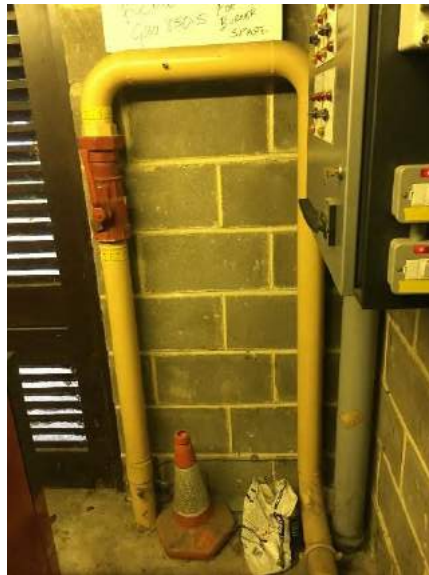
Photograph No 1 – Incoming gas into main boilerhouse complete with manual valve to serve main boilers.

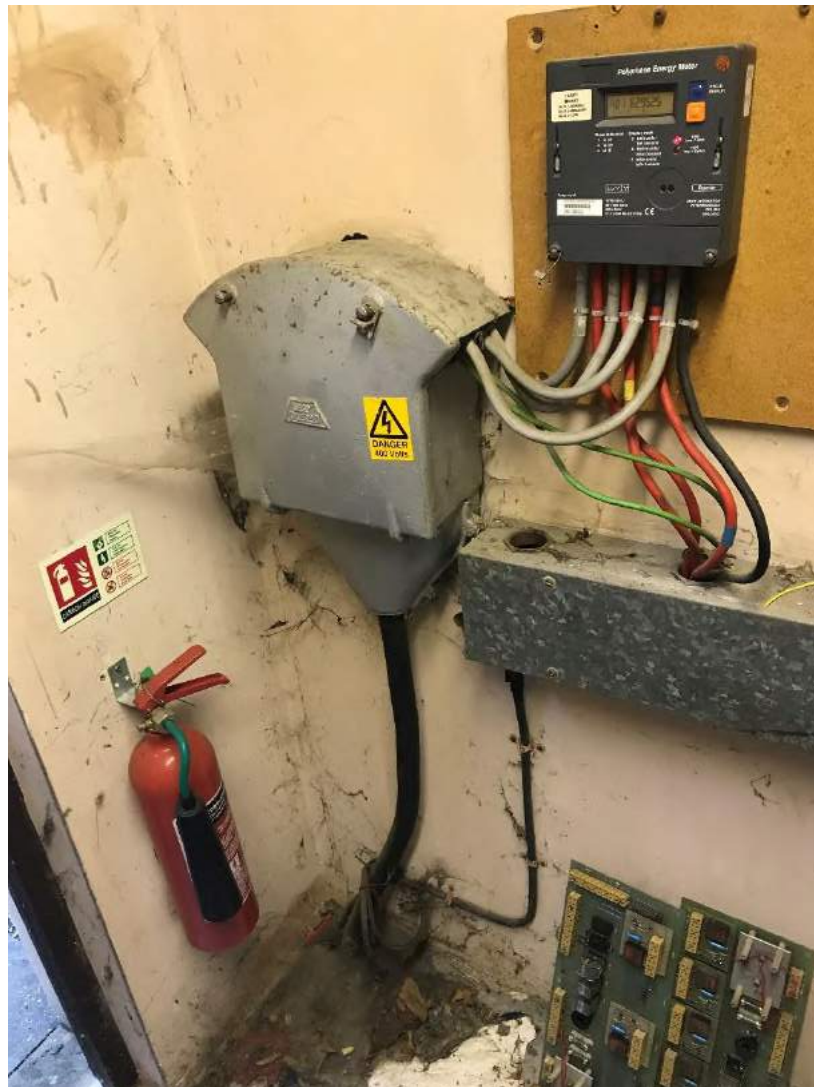
The electrical incoming utility supply enters the building in an electrical switchroom room No. 022 wing and contains the incoming service head which is a Lucy cut-out and utility meter. The building has a 3 phase 100A supply with the meter being a direct reading meter

Photograph No 9 – Incoming electrical utility supply and utility meter.

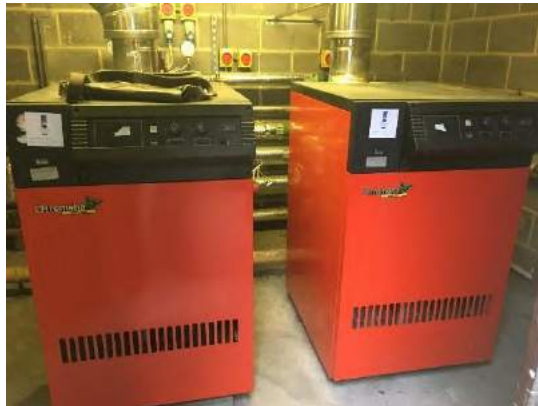
Photograph No 10 – 2 No. Remeha boilers located in main boilerhouse.

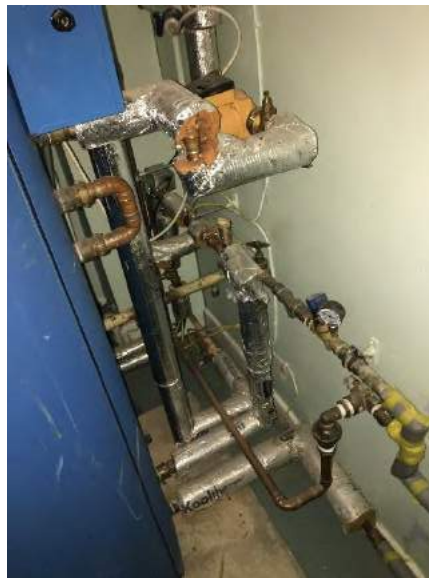
Photograph No 29 – Pipework not insulated, damage to insulation and poor quality insulation installed in place with tape holding it together.

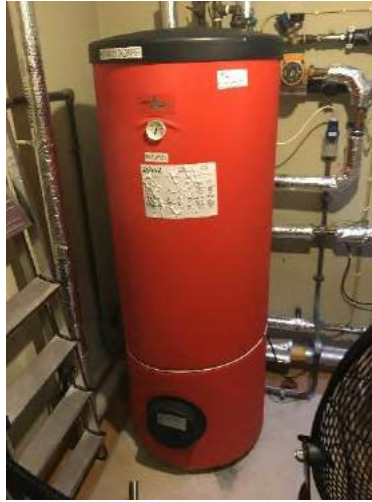
Photograph No 30 – Dovedale Wing – Remeha calorifier for the domestic HWS generation.

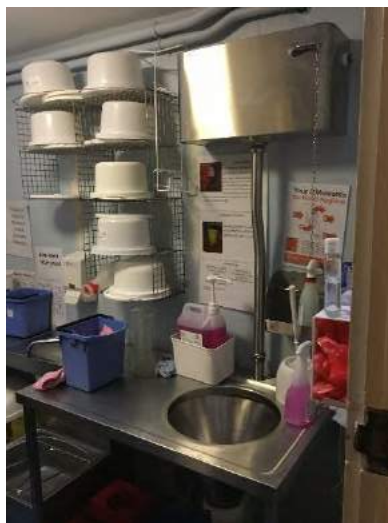
Photograph No 34 – Typical stainless steel sluice in sluice rooms.

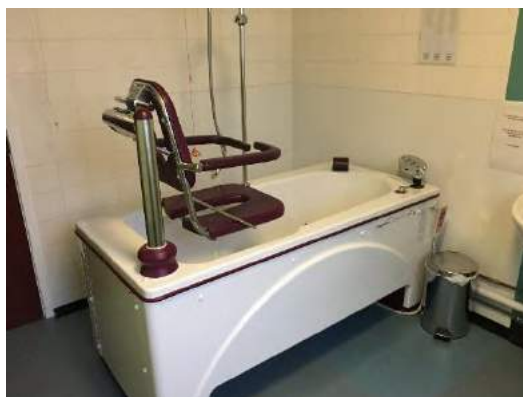
Photograph No 35 – Typical bathroom in bedroom blocks.

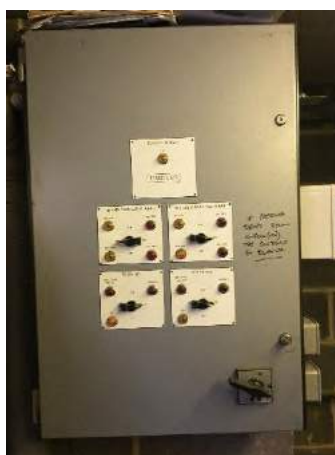
Photograph No 37 – Boiler and HWS plant control panel located in main boilerhouse. Note handwritten comment on panel "if pressure drops below 0.8 bar (ish) controls go blank"

The controls system is at the end of its life and should be replaced with a more energy efficient BMS controls system and this should be incorporated during a boiler and HWS plant replacement programme.

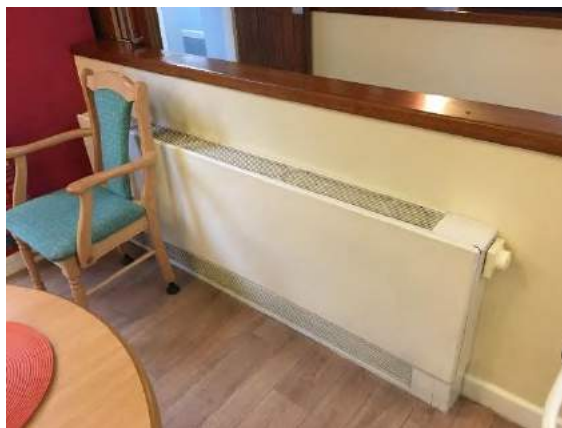
Photograph No 43 – Typical wall mounted LST radiator

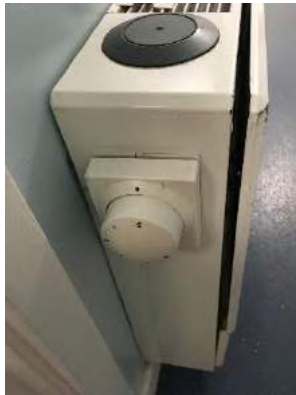
Photograph No 44 – Typical LST radiator. Note radiators are looking tired and damaged, casing on radiator falling away.

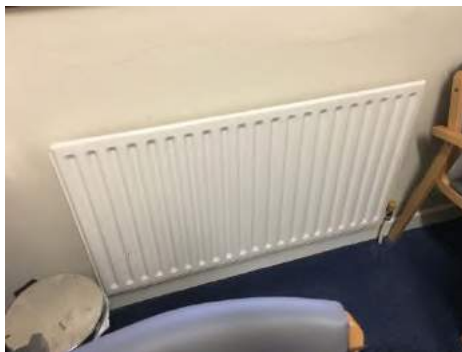
Photograph No 45 – Typical panel style radiator installed in office.

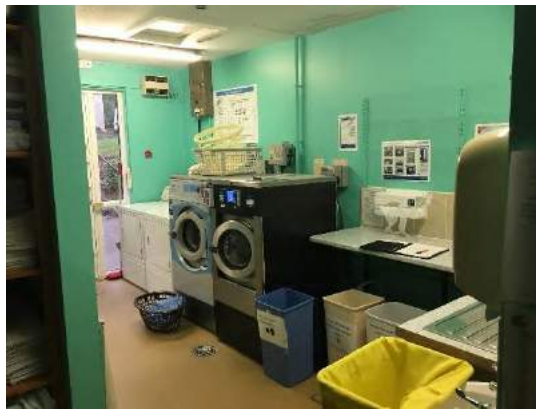
Photograph No 56 – Laundry washing machines and dryers.

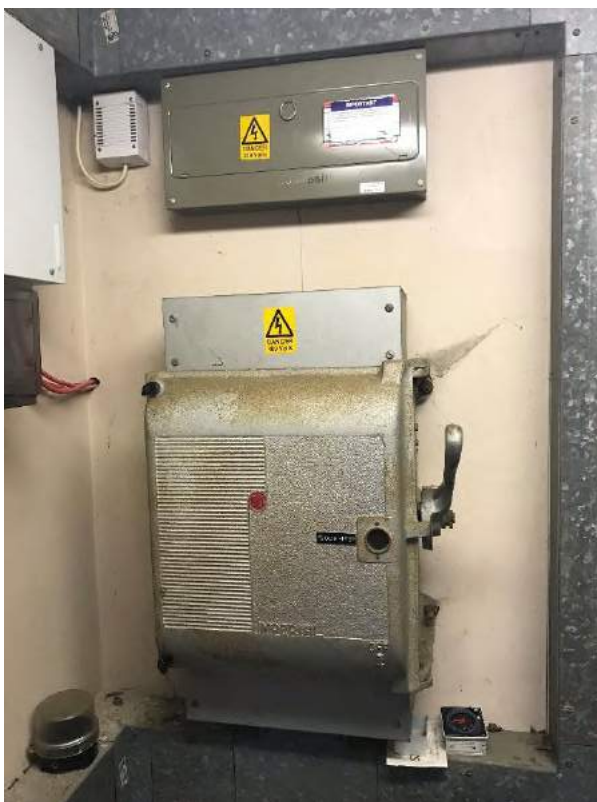
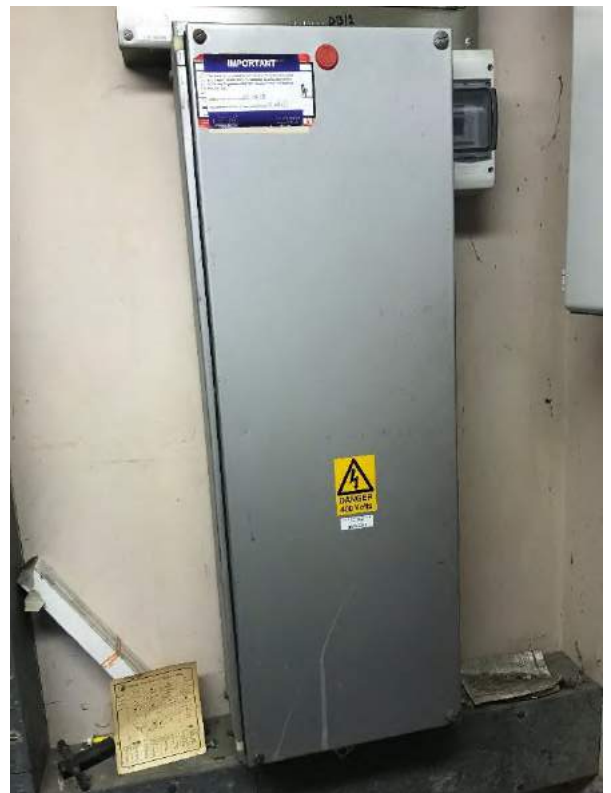
The switchgear arrangement and type does not achieve the required electrical discrimination and has limited RCD protection and should be replaced with more modern switchgear.

Photographs No 61 & 62 – Main incoming isolator and 8 way TPN HRC main distribution board

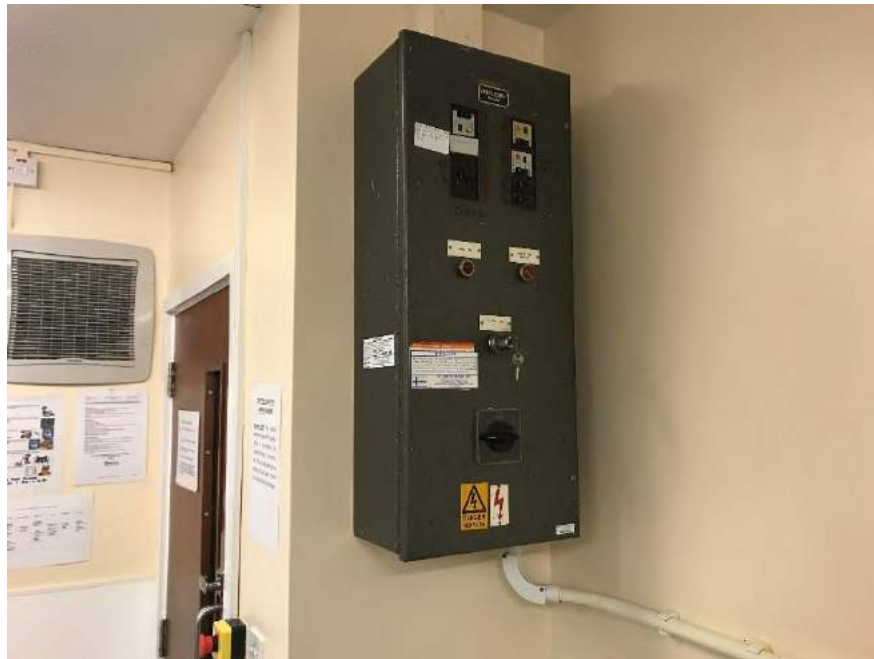
Photograph No 63 – TPN Distribution Board Serving Kitchen

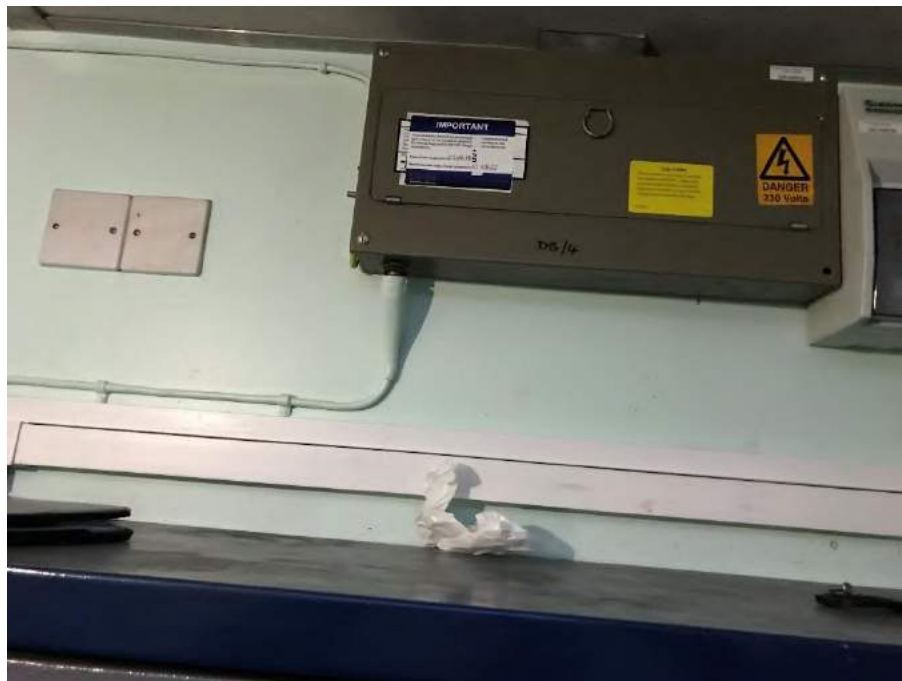
Photograph No 64 – Typical SPN MCB Distribution Board Serving a Bedroom Wing

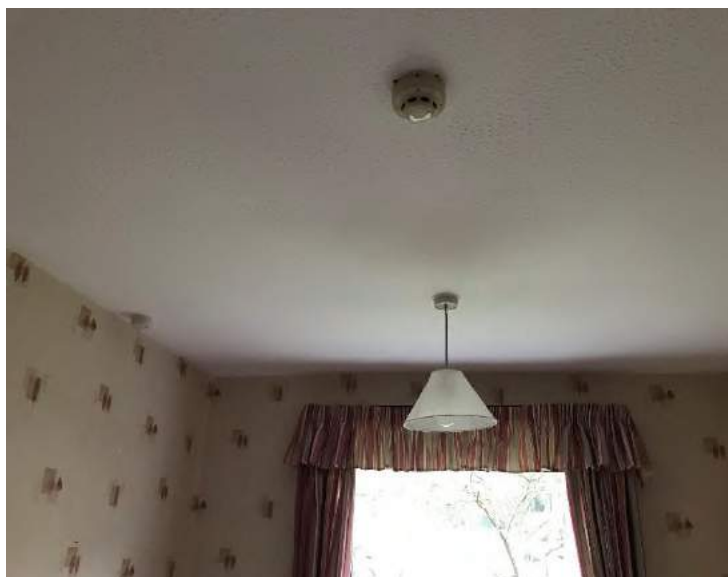
Photograph No 65 – Typical bedroom central pendant luminaire

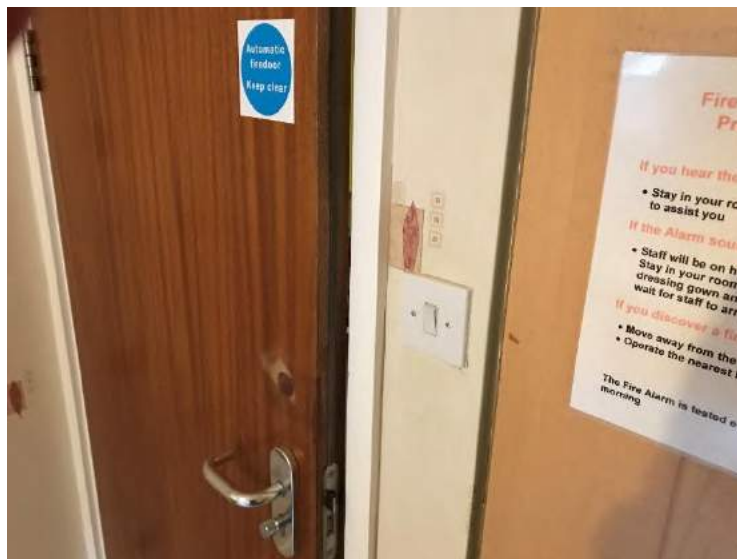
Photograph No 66 – Lighting switch for bedroom central pendant luminaire

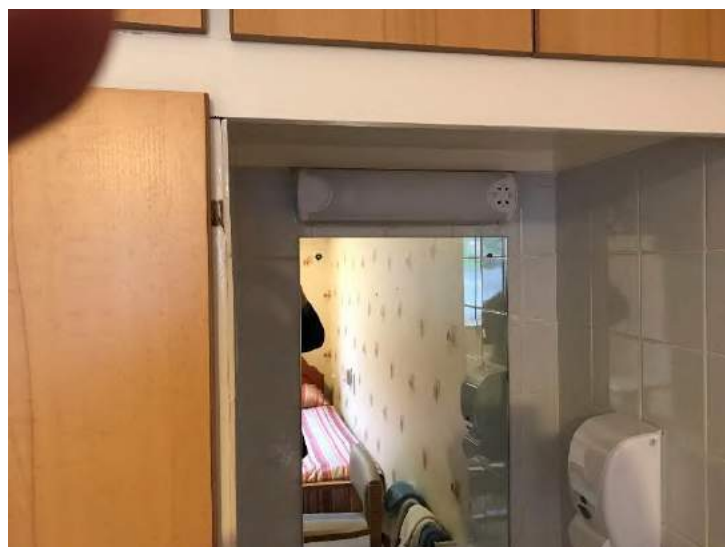
Photograph No 67 – Typical bedroom mirror luminaire.

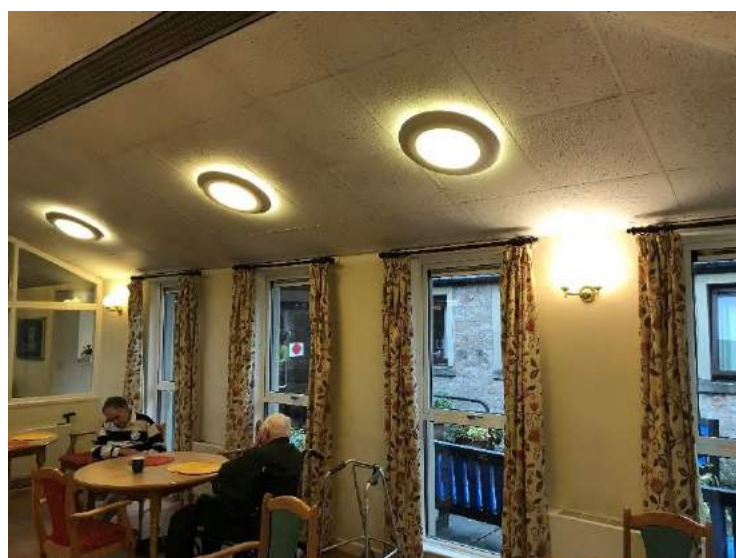
Photograph No 68 – Amenity lighting

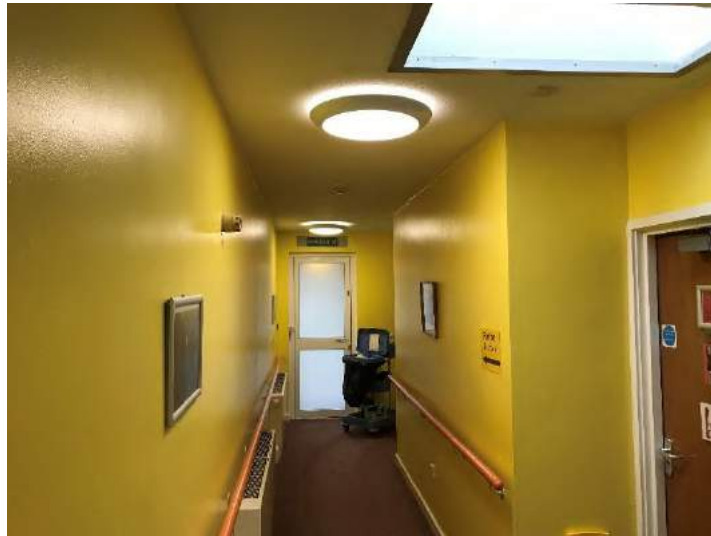
Photograph No 69 – Typical Bedroom Corridor lighting.

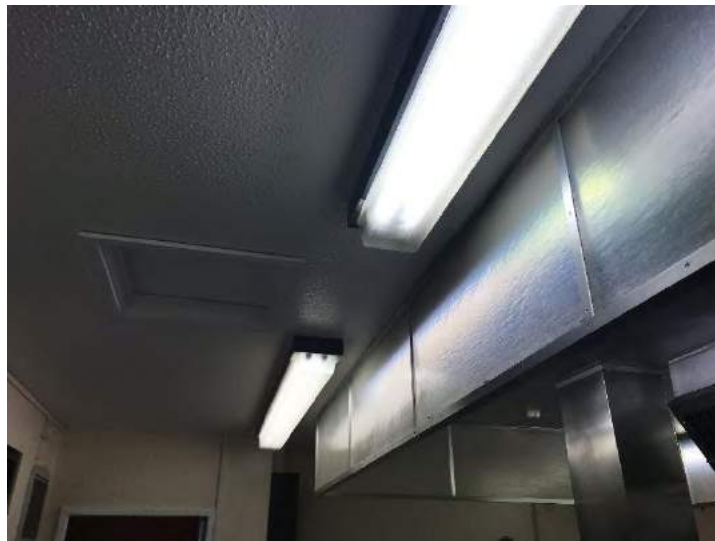
Photograph No 70 – Main Kitchen Lighting

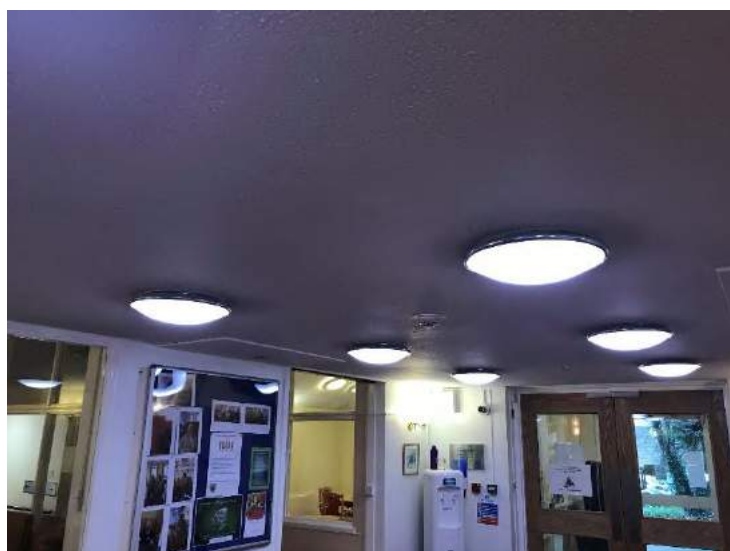
Photograph No 71 – New LED lighting in reception area.

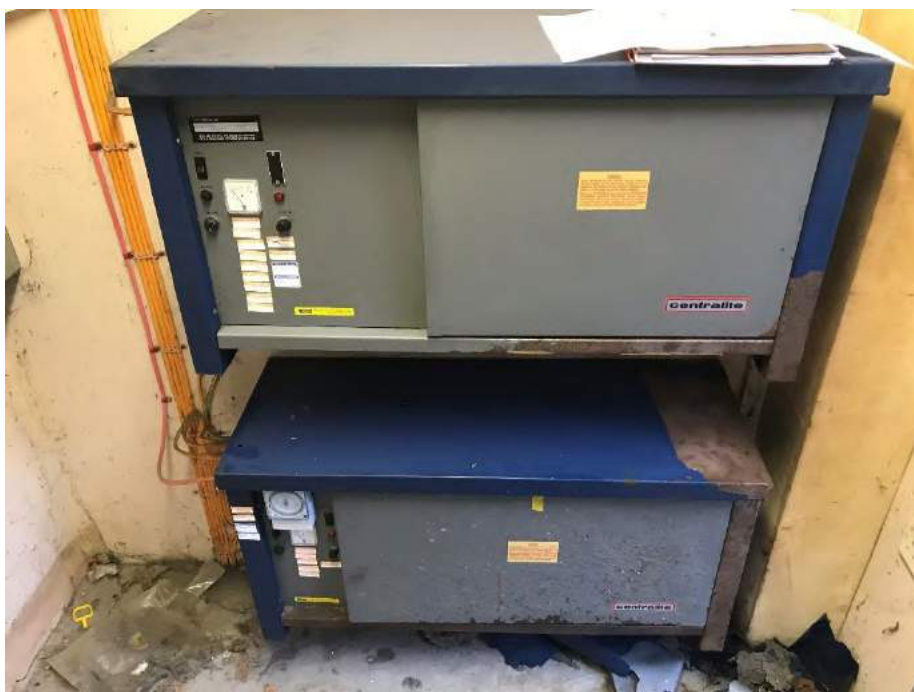
Photograph No 72 – Existing central battery units within switchroom

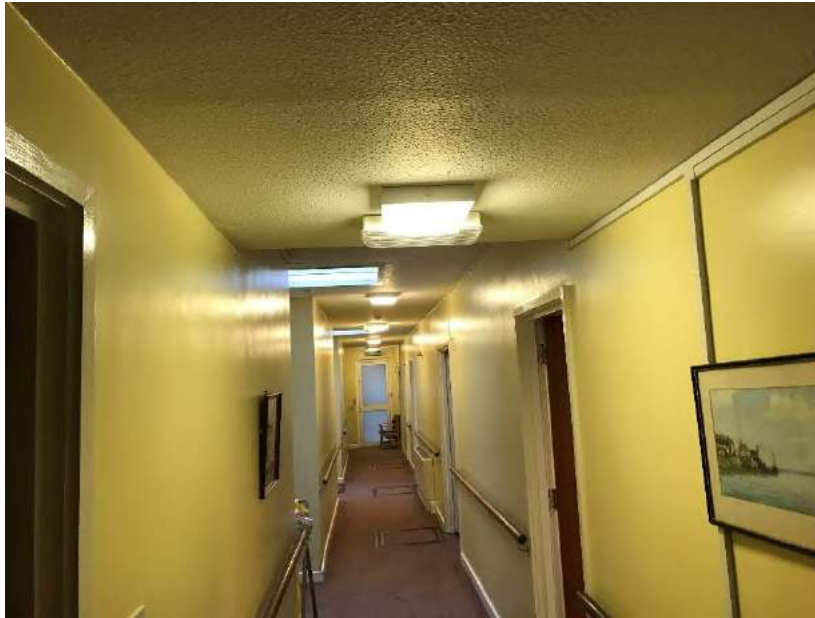
Photograph No 73 – New self-contained emergency lighting installed down the central corridors.

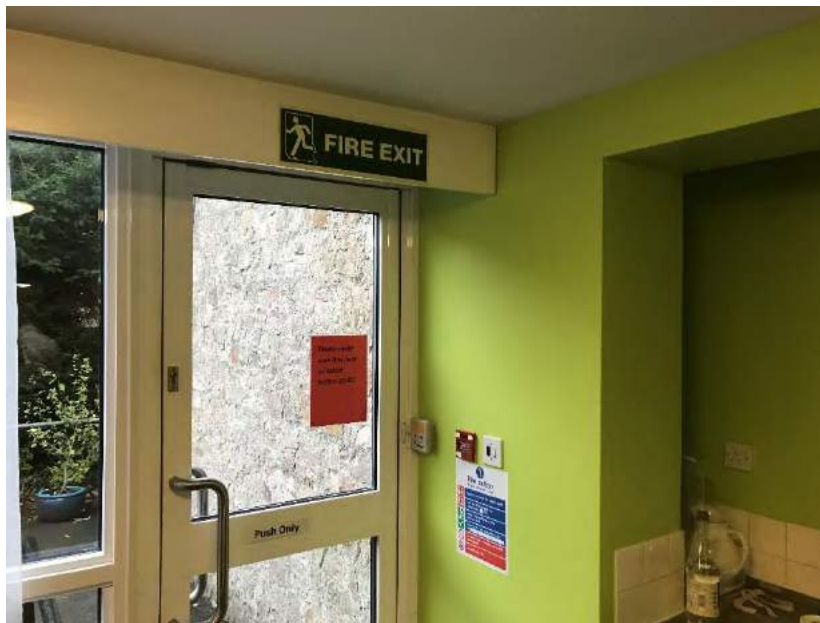
Photograph No 74 – Supplementary emergency lighting required to illuminate sign and fire alarm call point

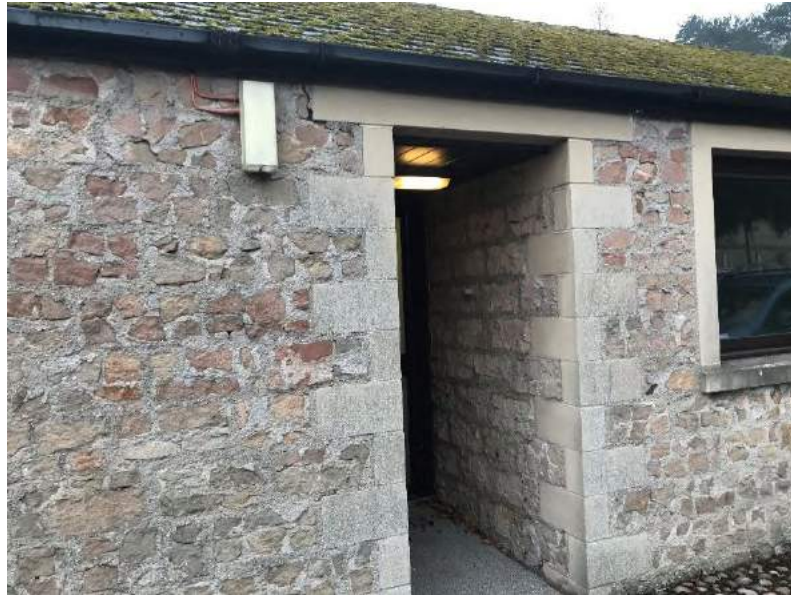
Photograph No 75 – External lighting including bulkhead emergency luminaire

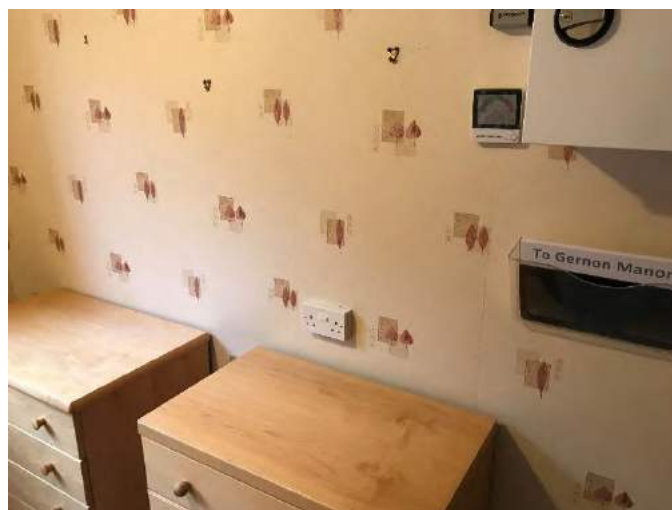
Photograph No 76 – Bedroom with sockets increased in height off the floor.

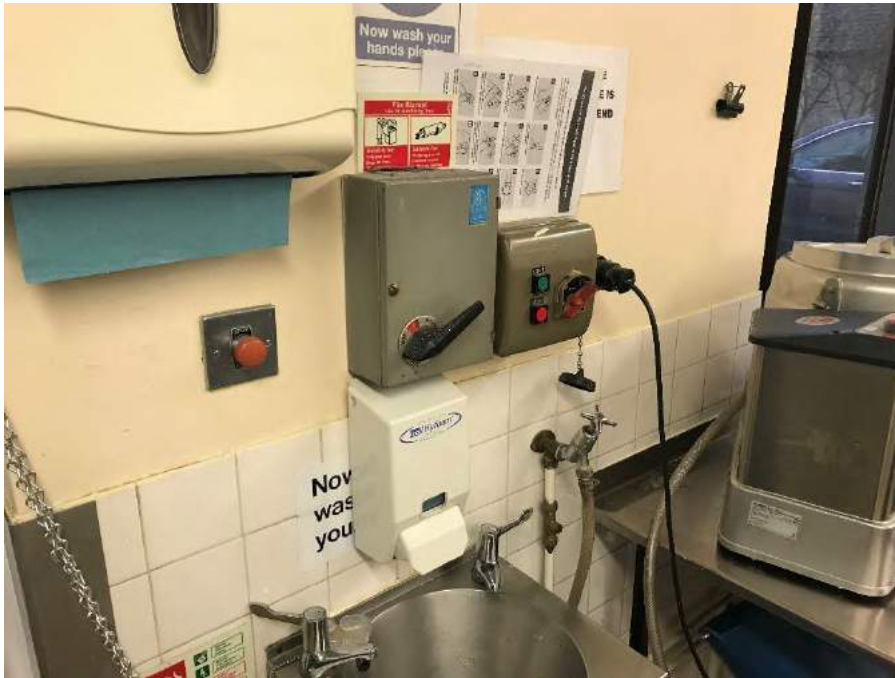
Photograph No 77 – Kitchen equipment via local isolator with emergency stop button

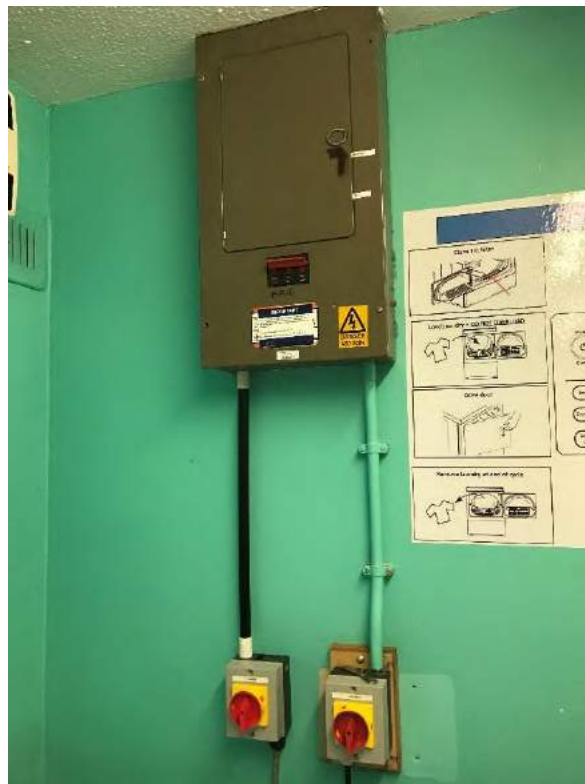
Photograph No 78 – Distribution board and isolators supplying laundry equipment

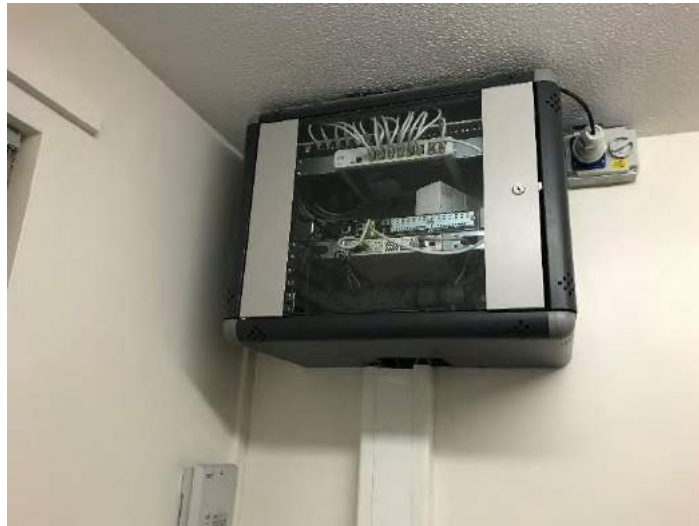
Photograph No 79 – Data rack installed in office.

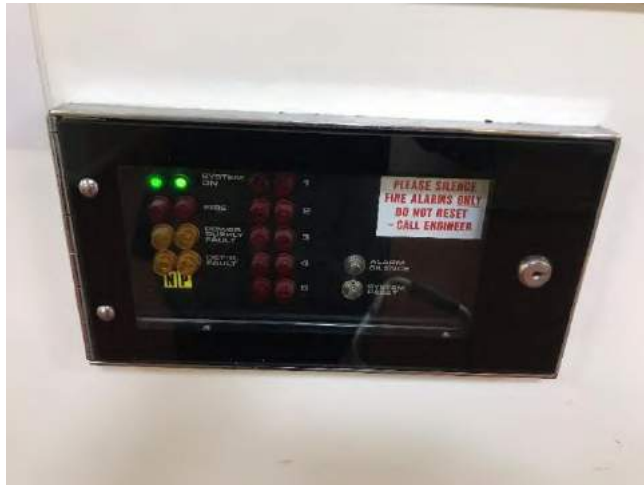
Photograph No 80 – Existing fire alarm panel original to the building.

It is recommended that the whole fire alarm system is replaced with a modern addressable system.

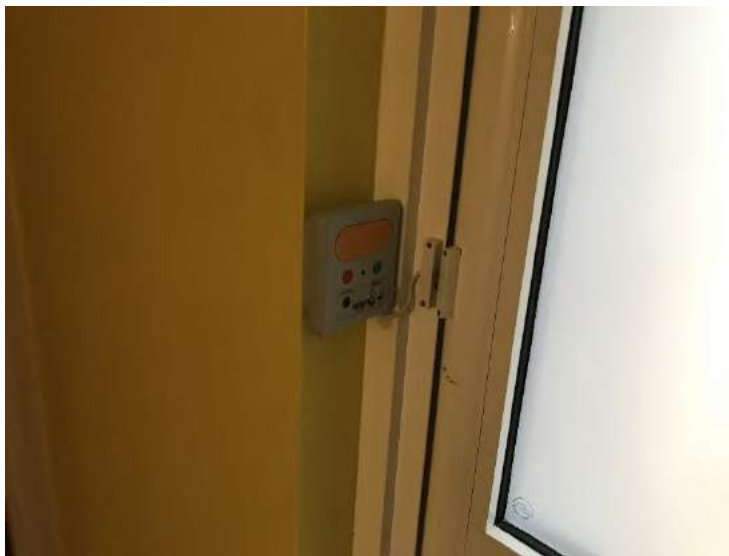
Photograph No 83 – Exit door with a call point & door monitoring function.

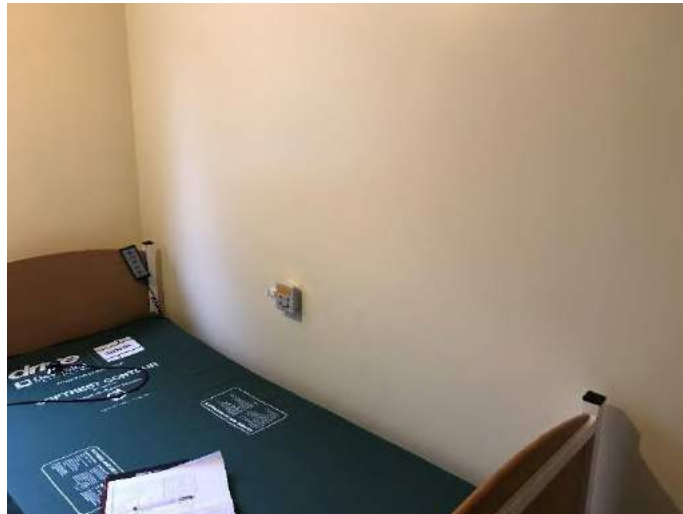
Photograph No 84 – Typical bedroom showing nurse call system.

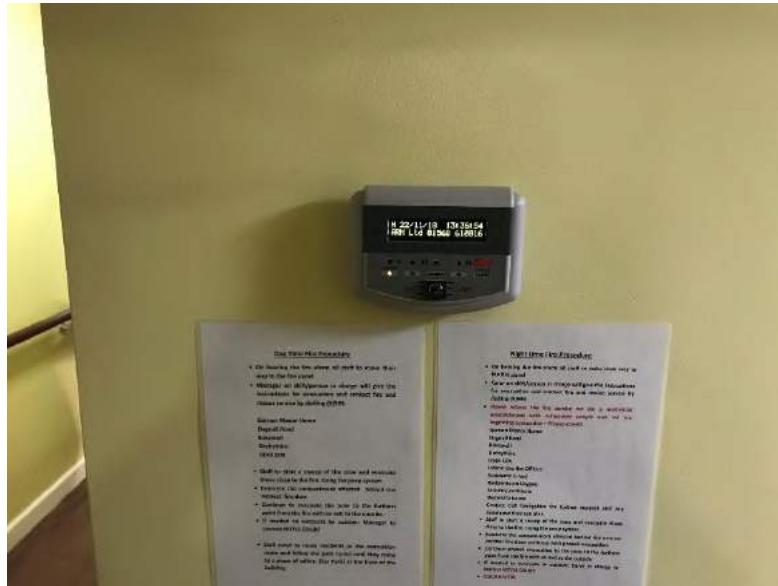
Photograph No 86 – Master Nurse Call system monitor located within a corridor.
