DERBYSHIRE COUNTY COUNCIL

Goyt Valley House HOP

Condition Survey

November 2018

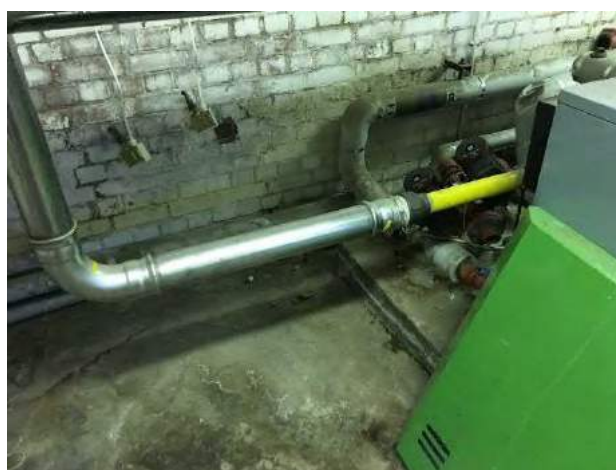
Photograph No 5 – Section of stainless steel push-fit pipework serving existing boilers.

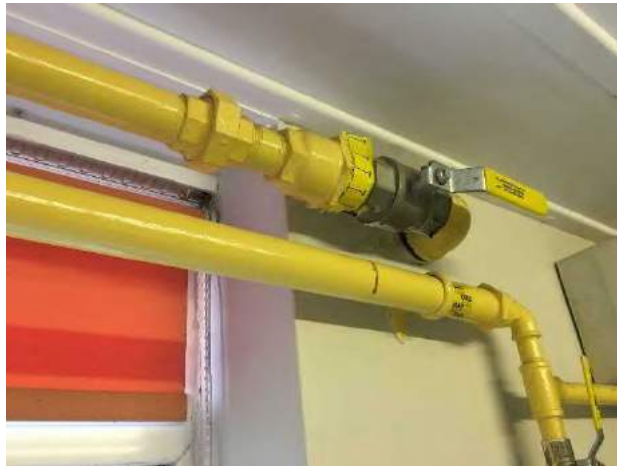
Photograph No 6 –Gas pipework enters Laundry at high level with valve and loops around laundry drying room.

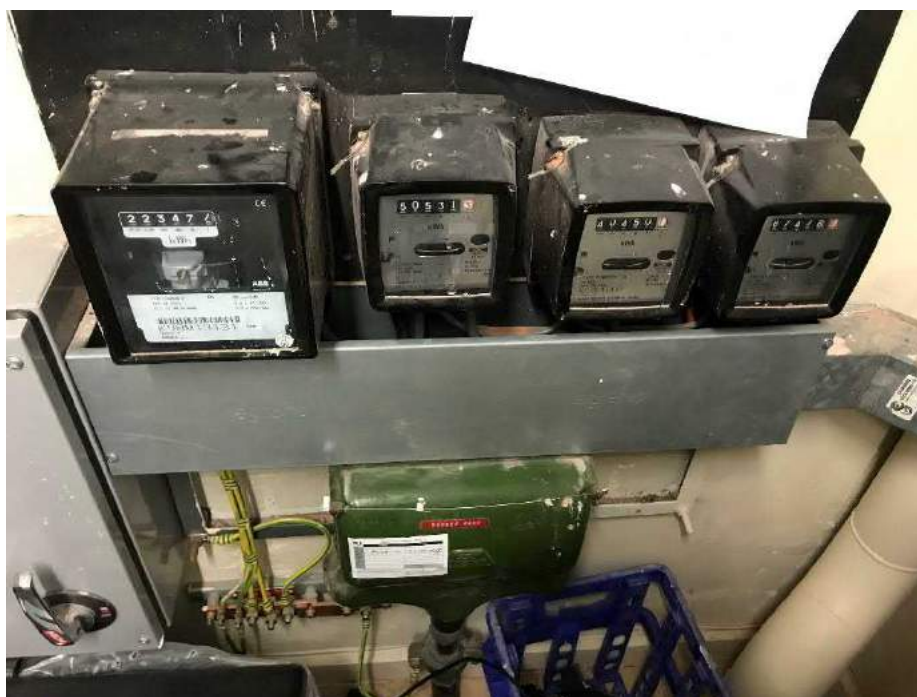
Photograph No 12 – Incoming utility meter

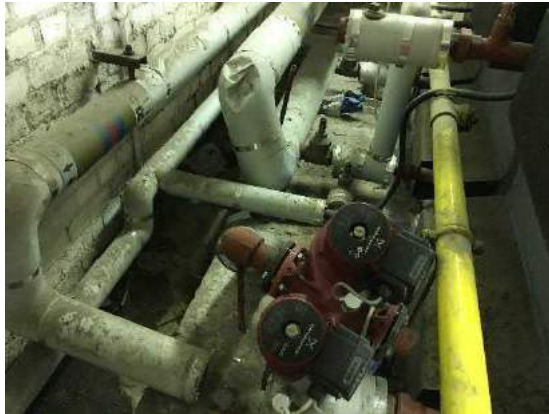
Photograph No 16 – Condition of pipework at rear of boilers, note redundant pump laying on top of pipework.

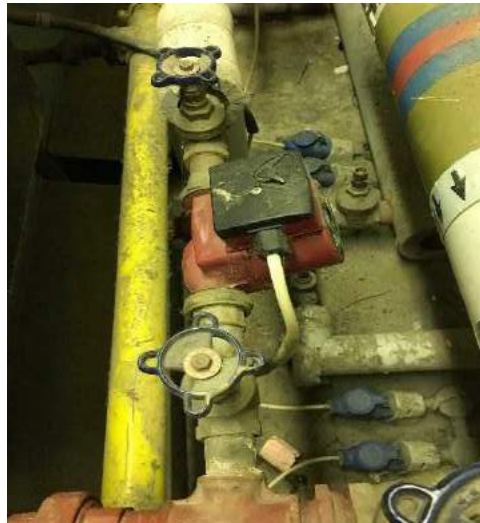
Photograph No 17 – Typical boiler shunt pump.

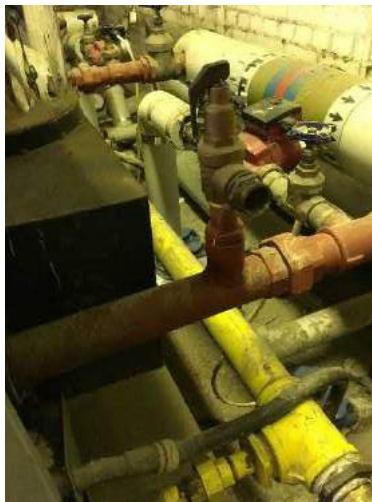
Photograph No 20 – Boiler safety valve with no discharge pipework, note insulation missing.

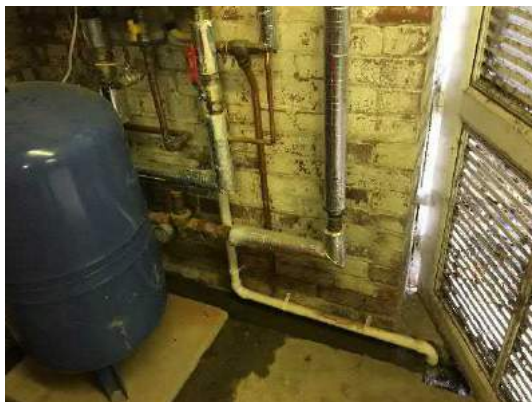
Photograph No 21 – Plastic condensate from wall mounted boiler discharges over gully, note safety valve discharges onto floor.

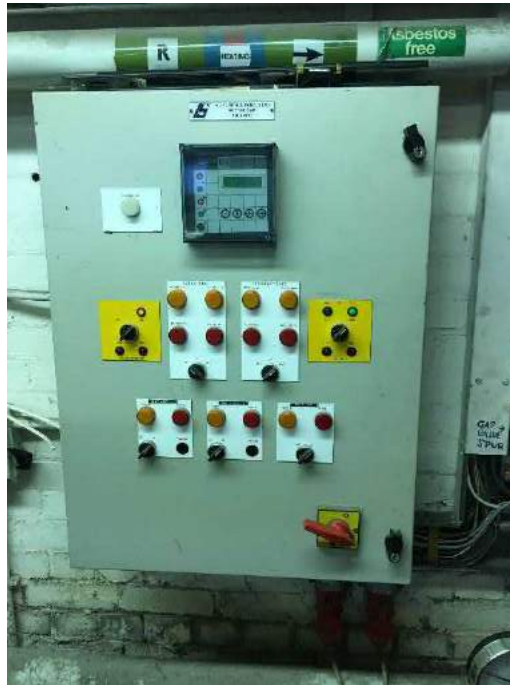
There were no controls schematics fitted within the plantrooms indicating how the controls operate and where the control devices are located.

The controls system is at the end of its life and should be replaced with a more energy efficient BMS controls system and this should be incorporated during a boiler replacement programme.

Photograph No 34 – Boiler and HWS plant control panel and system

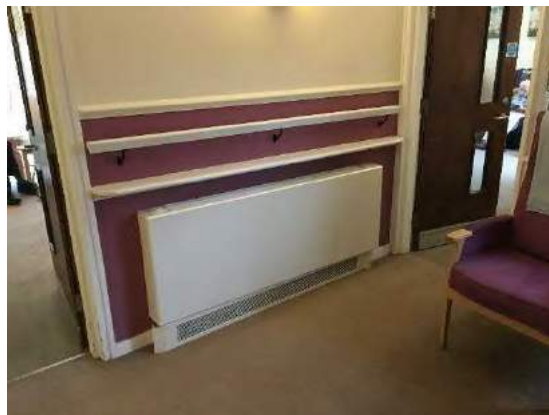
Photograph No 36 – Typical wall mounted LST radiator with pipework boxed in.

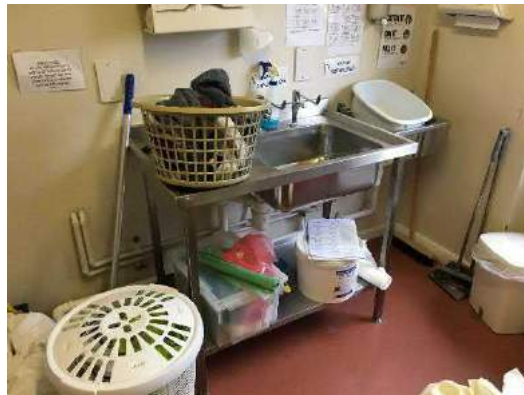
Photograph No 56 – Laundry stainless steel sink and wash hand basin with TMV

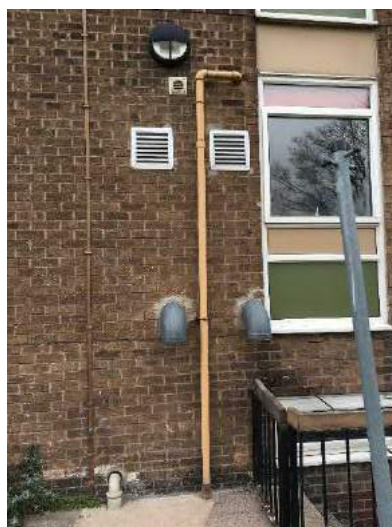
Photograph No 57 – Laundry dryer exhausts also showing 2 No. natural vents, extract fan discharge and laundry gas supply..

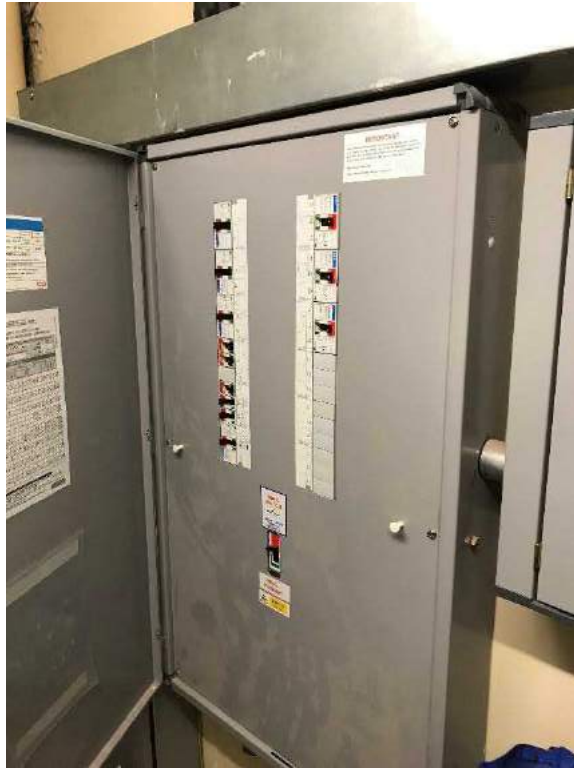
Photograph No 58 – Main Memshield 12 way TPN MCCB board)

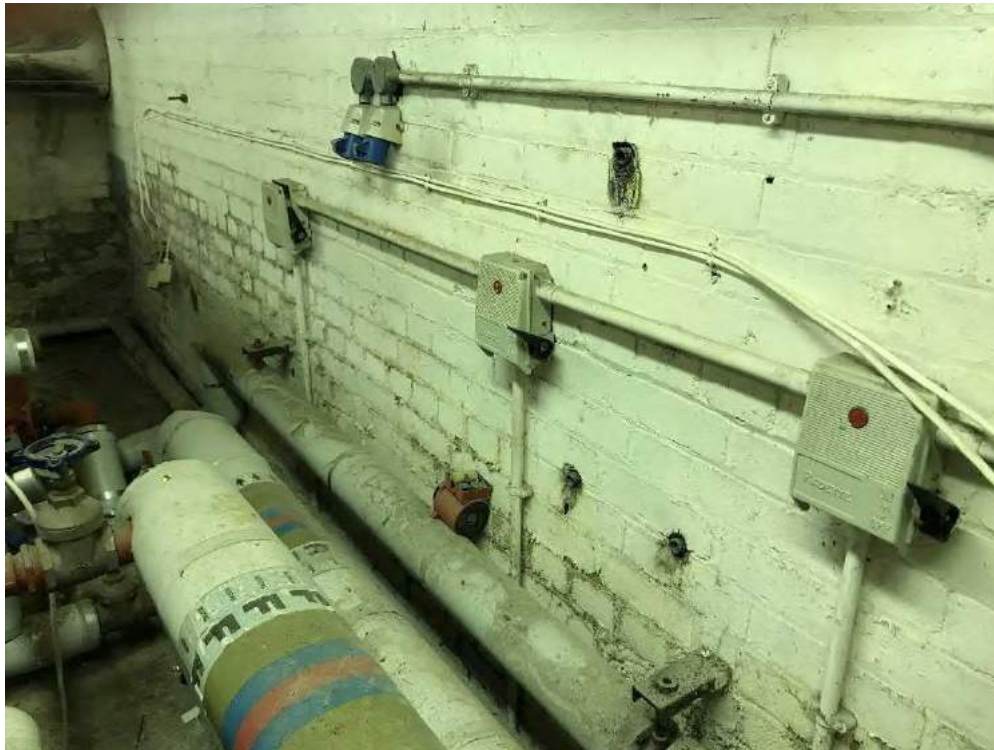
Photograph No 60 – Boilerhouse installation – Note isolator hanging from wall

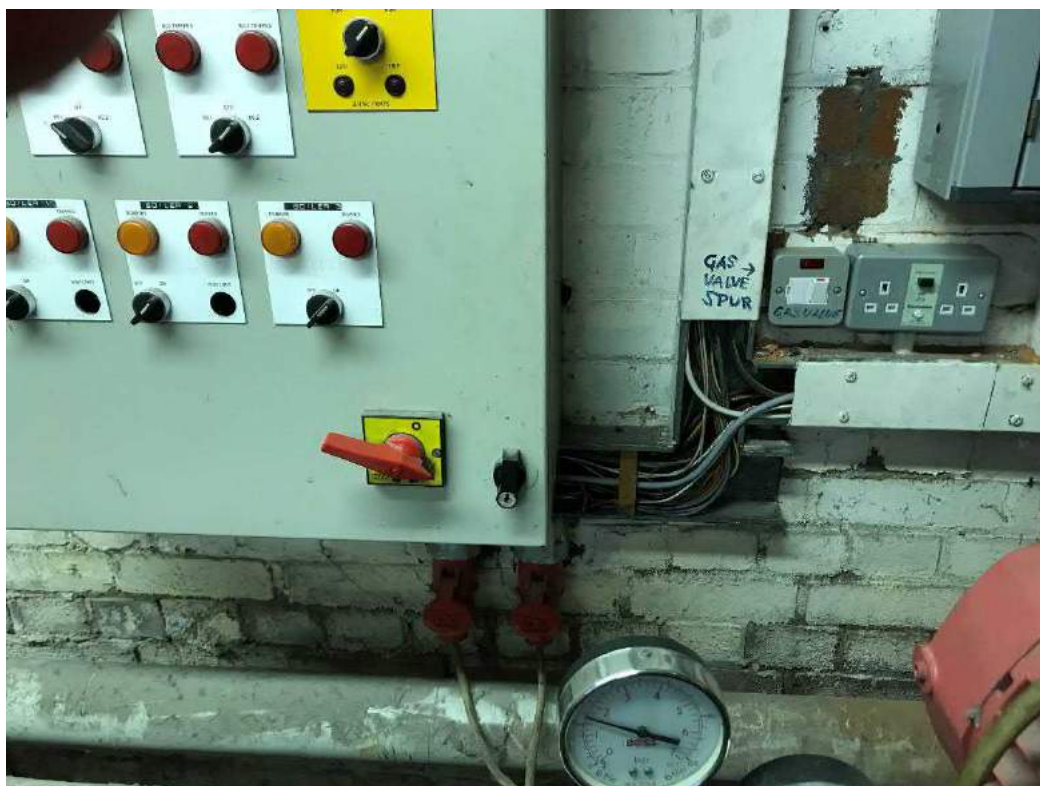
Photograph No 61 – Boilerhouse installation – Note exposed cabling

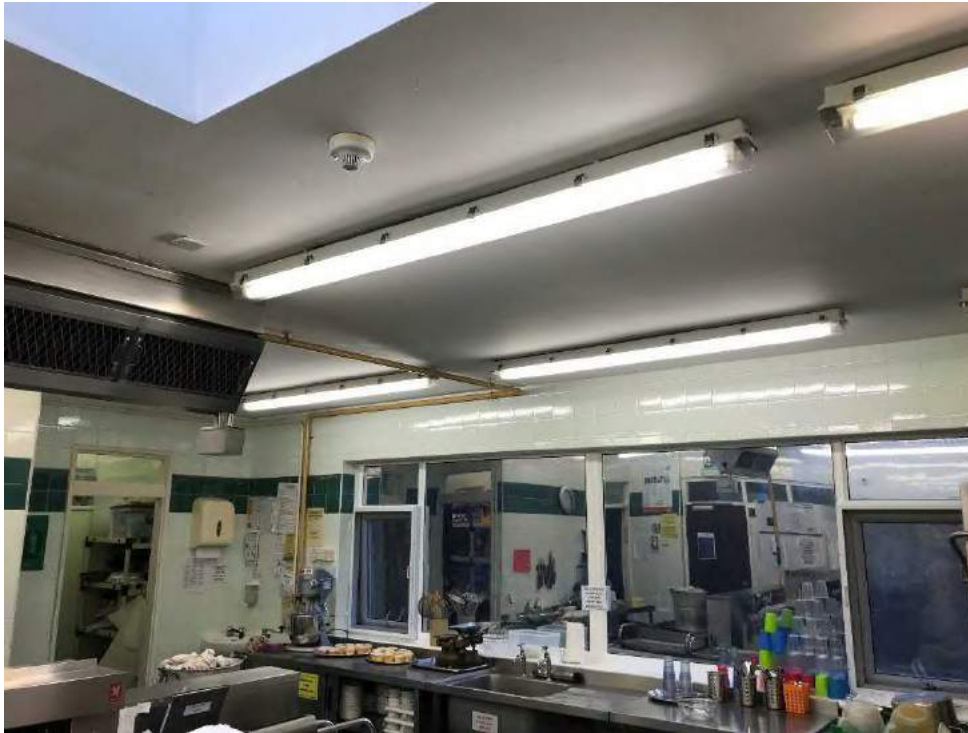
Photograph No 67 – Main Kitchen Lighting

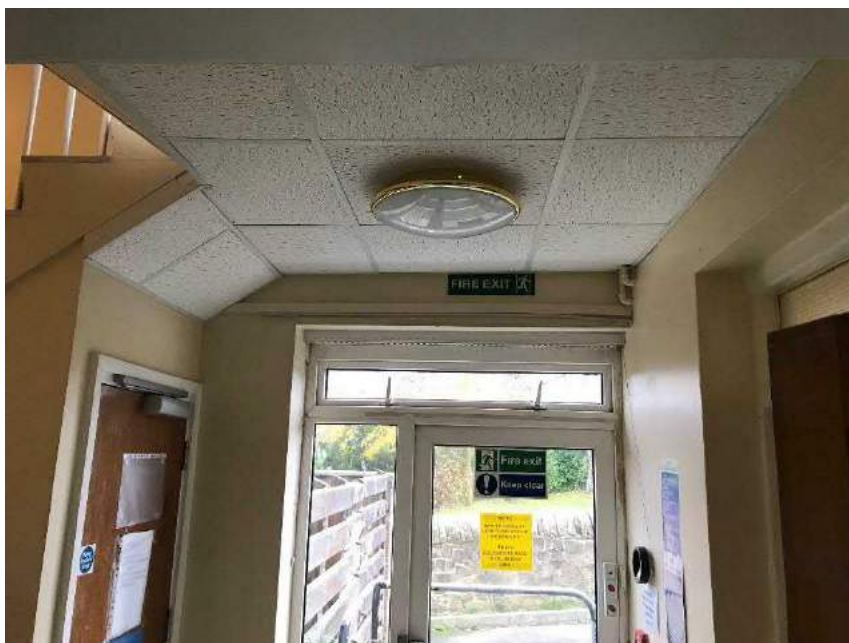
Photograph No 68 – Luminaire with integral battery/invertor pack

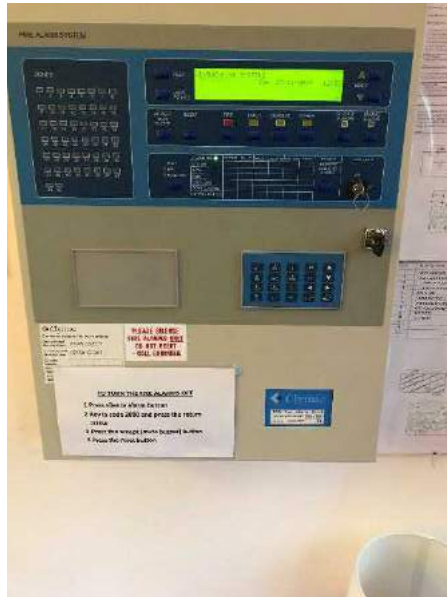
Photograph No 75 – New addressable fire alarm panel located in the main entrance.

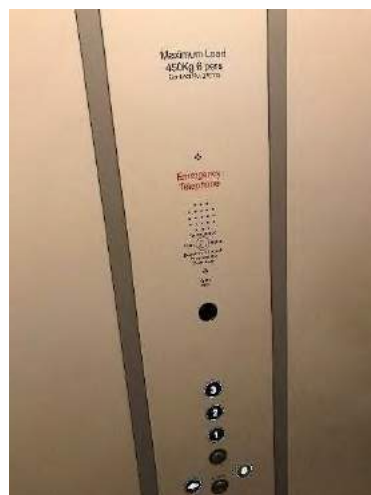
Photograph 81 – Lift Car controls

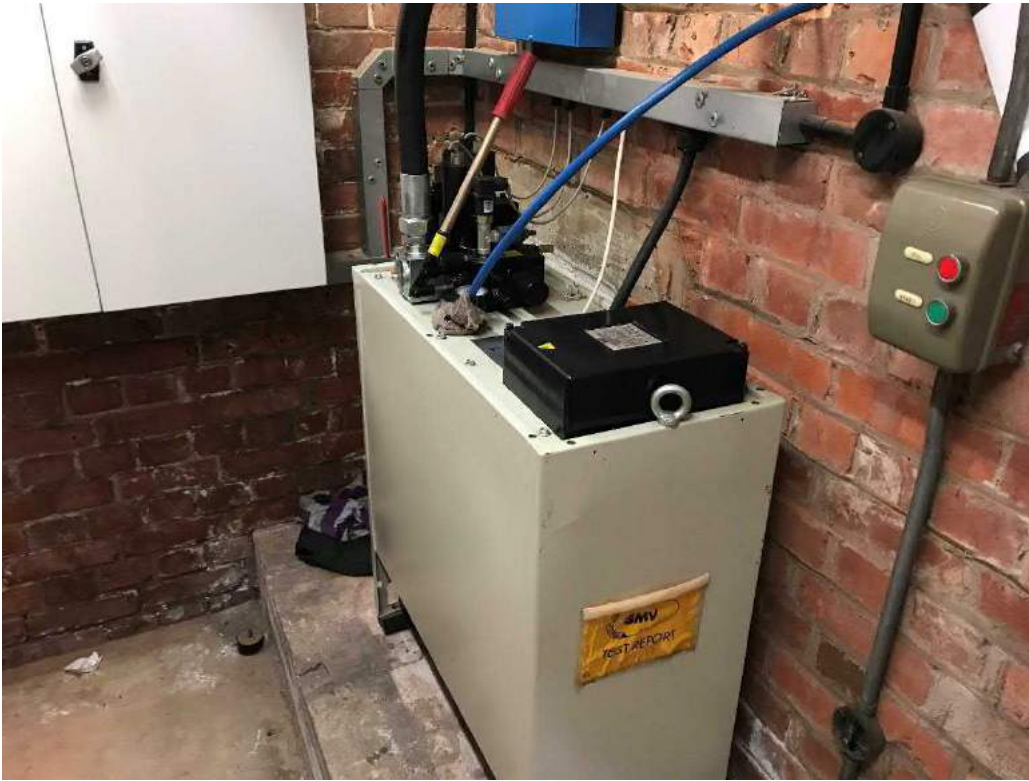
The lift motor hydraulic pump and associated control are at basement level and all appear in a reasonable condition with the lift being regularly maintained.

Photograph 82 – Lift Hydraulic pump unit and controls
