DERBYSHIRE COUNTY COUNCIL

Holmlea HOP

Condition Survey

November 2018

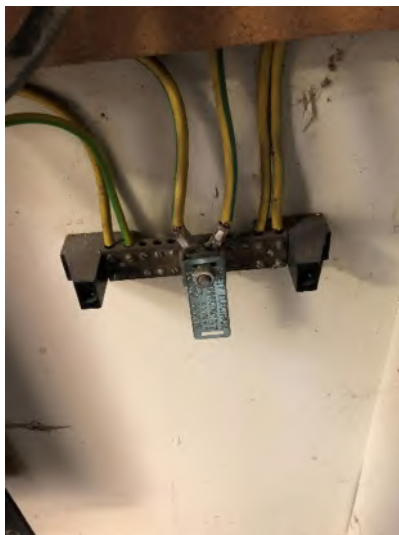
Photograph No 8 – The main earthing bar needs to be replaced with a new earth bar incorporating a test link and ensuring the earthing/bonding is up to current standards and fully labelled.

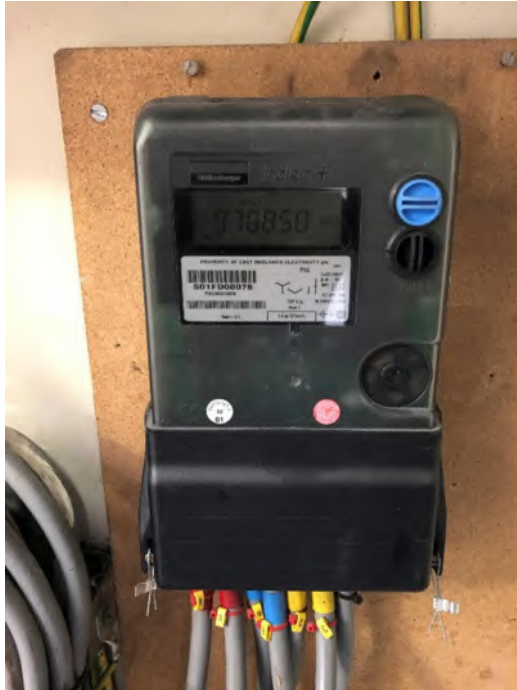
Photograph No 9 – The building direct reading 100A utility meter.

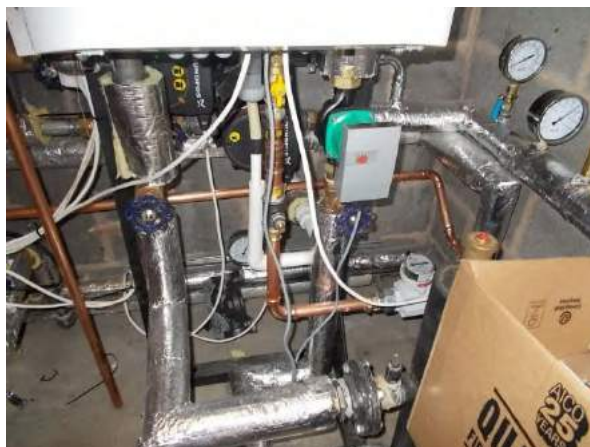
Photograph No 13 – Typical boiler houses – Replacement HWS primary heating pump and main heating pump being installed in boiler house 064. Note pressure relief pipework discharges directly onto the floor.

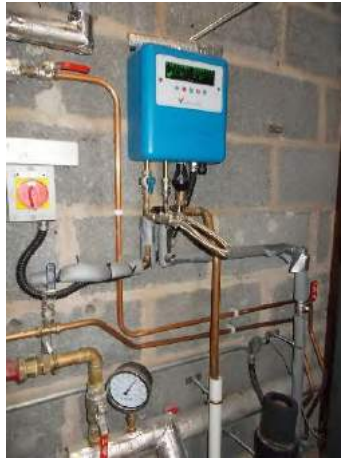
Photograph No 14 – Mikrofill EFD heating system pressurisation unit – Note water drain off pipe not connected to any pipework and kinked pressure pipe.

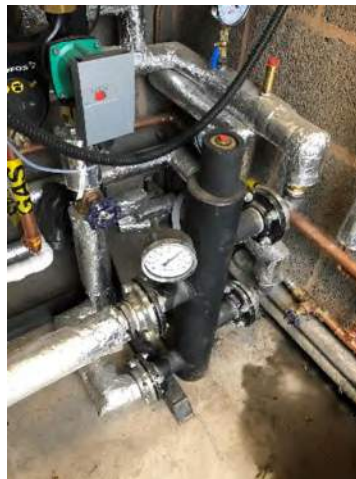
Photograph No 15 – Boiler connected to a small low loss header, note insulation missing to local pipework.

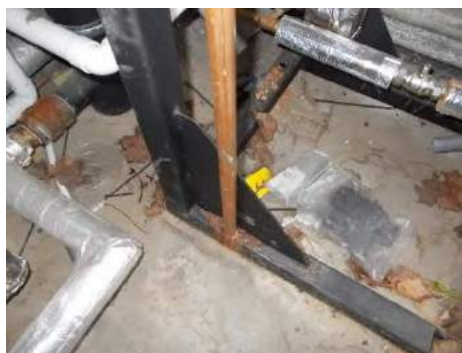
Photograph No 16 – Boiler house No 082 - Pressure relief pipework causing rusting of the boiler supporting framework.

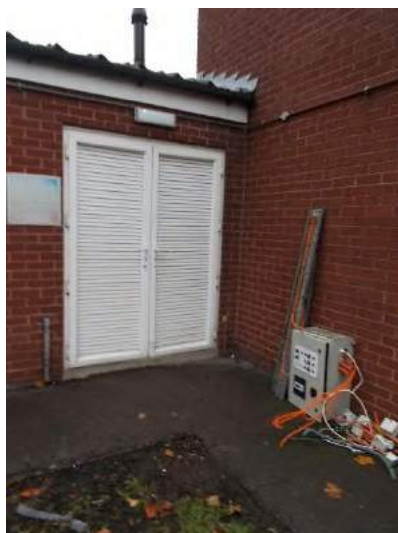
Photograph No 28 – Boiler house No 064 – Original boiler control panel being stripped out and replaced with a new panel.

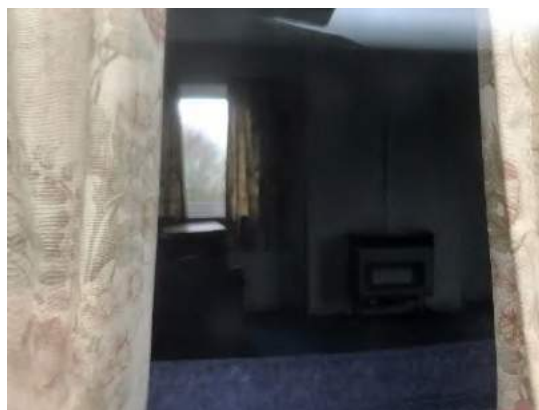
Photograph No 49 – Bungalow living room gas fire. We were not able to gain access into this bungalow to check condition of the heater.

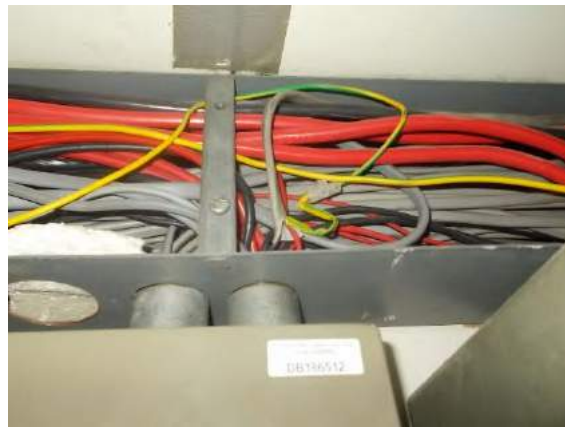
Above the main distribution boards the trunking lid is missing and is revealing cabling of an age that is nearing the end of its useful life. There are a number of joints in the cables which are not identified as to which distribution board they are connected to. There is a series of earth cables wrapped together and jointed to a single cable which connects to the trunking sides. The building should be rewired to ensure that the circuits are correctly earthed and all cables are clearly identified, thus allowing the use of RCBO's to any new boards.

Photograph No 58 – The wiring in the trunking above distribution boards, note lid is missing and earth cable has been extended by the use of a connector strip.

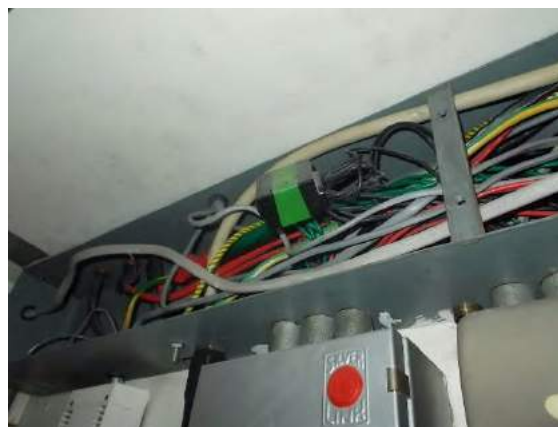
Photograph No 59 – The neutrals in the trunking have been connected together utilising a connector block.

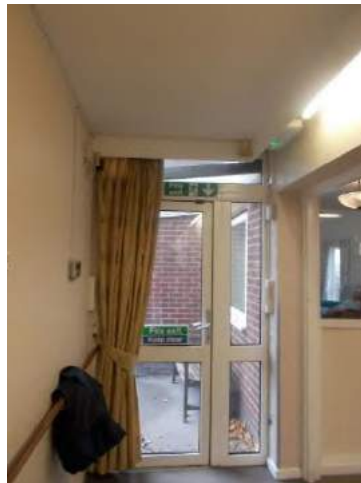
The building is lacking the correct number of illuminated exit signs to ensure that the escape routes are clearly identified. It is not clear if this building should be classified as a public building as visitors for the residents may be within the building and would need directing to an emergency exit, again this should be reviewed with the Fire Officer to ensure the correct illuminated signage is installed.

Photograph No 77 – Emergency escape door with no illuminated exit sign, note emergency luminaire installed behind the pelmet
