DERBYSHIRE COUNTY COUNCIL

Ladycross House HOP

Condition Survey

1st October 2018

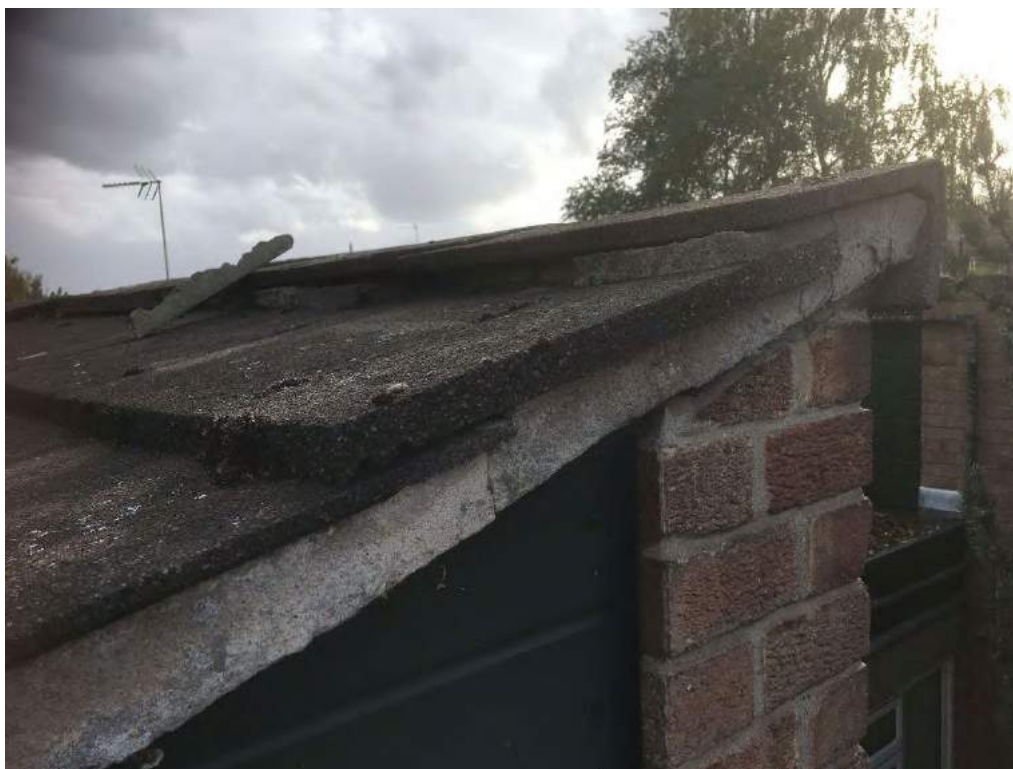
Pitched roofs are covered with a concrete interlocking tile which possibly original to the building. The roof finish is showing signs of deterioration, the mortar has failed to the ridge, there is moss build up in areas, tiles are deteriorating and there is evidence of historic repairs.

Photo 4 – Typical pitched roof

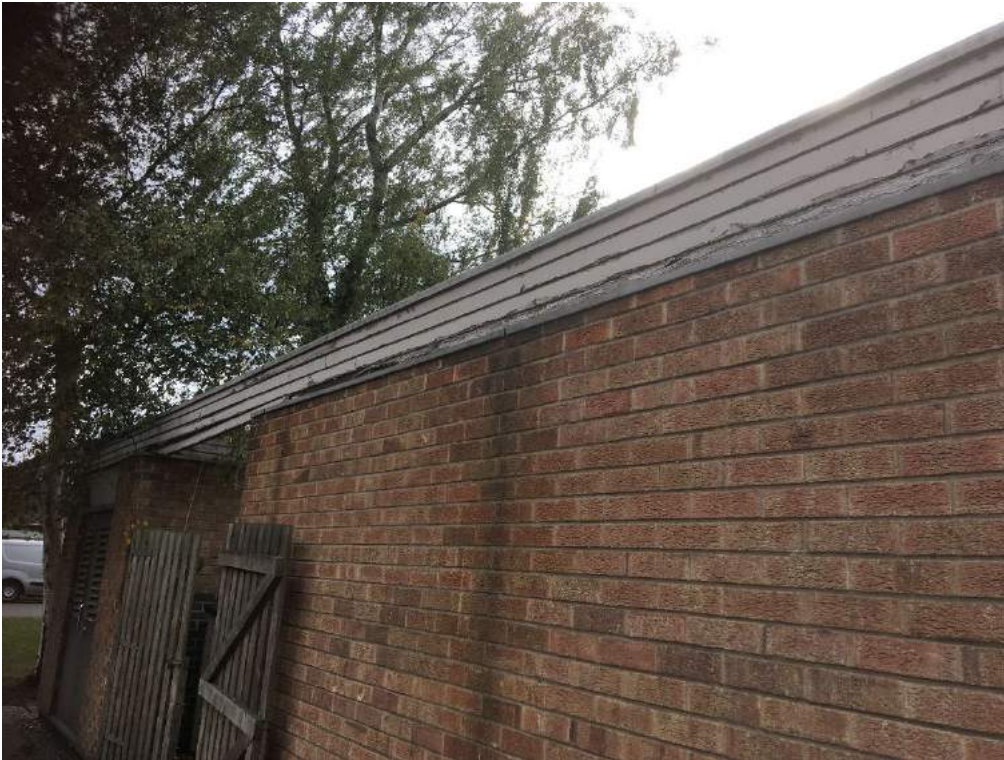
At high level there is a timber fascia and lead wall capping detail that has been replaced with powder coated a pressed metal profile. Where not replaced the timber and lead are in poor condition

Photo 5 – Defective cladding

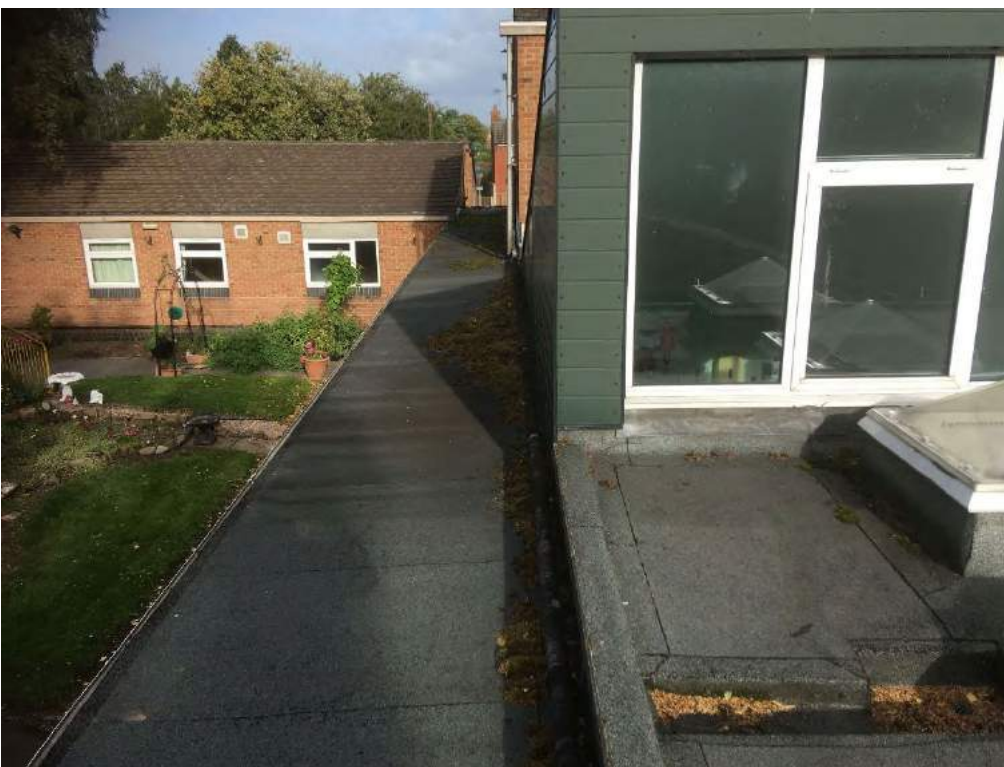
Flat roofs appear to have been recovered and rooflights replaced within the last 5-10 years and are generally in fair condition.

Photo 6 – Typical flat roof

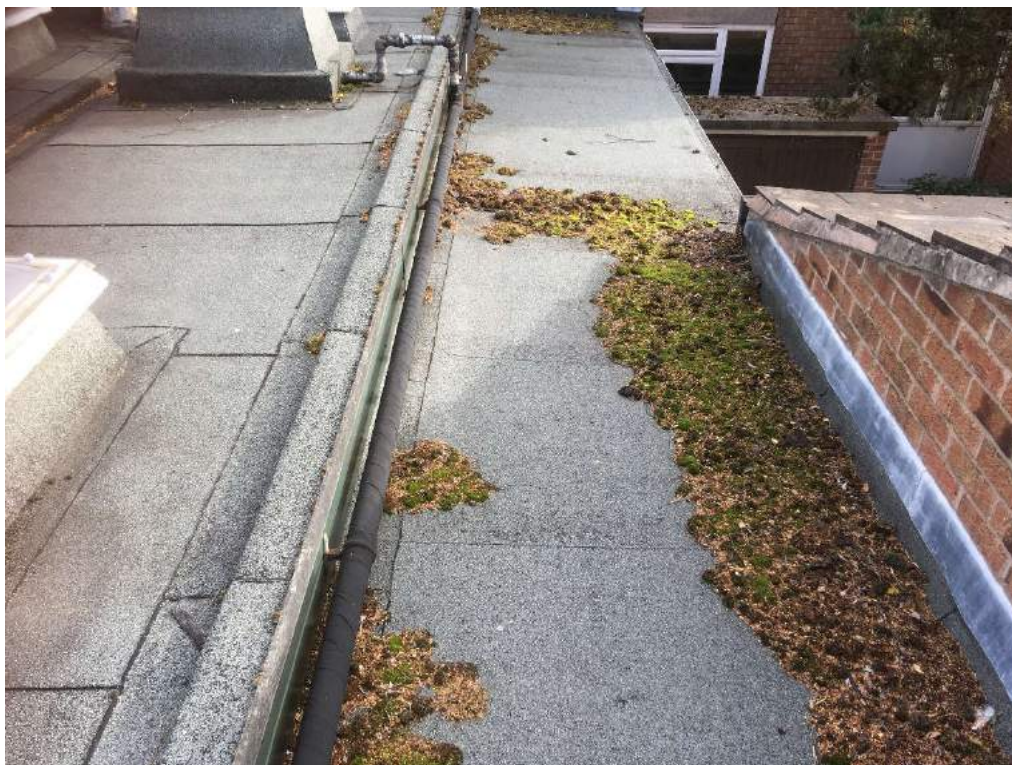
Photo 7 – Debris to flat roof

All 'flat' and very low pitch roof areas should also be cleaned off on a minimum yearly basis, to prevent damage to the roof covering and blockage of roof outlets. All debris and rubbish should be comprehensively collected and removed, which may include old building materials, balls, bottles, drinks tins, plastic bags, leaf and branch litter, glass, nails/screws, dead birds, paper etc.

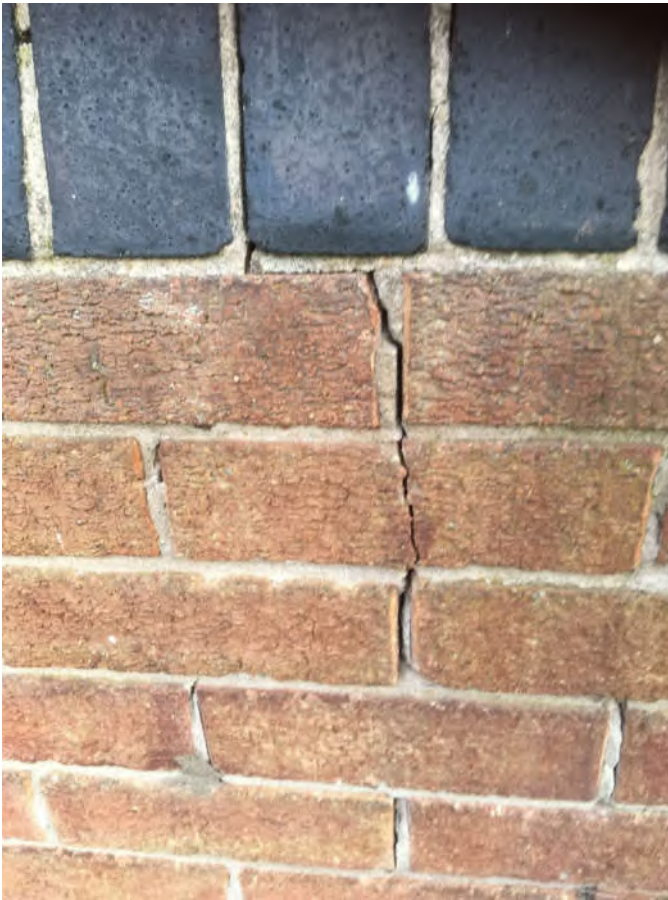
External walls comprise cavity masonry with block inner leaf and stretcher bond external leaf with blue engineering brick window cills. Areas of cracking were noted around the windows and at high level – see structural engineers report.

Photo 9 – External wall cracking below window

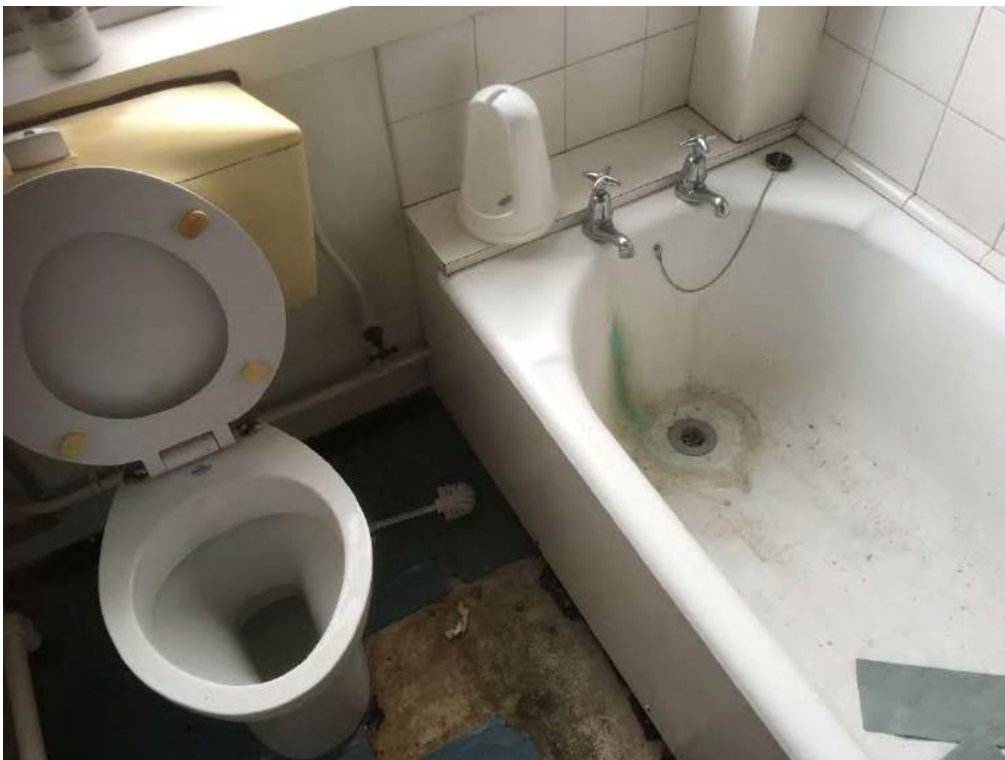
The bathrooms to the first-floor flats are antiquated and in poor condition.

Photo 18 – First floor bathroom

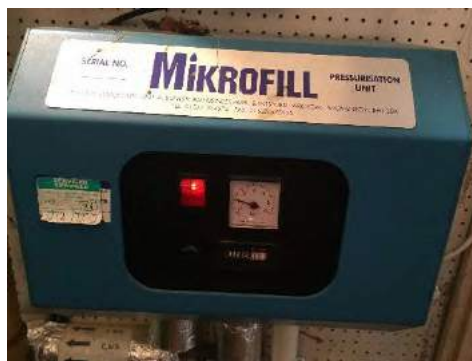
Photograph No 18 – One of the LTHW pressurisation units is an old Mikrofill unit, it would be prudent to replace this unit with a new modern version of this unit.

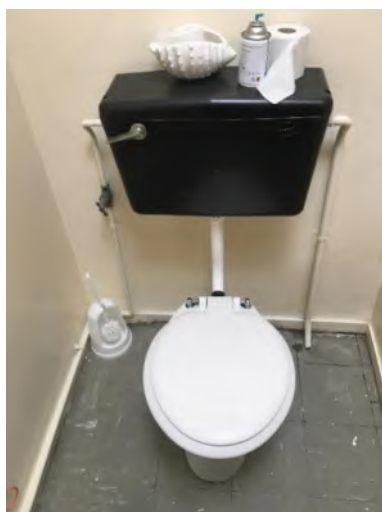
Some of the toilet cisterns are made of an unknown plastic material, these may contain asbestos and will need to be replaced with a modern toilet/cistern, and the new toilets should be designed to provide a minimum flush to provide water conservation.

Photograph No 26 – Some of the Toilets have plastic cisterns which may contain asbestos and will need to be replaced.

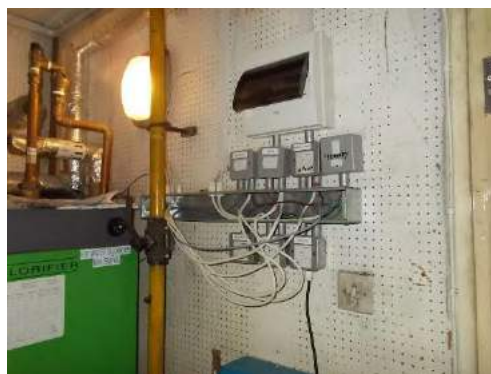
Photograph No 28 – Boiler plantroom No 010 - Boiler and HWS plant control system with trunking lid missing.

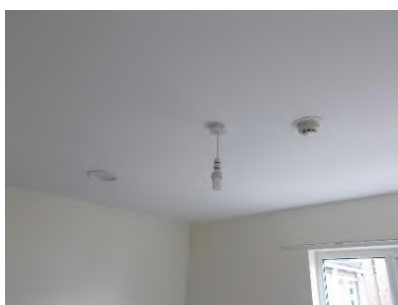
Photograph No 48 – Refurbished bedroom pendant luminaire with recessed down lighter. Note the pendant luminaire has a fluorescent lamp, this should be replaced with a dimmable LED lamp.

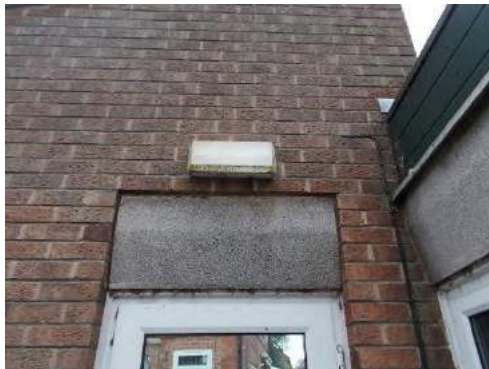
Photograph No 51 – Typical wall mounted bulkhead luminaire over some of the fire exit doors with yellowing and dirty diffusers. It was not clear if these were fully operational and working.

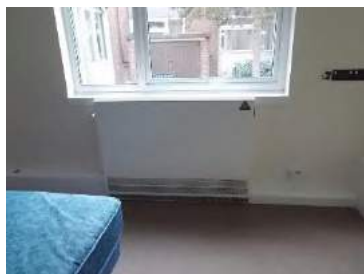
Photograph No 52 – Refurbished bedroom with sockets increased in height off the floor and in a contrast colour to the walls, this should be considered for all bedrooms.

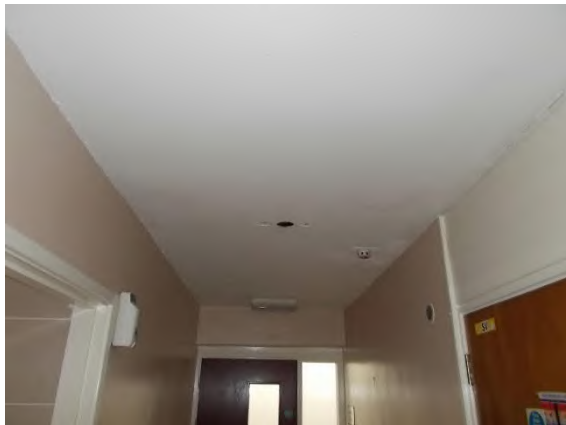
Photograph No 56 – Corridor with smoke detector missing

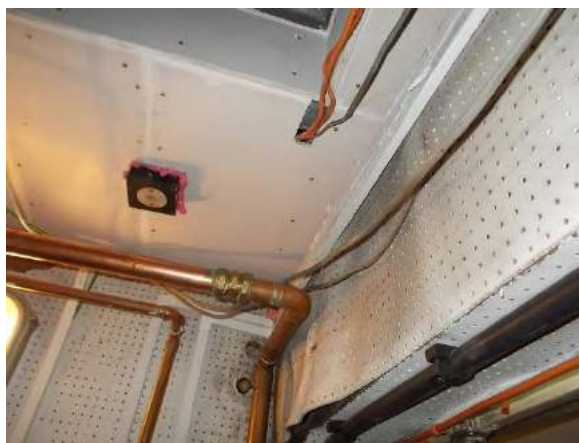
Photograph No 57 – In the boiler houses there is what appears to be some form of fire alarm detection equipment fed by MICC cable with orange sheath. It is not clear if this is fully operational and working.
