DERBYSHIRE COUNTY COUNCIL

New Bassett House HOP

Condition Survey

13 November 2018

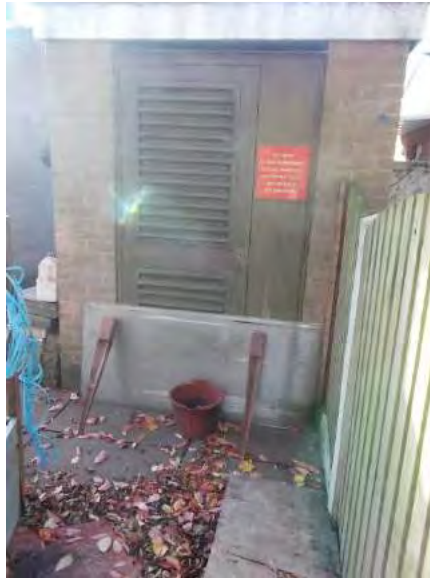
Photograph No 1 – Incoming Gas meter brick enclosure located in garden of adjacent bungalow.

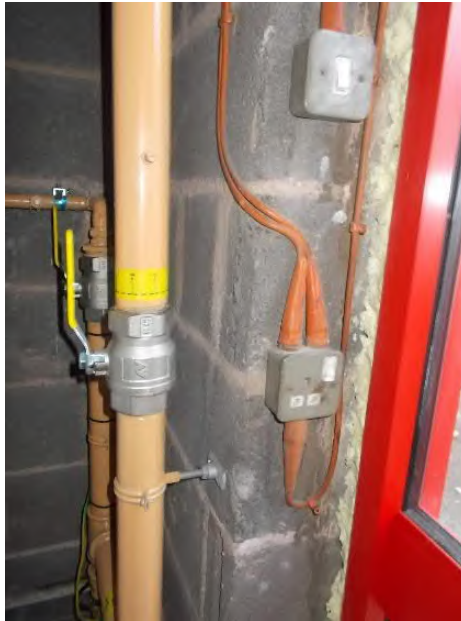
Photograph No 4 – The Gas pipework inside boiler house (room No 003) showing incoming gas shut off valves, the gas supply in all of the boiler houses is manual shut-off only.

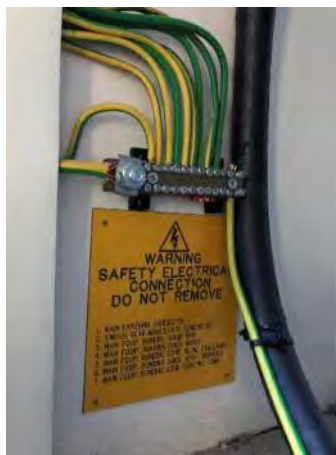
Photograph No 8 – Main Earth bar, this should be replaced with a new earth bar incorporating a test link and all earthing and bonding cables brought up to current standards.

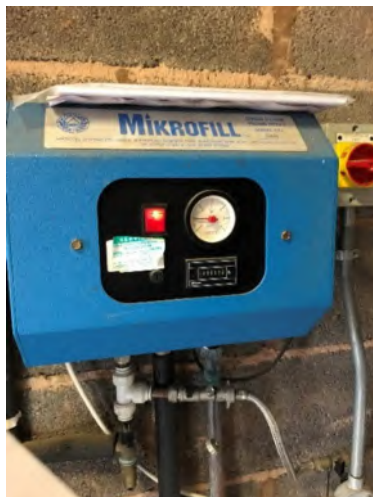
Photograph No 20 – Mikrofill EFD heating system pressurisation unit – Note, this is an old unit installed in boiler house room No 003 and should be replaced by its modern version.

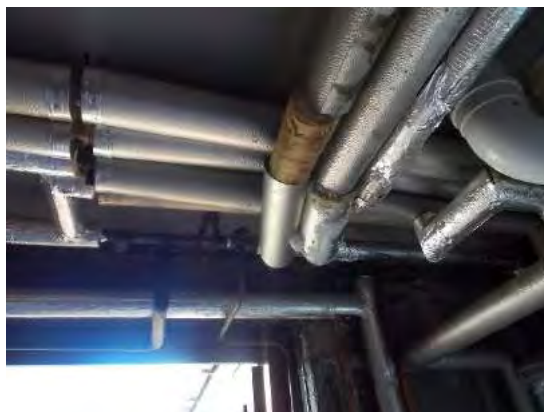
Photograph No 21 – Boiler house Room No 107 – Pipework insulation with metal finish missing and signs of corrosion forming on metal finish.

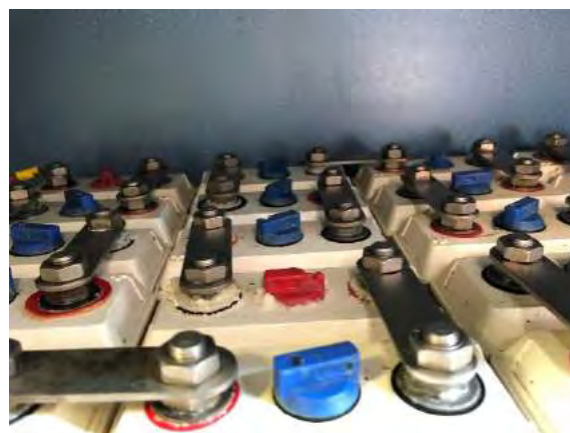
Photograph No 81 – Emergency lighting batteries in room No 066 showing signs of corrosion on the terminals.

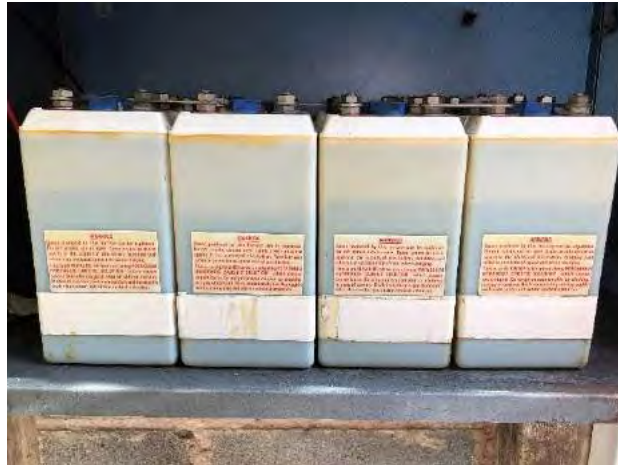
Photograph No 82 – Emergency lighting batteries in room No 066 showing differing levels of electrolyte the LHS battery is midway between the high and low level marks.

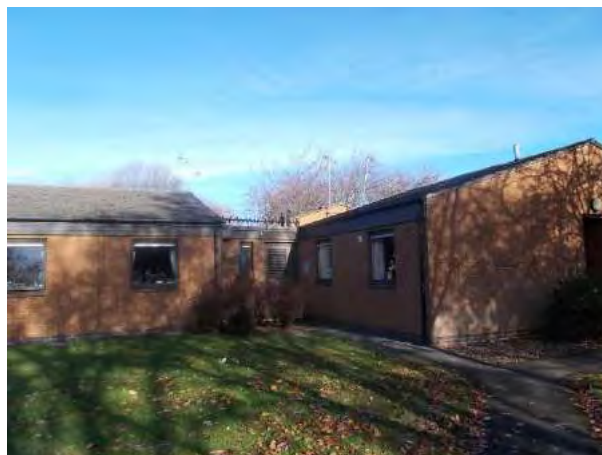
Photograph No 89 – Boiler house with no lighting or emergency lighting over the door.

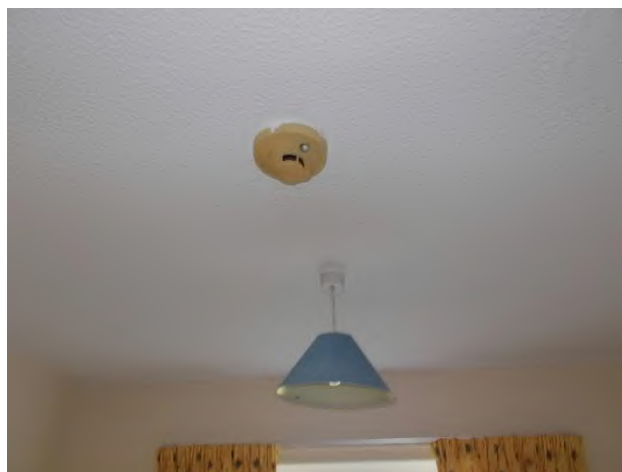
Photograph No 97 – Bedroom with old smoke detector installed.

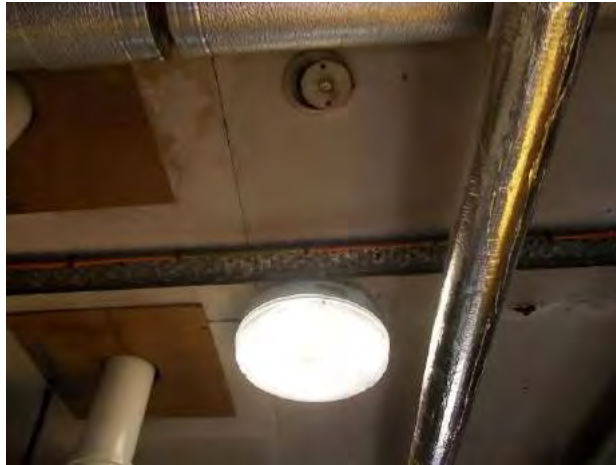
Photograph No 98 – In the boiler houses there is what appears to be some form of fire alarm detection equipment. It is not clear if this is fully operational and working.

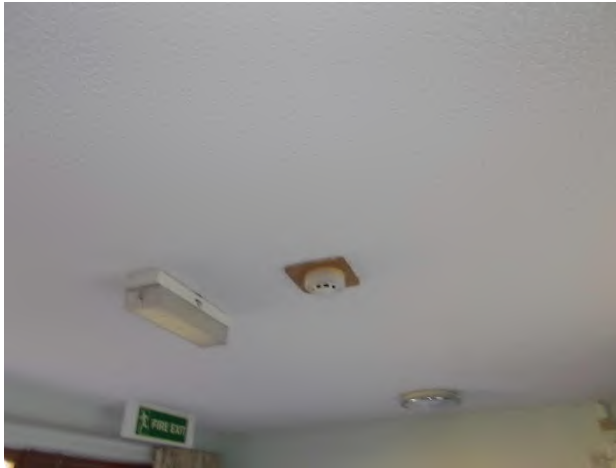
Photograph No 99 – replacement of an automatic detector installed on a wooden plate covering the hole from the older detector.

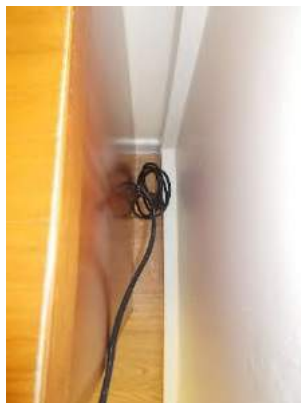
Photograph No 106 – TV aerial cable left behind chest of draws for a television to be connected.

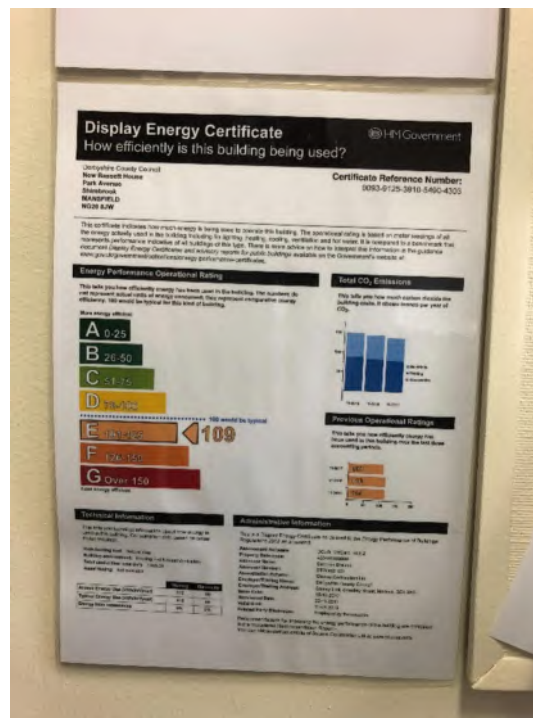
Photograph No 107 – Current EPC Certificate with a rating of E - 109
