DERBYSHIRE COUNTY COUNCIL

Rowthorne HOP

Condition Survey

November 2018

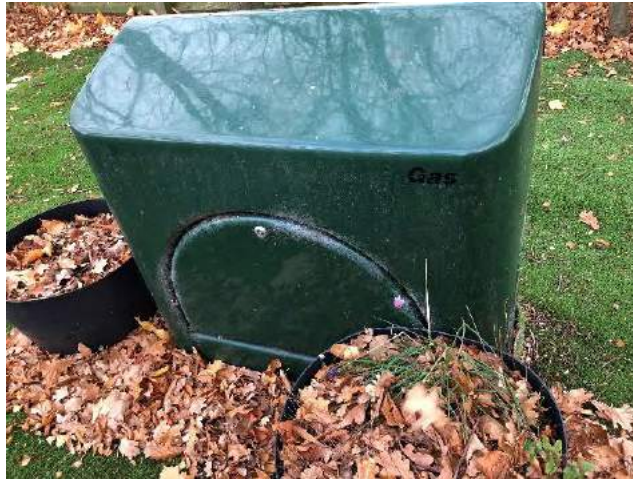
Photograph No 1 – Incoming Gas meter cubical.

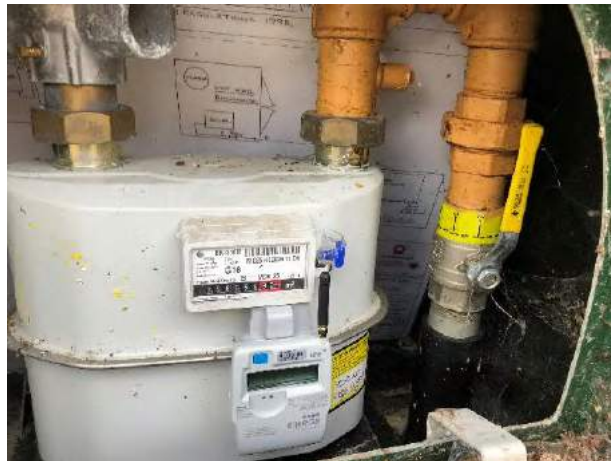
Photograph No 2 – Incoming gas meter.

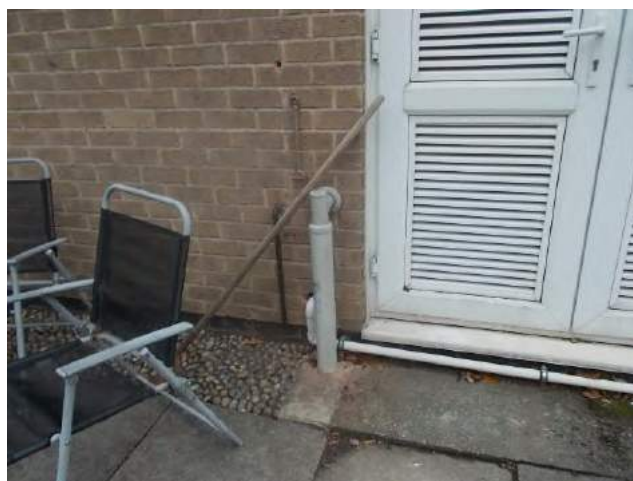
Photograph No 3 – Typical gas main entering a plantroom.

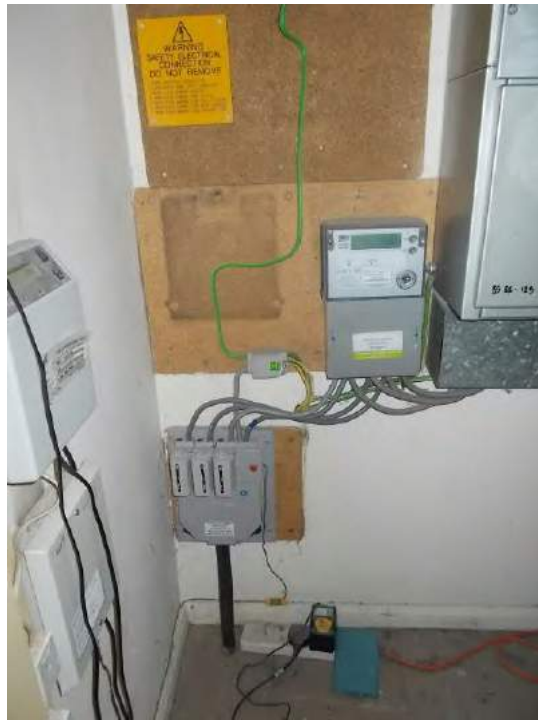
Photograph No 7 – The Incoming electrical utility supply is located in the cupboards off corridor 011.

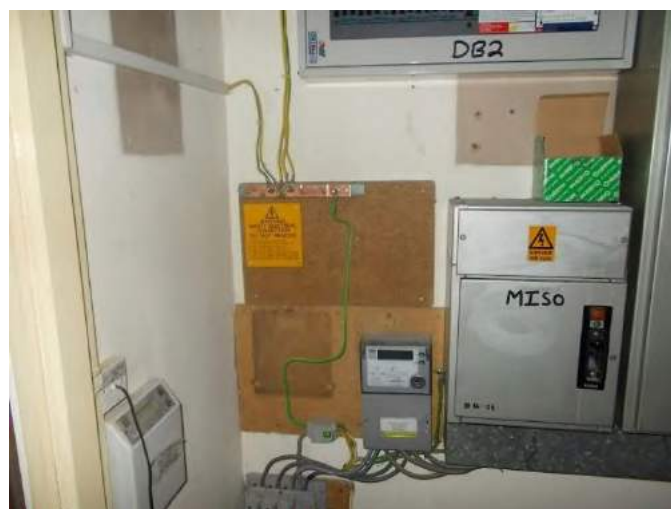
Photograph No 8 – The main earthing bar has been replaced with new but has not been fully labelled.

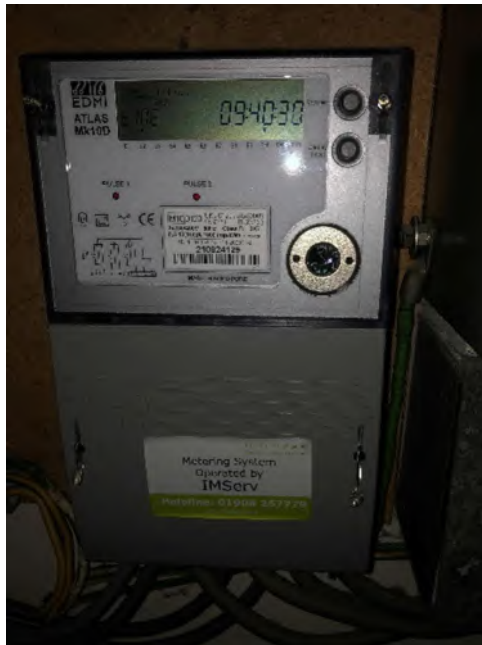
Photograph No 9 – The Incoming direct reading 100A meter

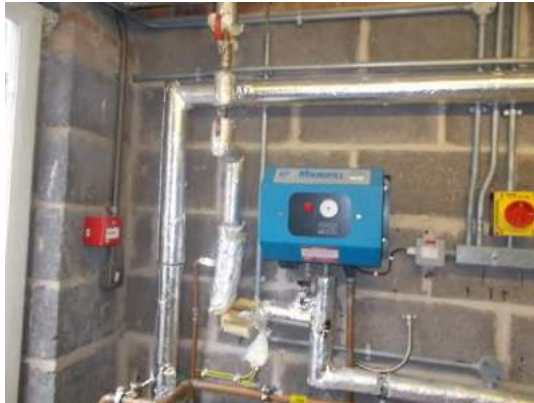
Photograph No 17 – Boiler house (room No 051) original Mikrofill Pressurisation unit. This unit is old and should be replaced with the modern replacement.

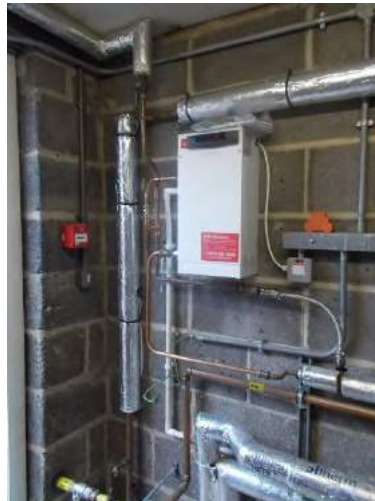
Photograph No 18 – Boiler house (room No 079) has a different Pressurisation unit. This unit should be replaced with the Mikrofill unit to bring all of the boiler housed to the same equipment.

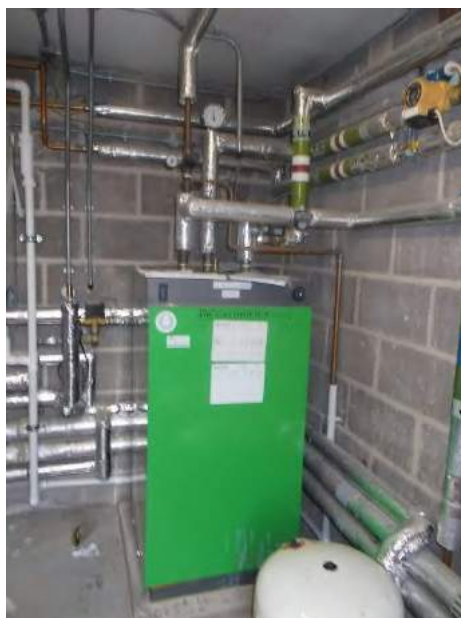
Photograph No 19 –Typical boiler house – Beeston HR Calorifier for the domestic HWS generation.

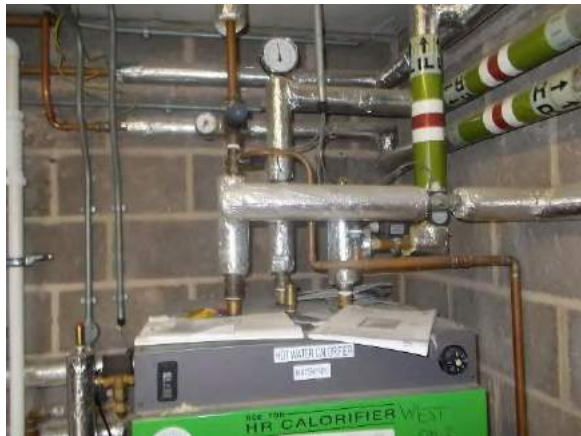
Photograph No 20 – Typical boiler house - Calorifier pressure relief discharge pipework draining directly onto the floor.

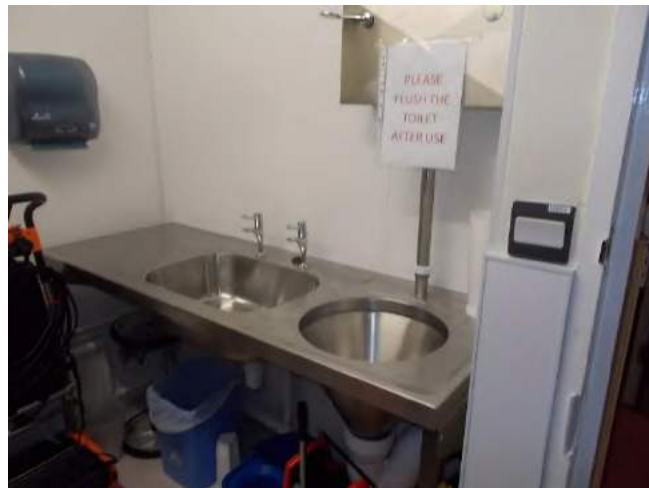
Photograph No 24 – Typical stainless steel sluice in sluice rooms.

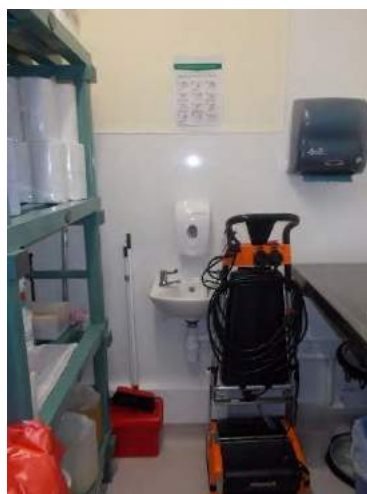
Photograph No 25 – Typical ceramic wash hand basin in sluice rooms.

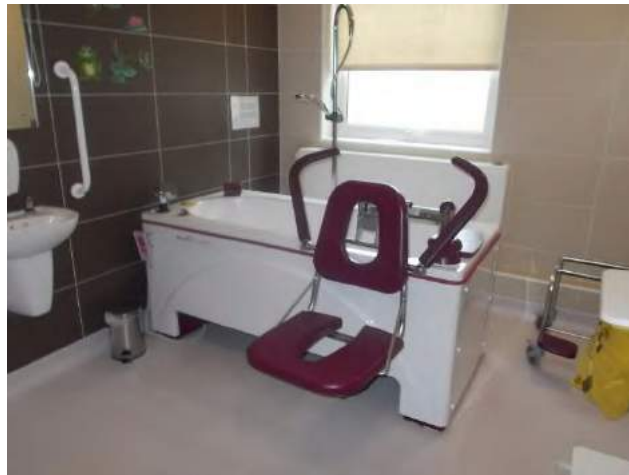
Photograph No 26 – Typical refurbished motorised assisted bathrooms.

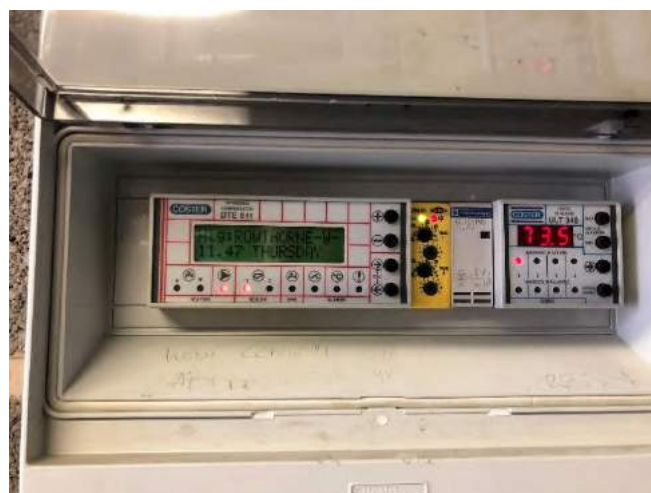
Photograph No 30 – Typical boiler house – Coster DTE 611 and ULT348 Controllers.

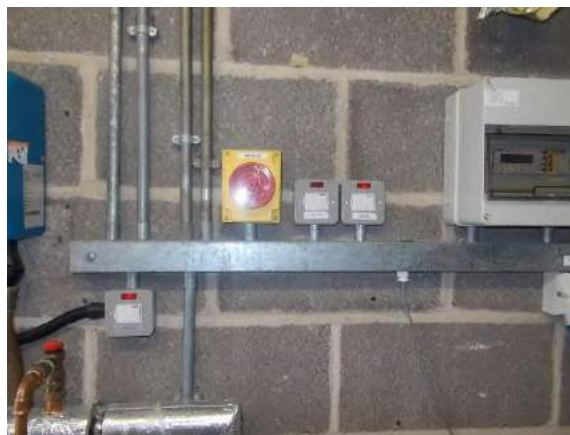
Photograph No 32 – Typical boiler house – Manual pump controls

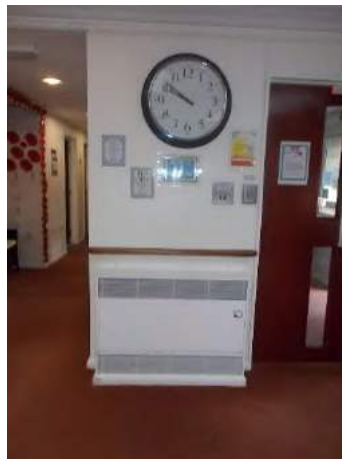
Photograph No 34 – Main entrance area fan convector unit.

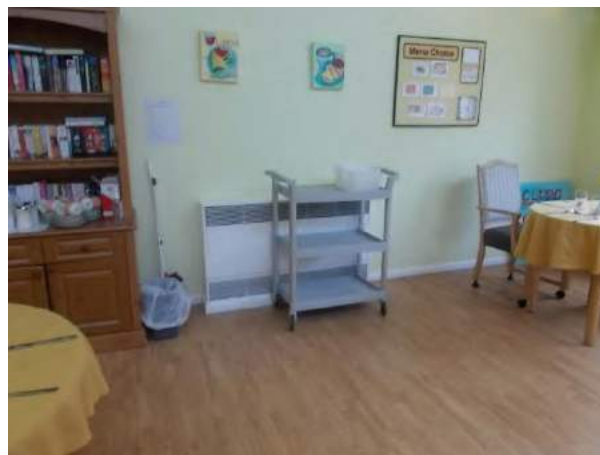
Photograph No 35 – Typical Floor mounted fan convector units in the common rooms/dining rooms.

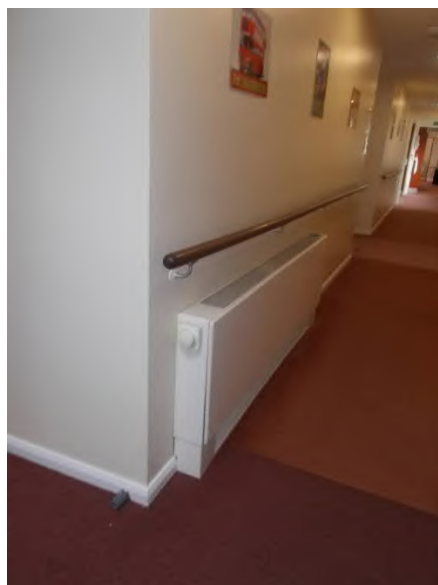
Photograph No 38 – Typical corridor LST Radiators with thermostatic control valve.

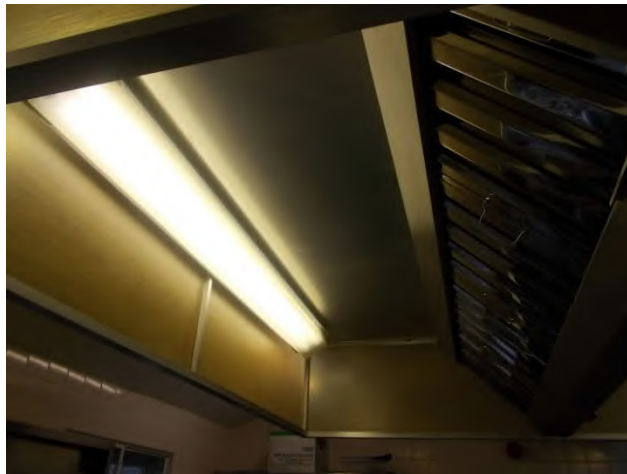
Photograph No 39 – New kitchen extract fan currently installed in the main kitchen.

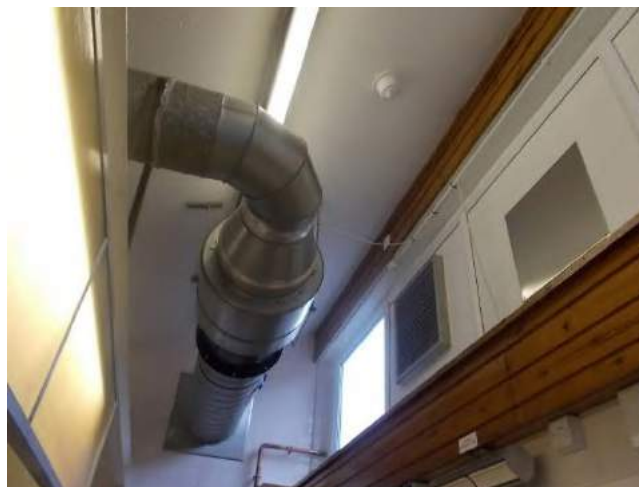
Photograph No 40 – Additional air enters the kitchen from the high level fan units in the windows. Note the extract fan installed at high level in the kitchen.

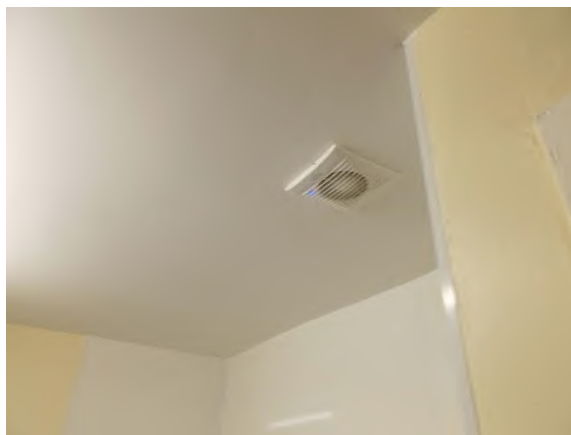
Photograph No 43 – Typical Sluice room ceiling mounted extract fan.

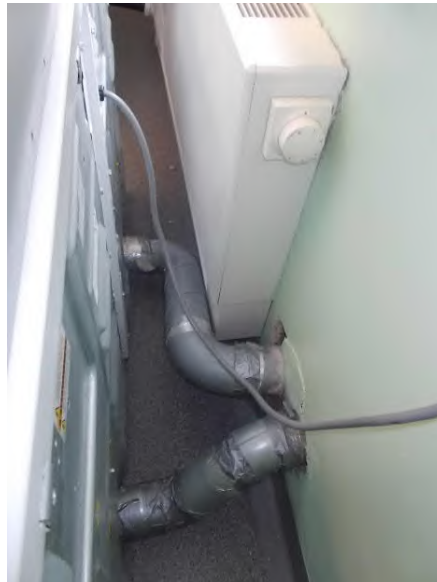
Photograph No 47 – The dryers have been ducted to an external grille. Note the incoming gas pipe has been provided with a solenoid valve.

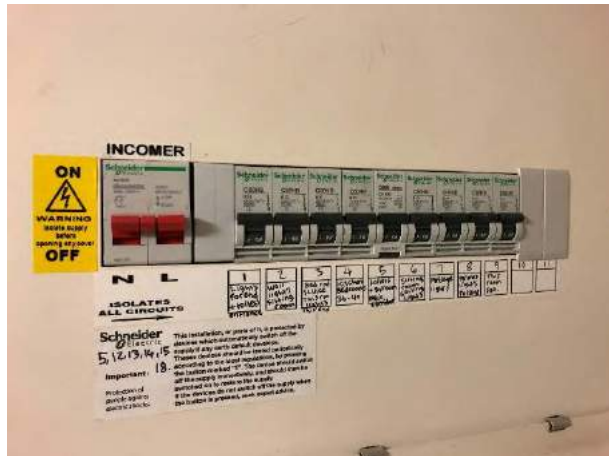
Photograph No 54 – Typical new distribution showing Schneider MCB/RCBO's fitted.

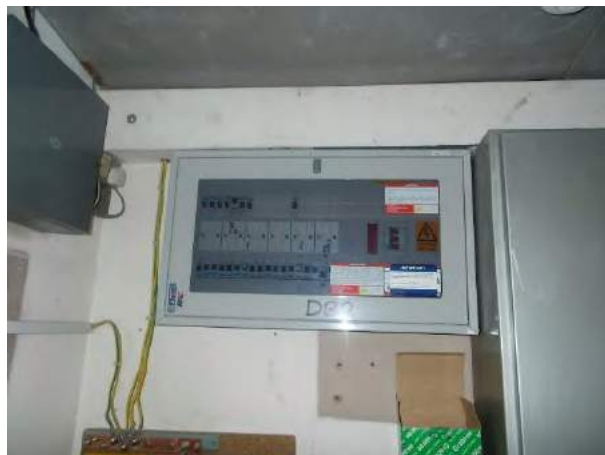
Photograph No 55 – Distribution board No 2, this Proteus distribution board has been installed on its side.

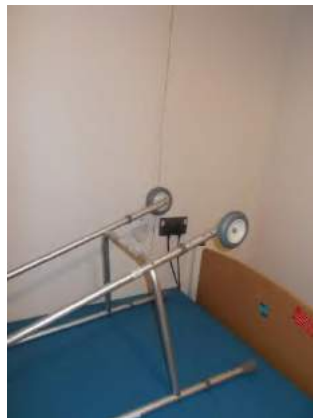
Photograph No 74 – Typical bedrooms with sockets by the bead head for a table lamp and for a hospital bed, there is also a twin socket for a television.

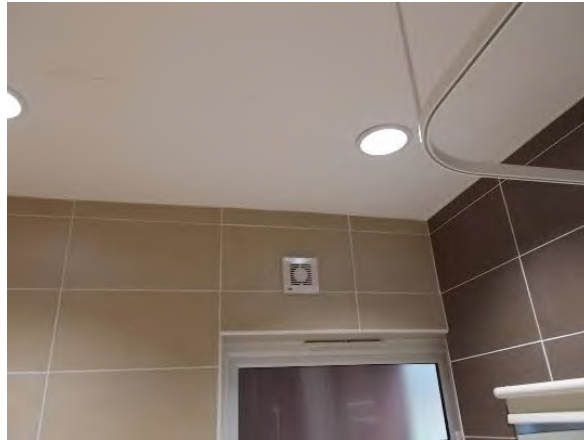
Photograph No 76 – Typical toilet extract fan, it was not clear if a DP switch had been fitted in the room for the fan disconnection as it was not local to the fan. All fans require isolation switches in the bathroom.

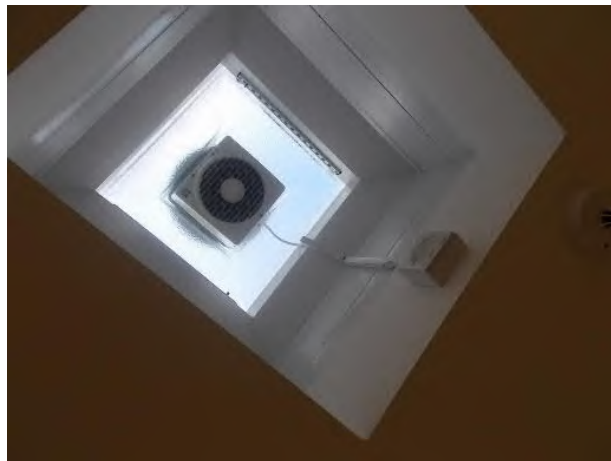
Photograph No 77 – Typical kitchenette extract fan mounted in roof light with local isolator.

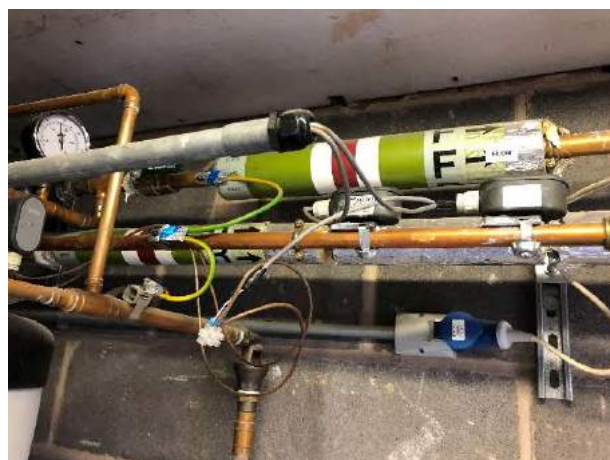
Photograph No 78 – Boiler house (room No 079) – wiring not correctly installed with connector strips unsupported by the pipework.

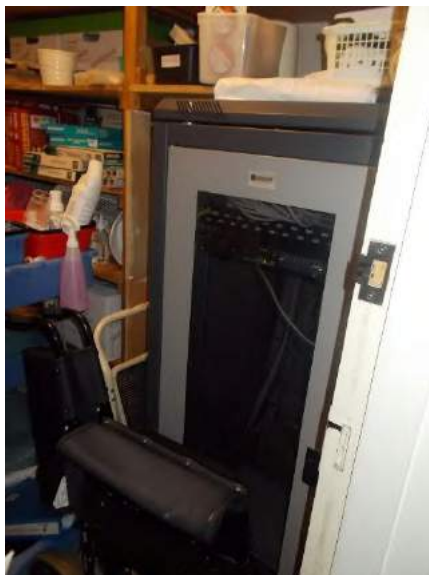
Photograph No 79 – Data rack installed in room No 010.

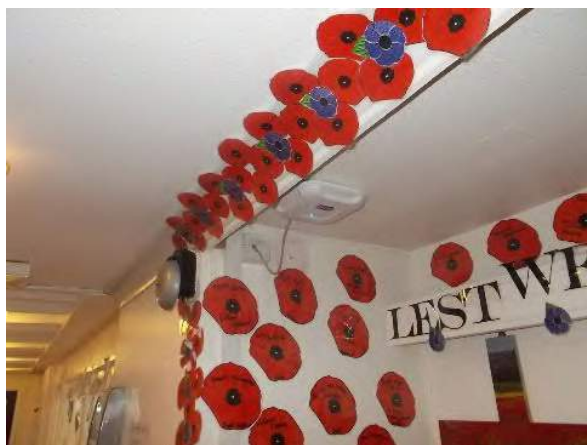
Photograph No 80 – Wi-Fi unit installed in the main entrance area adjacent to the offices.

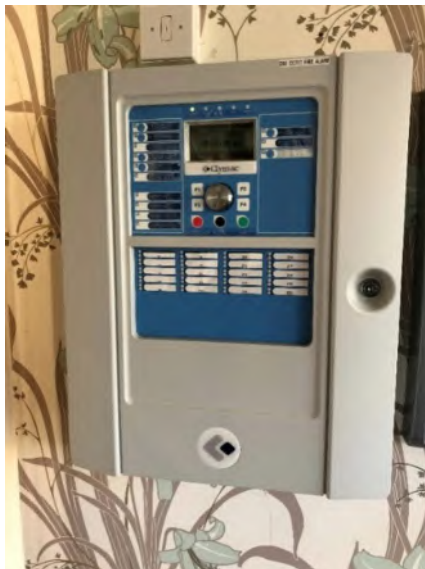
Photograph No 82 – Clymac Addressable fire alarm panel located in the main entrance.

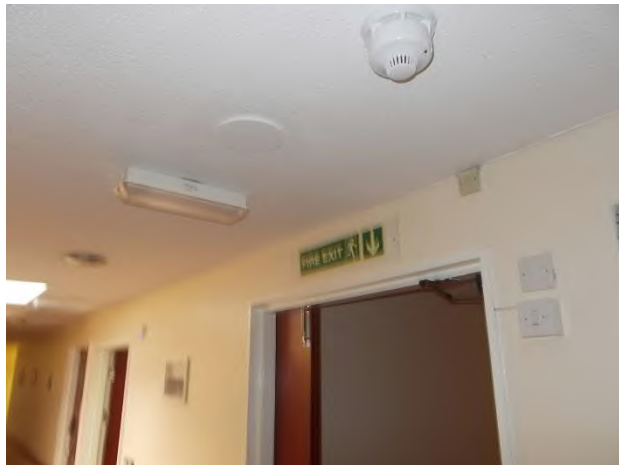
Photograph No 85 – Corridor smoke detector and sounder.

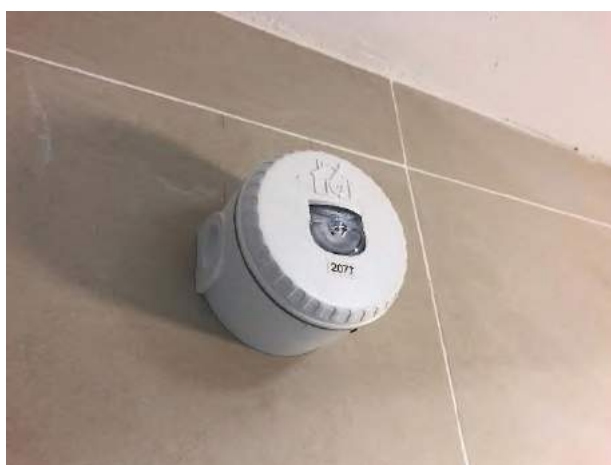
Photograph No 87 – Refurbished bathrooms have been provided with visual alarm devices

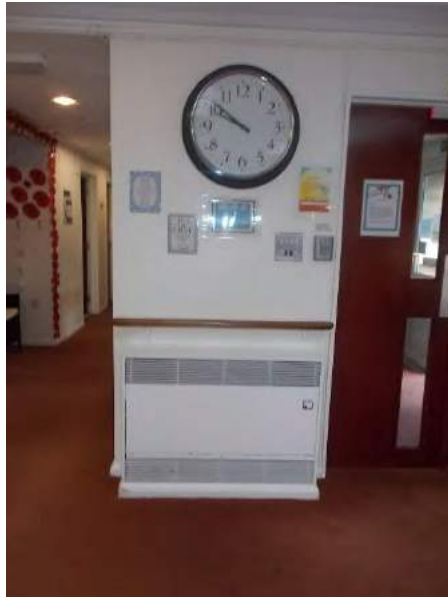
Photograph No 90 – Main door into the exit lobby has a key pad but no green emergency break glass unit to get out of the building in case of emergency.

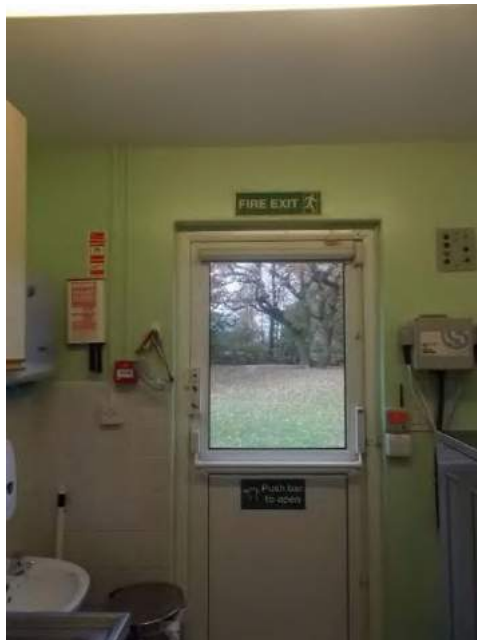
Photograph No 91 – Fire exit door with Medicare System Nursecall+ and ARM nurse call system fitted.

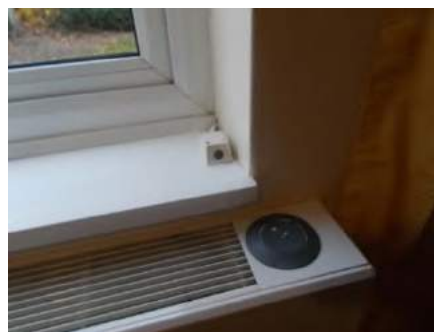
Photograph No 97 – TV aerial outlet in the bedrooms.

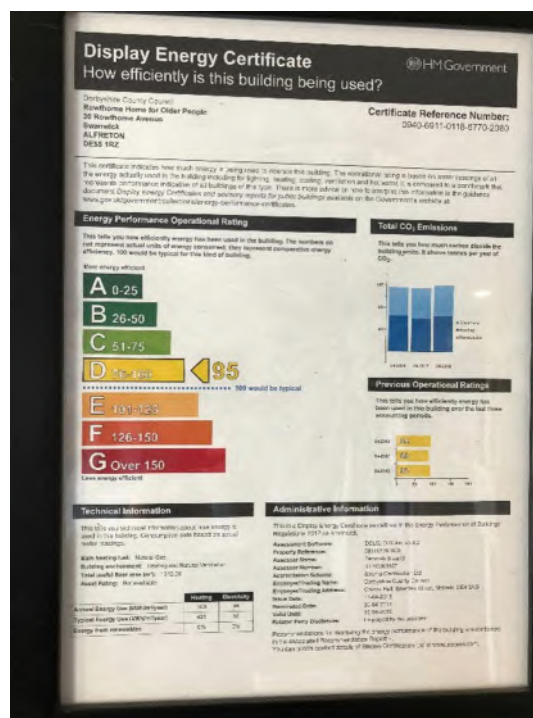
Photograph No 98 – Current EPC Certificate with a rating of D - 95
