DERBYSHIRE COUNTY COUNCIL

# The Spinney HOP

## Condition Survey

November 2018

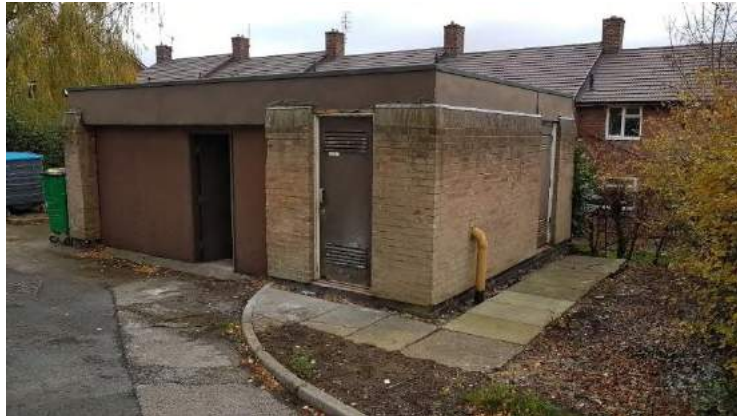
Photograph No 1 – Gas meter house.

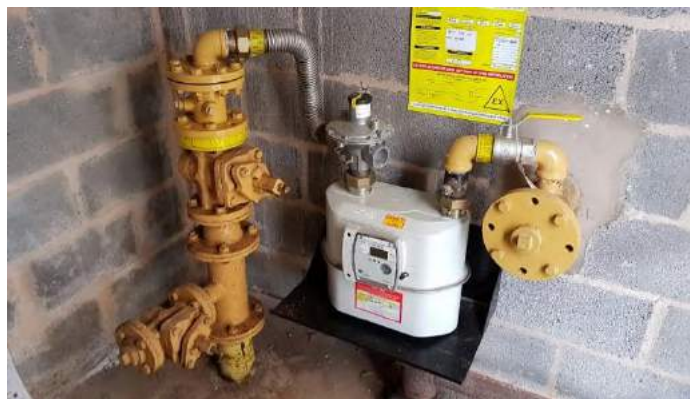
Photograph No 2 – Gas meter.

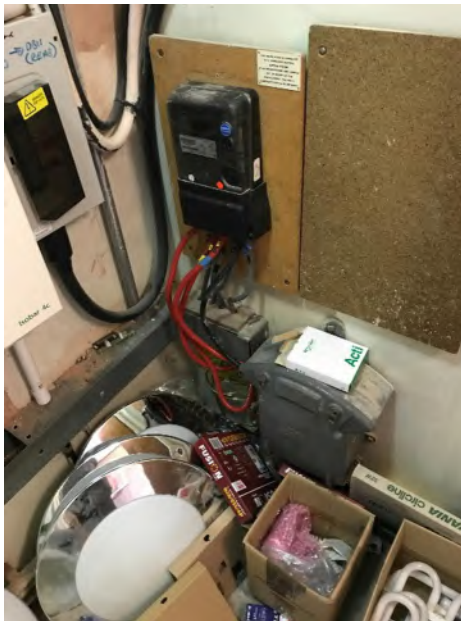
Photograph No 6 – Incoming electrical utility supply.

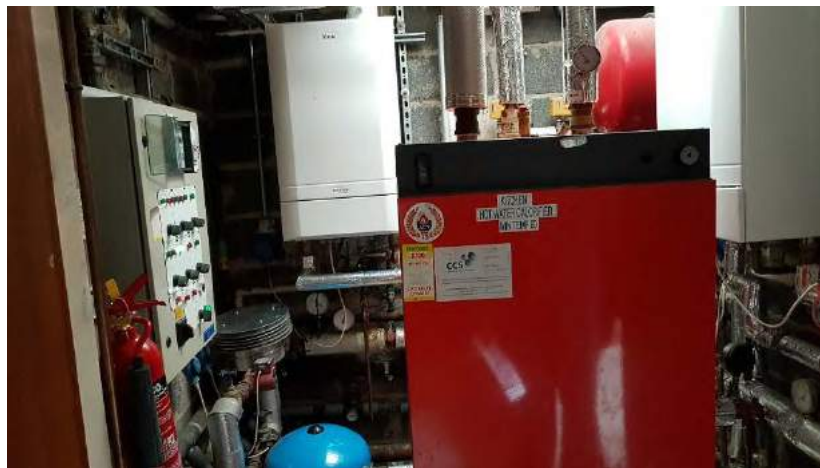
Photograph No 10 –Central calorifier serving Kitchen, Laundry and other small rooms

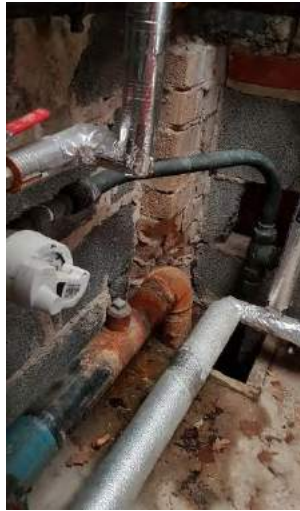
Photograph No 12 – Corrosion to steel pipework due to leaking condensate fitting above

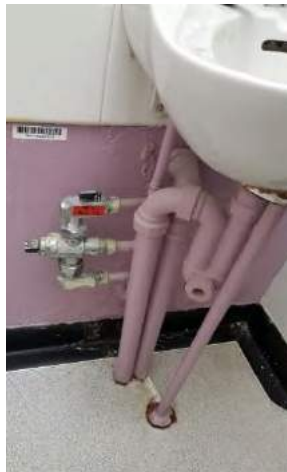
Photograph No 13 – Typical core basin with thermostatic mixing valve installed below.

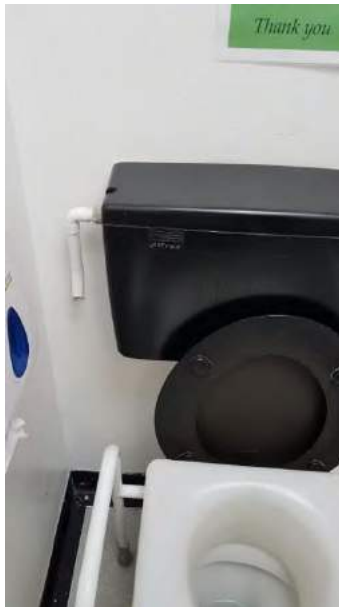
Photograph No 15 – Some of the Toilets have plastic cisterns which may contain asbestos and may need to be replaced.

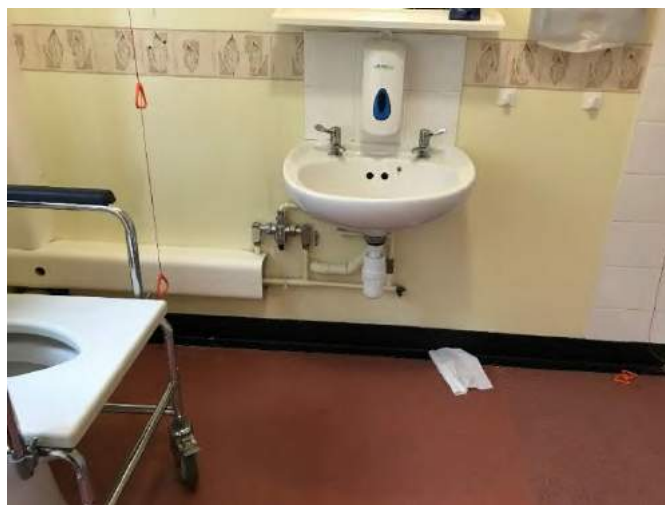
Photograph 16 – Typical bedroom basin with TMV (hot pipework boxed in)

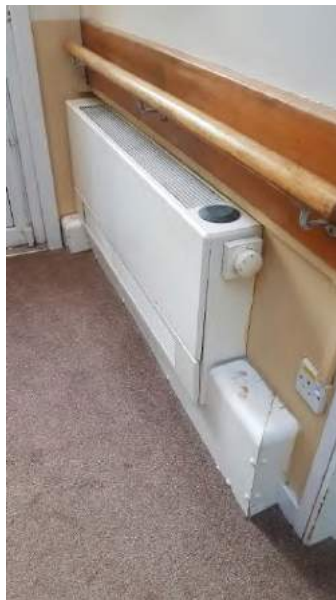
Photograph No 18 – Typical wall mounted LST radiators with pipework boxed in.

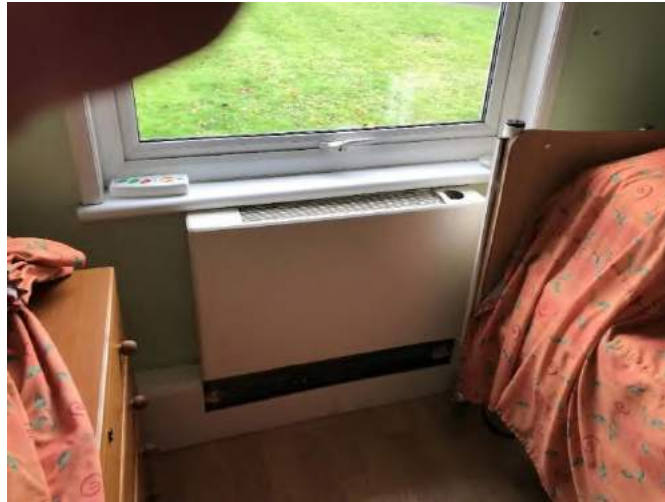
Photograph No 19 – Unoccupied bedroom LST radiator requiring pipe cover.

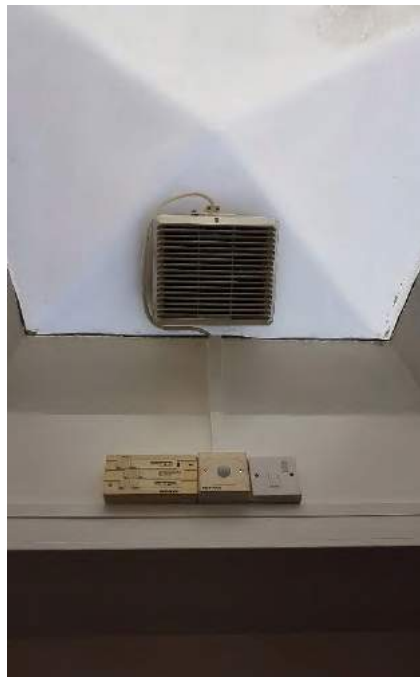
The toilets have all been provided with either wall mounted or ceiling mounted extract fans located within the roof lights, some of the fans appeared not to be operational and they need to be checked for operation.

Photograph 20 – Typical core area WC extract fan

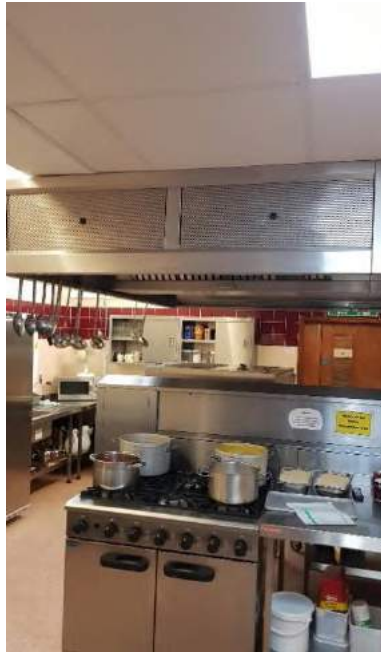
Photograph No 21 – Kitchen extract canopy. The bedrooms are ventilated via opening windows and wall mounted extract fans located in the en-suite bathrooms.

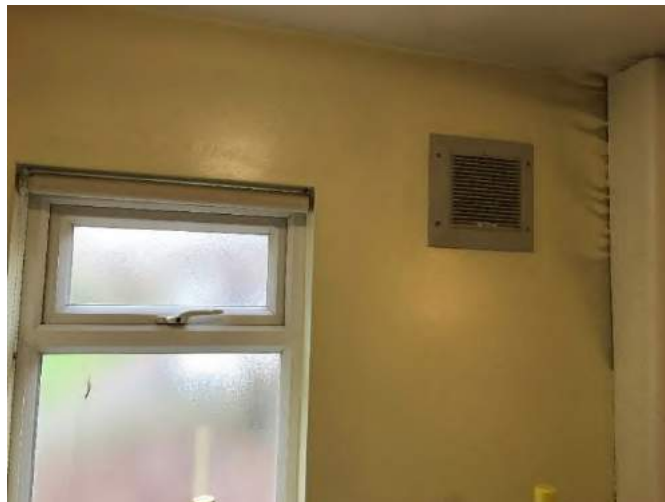
Photograph No 22 – Typical toilet and bathroom extract fan.

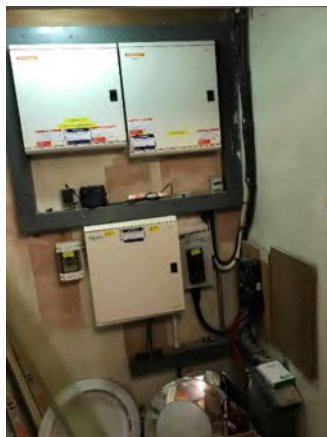
Photograph No 23 – Main Hager 8 way TPN MCB board and DB1 & DB2

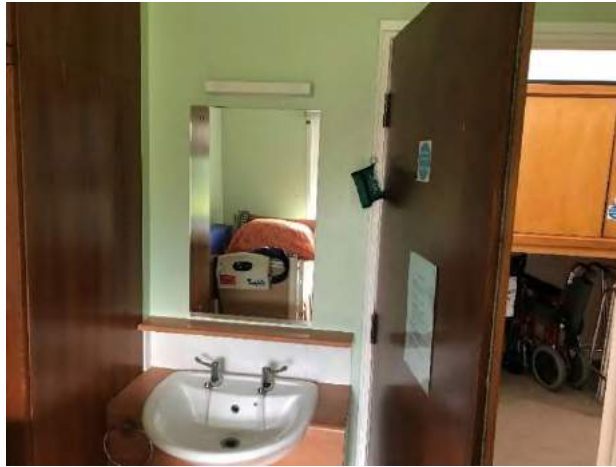
Photograph No 26 – Typical bedroom mirror luminaire.

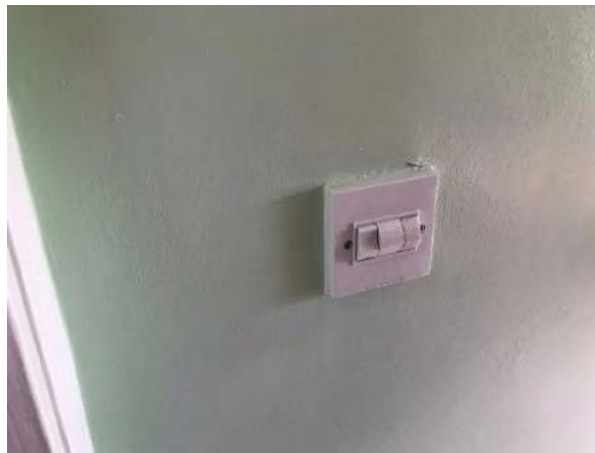
Photograph No 27 – Lighting switch controlling bedroom lighting

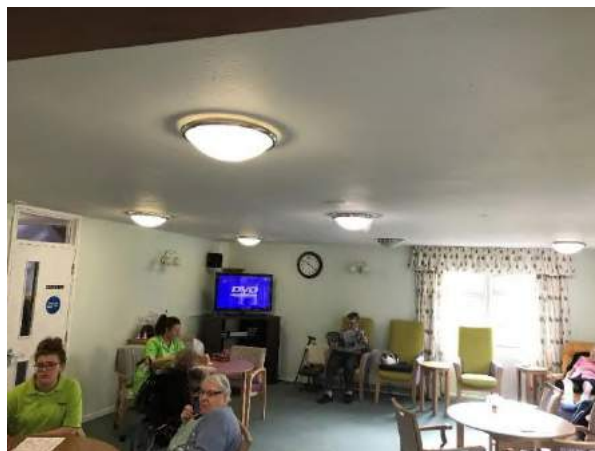
Photograph No 28 – Amenity lighting

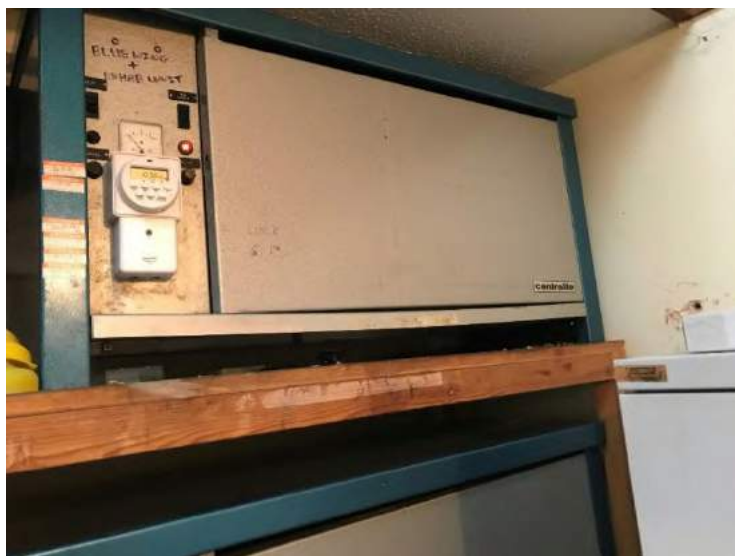
Photograph No 32 – Typical central battery unit

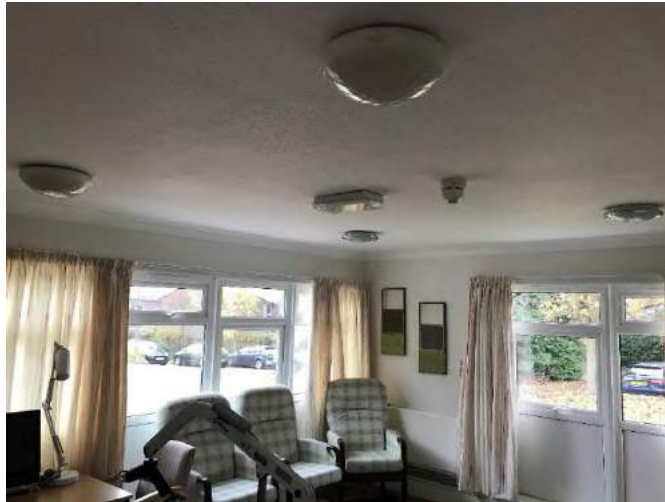
Photograph No 33 – Emergency lighting within dayroom

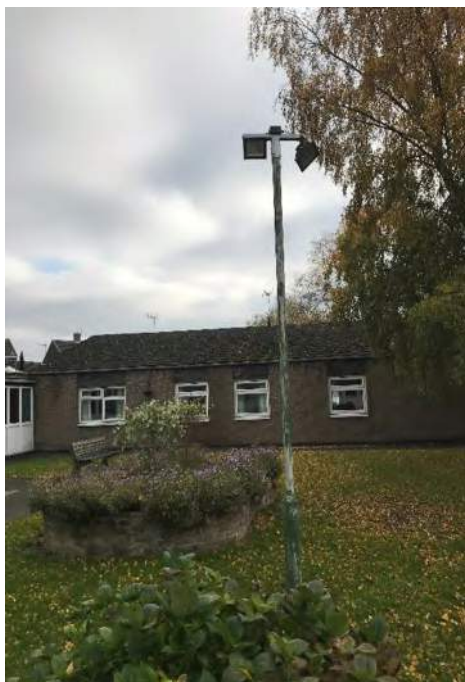
Photograph No 34 – There are a few lighting column on the site illuminating the main garden areas.

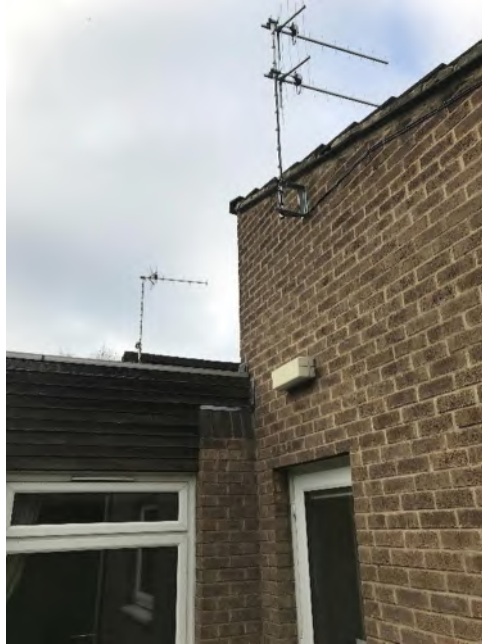
Whilst external escape doors are provided with lighting it is not clear whether these are emergency lights or just normal lighting.

Photograph No 35 – Typical wall mounted bulkhead luminaire a fire exit door. It was not clear if these were emergency luminaires.

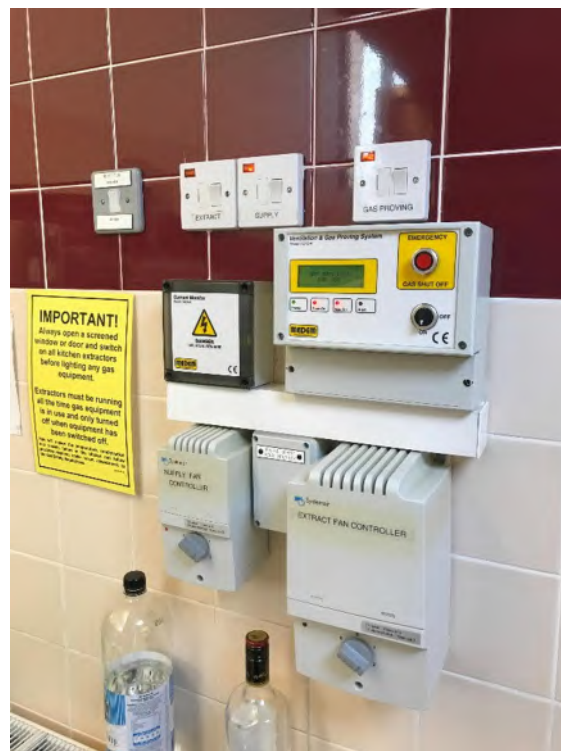
Photograph No 38 – Various power supplies within kitchen

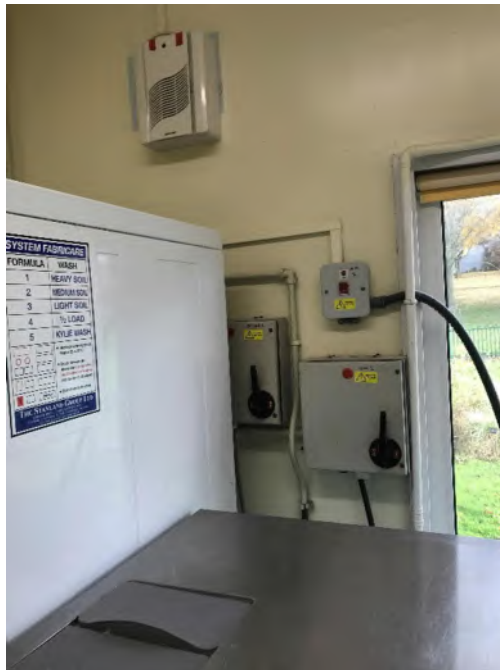
Photograph No 39 – Isolators supplying laundry equipment

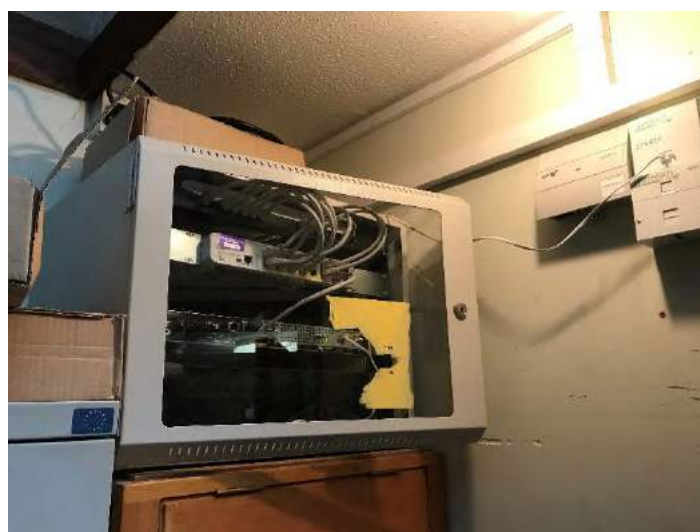
Photograph No 40 – Data rack installed in office.

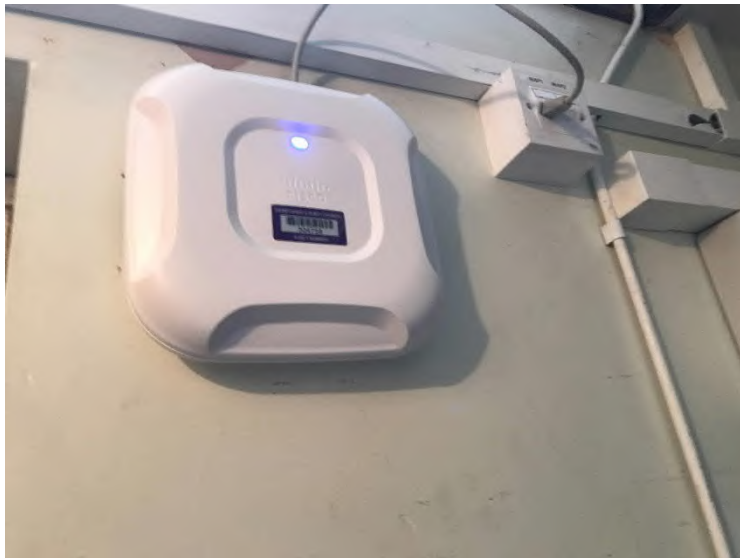
Photograph No 41 – Wi-Fi distribution point.

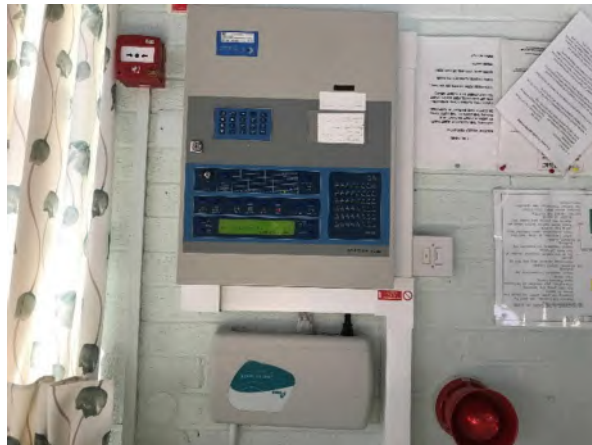
Photograph No 42 – New addressable fire alarm panel located in the main entrance.

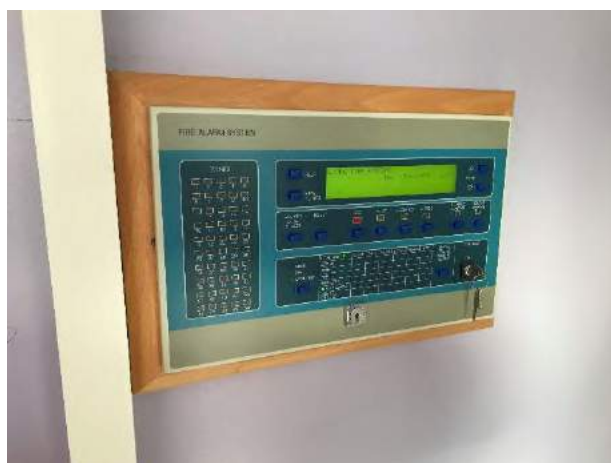
Photograph No 44 – First floor flat has a separate fire alarm panel

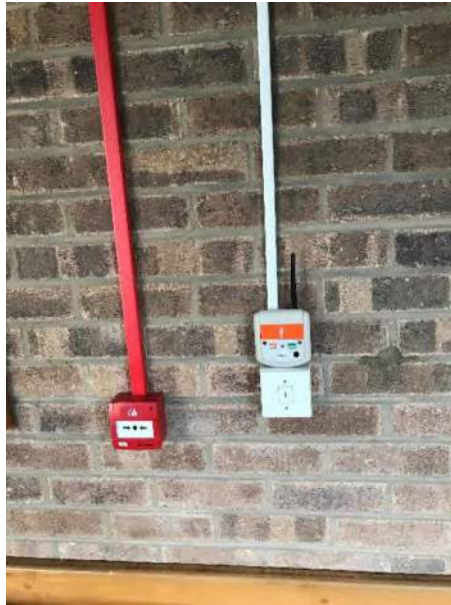
Photograph No 45 – Manual call points are not fitted with covers

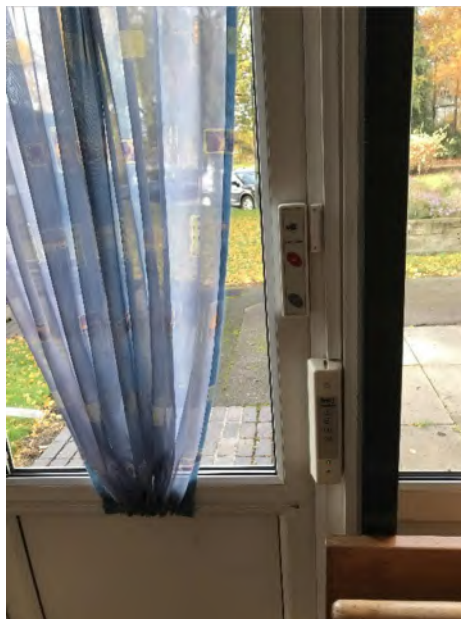
Photograph No 46 – Exit door with a call point & First Q Wander Guard alarm fitted.

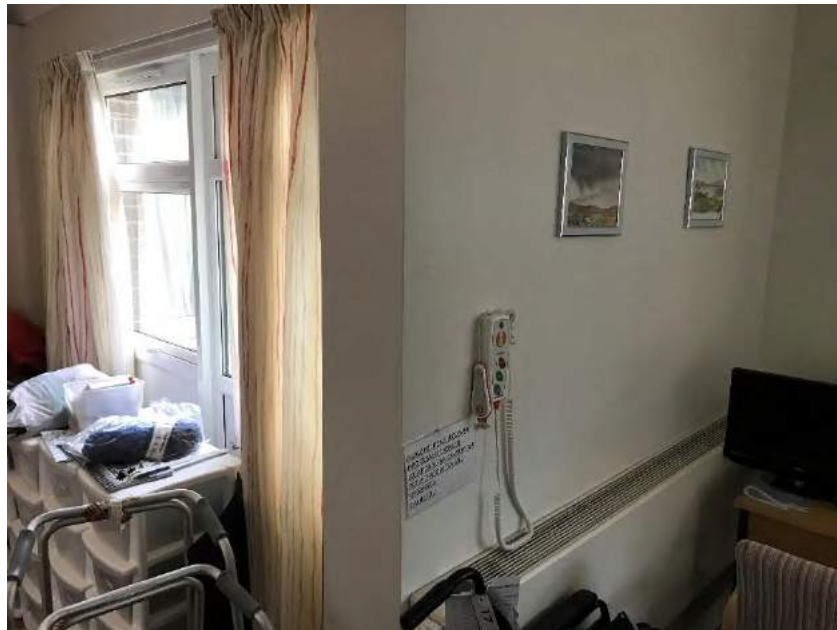
Photograph No 47 – Nurse call point within activity room

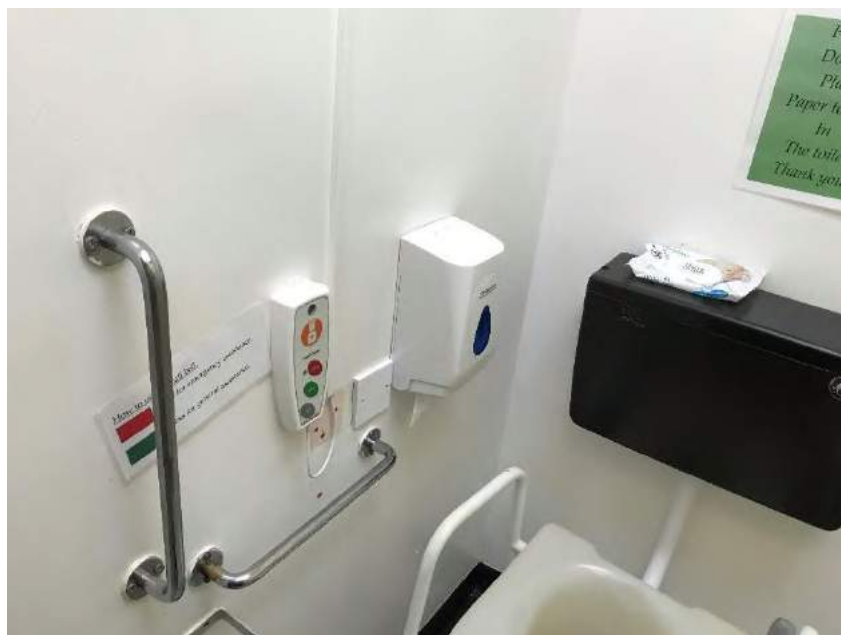
Photograph No 48 – Nurse call point within assisted toilet

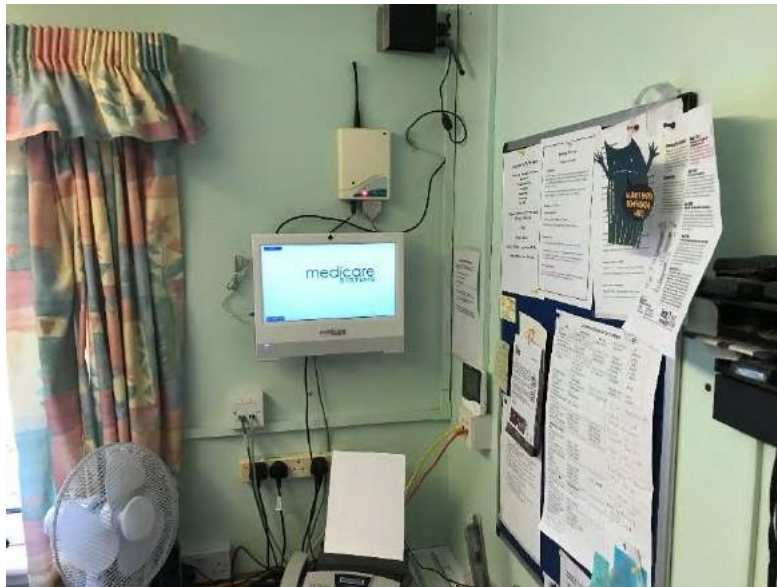
Photograph No 49 – Master Nurse Call system monitor located within office.

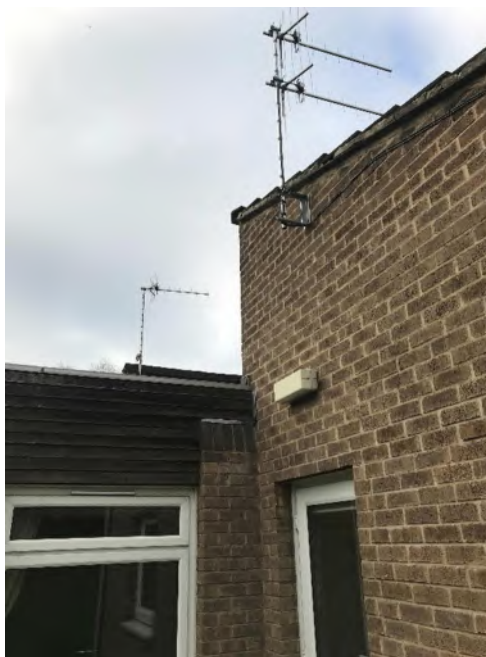
Photograph No 50 – Terrestrial TV aerials at roof level.

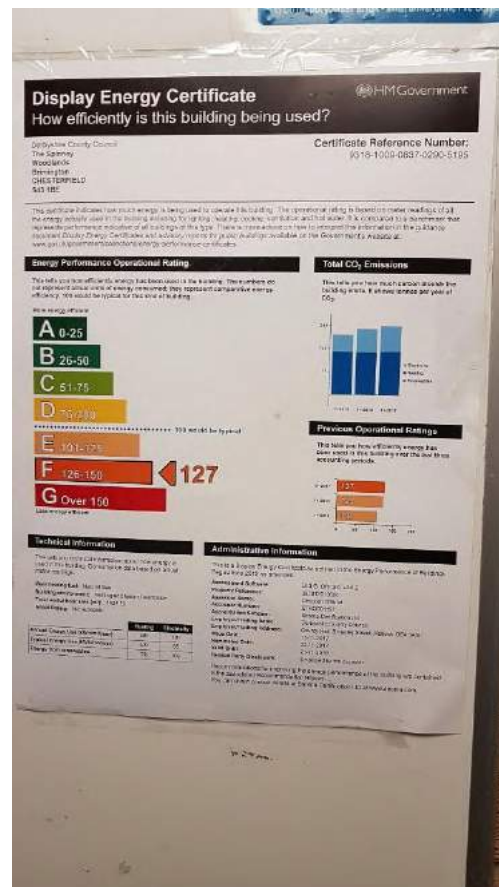
Photograph No 51 – Current DEC with a rating of F – 127.
