### Appendix 3 – Examples of Modes of Failure at Various A6 Derwent Valley Wall Locations

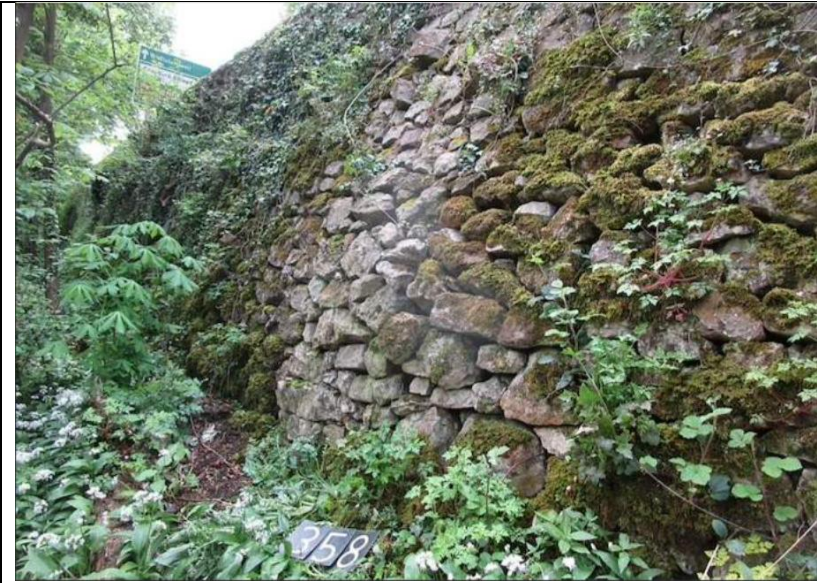
| | <p><b>Bulging &amp; Voids</b></p> <p>The photograph shows the bulging of the retaining wall and voids on the face of the wall.</p> |

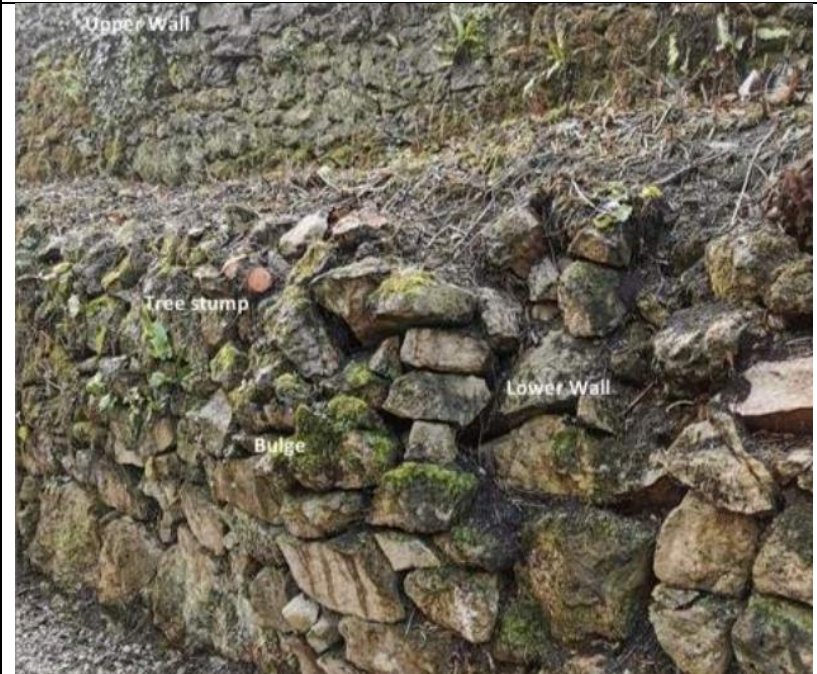
| | <p><b>Bulging on a lower wall</b></p> <p>Photograph shows bulging and stone displacement to lower section of tiered retaining wall.</p> |

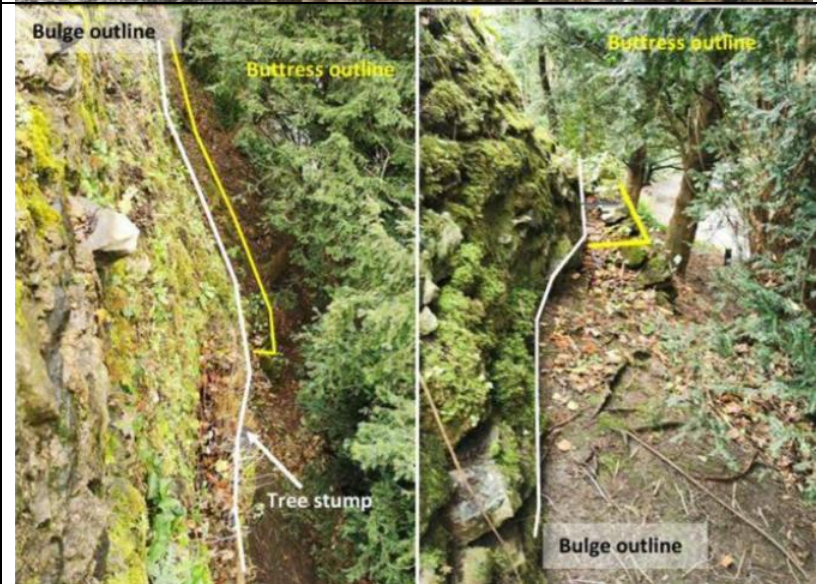
| | <p><b>Large Bulge at Base</b></p> <p>Photograph shows large bulge at the base of the wall and stone displacement.</p> |

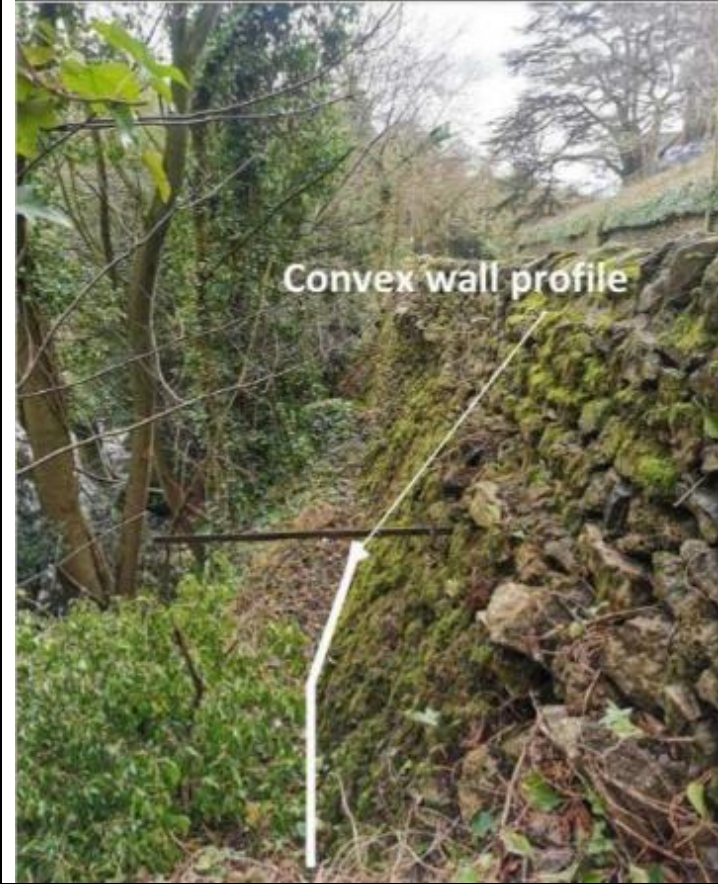
| <p>Convex wall profile</p> | <p><b>Bulging &amp; Convex Wall Profile</b></p> <p>Photograph shows bulging exhibiting a convex profile, with voids and rock displacement visible.</p> |

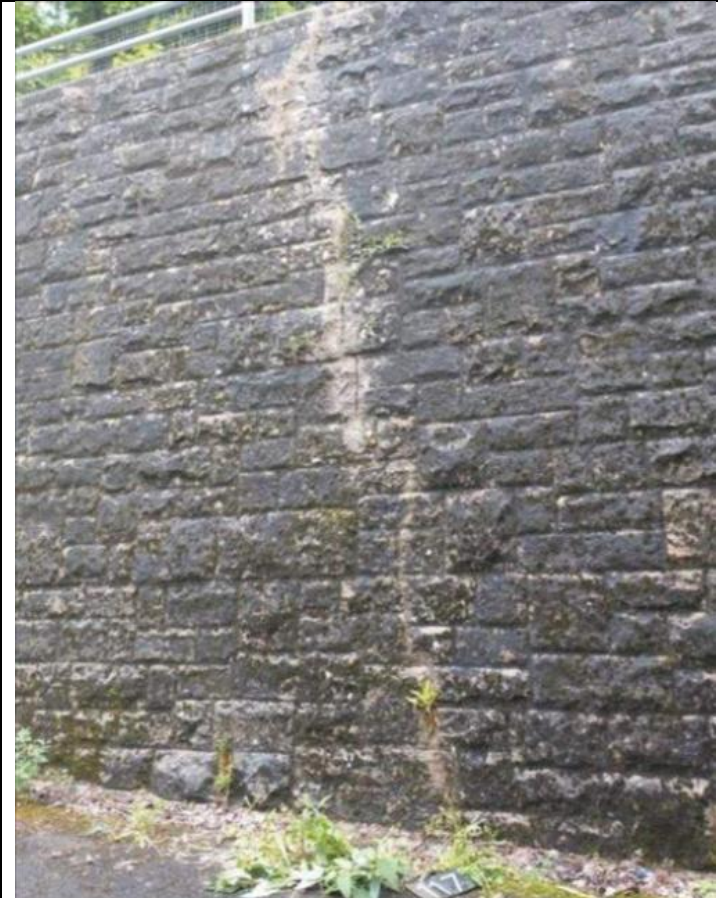
| | <p><b>Vertical Crack</b></p> <p>Photograph showing a full height vertical crack and water seepage, weakening the wall's loading capability.</p> |

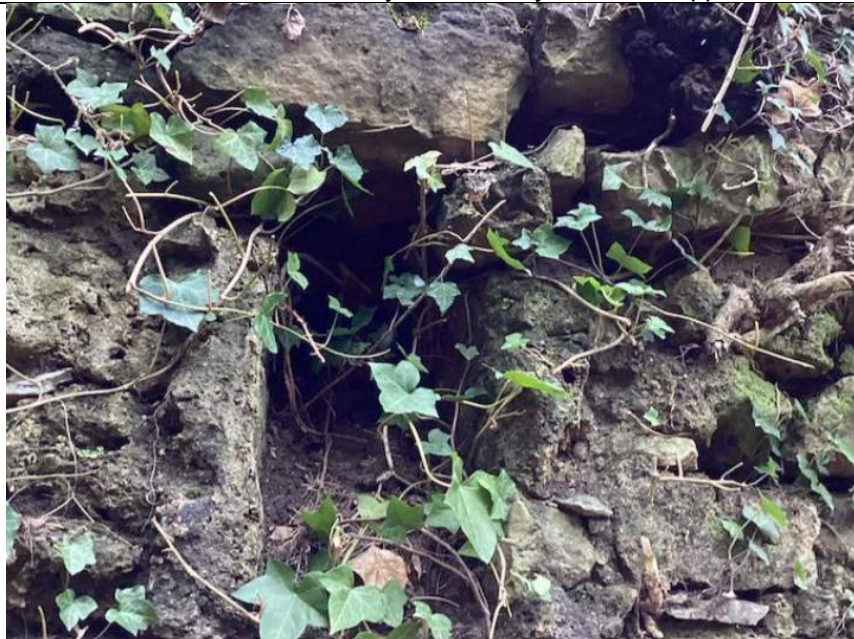
**Voiding**

Photograph shows voiding on face of the wall

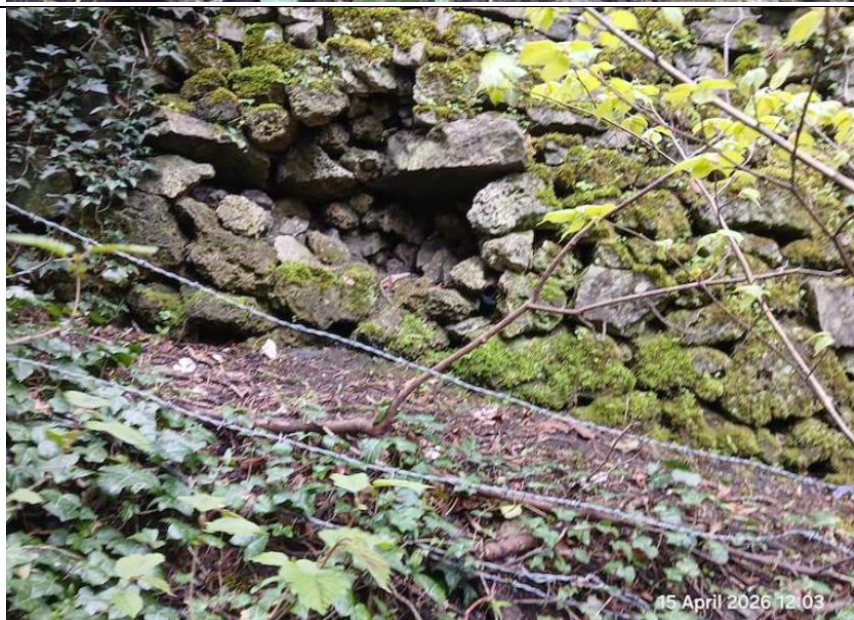
**Voiding with Collapse**

Photograph showing collapse following voiding.

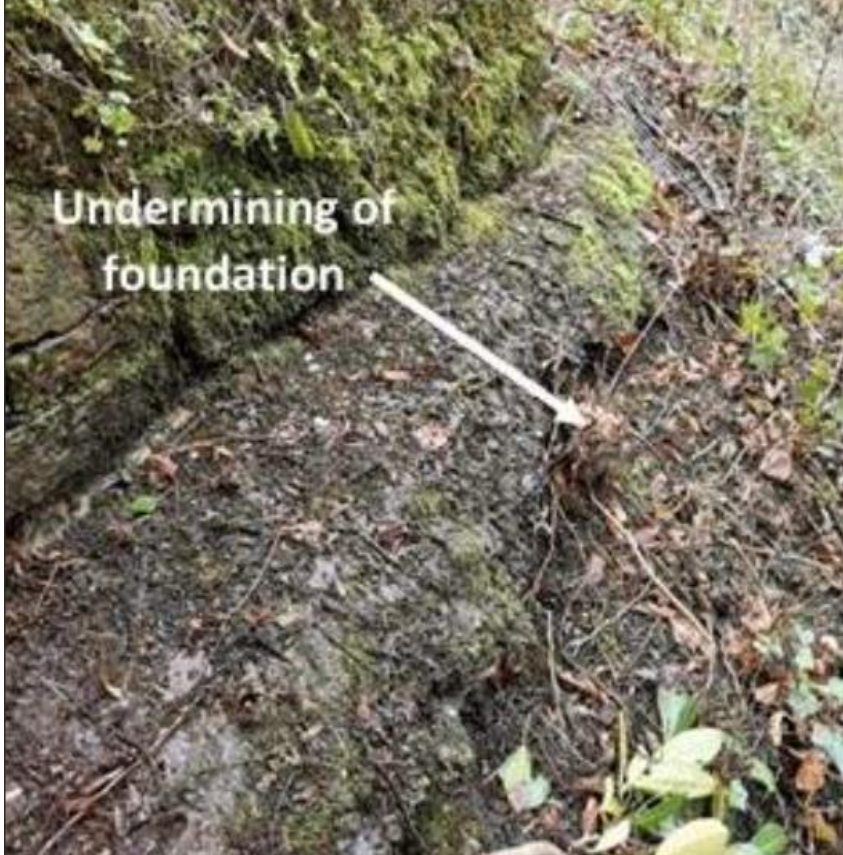
| | <p><b>Undermining of Foundations</b><br/>Effects of more extreme rainfall events causing erosion and undermining of the wall foundations.</p> |

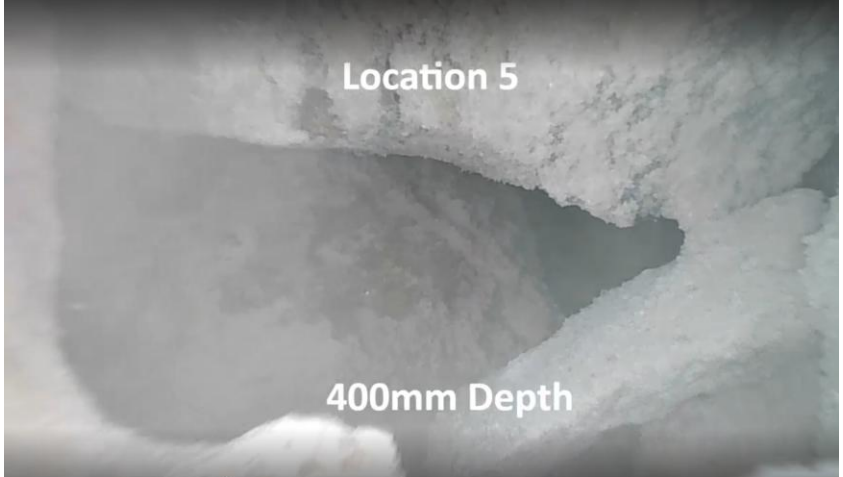
| | <p><b>Internal Void</b><br/>Extract from exploratory video showing existence of voids beyond 400mm depth within the retaining wall.</p> |
