# Property Flood Resilience

Stories from homes and businesses who have made adaptations to help them recover more quickly after a flood

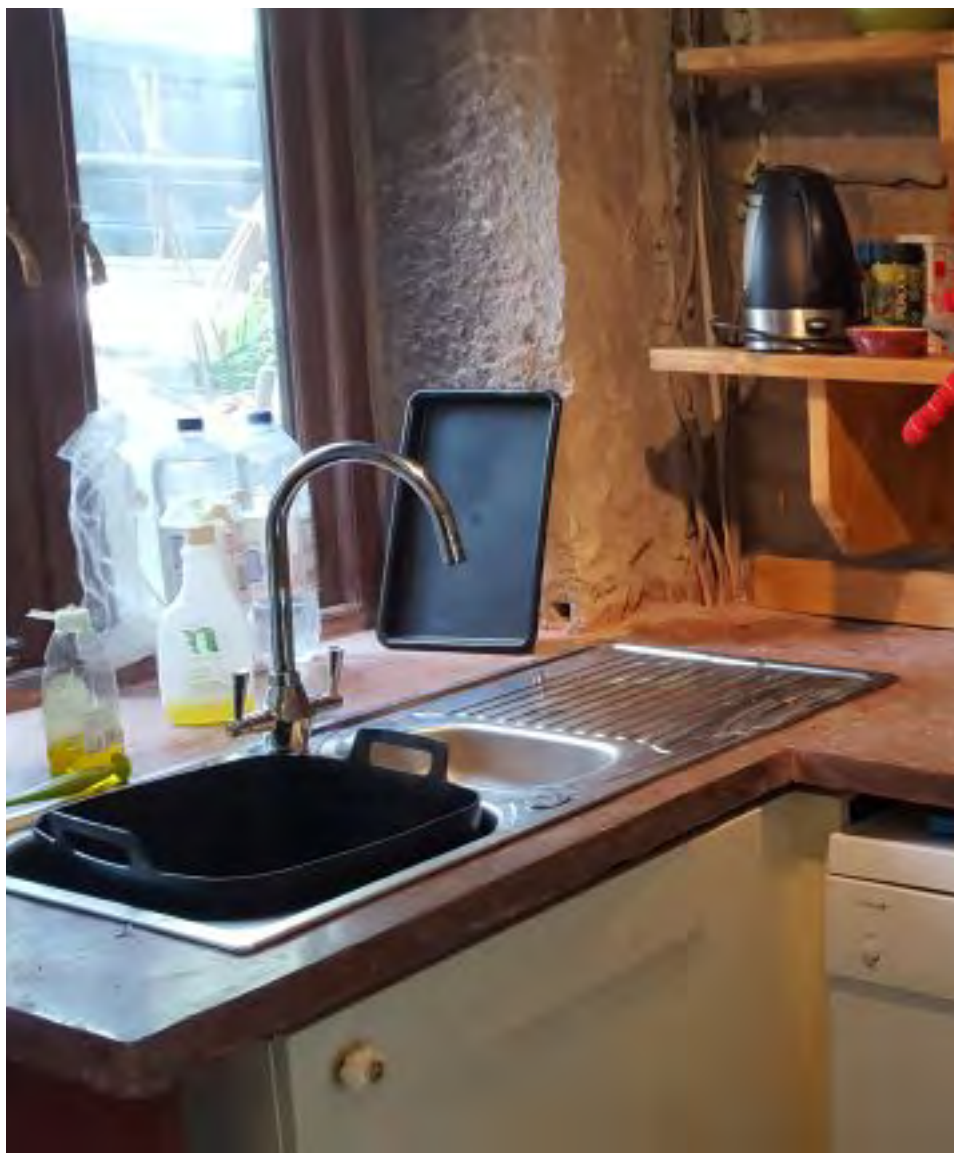
*The kitchen worktop is polished concrete and was saved in the flood*

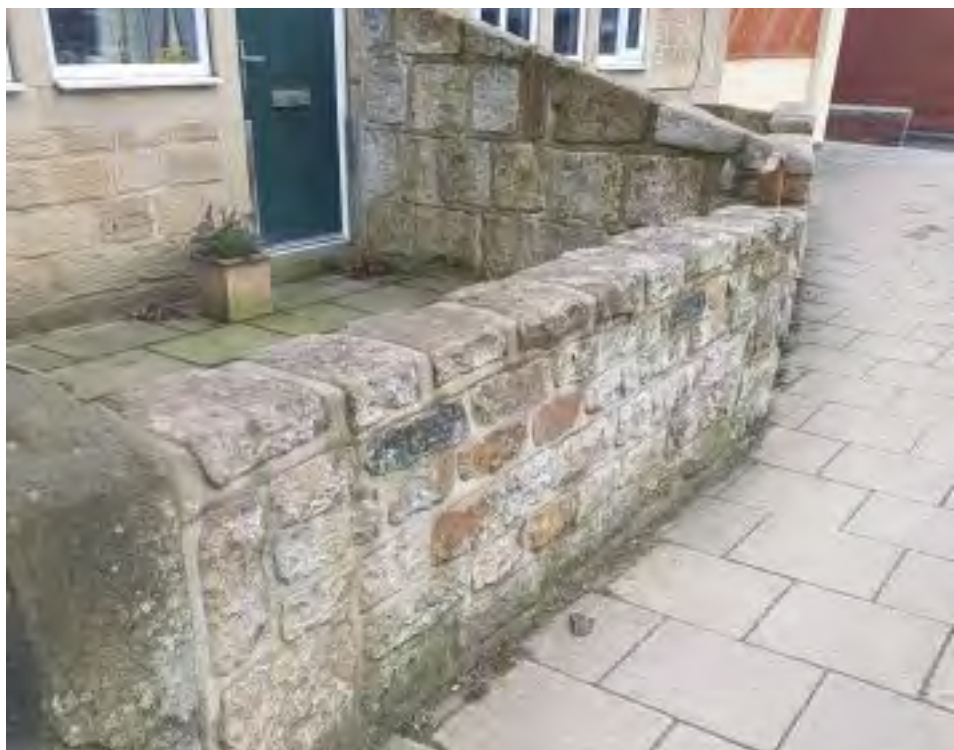
*New wall at front of house with a flood-proof gate*

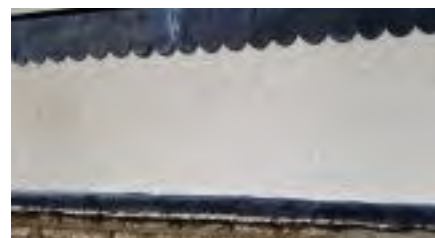
Walls on river-facing side of house have multi-layered waterproofing.

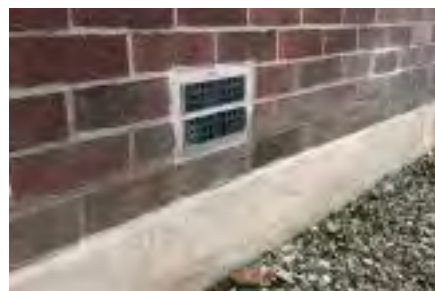
*Self-closing air bricks and waterproof rendering was applied underground to the foundations and 30cm above ground.*

- Waterproof rendering was applied underground to the foundations and 30cm above ground.
- Water resistant spray to walls above the render.
- Self-closing air bricks.

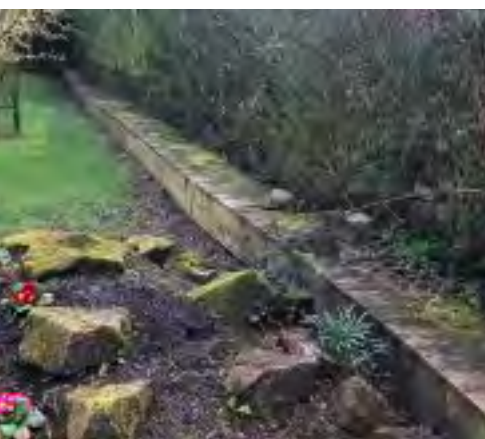
*Wall with substantial foundations in the garden.*

- Rob has built a wall with substantial foundations in the garden.
- They have non-return valves fitted to the sewers.
- White goods are raised up on plinths.

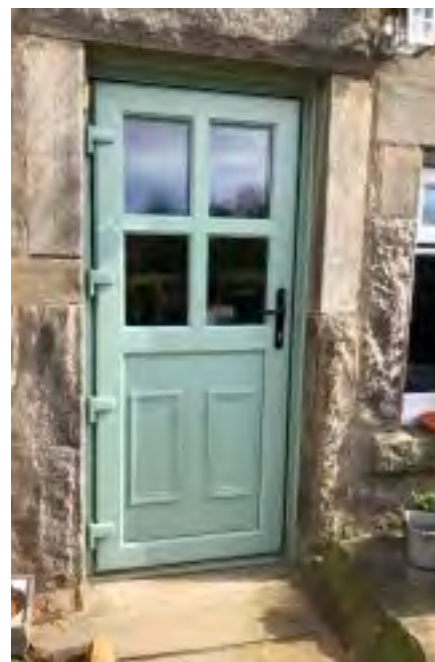
*Flood door fitted.*

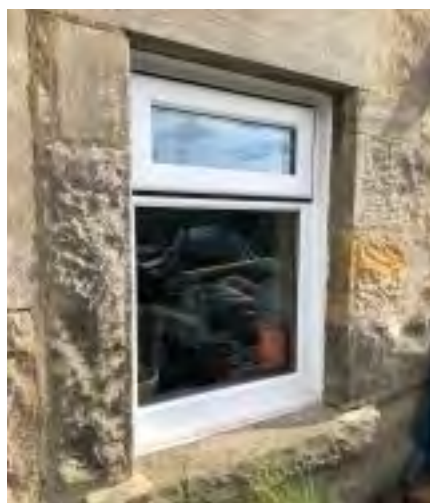
*Original window replaced with a flood proof window.*

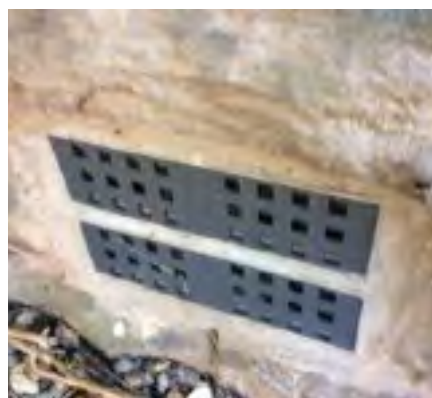
*Self-closing airbricks.*

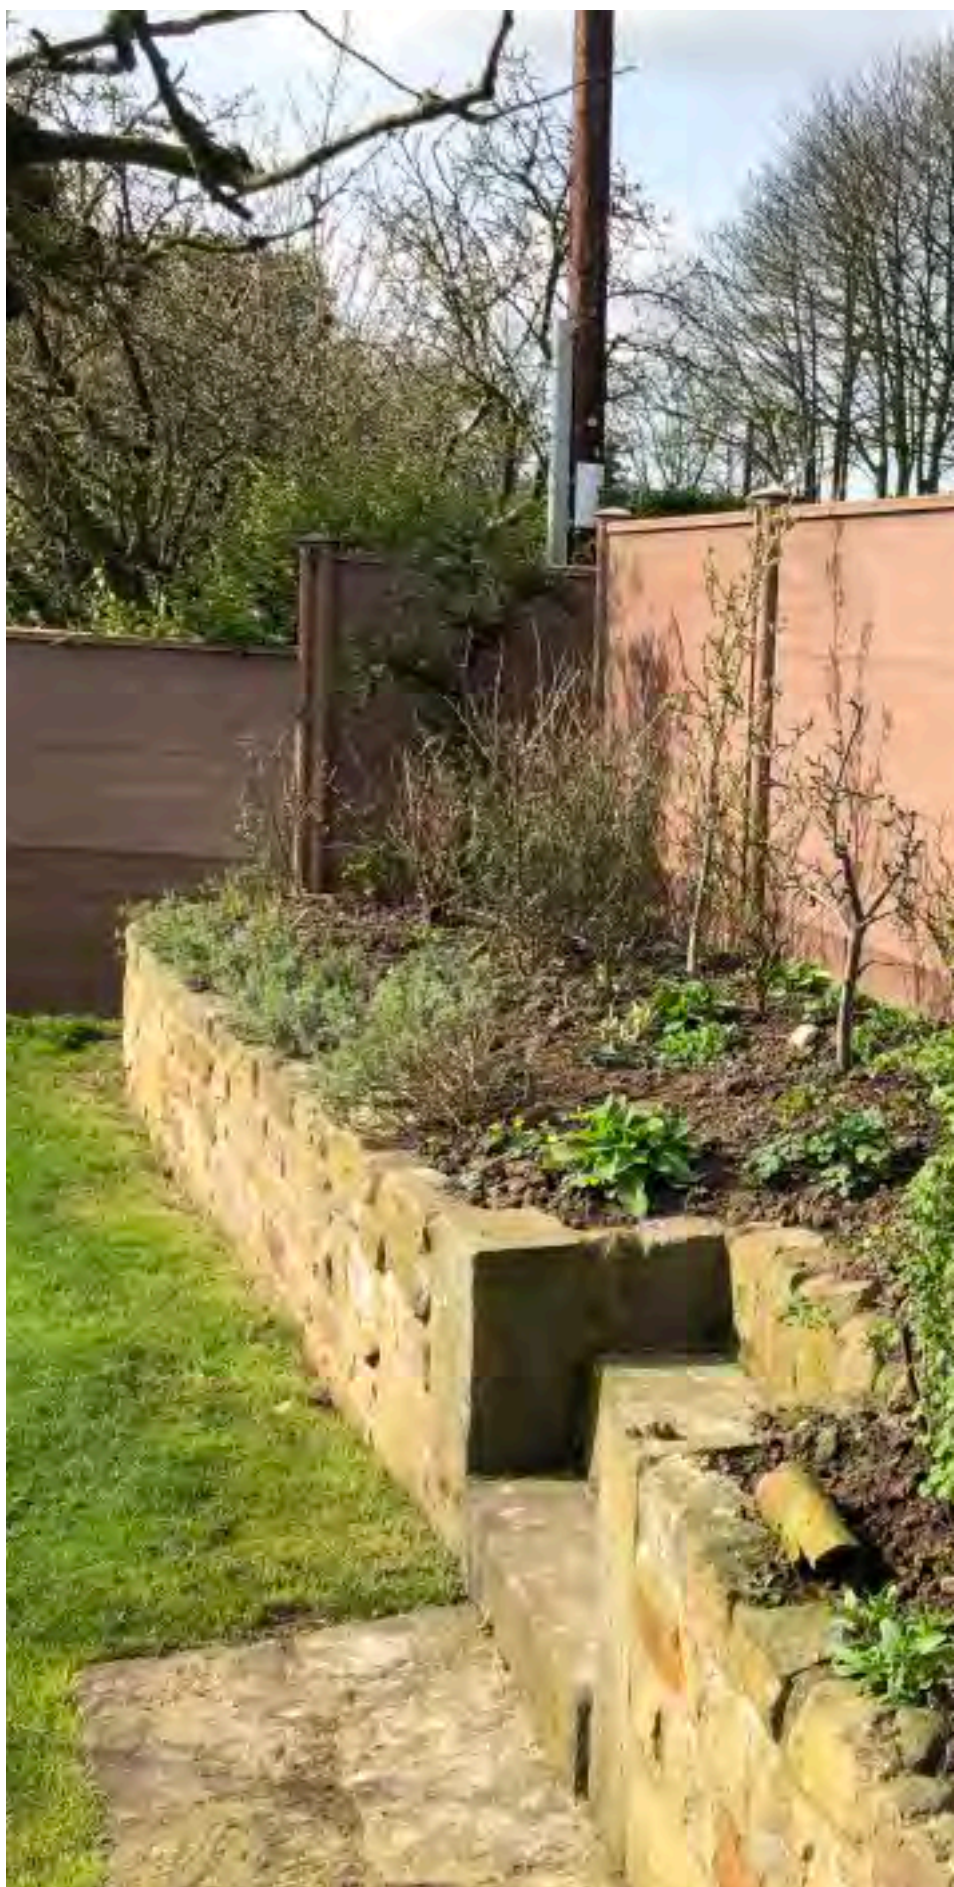
*At the perimeter of the garden one-metre-deep holes were filled with concrete, into which posts and reinforced 'Task Green' waterproof fence panels were fitted.*

- Plaster was replaced with a lime-based mix.
- Plug sockets were raised up the wall.
- At the perimeter of the garden their contractor dug one-metre-deep holes, which were filled with concrete, into which 'Task Green'\* waterproof posts and fence panels were then fitted, with the lowest panel sunk into a 2ft trench, also filled with concrete. The contractors also reinforced the fence panels with steel bars, to enable them to withhold the weight of deep water.

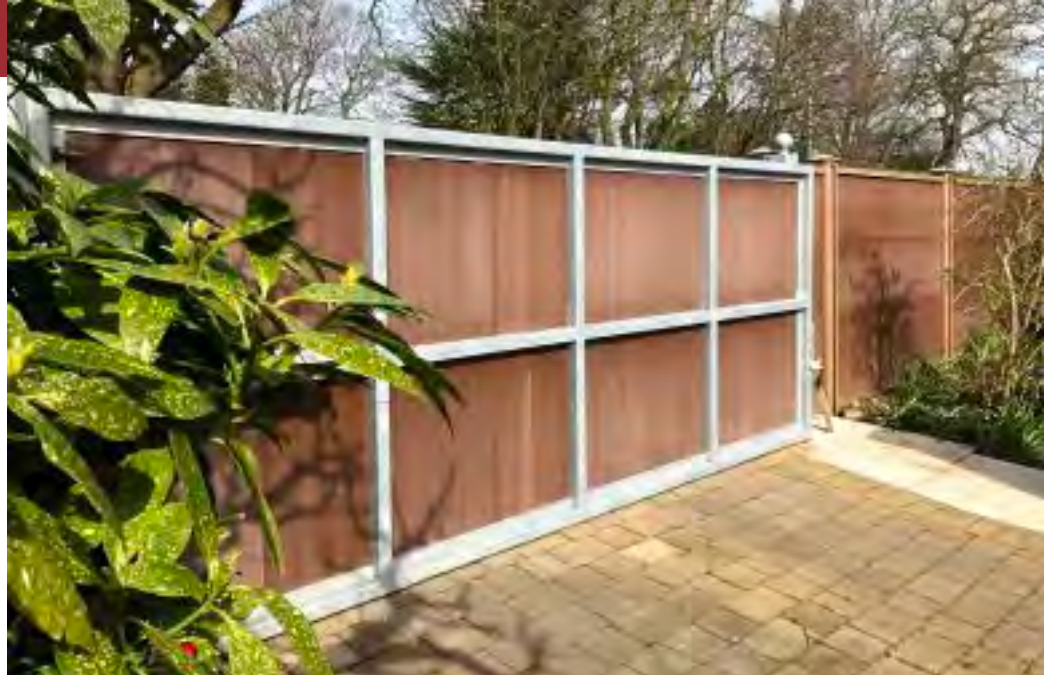
*The front entrance gate is the same material as the fence panels and is fitted tightly to prevent ingress of water.*

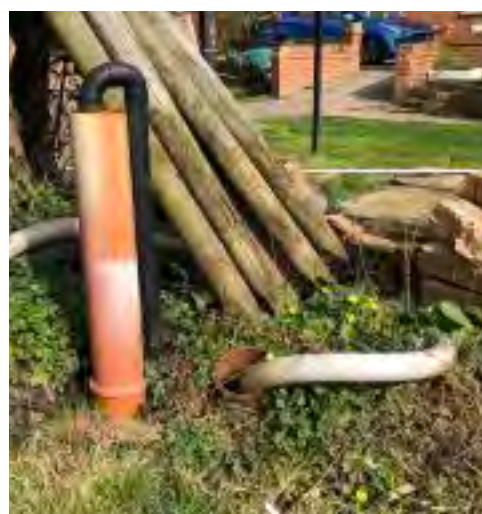
*Rainwater runs through a series of French drains into a large sump into which a strong pump is fitted which pumps the water outside the garden boundaries.*

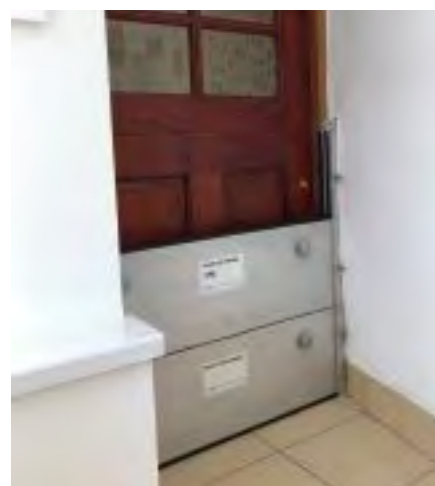
*Flood barriers to all external doors and tiled floors.*

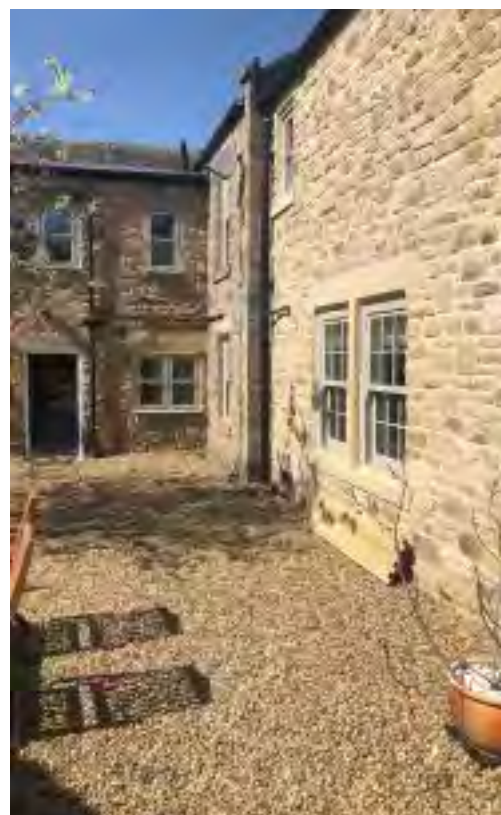
*Permeable patio areas surround most of the house.*

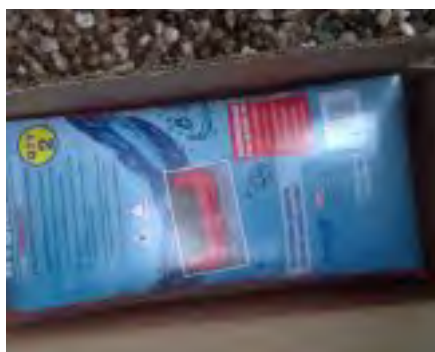
Absorbent packs swell up and block water.

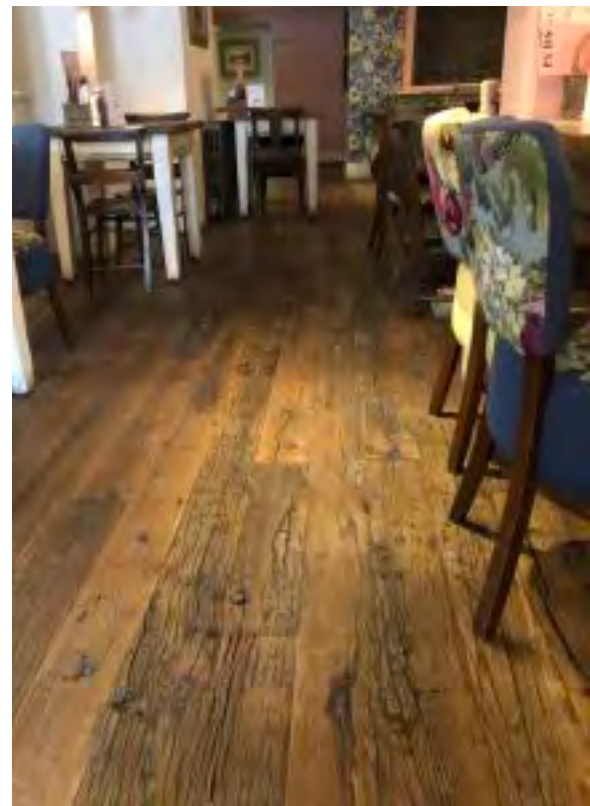
The floors all have a resin damp proof membrane beneath them, to prevent the water rising from underneath.

- The floors all have a resin damp proof membrane beneath them, to prevent the water rising from underneath.
- The bar is solid oak and survived the 2015 flood. It has stainless steel fittings and easily removable equipment.

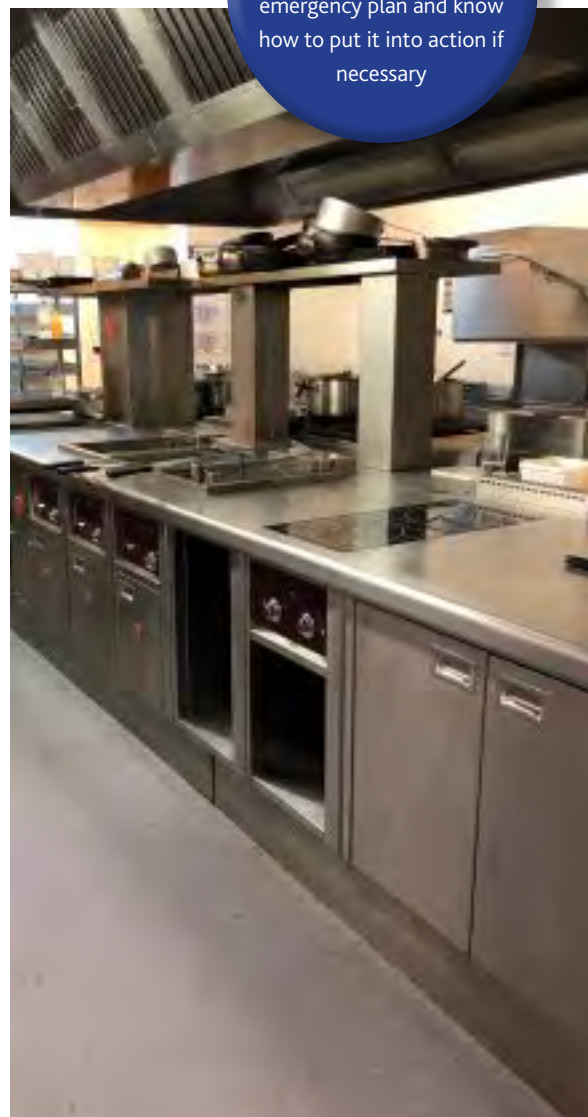
*The motor can be removed from the stainless-steel kitchen 'Chave block' (cooking area).*

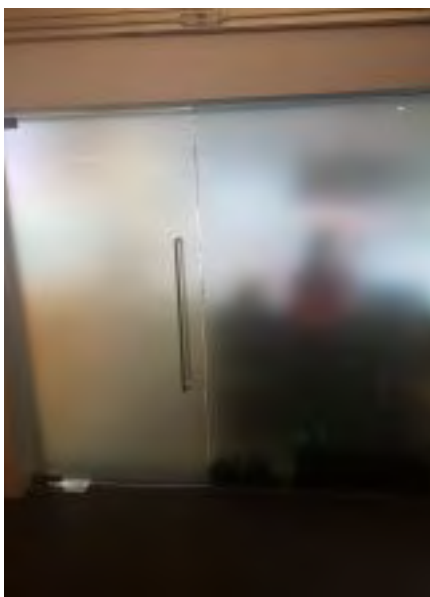
*Interior doors are now 'Rainscreen' panels, mounted on stainless steel supports.*

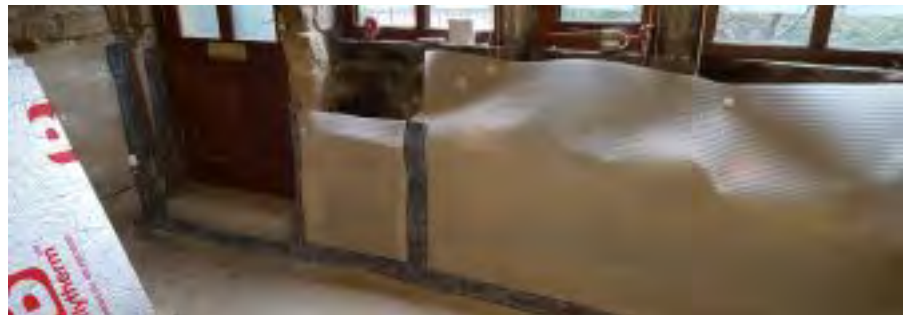
Waterproof membrane during installation.

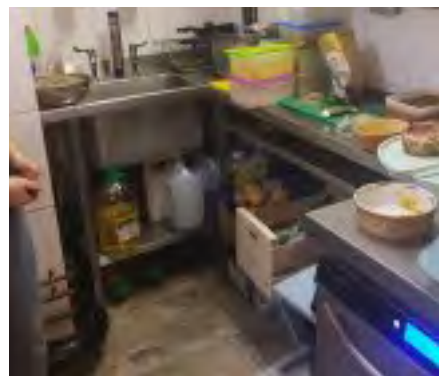
Kitchen is stainless steel and can be hosed down.
