**STRUCTURE SUMMARY REPORT**
**Wednesday, July 29, 2026**

| <b>Name:</b> | POPLARS RETAINING WALL |
| <b>Reference:</b> | RB350073 |
| <b>Sub Type:</b> | Highway Retaining Wall |

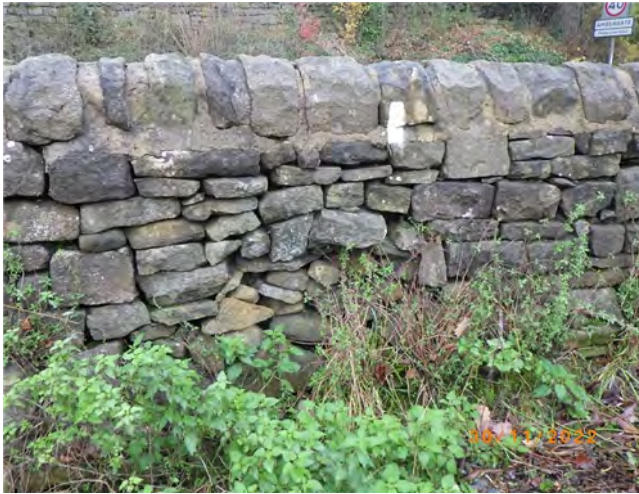
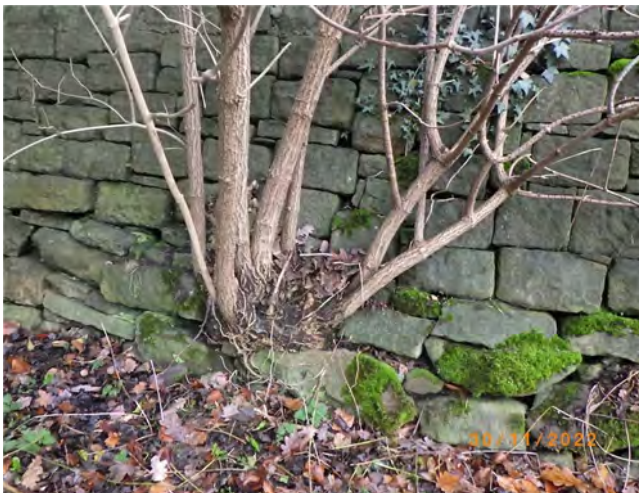
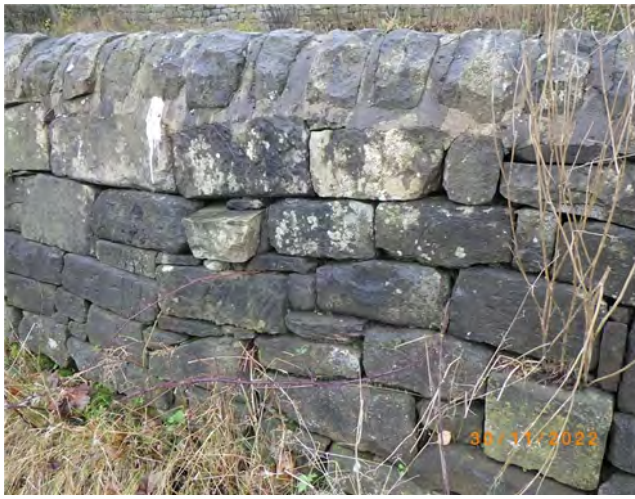
| M<br>a<br>i<br>n<br><br>E<br>l<br>e<br>m<br>e<br>n<br>t<br>s | 2 | Retaining Wall (Primary) | 3 | D | 5.2 | | | £0 | Encroaching ivy to wall elevation providing a boundary to the residence to the North. Two short sections of slumped stone courses. Semi mature tree growing from the basal stonework. |

| Element No. | S | Ex | Defect | Comments |
|---|---|---|---|---|
| 2 | 3 | D | 5.2 | Encroaching ivy to wall elevation providing a boundary to the residence to the North. |
| 2 | 3 | B | 3.1 | Two short sections of slumped stone courses. |

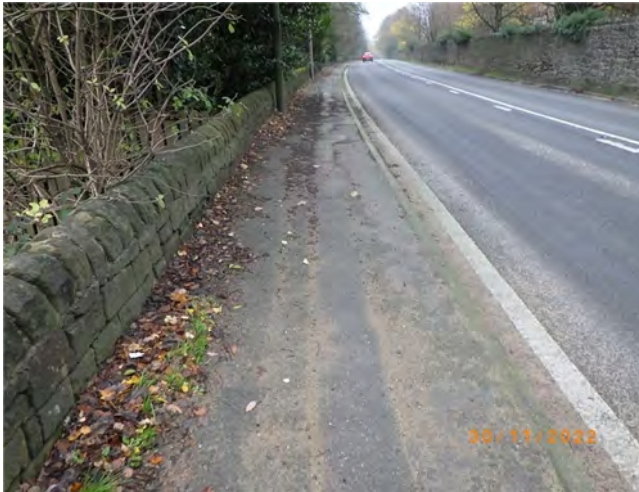
| E<br>l<br>e<br>m<br>e<br>n<br>t<br>s | 12 | Footway/Verge (Top) | 2 | D | 9.1 | | | £0 | Wear and reinstatement scars. |

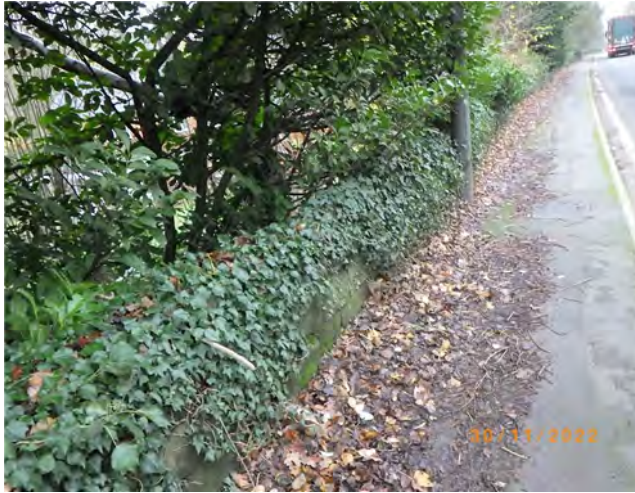
| | 9 | Handrail/parapet/safety fences | 3 | C | | | | £0 | Slight historical horizontal misalignment. Ivy to the parapet to the North at the boundary to the residence. |

| Element No. | S | Ex | Defect | Comments |
|---|---|---|---|---|
| 9 | 2 | E | 3.1 | Slight historical horizontal misalignment. |

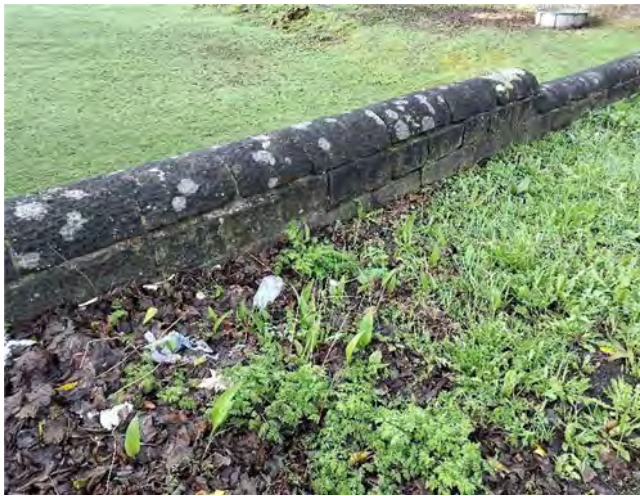
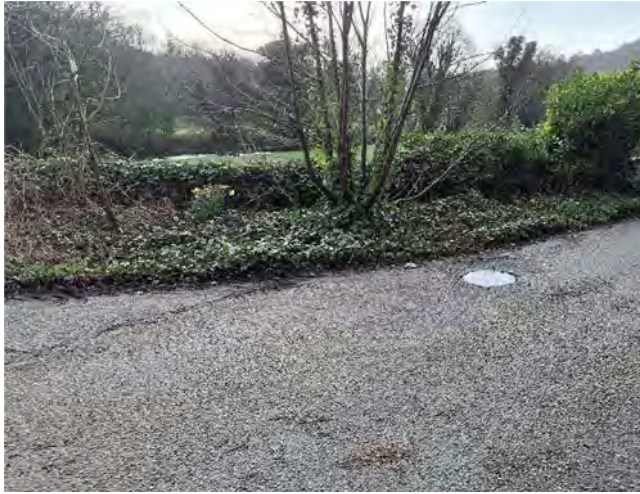
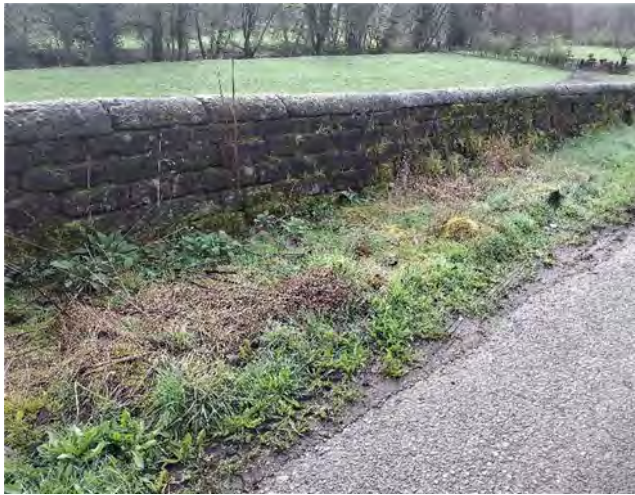
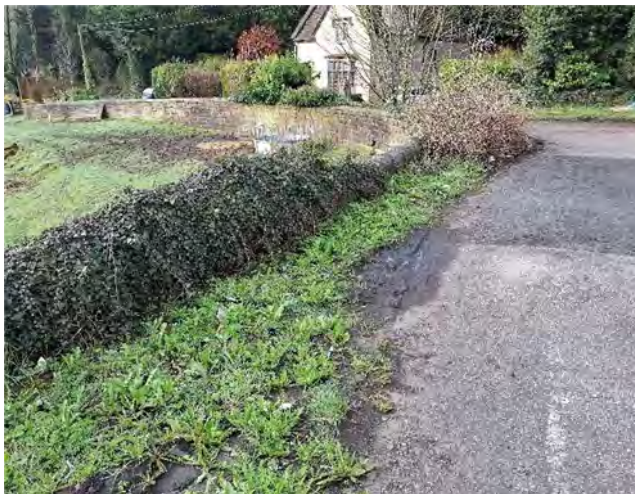
| Safety Elements | 9 | Handrail/parapet/safety fences | 2 | C | 3.2 | | | £500 | minor loss of pointing, inside face of wall. overhanging/eveloping vegetation. remove | |

| Element No. | S | Ex | Defect | Comments |
|---|---|---|---|---|
| 9 | 2 | C | 5.1 | overhanging/veloping vegetation. remove |

| Ref No. | Item No. | Work Description | Priority | Estimated Cost | Work Ordered |
|---|---|---|---|---|---|
| A5/GE260250 | 9 | overhanging/veloping vegetation. remove | L | £500 | |

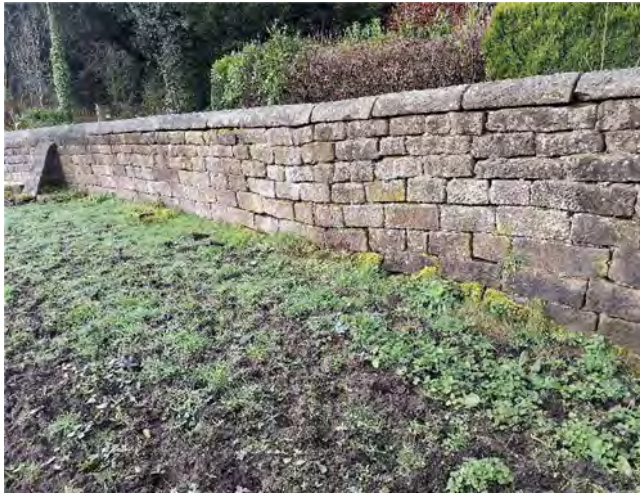
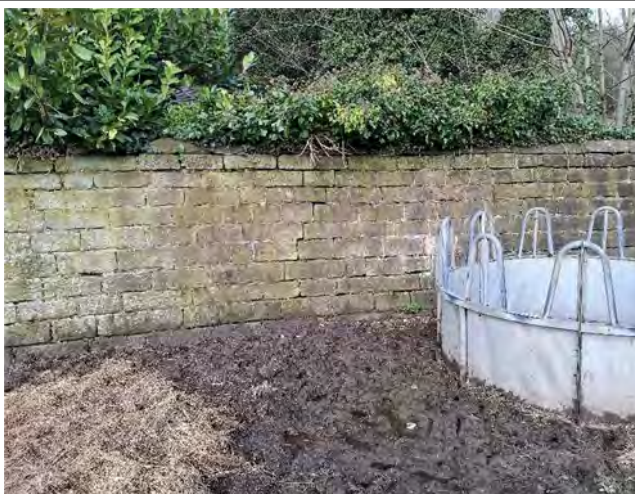
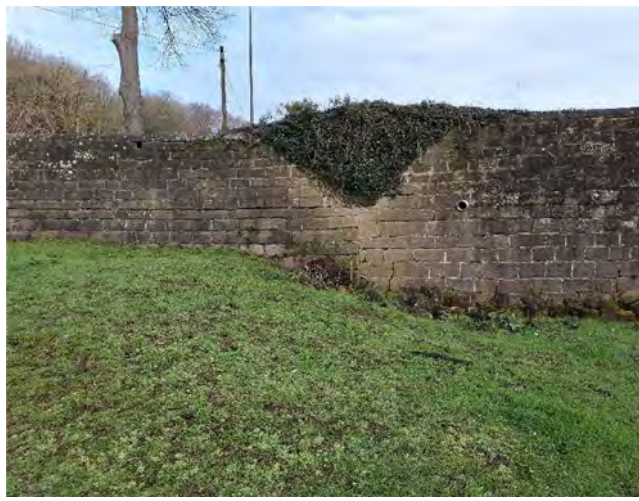
| | 2 | Retaining Wall (Primary) | 3 | C | 5.1 | | | £0 | small area of overhanging vegetation . historic stepped crack. opposite cottage wall leans outwards , 7 lin m | |

| Element No. | S | Ex | Defect | Comments |
|---|---|---|---|---|
| 2 | 3 | C | 3.7 | opposite cottage wall leans outwards , 7 lin m |
| 2 | 2 | B | 3.5 | historic stepped crack |

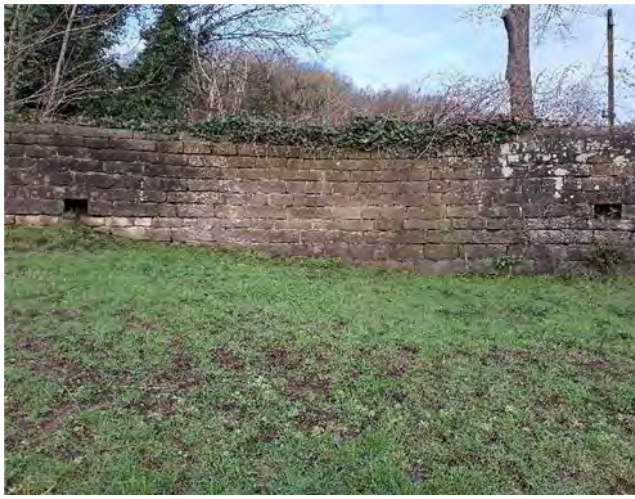
| | 5 | Drainage | 5 | E | 8.1 | | | £0 | totally blocked with silt | |

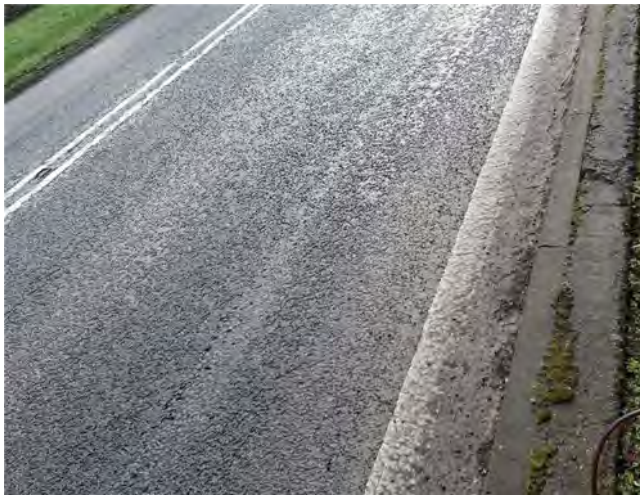
| Safety Elements | 10 | Carriageway (Top) | 1 | A | 0 | | | £0 | minor loss to surface dressing | |

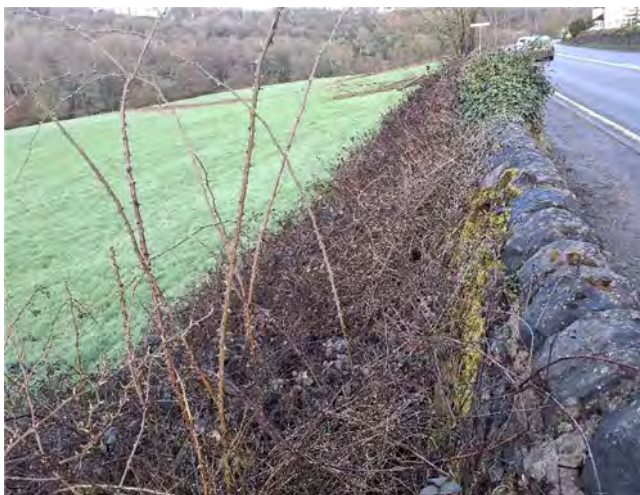
| | 2 | Retaining Wall (Primary) | 3 | E | 5.1 | | | £0 | vegetation envelops the whole outside face of wall | |

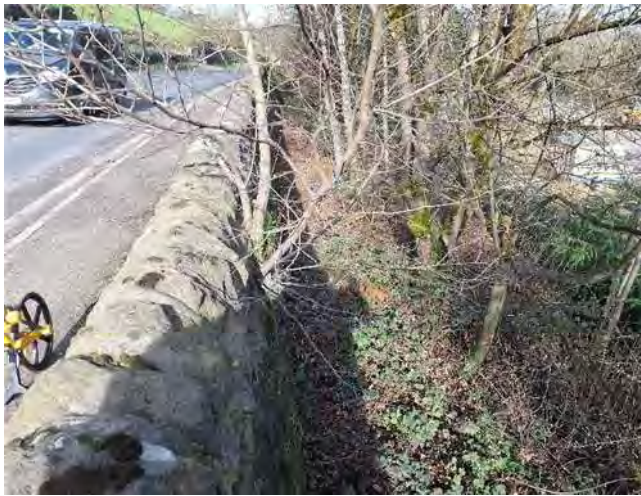
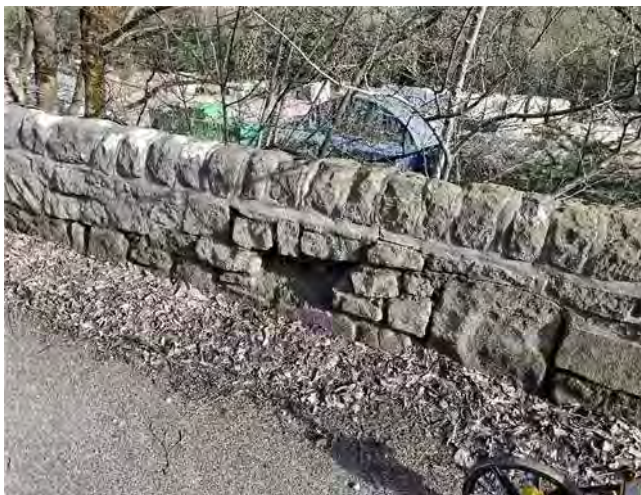
| | 9 | Handrail/parapet/safety fences | 4 | B | 5.1 | | | £0 | well established thick stemmed vegetation at ch 109, outside face, causing displacement of masonry, remove vegetation . ch109, missing masonry due to roots of vegetation |

| Element No. | S | Ex | Defect | Comments |
|---|---|---|---|---|
| 9 | 3 | B | 3.6 | ch109, missing masonry due to roots of vegetation |

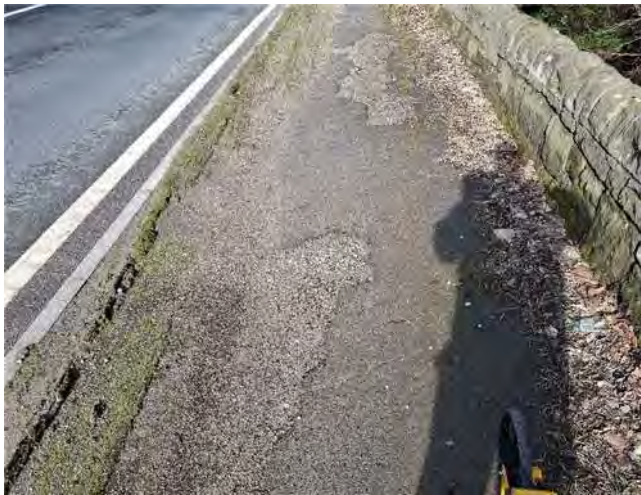
| Elements | 12 | Footway/Verge (Top) | 2 | B | 9.6 | | | £0 | loss of wearing course approximately 3sqm at ch32 |

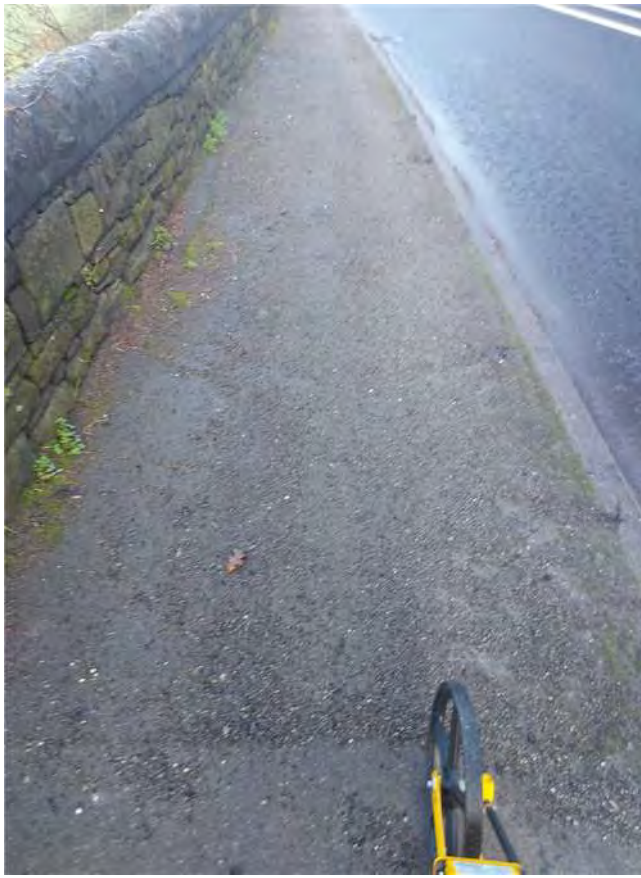
| | 12 | Footway/Verge (Top) | 2 | C | 9.4 | | | £0 | loss of wearing course/pebbles of surfacing from ch105m to 218m |

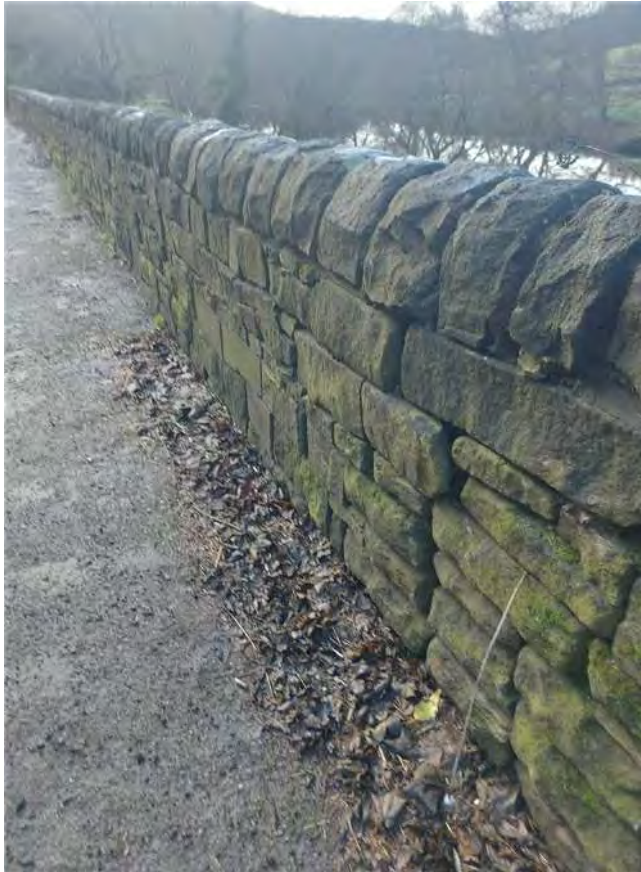
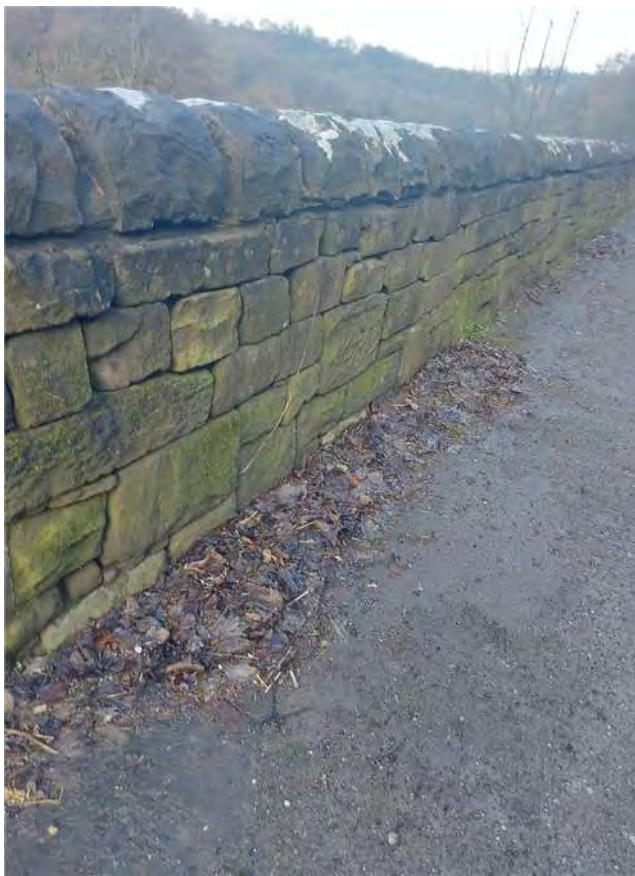
| | 9 | Handrail/parapet/safety fences | 3 | B | 3.5 | | L | £250 | stepped vertical crack at ch 44m. mortar the crack to strengthern. stepped vertical crack at ch 44m. mortar the crack to strengthern. loss of mortar under copings at ch. 24 to 44m, again at ch. 218 |

| Element No. | S | Ex | Defect | Comments |
|---|---|---|---|---|
| 9 | 3 | B | 3.5 | stepped vertical crack at ch 44m. mortar the crack to strengthen |

| Ref No. | Item No. | Work Description | Priority | Estimated Cost | Work Ordered |
|---|---|---|---|---|---|
| A5/GE2602493 | 9 | stepped vertical crack at ch 44m. mortar the crack to strengthen | L | £250 | |

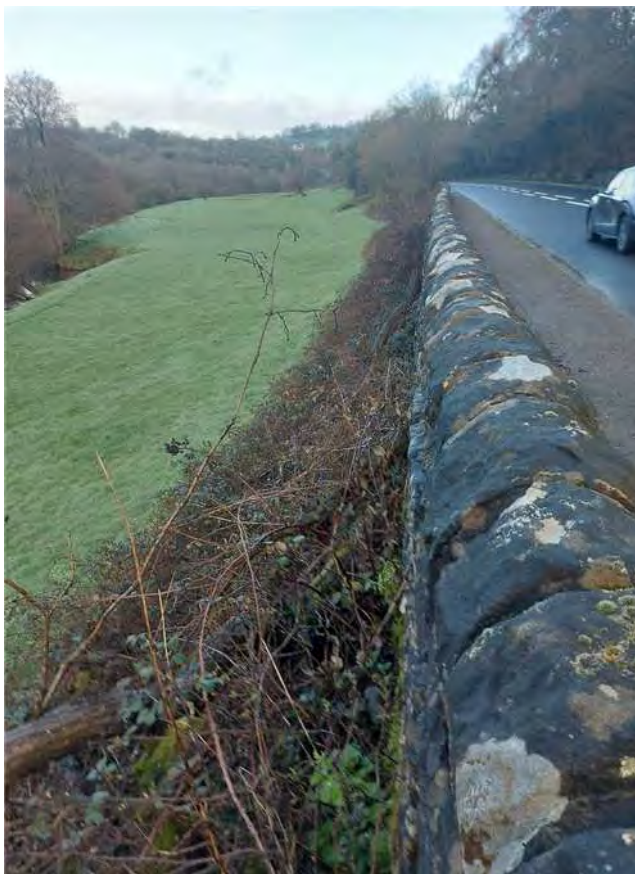
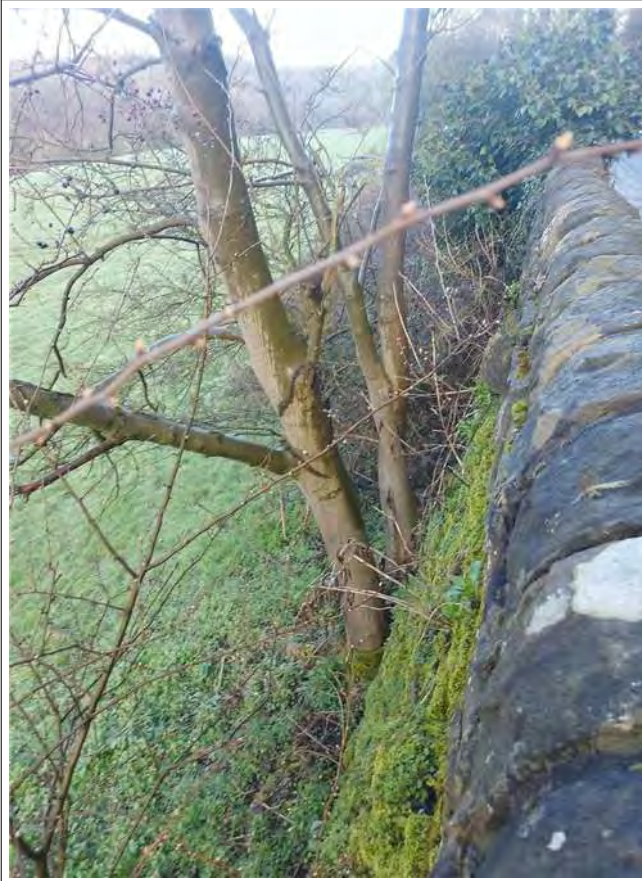
| | 2 | Retaining Wall (Primary) | 3 | B | 5.1 | | M | £650 | at ch. 77m tree growing at base of outer face, pushing against the wall and juvenile tress growing from the mortar joints. remove all trees in this area. a good section of the outer face enveloped in barmbles |

| Element No. | S | Ex | Defect | Comments |
|---|---|---|---|---|
| 2 | 3 | B | 5.1 | at ch. 77m tree growing at base of outer face, pushing against the wall and juvenile tress growing from the mortar joints. remove all trees in this area |

| Ref No. | Item No. | Work Description | Priority | Estimated Cost | Work Ordered |
|---|---|---|---|---|---|
| A5/GE2602494 | 2 | at ch. 77m tree growing at base of outer face, pushing against the wall and juvenile tress growing from the mortar joints. remove all trees in this area | M | £650 | |

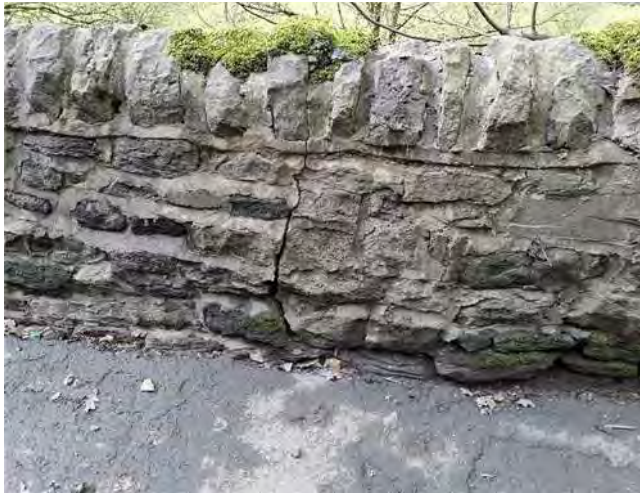
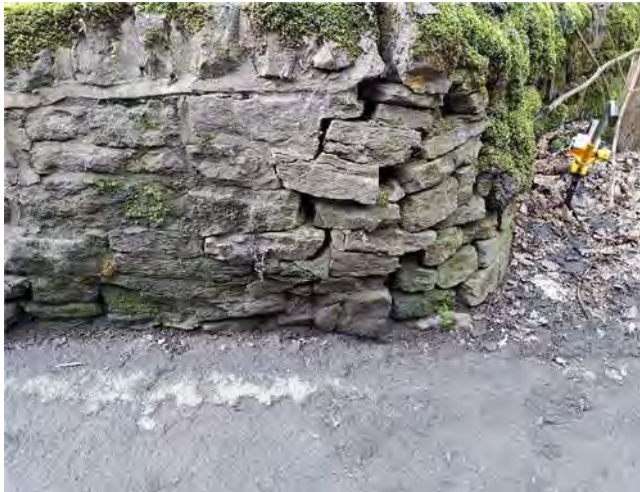
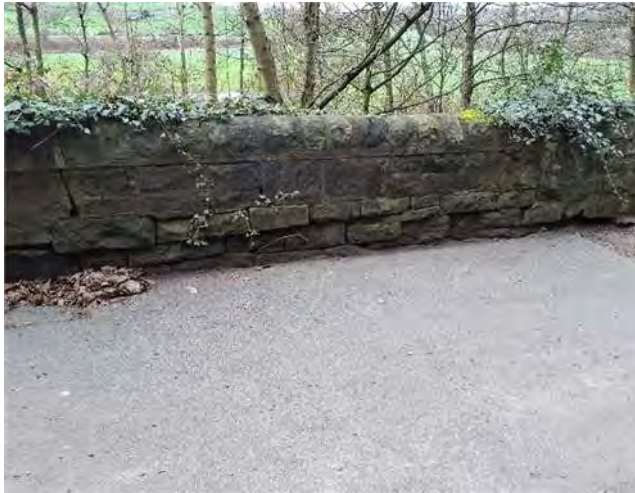
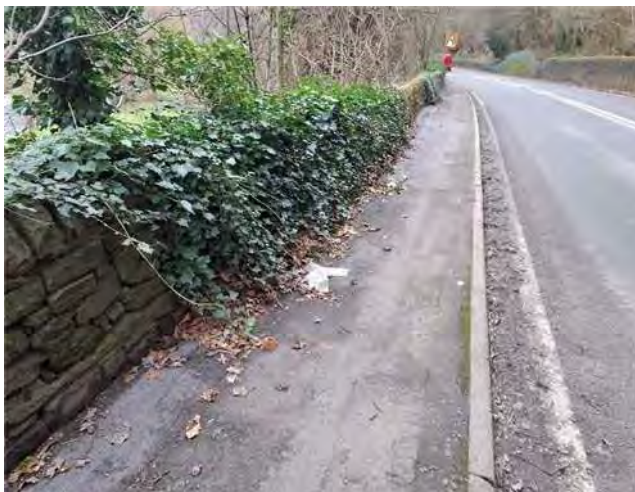
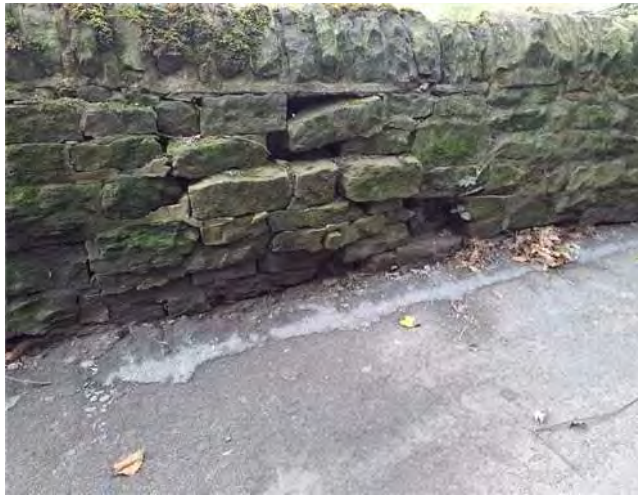
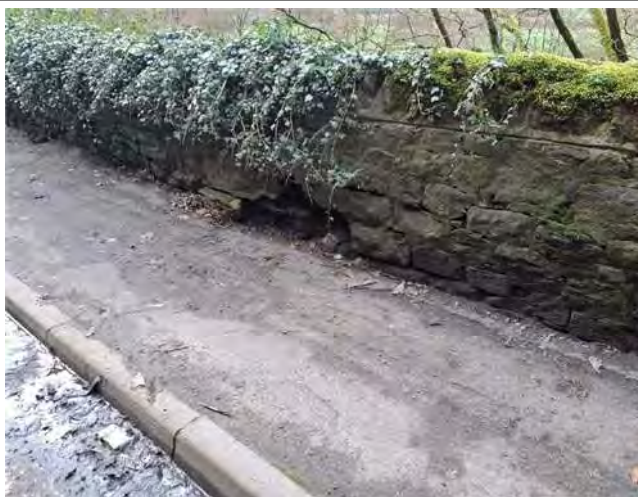
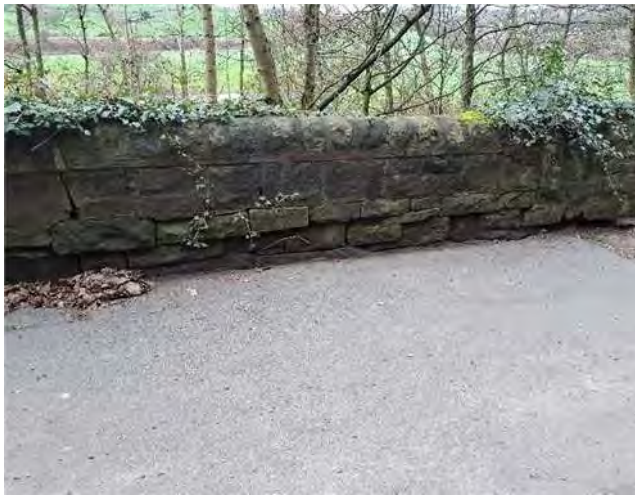
| | 9 | Handrail/parapet/safety fences | | | 3 | B | 3.5 | | | £300 | 2 vertical stepped cracks , also at 332 m . at ch.0 to 4 displaced masonry. at ch305 to 306m loss of individual block too. from ch. 57m to 332m, various vegetation growing over parapet . at ch. 329m loss of masonry to lower layer, repair needed to prevent localised wall failure |

| Element No. | S | Ex | Defect | Comments |
|---|---|---|---|---|
| 9 | 3 | B | 3.6 | at ch. 329m loss of masonry to lower layer, repair needed to prevent localised wall failure |

| Ref No. | Item No. | Work Description | Priority | Estimated Cost | Work Ordered |
|---|---|---|---|---|---|
| A5/GE2602430 | 9 | at ch. 329m loss of masonry to lower layer, repair needed to prevent localised wall failure | M | £300 | |

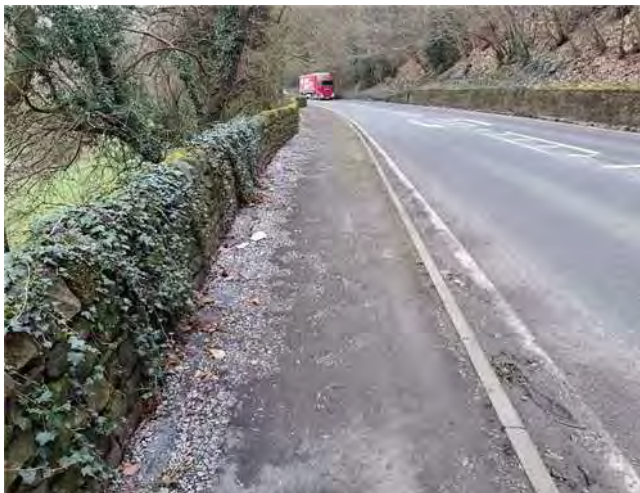
| Elements | 12 | Footway/Verge (Top) | | | 2 | C | 9.4 | | | £0 | loss of wearing course from ch. 144 to m. |

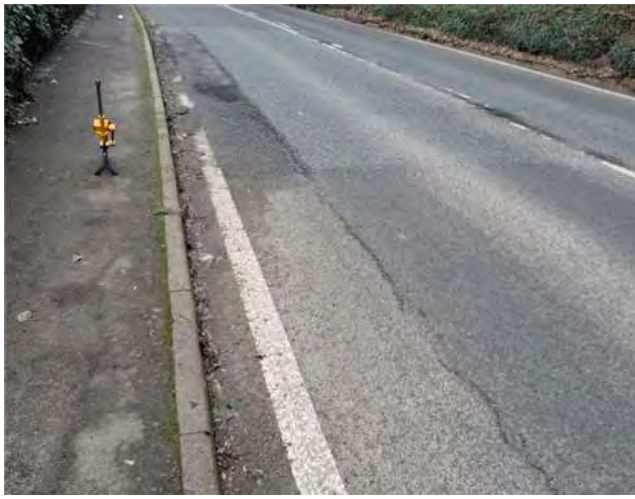
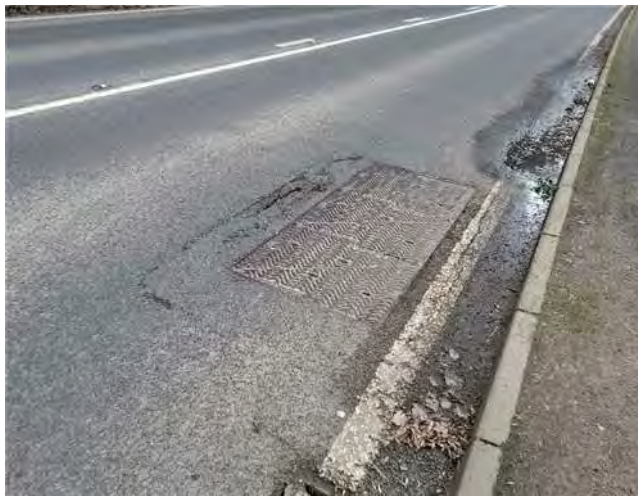
| | 10 | Carriageway (Top) | | | 2 | B | 9.6 | | | £0 | pothole/loss of material and cracking around ironwork at ch 157m. loss of wearing course/depression of trench under surface dressing ch.272 to 294m |

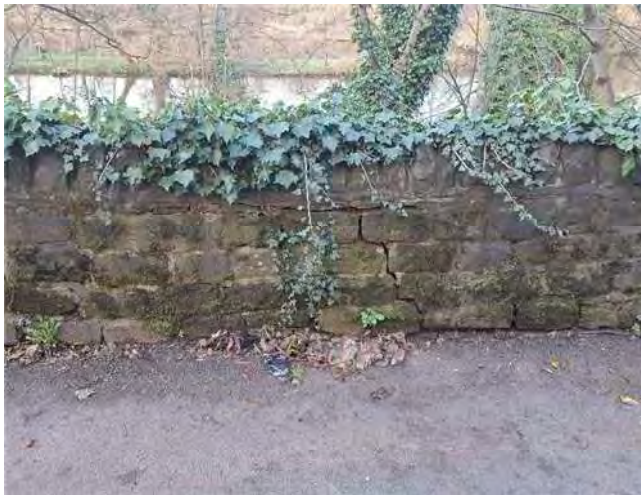
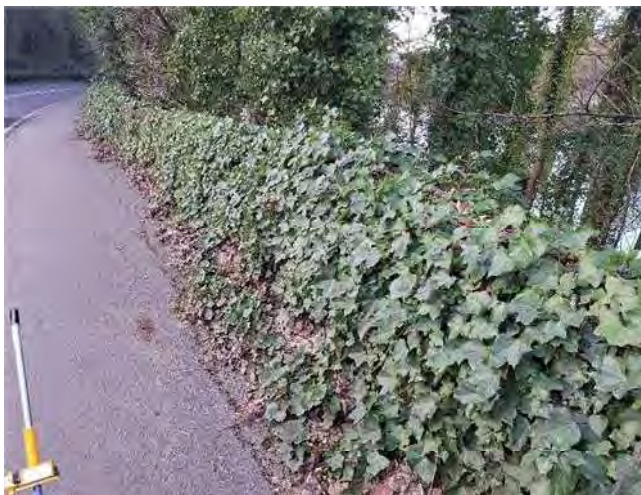
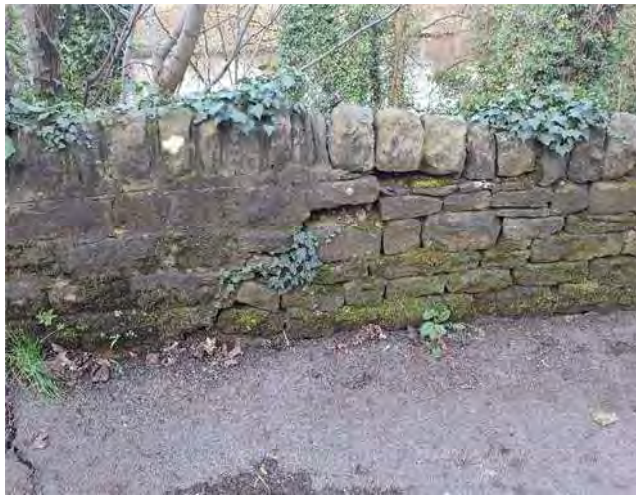
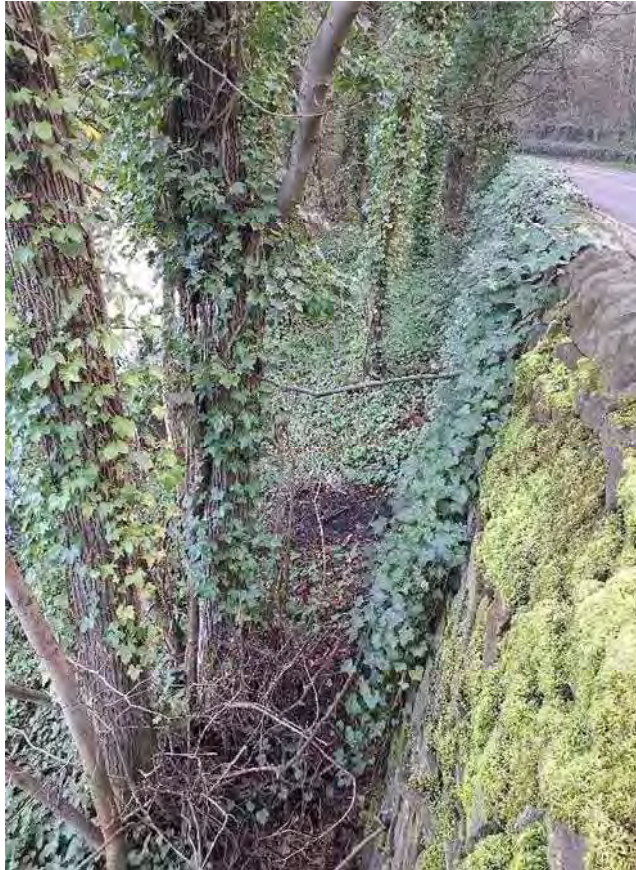
| Safety Elements | 9 | Handrail/parapet/safety fences | 3 | B | 5.1 | | | £0 | ivy enveloping pockets of the parapet, road side. total coverage outside face. ch. 133m parapet leans outwardly for 9m . ch 204m, stepped vertical crack through mortar. again at 207m |

| Element No. | S | Ex | Defect | Comments |
|---|---|---|---|---|
| 9 | 3 | B | 3.5 | ch 204m, stepped vertical crack through mortar. again at 207m |

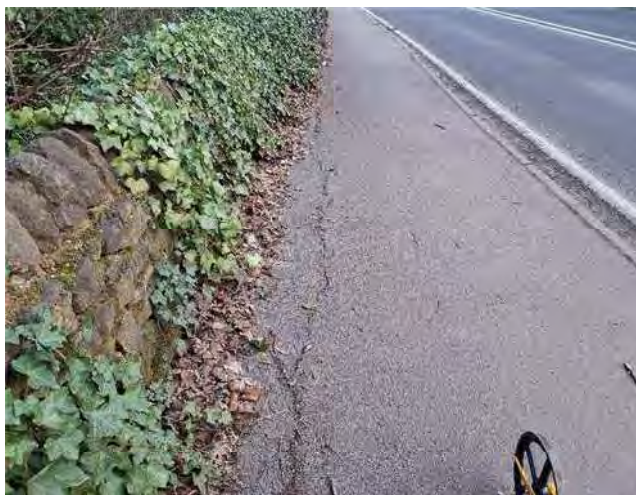
| | 12 | Footway/Verge (Top) | 2 | B | 9.6 | | | £0 | cg 133m crack to rear of footway for 20m |

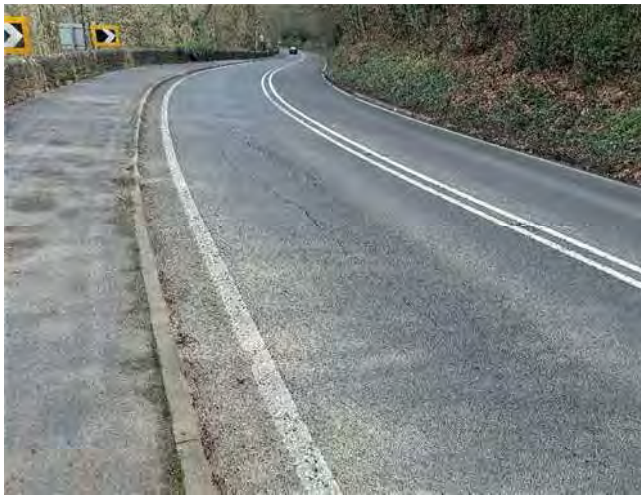
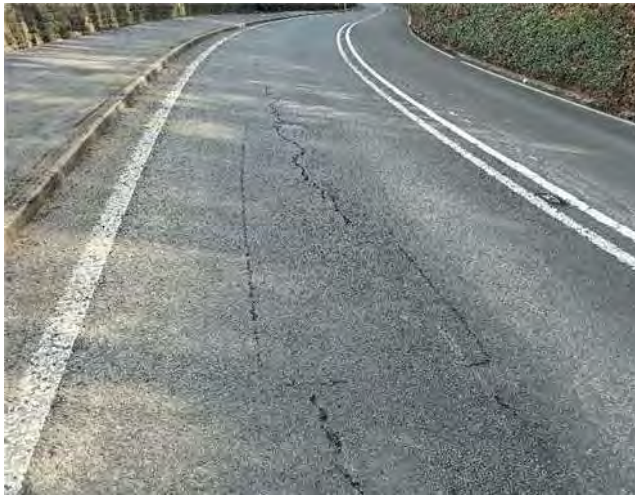
| Inspection Type: RT Panel | | Form No.: 1 of 1 | | Description: RT Panel 1 | | | | | |
|---|---|---|---|---|---|---|---|---|---|
| | 10 | Carriageway (Top) | 2 | B | 9.6 | | | £0 | longitudinal crack in north bound lane |

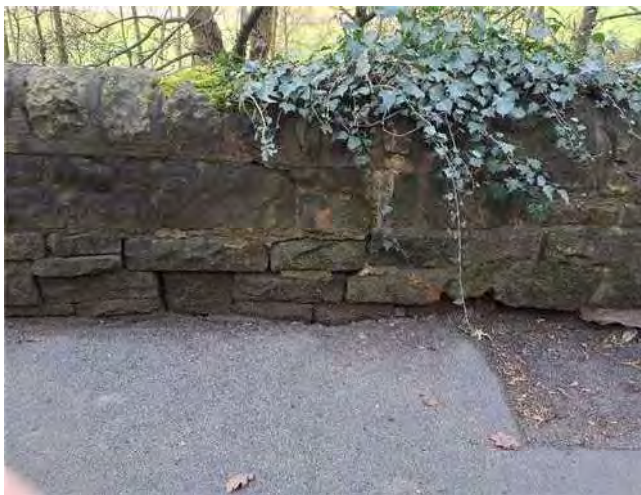
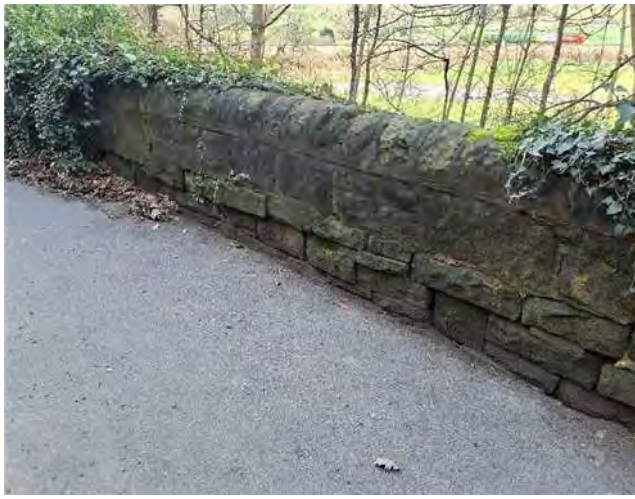
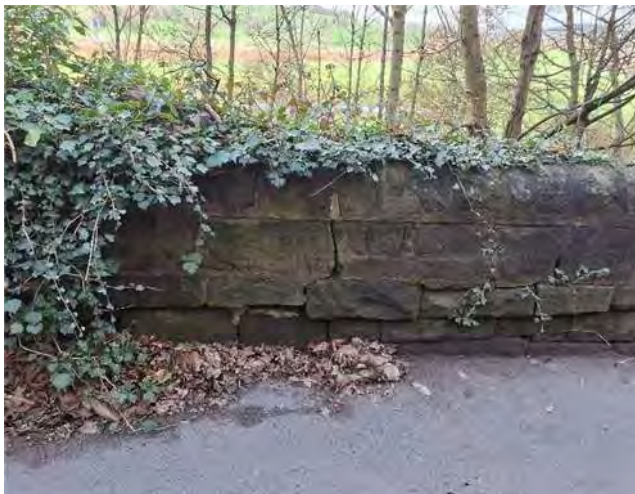
| Inspection Type: RT Panel | | Form No.: 1 of 1 | | Description: RT Panel 1 | | | | | |
|---|---|---|---|---|---|---|---|---|---|
| Safety Elements | 9 | Handrail/parapet/safety fences | 3 | B | 3.5 | | | £0 | minor to moderate stepped cracks at various locations throughout the structure |

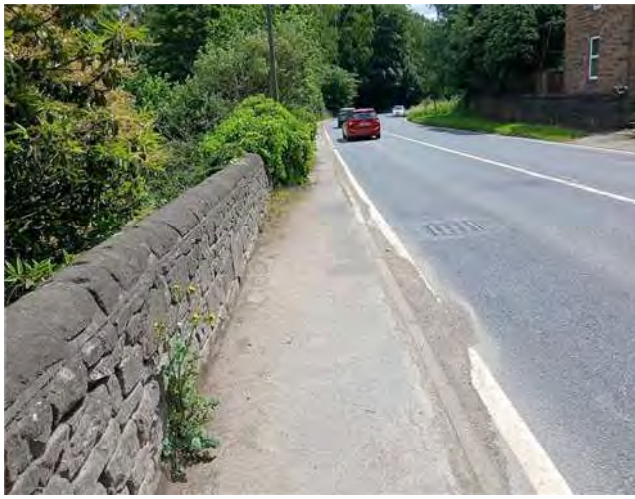
| Inspection Type: RT Panel | | Form No.: 1 of 1 | | Description: 1 - RT Panel | | | | | |
|---|---|---|---|---|---|---|---|---|---|
| | 12 | Footway/Verge (Top) | 2 | D | 9.1 | | N | £0 | General wear to footway surface with build up of debris. |
