DERBYSHIRE COUNTY COUNCIL

# Beechcroft HOP

Six Facet Survey

1st November 2018

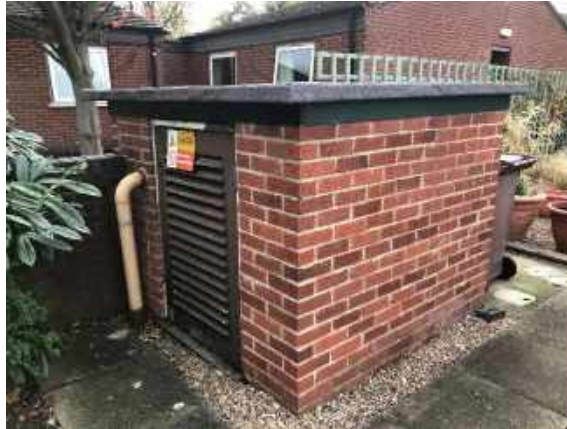
Photograph No 1 – Incoming Gas meter cubical.

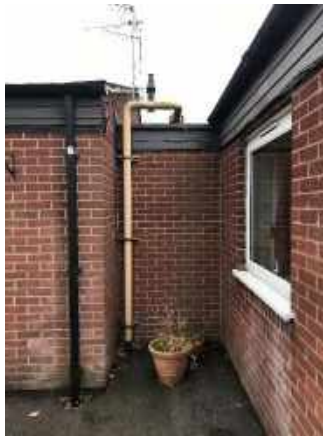
Photograph No 2 – The Gas main rises from ground level to pass over roof to reach Sycamore Wing boiler house.

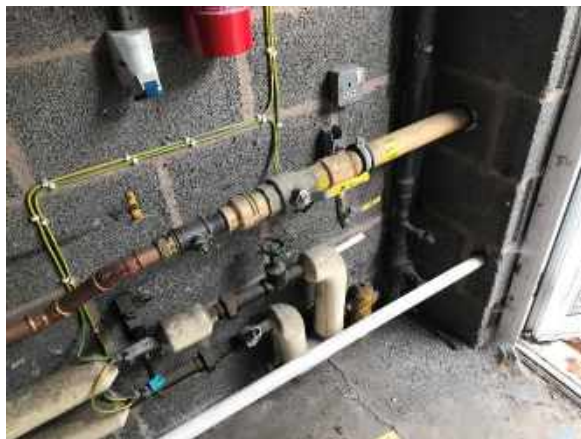
Photograph No 3 – Typical Gas pipework entering the boiler houses with a manual gas isolation valve in the boiler house.

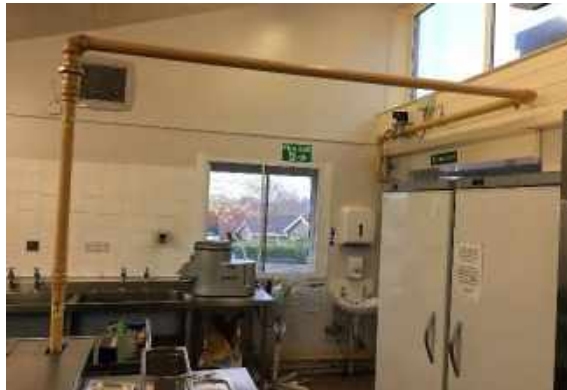
Photograph No 4 – The Gas enters into the main kitchen at low level and rises to high level complete with a gas solenoid valve prior to serving kitchen appliances.

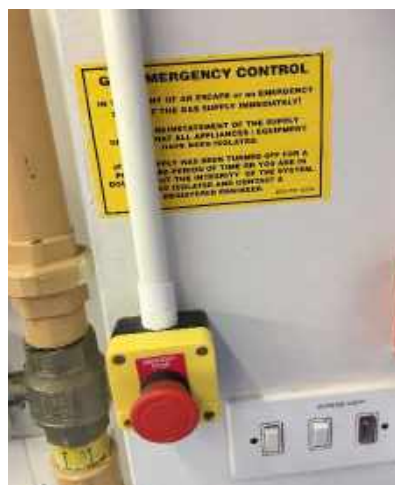
Photograph No 5 – Emergency gas shut off button connected to high level solenoid valve.

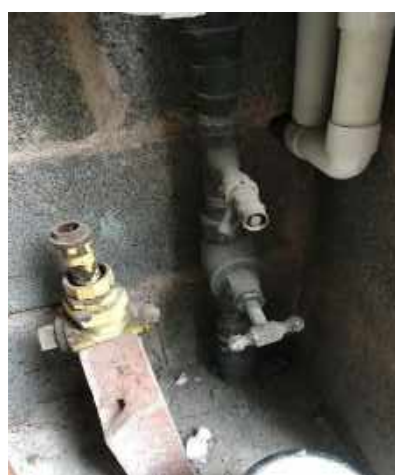
Photograph No 6 – Typical Incoming MCWS entering each of the boiler houses, there was no evidence of a water meter.

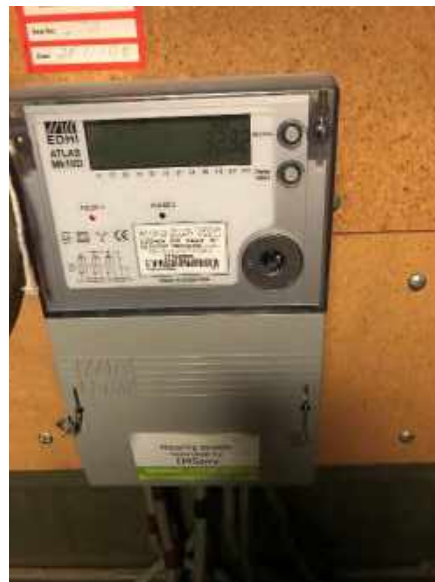
Photograph No 8 – Incoming utility meter

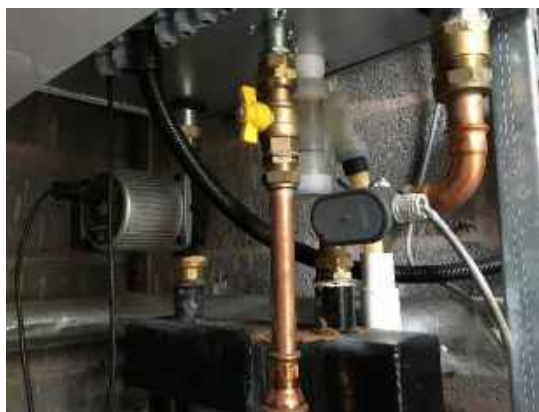
Photograph No 10 – Grundfos Boiler shunt pump on Cedar Wing

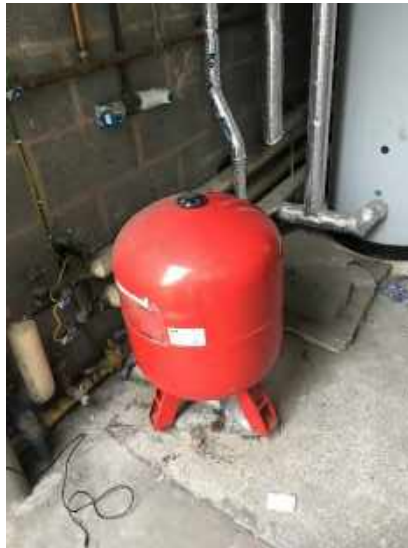
Photograph No 13 – Typical heating system expansion vessel in each boiler house.

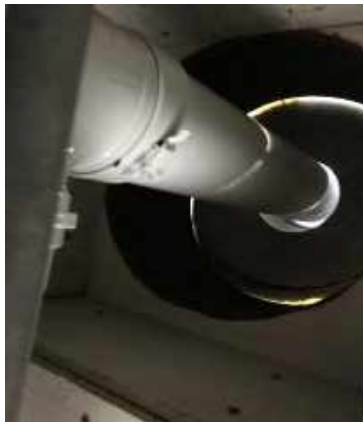
Photograph No 16 – Typical boiler flue passing through roof – note gaps around flue as it passes through roof.

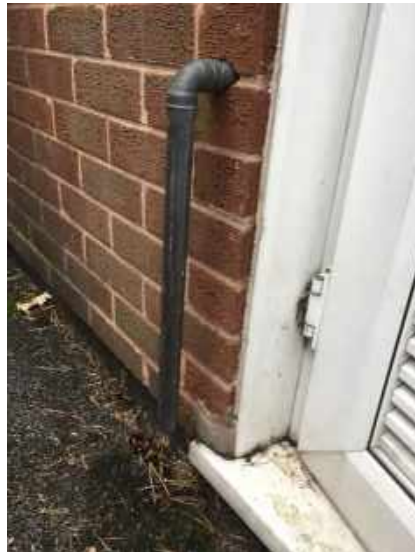
Photograph No 22 – External discharge pipework from Calorifier pressure relief and expansion.

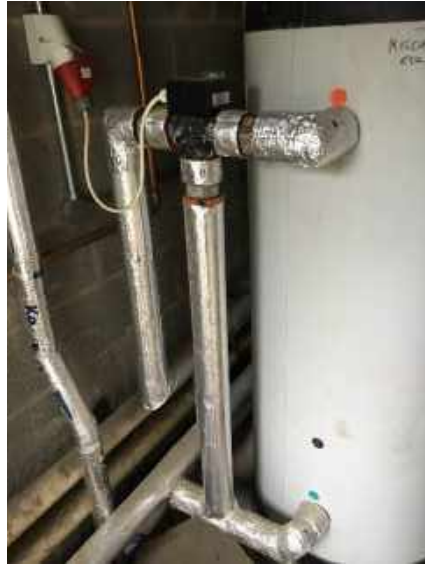
Photograph No 23 - LTHW control diverting valve to control the Calorifier temperature.

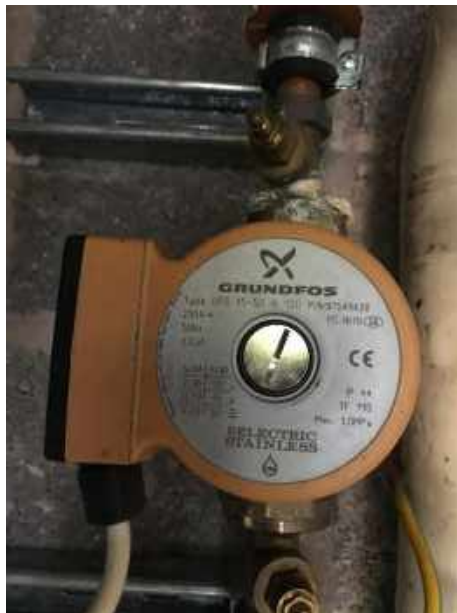
Photograph No 24 – Typical HWS secondary pump installed within the boiler houses, note there is some scale forming by the pipework joints

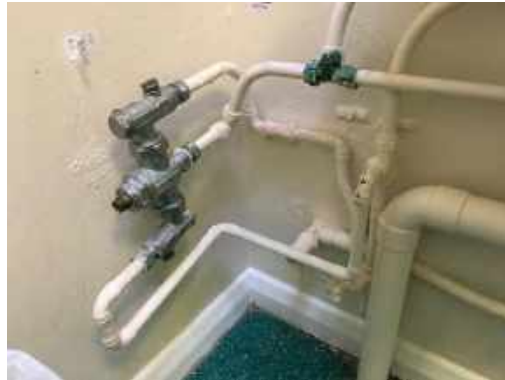
Photograph No 28 – Typical layout of existing domestic pipework installation and modifications for thermostatic mixing valves – note age of pipework.

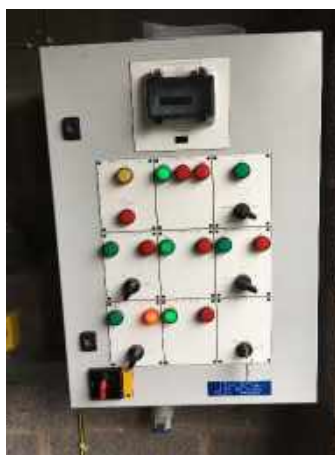
There were no controls schematics fitted within the plantrooms indicating how the controls operate and where the control devices are located.

Photograph No 29 – Typical boiler and HWS plant control panel located in each boiler house.

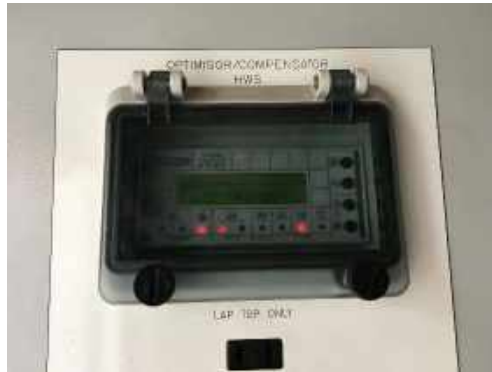
Photograph No 30 – Boiler and HWS Optimiser and Compensator controls incorporated on each panel

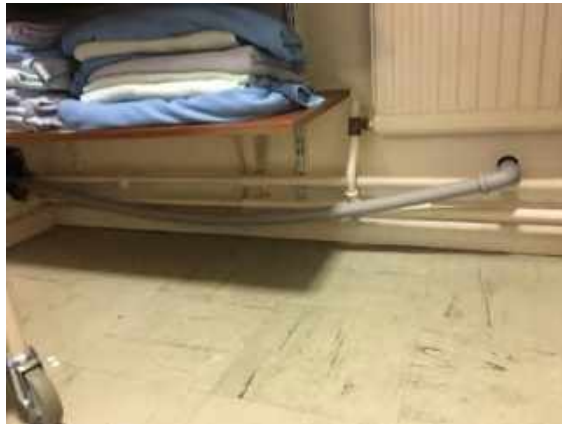
The existing pipework would appear to be mainly from the original installation with modifications carried out in certain areas. The pipework is at or is approaching the end of its expected lifespan and with no apparent dosing system or records of chemical treatment to the existing heating system the condition of the pipework internally is not known.

Photograph No 35 – Typical existing heating pipework installation from original install.

A magnetic filter has been installed on the Cedar Wing heating system, this gives some protection for the new boiler to deterioration within the existing pipework on that wing. These should have been installed on all boiler installations to assist in the removal of any metal filings within the system. It would also be recommended that the heating systems should be provided with a chemical dosing pot to allow the systems to be dosed although due to the age of the systems this may no longer be effective.

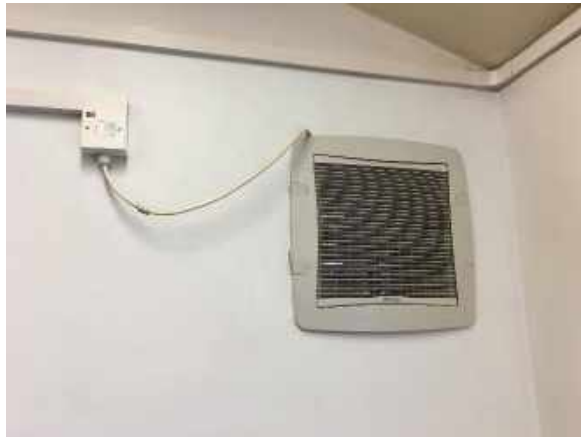
The kitchen ventilation does not comply for a modern kitchen and is not interlocked with the kitchen gas system. There are signs around the kitchen stating that prior to gas equipment being switched on that extract fans must be switched on and window and doors should be opened to aid in ventilation to the kitchen.

Photograph No 36 – Wall mounted kitchen extract fan. Note there is no cooker ventilation hood currently installed.

A purpose made cooker hood and a kitchen supply and extract ventilation system should be installed into the main kitchen to suit the requirements of the catering equipment installed. The ventilation system should then be interlocked with the gas system within the kitchen.

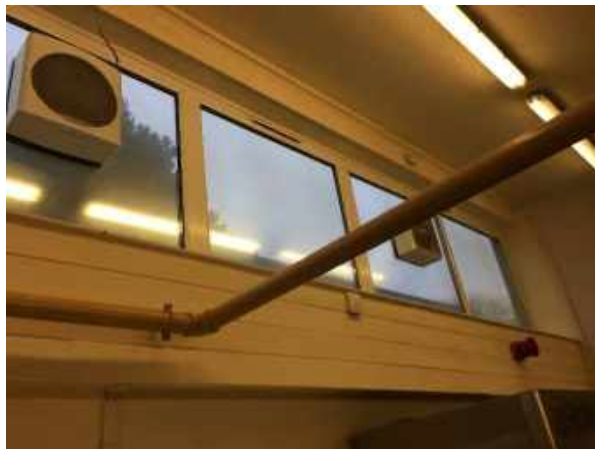
Photograph No 37 – Window mounted high level kitchen extract fans.

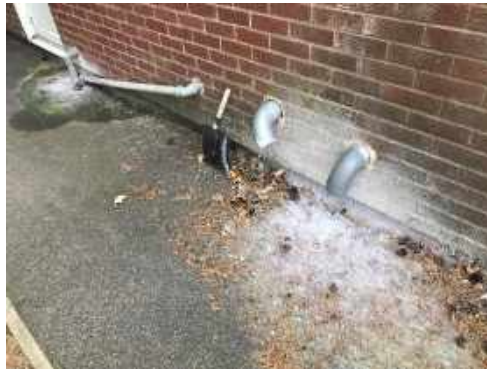
The ductwork discharges externally directly onto the floor below the ducts, there is evidence of fibres being deposited on the floor, it is not clear if the circular ducts have been cleaned to ensure that there is no build-up of lint within the ducts restricting the discharge of air from the dryer.

Photograph No 45 – Laundry dryer exhausts with clear build-up of fibres discharged onto floor.

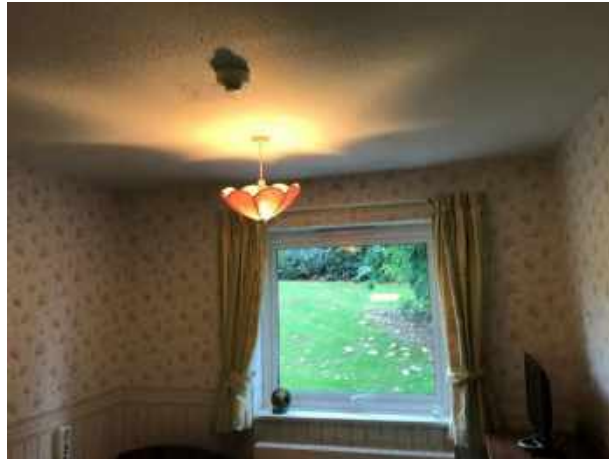
Photograph No 50 – Typical bedroom central pendant luminaire

- Replacement of the existing laundry lighting with sealed LED luminaires.
- Install dimmable LED lamps to the central pendent bedroom luminaires and where necessary replace the lighting switch with a suitable dimmer switch for the LED Lamps.

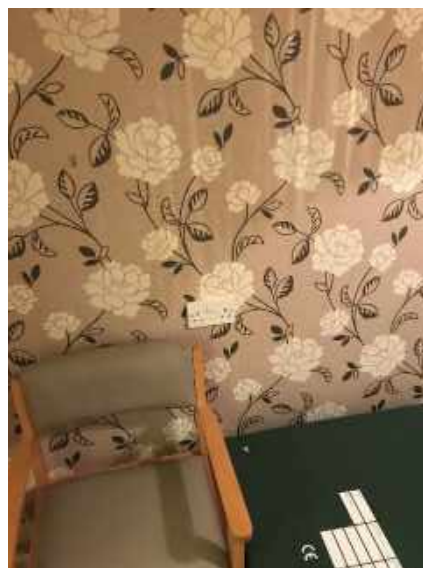
Photograph No 61 –Bedroom with sockets increased in height off the floor.

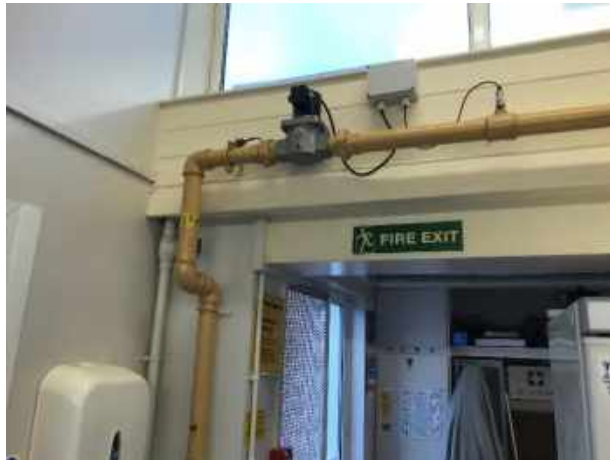
Photograph No 67 – Kitchen gas shut-off valve linked to fire alarm

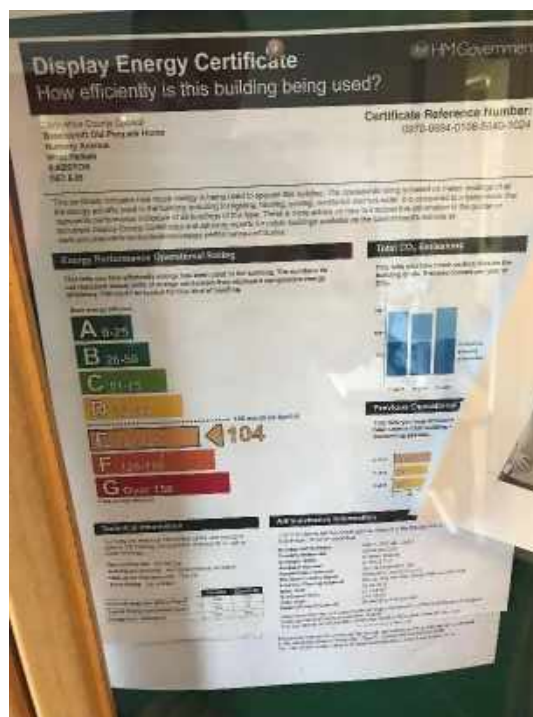
Photograph No 74 – Current EPC Certificate with a rating of E - 104

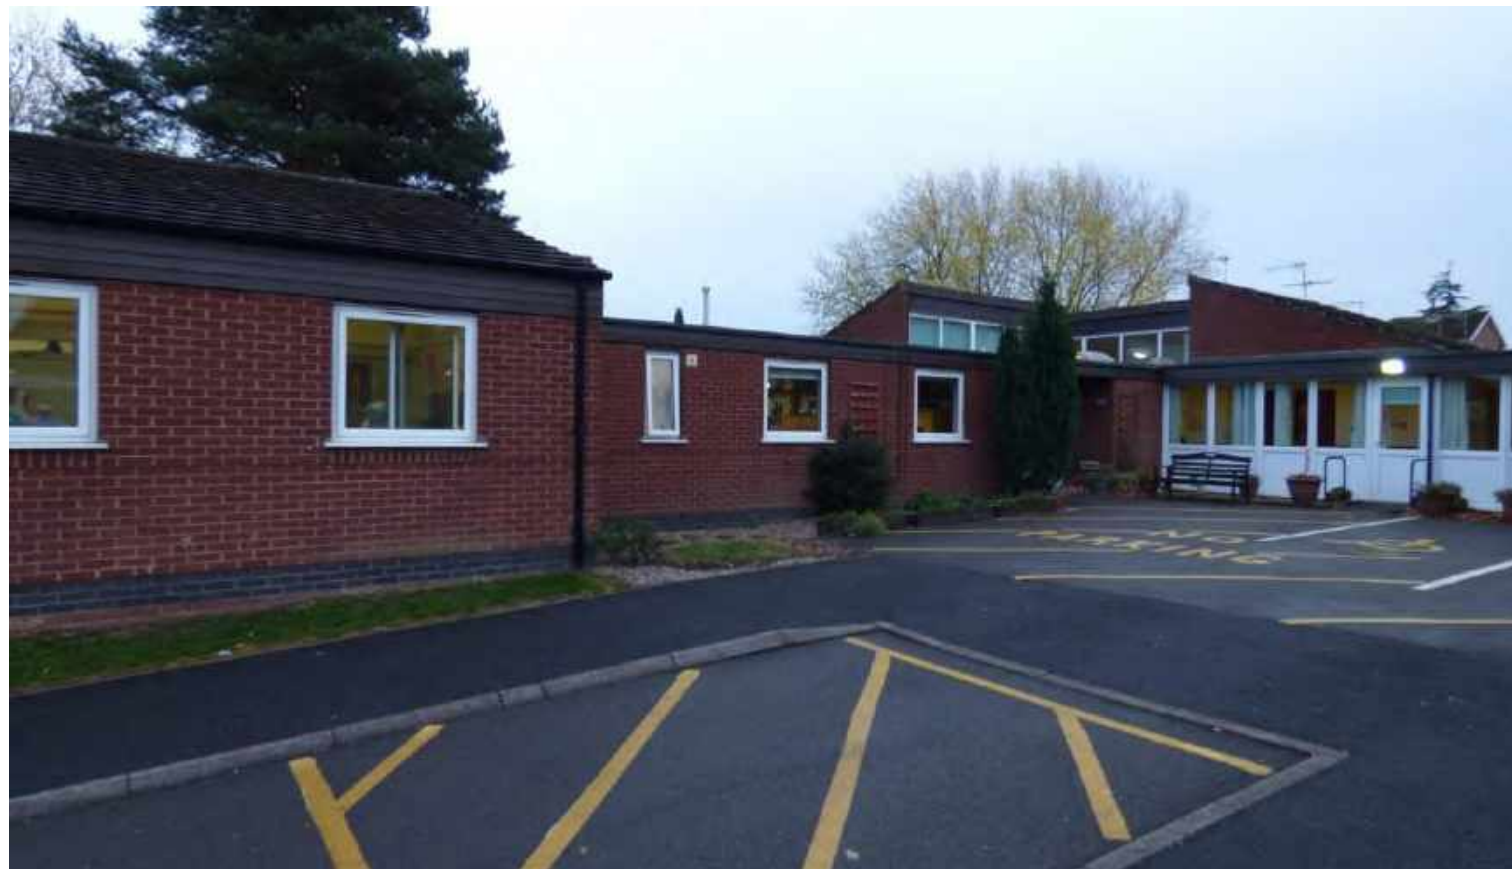
Photo 01

- 201. The premises were visited on the afternoon of Friday 9<sup>th</sup> November 2018 by a Chartered Structural Engineer from GCA (UK) Ltd and at the time of the survey the weather was overcast and mild.
- 202. The premises comprises an extensive bungalow of traditional masonry construction thought to be some 40 years old and it has four wings forming a crucifix on plan. The wings will be referred to as North, South, East and West wings in accordance to its true cardinal directions.(See GCA SK01)
- 203. The roofs over the building wings are a mixture of mono-pitch, duo-pitch and flat roofs.
- 204. The ground around the property slopes steeply up from front to rear and the footprint of the bungalow is on a relatively level plateau cut into the bank.
- 205. There is a bitumen paved drive and car park area towards the main entrance and adjacent to the North Wing. (See Photo 01)

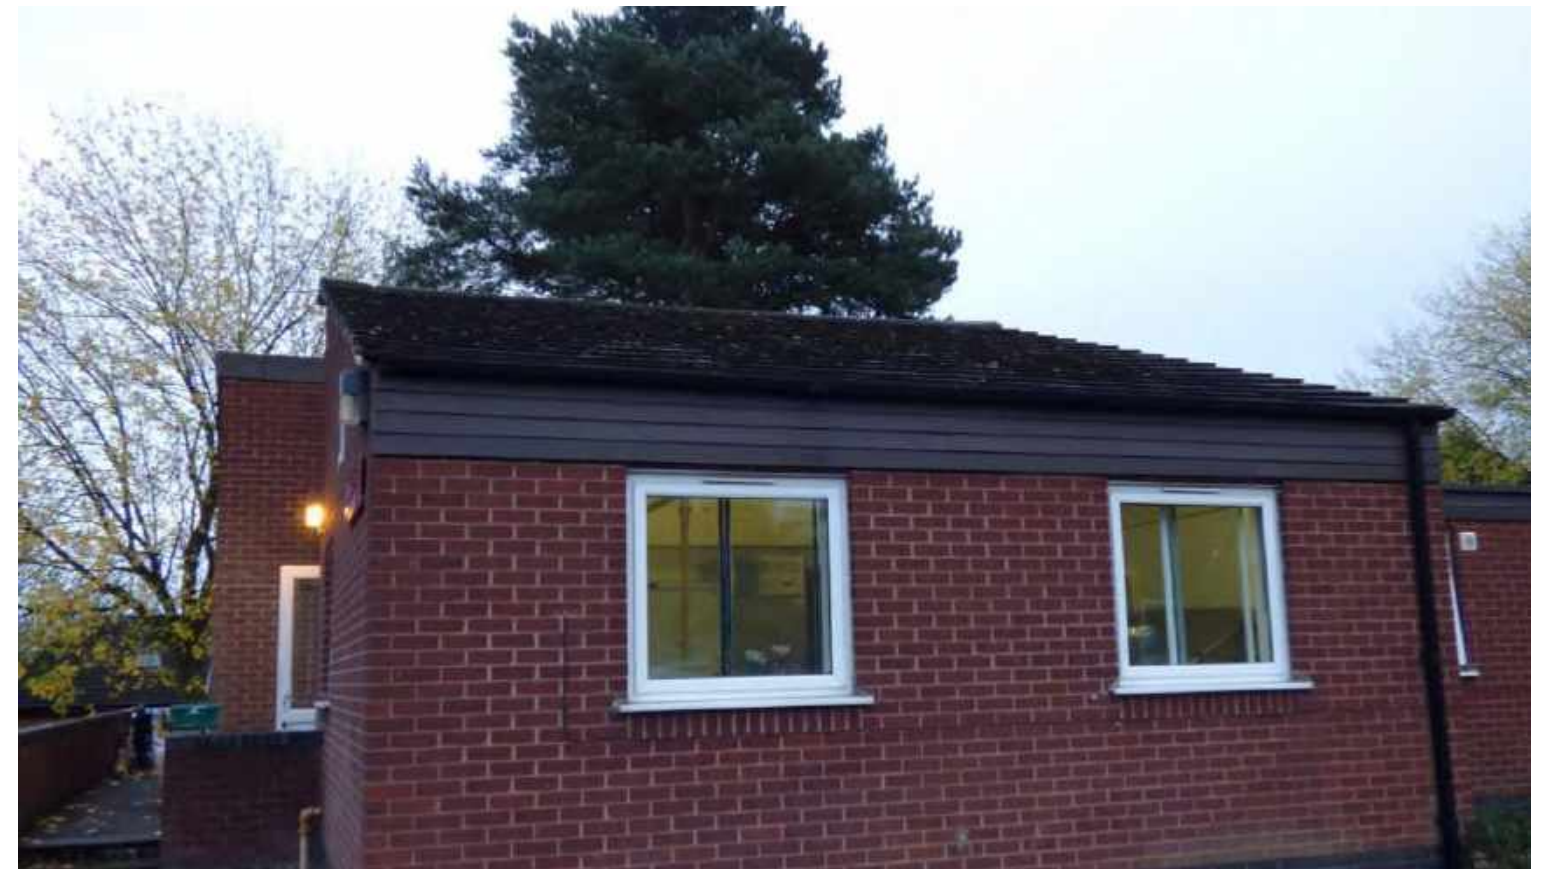
Photo 02

301. The front elevation comprises two opposing mono-pitched roofs with a flat roof section between. The mono-pitched roofs are covered with concrete interlocking tiles and there is no evidence of significant structural movement, however there is moss growing on the tiles. **(See Photo 02)**
302. There is no evidence of significant structural distortion to the gables.

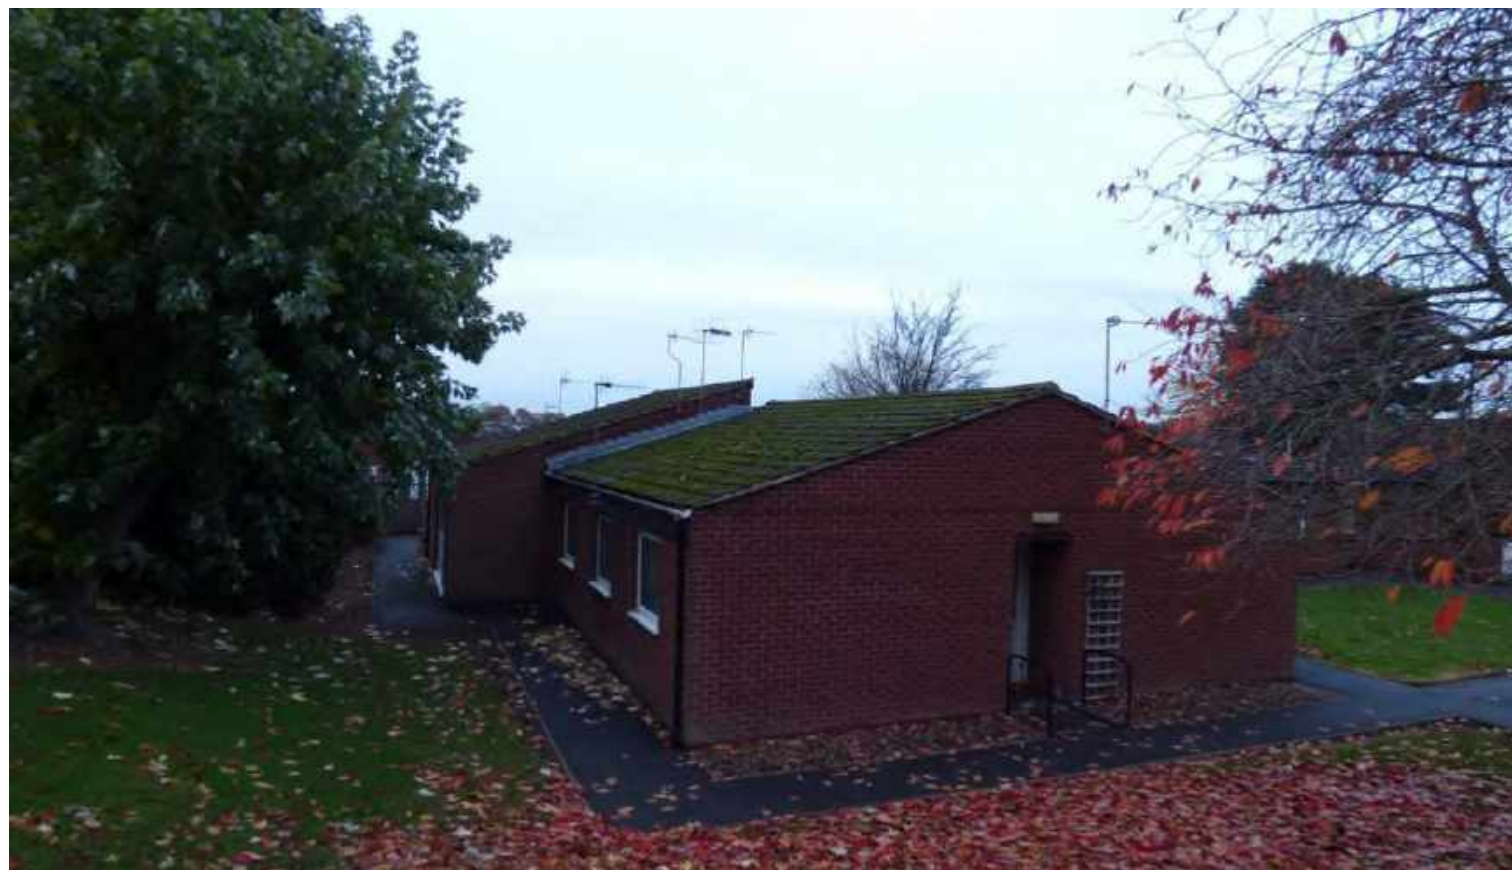
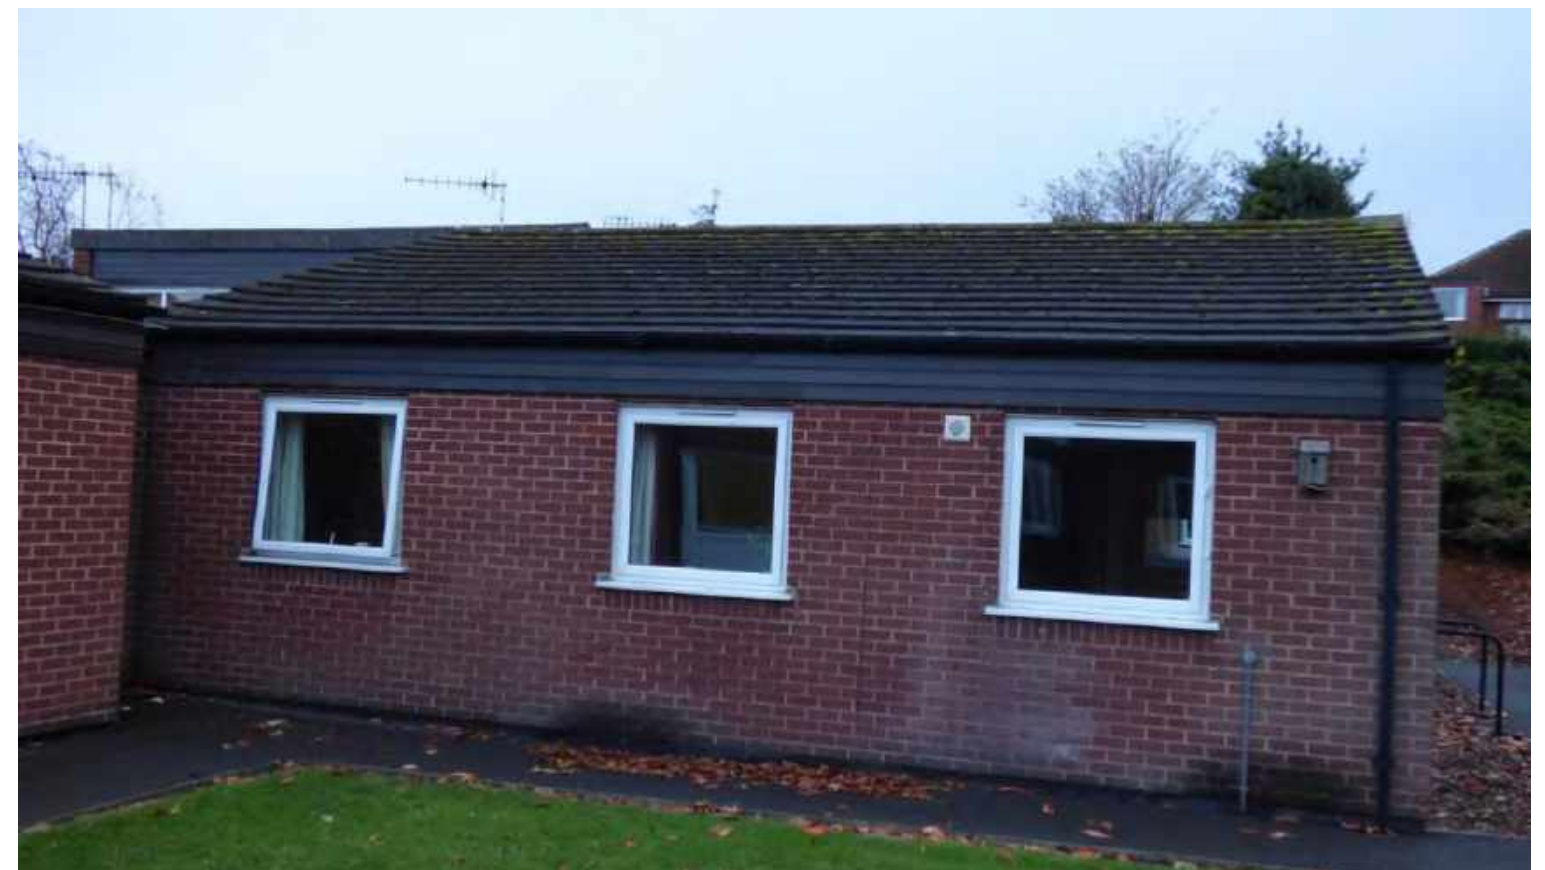
303. The wings comprise duo-pitched, mono-pitched and flat roof sections. The pitched roofs are covered with concrete interlocking tiles which has been overgrown with moss, however there is no evidence of significant structural movement. **(See Photos 03 & 04)**
304. There is no evidence of significant structural distortion to the gables.

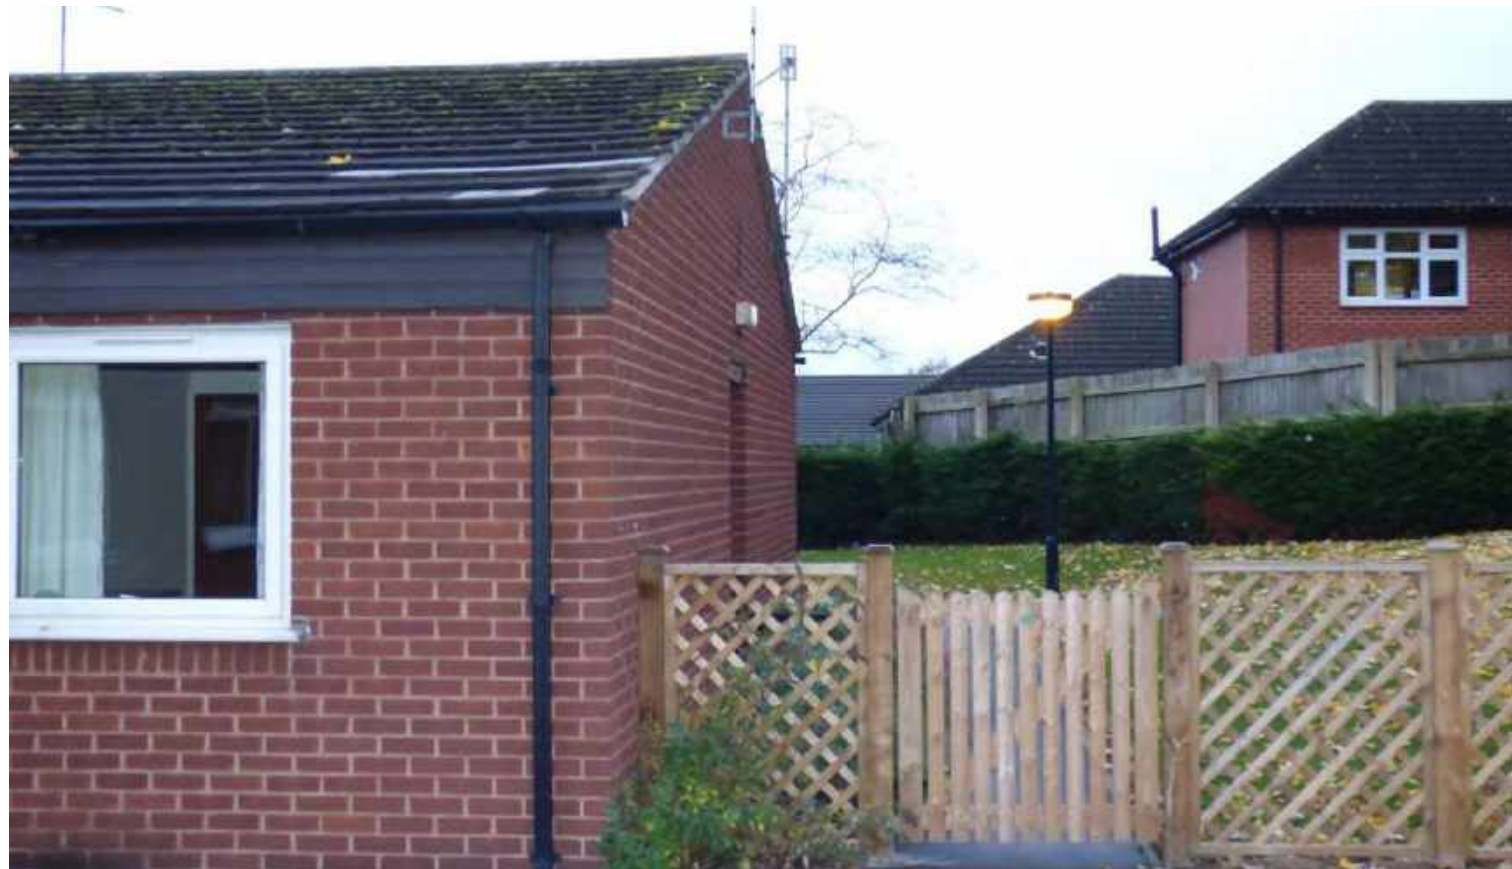
Photo 05

305. The wing also comprises duo-pitched, mono-pitched and flat roof sections. The pitched roofs are covered with concrete interlocking tiles which has been overgrown with moss **(See Photo 05)**
306. There is evidence of relatively recent roof tile replacement, however there is no evidence of significant distortion to the ridges. **(See Photo 05)**
307. The roof gutter at the return corner appears to be blocked and wetting the masonry beneath. **(See Photo 06)**
308. There is no evidence of significant structural distortion to the gables.

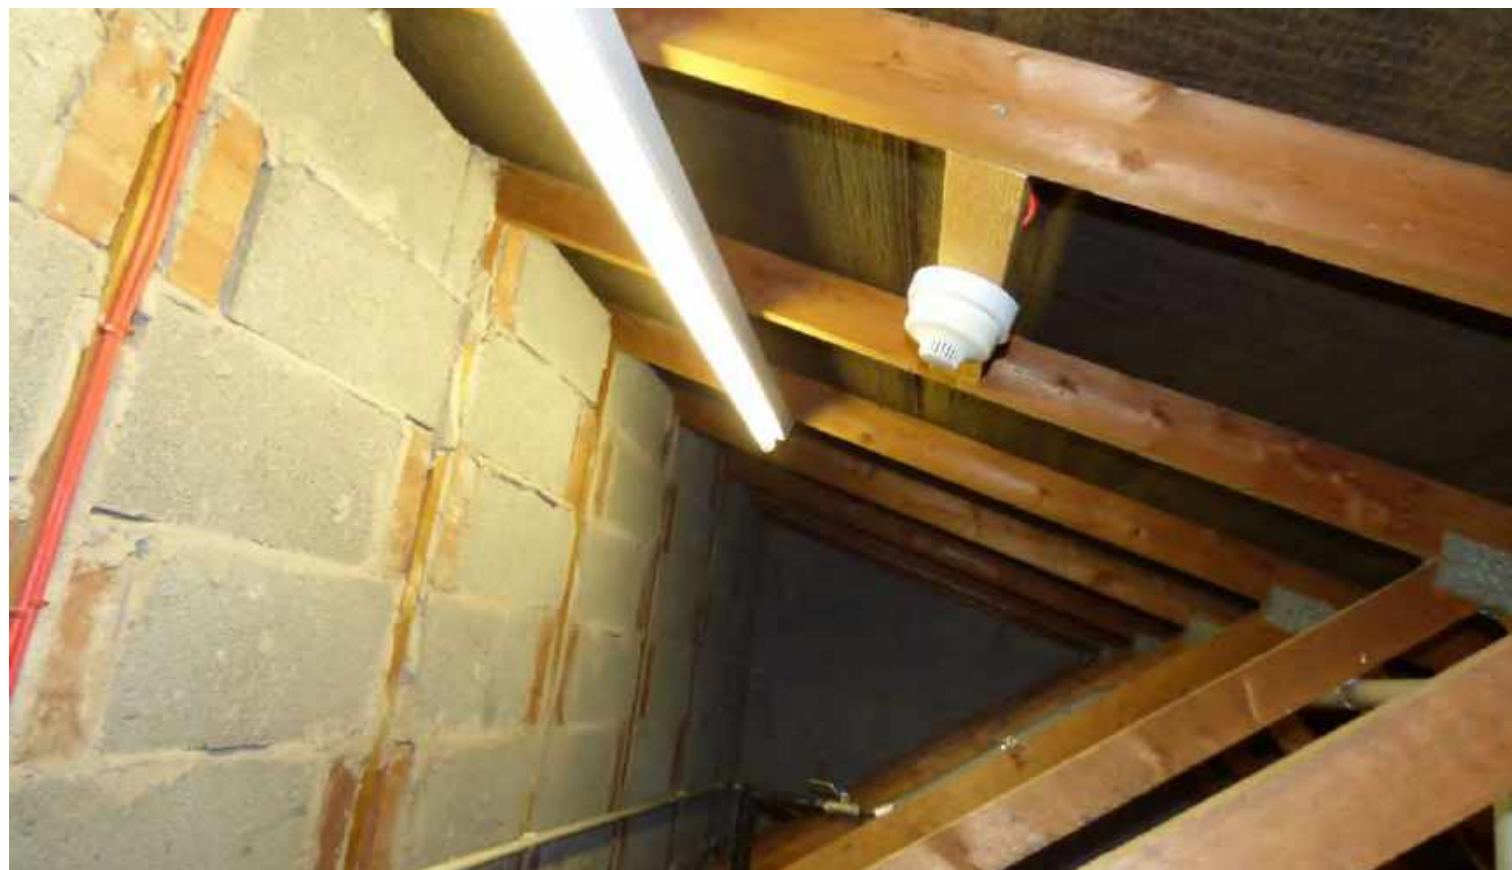
Photo 07

- 401. The mono-pitched roof comprises proprietary light timber trusses spaced at some 600mm centres with their higher end built into the block wall. **(See Photo 07)**
- 402. There is no evidence of significant distortion or racking to the truss members and the roof has been underdrawn with sarking felt.
- 403. There are no diagonal & longitudinal roof bracings or positive fixings between the trusses and the gable walls, however there is no evidence of significant distortion or racking. **(See Photo 08)**

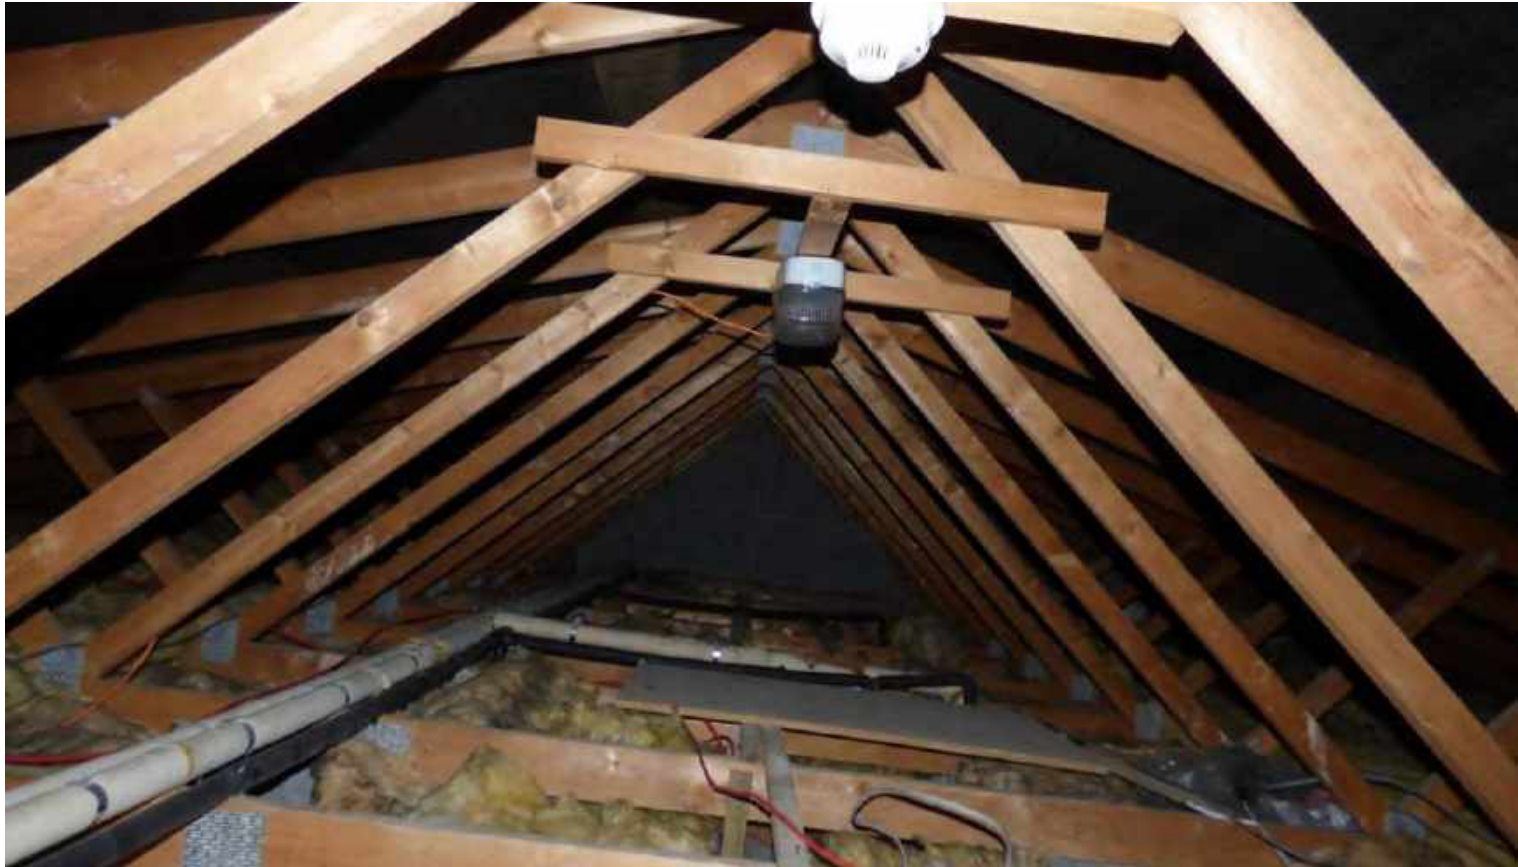
Photo 09

- 404. The roof has been underdrawn with sarking felt and comprises light timber proprietary roof trusses which are spaced some 600mm centres. **(See Photo 09)**
- 405. There are no diagonal & longitudinal roof bracings or positive fixings between the trusses and the gable walls, however there is no evidence of significant distortion or racking.
- 406. There appears to be damp in the top boom of the end timber truss adjacent to the gable. **(See Photo 10)**

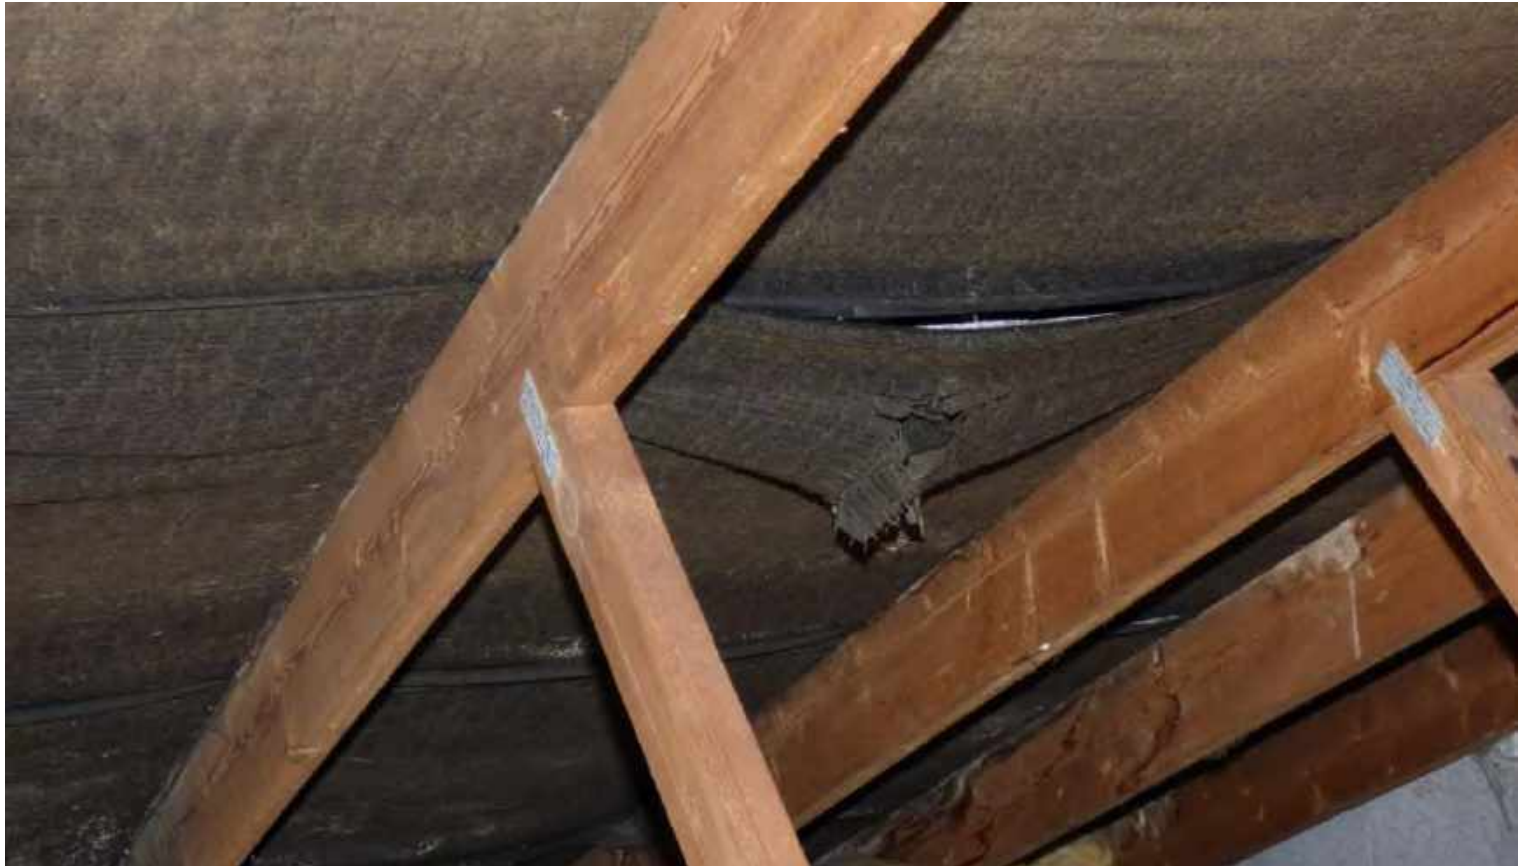
Photo 11

- 409. The roof has been underdrawn with sarking felt and comprises light timber proprietary roof trusses which are spaced some 600mm centres.
- 410. There is a torn section of the sarking felt near the gable. **(See Photo 11)**
- 411. There are no diagonal & longitudinal roof bracings or positive fixings between the trusses and the gable walls, however there is no evidence of significant distortion or racking.
