DERBYSHIRE COUNTY COUNCIL

# The Spinney HOP

## Condition Survey

November 2018

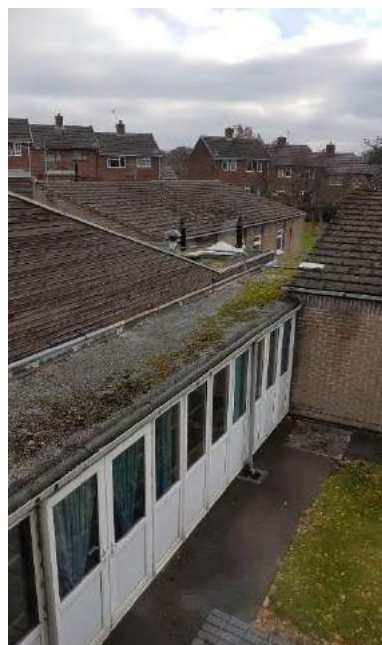
The gas is distributed in 125mm pipework beneath the ground around the perimeter of the building with 1-1/4" pipework rising externally and running over the roof to then drop into each boiler house (2" rising to serve the kitchen appliances and kitchen boiler house). The external pipework would appear to be in good condition but should be painted yellow ochre to identify the pipework as gas (see Photograph No. 3).

Photograph No 3 –Gas pipework running across roof to serve each boiler house.

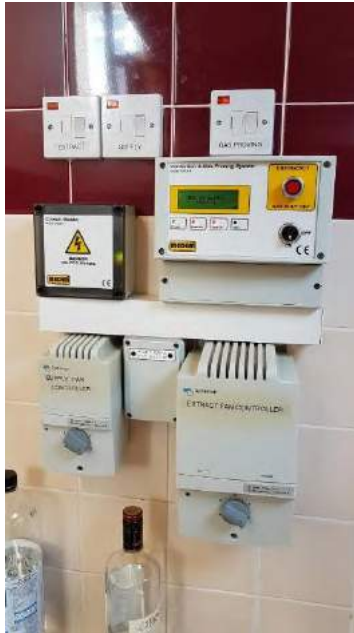
Within the kitchen the gas system is linked to the kitchen ventilation system and has a airflow proving/interlock system installed. This appears to be in good condition (see Photograph No.4).

Photograph No 4 – Gas interlock to the kitchen ventilation system.

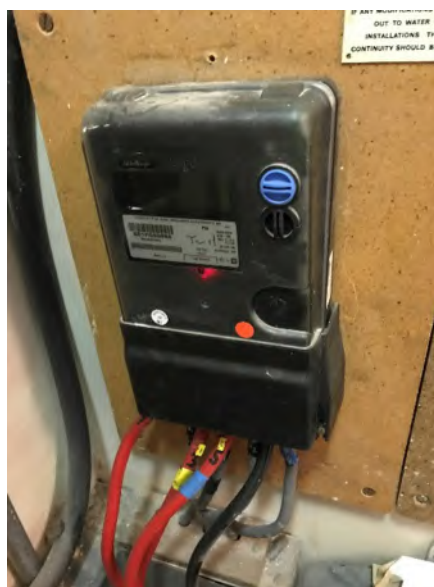
Photograph No 7 – Incoming utility meter

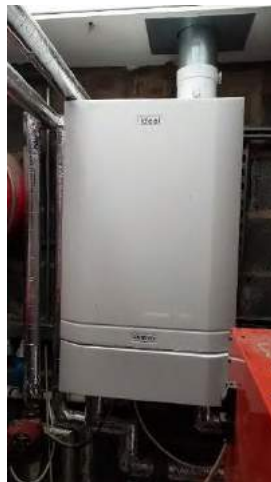
Photograph No 8 – Typical Evomax boiler (Central & Blue Wing)

Pressurisation units should be fitted to all heating systems.

A magnetic filter should be fitted to the heating return pipework on all boiler installations to assist in the removal of any metal filings within the system.

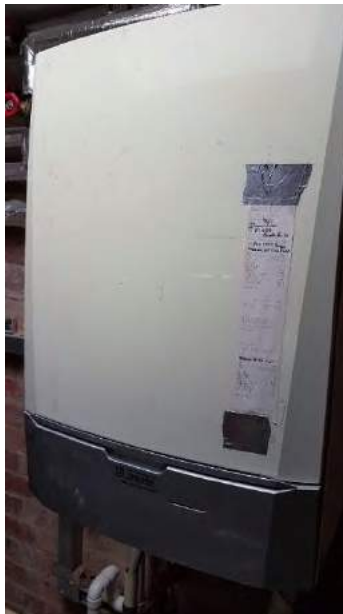
Photograph No 9 – Broag Remeha Quinta-Pro boiler in Green Wing boiler house.

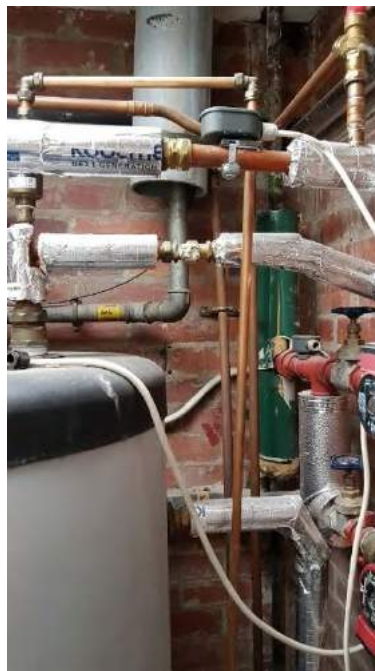
Photograph No 11 – Calorifier pressure relief and automatic air vent discharge pipework draining directly onto the floor and unsupported.

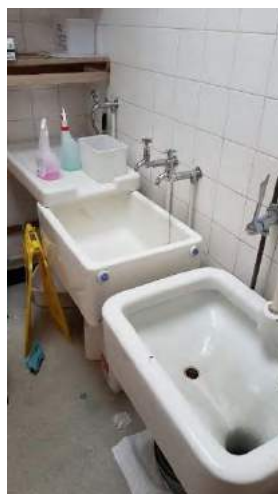
Photograph No 14 – Typical sluice rooms.

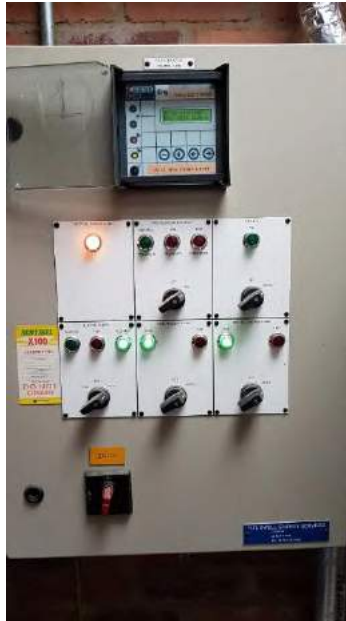
There were no controls schematics fitted within the plantrooms indicating how the controls operate and where the control devices are located.

Photograph No 17 – Typical boiler and HWS plant control system

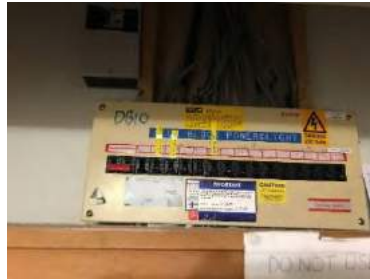
Although we were not able to access most of the cabling, where we were due to gaps in the containment system, then it all appeared to be PVC/PVC in a reasonable condition. All the cabling appears to be PVC/PVC, though there are areas where it exits from final boards where it requires the covering re-fixing.

Photograph No 24 – Bedroom wing SPN MCB distribution board with exposed sub-circuit wiring leaving the board.

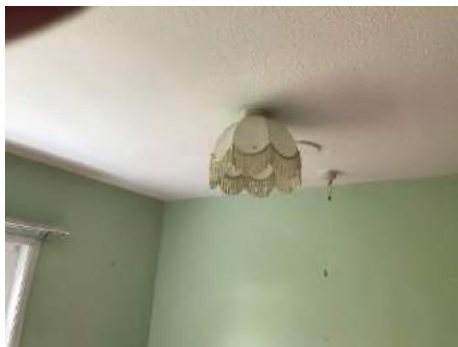
Photograph No 25 – Typical bedroom central pendant luminaire

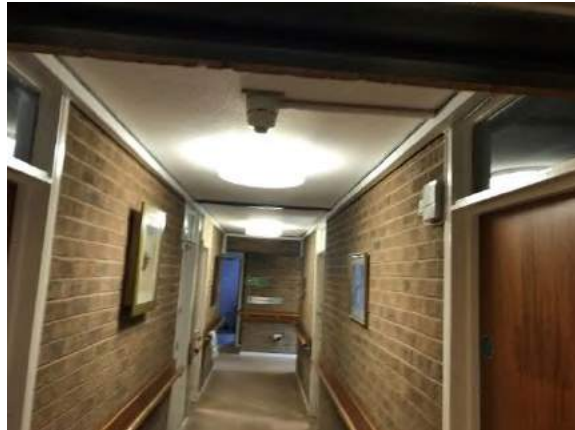
Photograph No 29 – Typical Bedroom Corridor lighting.

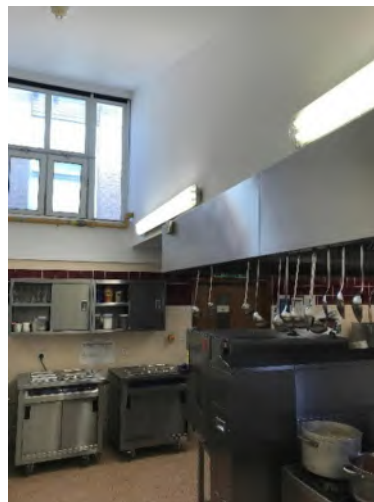
Within the main kitchen, kitchenettes, laundry and bathrooms/shower rooms lighting was by means of linear water proofed fluorescent luminaires all generally in a good condition.

Photograph No 30 – Main Kitchen Lighting

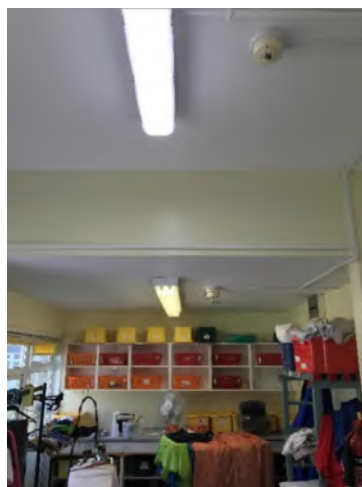
Photograph no 31 – Laundry room lighting and fire detectors.

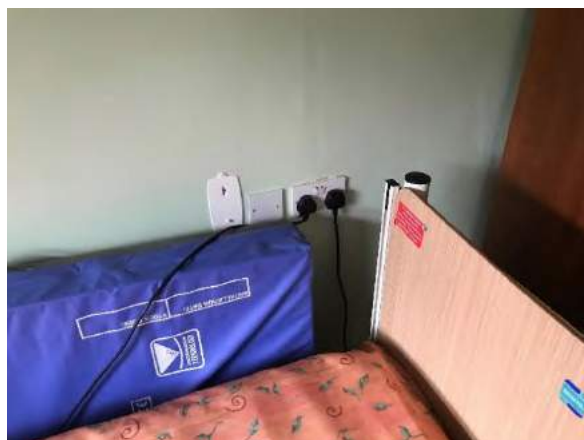
Photograph No 36 –Bedroom with sockets increased in height off the floor.

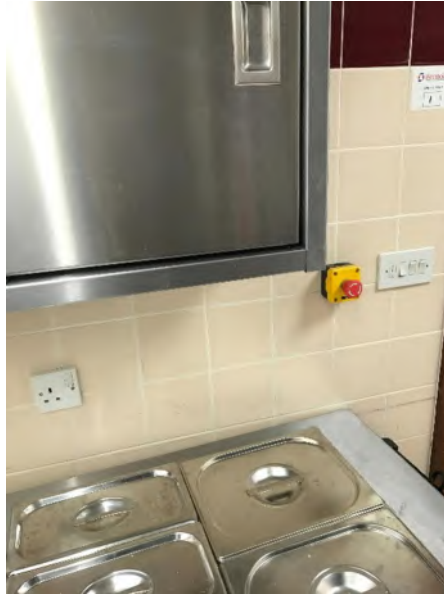
Kitchen power is operated via a contactor controlled by emergency stop buttons. Laundry equipment is fed from a 3 phase distribution board via local isolators.

Photograph No 37 – Kitchen equipment via local isolator with emergency stop button

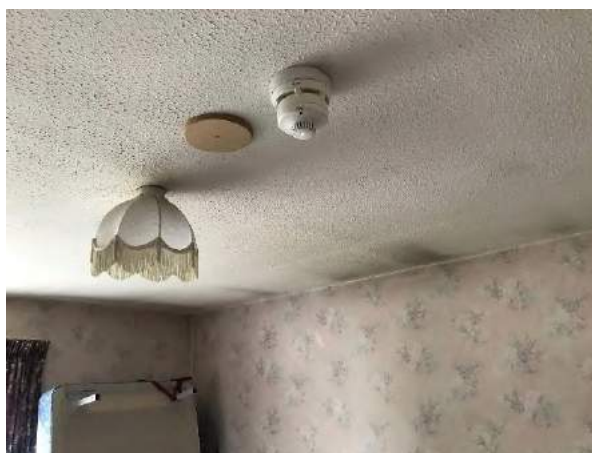
Photograph No 43 – Example of smoke detector installed in bedroom

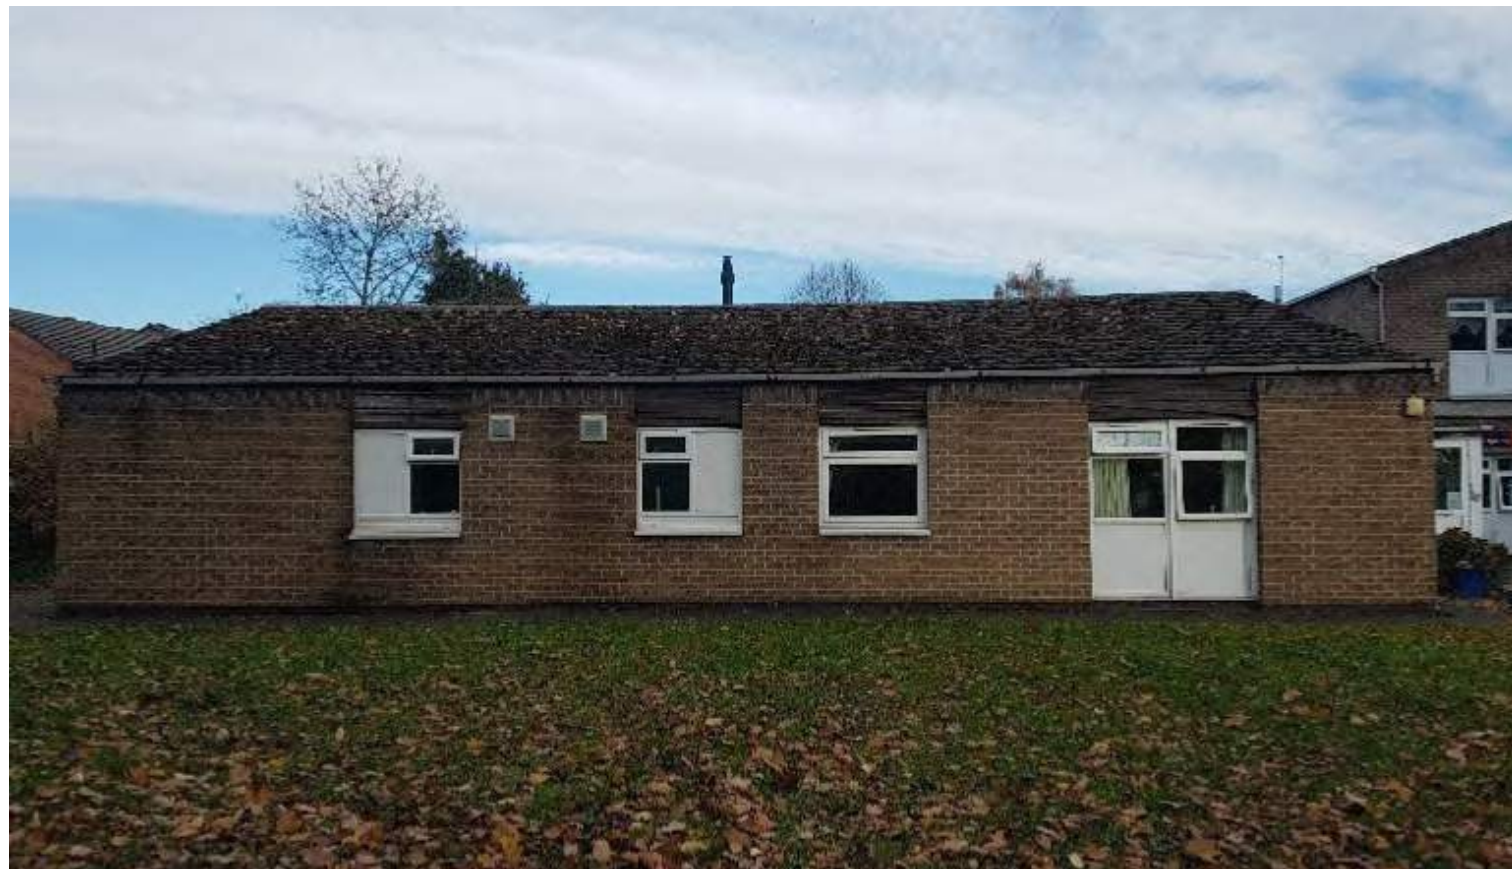
Photo 1

- 301. The roofs are typically finished with concrete tiles. (See photo 1)
- 302. Where visible, tiles appear to be in reasonable condition. On isolated elevations the roof slopes are obscured by moss growth.
- 303. The verges of the concrete tiles are exposed and the mortar beneath the tiles has perished. (See photo 2)
- 304. The ridges appear line and level to the eye. There is evidence of deterioration of the ridge tiles in several localised locations
- 305. There were no obvious signs of distortion to the ridges and the pointing to the gable was in generally reasonable condition and brickwork showing no evidence of significant distortion.
- 306. The condition of the fascia and above ground rainwater goods are in varying states of repair.

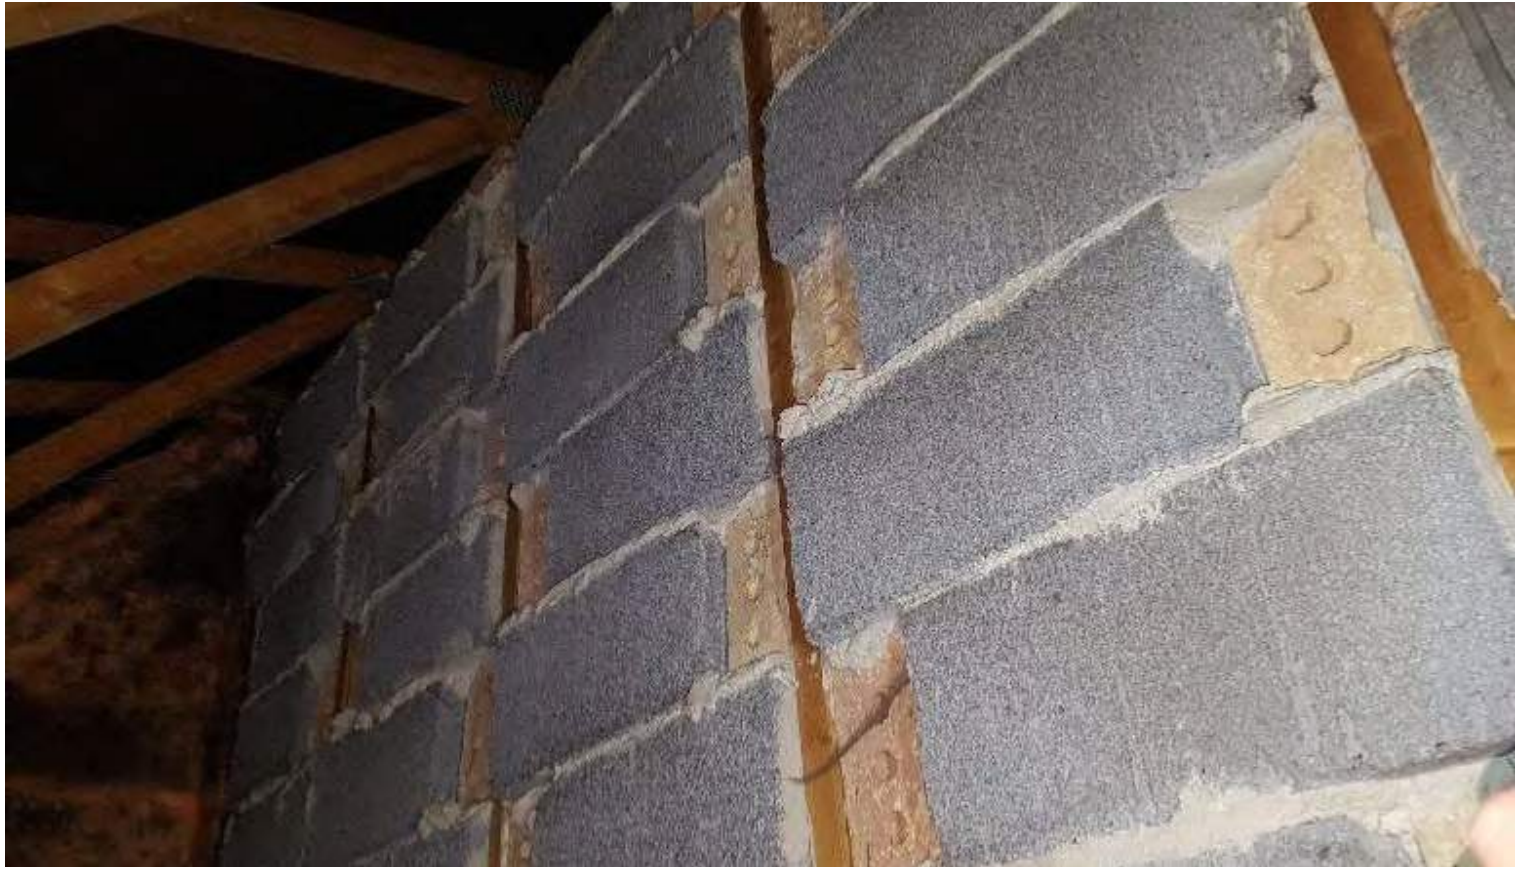
Photo 5

- 401. The mono-pitched roof comprises proprietary light timber trusses spaced at some 600mm centres with their higher end built into the block wall. (See photo 5)
- 402. There is no evidence of significant distortion or racking to the truss members and the roof has been underdrawn with sarking felt.
- 403. There are no diagonal and longitudinal roof bracings or positive fixings between the trusses and the gable walls, however there is no evidence of significant distortion or racking.
- 404. Light wells were present within the corridor areas. It was not possible to determine whether the light wells were introduced at the time of construction or had been retrofitted into the structure. (See photo 6)

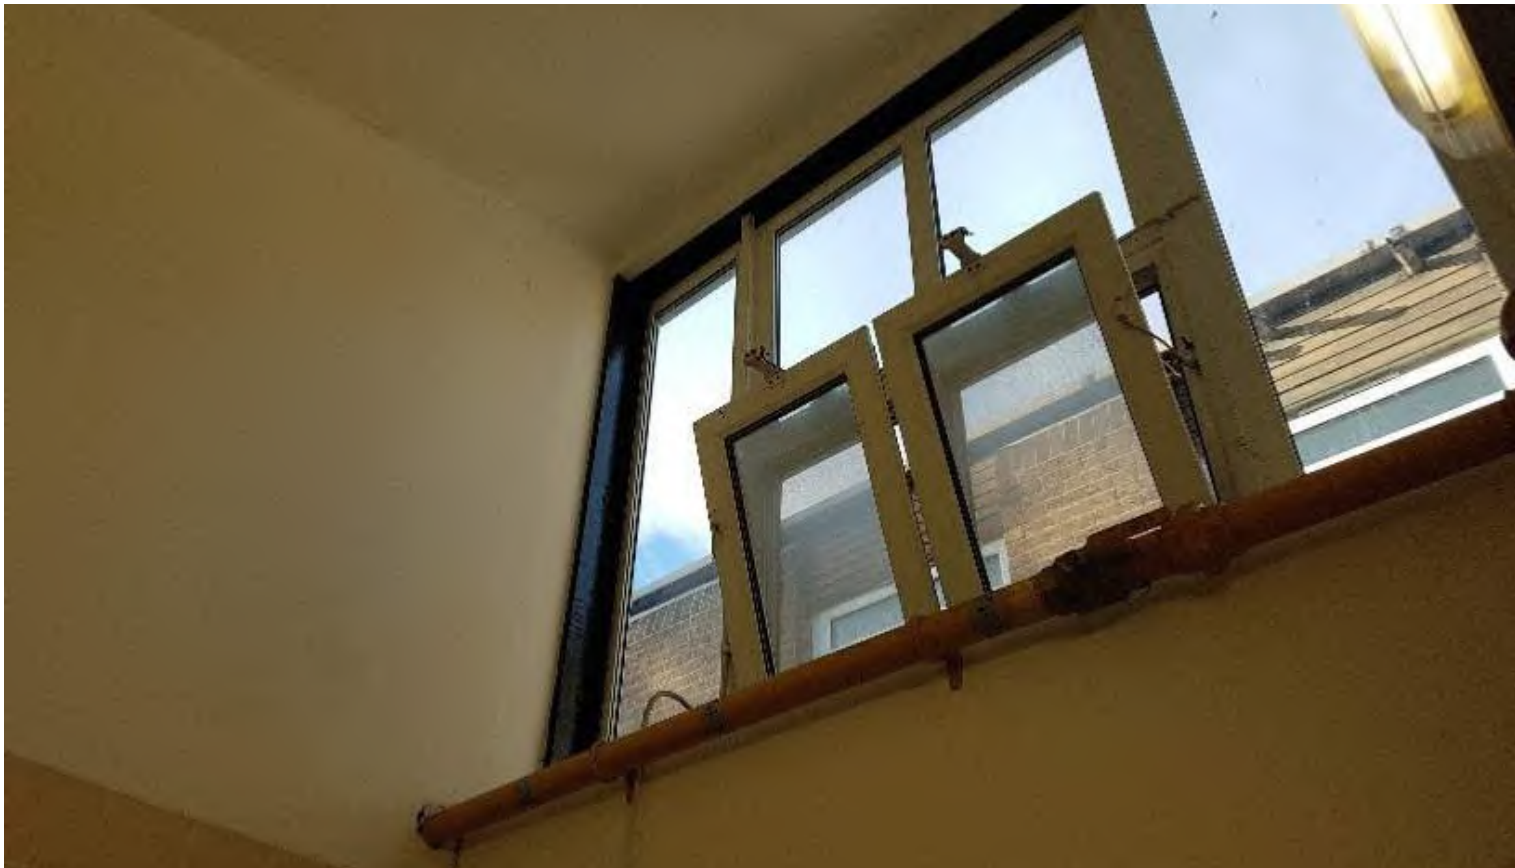
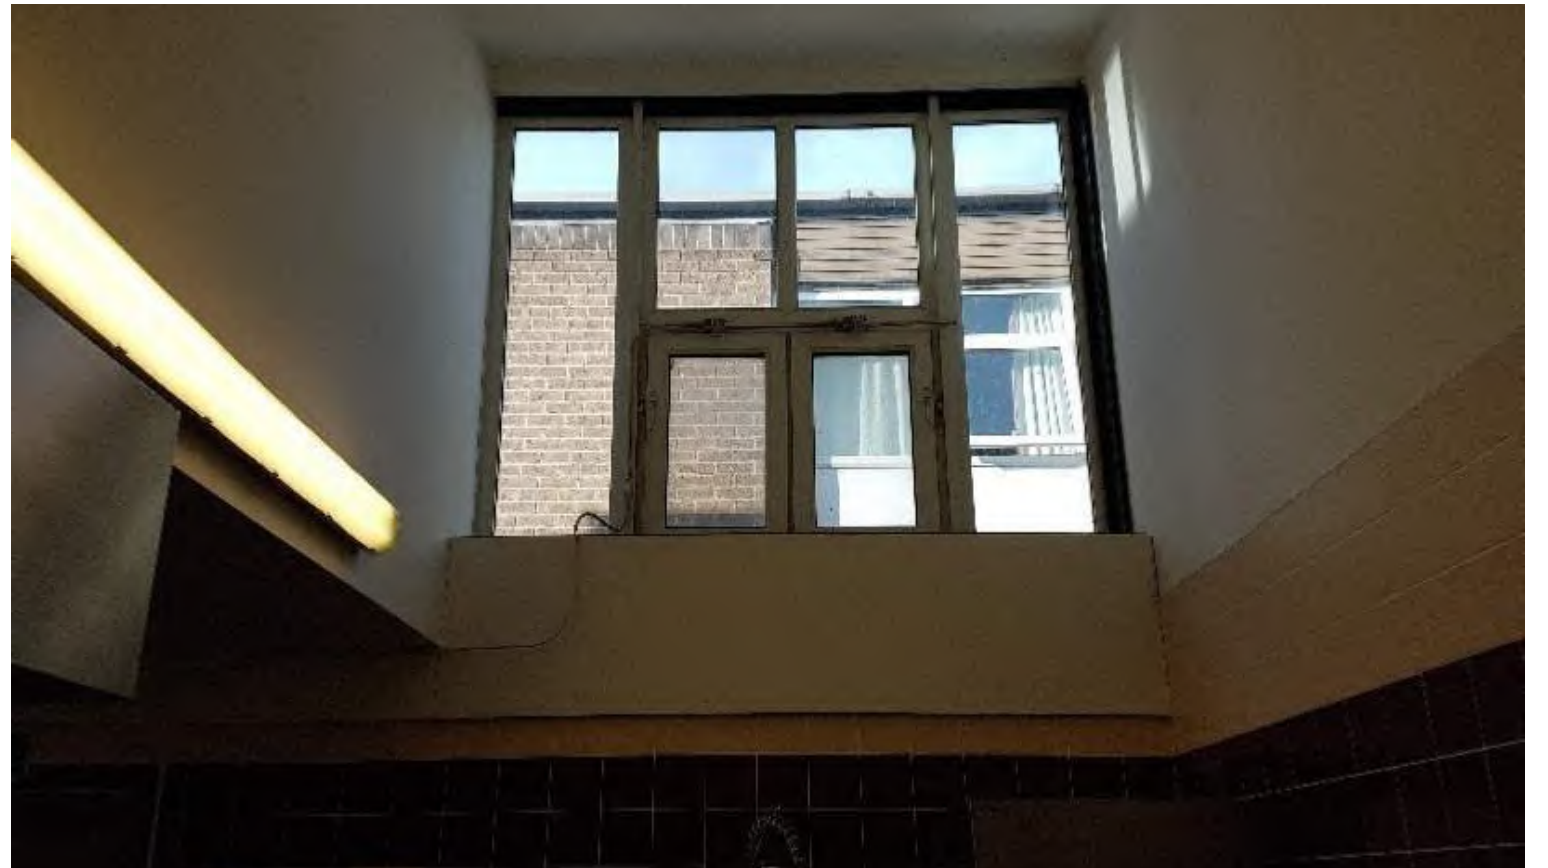
- 406. It was not possible to determine the construction of the roof over the kitchen, however it is thought that the roof was constructed from timber.
- 407. The wall at the high end of the vaulted roof was infilled with curtain walling. No lateral bracing to the higher end was identified. (See photos 7 and 8)
- 408. The walls within the kitchen area at high level were finished with plaster and tiles at low level. There was no evidence of cracking within the walls.

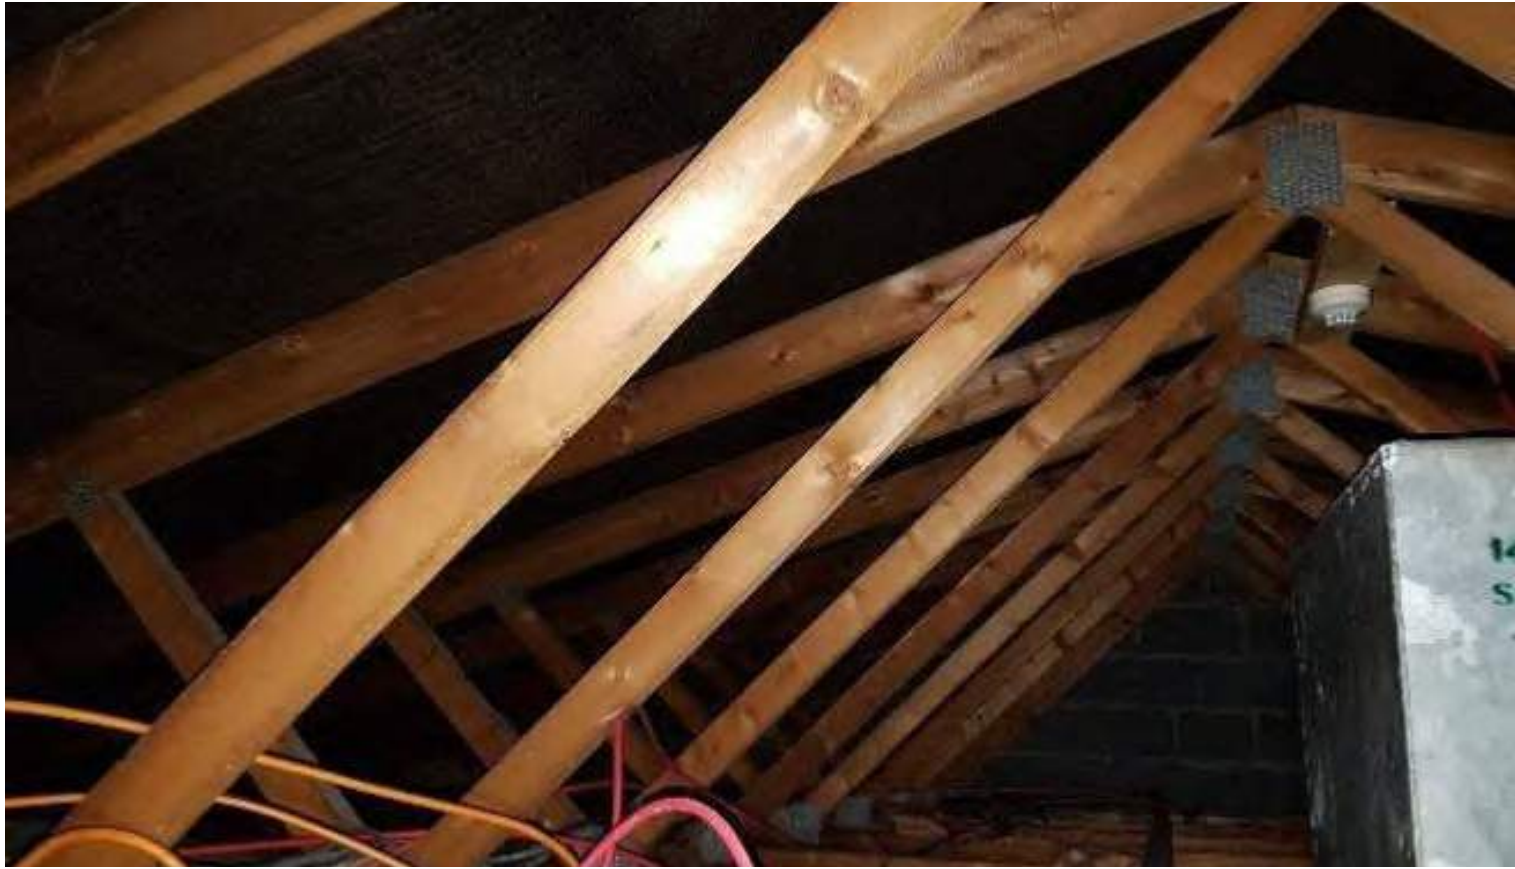
Photo 9

- 409. The duo-pitched roof comprises proprietary light timber trusses spaced at some 600mm centres presumably spanning between load bearing external walls to external walls. (See photo 9)
- 410. There is no evidence of significant distortion or racking to the truss members and the roof has been underdrawn with sarking felt.
- 411. Based on our findings from our restricted inspection there are no diagonal and longitudinal bracings or positive fixings between the trusses and gable walls.
