Derbyshire
Stone Slate Roofs

**Guidance
for Owners
of Historic
Buildings**

TRADITIONAL STONE ROOFING - DERBYSHIRE STONE SLATE ROOFS

GUIDANCE FOR THE OWNERS OF HISTORIC BUILDINGS

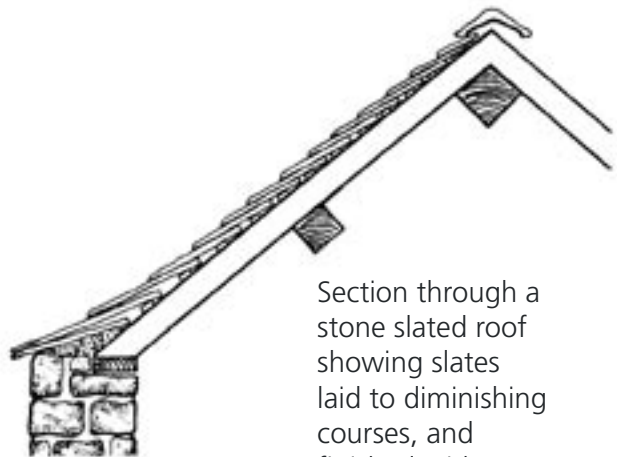
Section through a stone slated roof showing slates laid to diminishing courses, and finished with a stone ridge.

The stone slates were laid in diminishing courses with large eaves slates several feet wide down to the courses near the ridge which were considerably smaller. The slates were hung by means of oak pegs, driven into holes in the heads of the slates, made by using a pointed pick-end. The slates were hung on riven oak laths, except where a peg hole coincided with a rafter position in which case the slate was nailed, using a large 'sprag' or round headed nail. At the eaves, an under-eaves slate sometimes known as a 'cussome' or a 'counter' was bedded directly onto a wall and the 'house course', or first course, of slates laid onto that with the tails meeting. However, in order for the house course to bed closely on the counter slate, stone wedges were inserted between the two slates, a device which gave additional support at the centre of the house course slate and which supplemented the action of the cussome. Successive courses would then be at the correct pitch. The large eaves slates and cussomes projected up to 6" beyond the face of the wall and gave a substantial overhang for the discharge of rainwater, prior to the use of guttering.

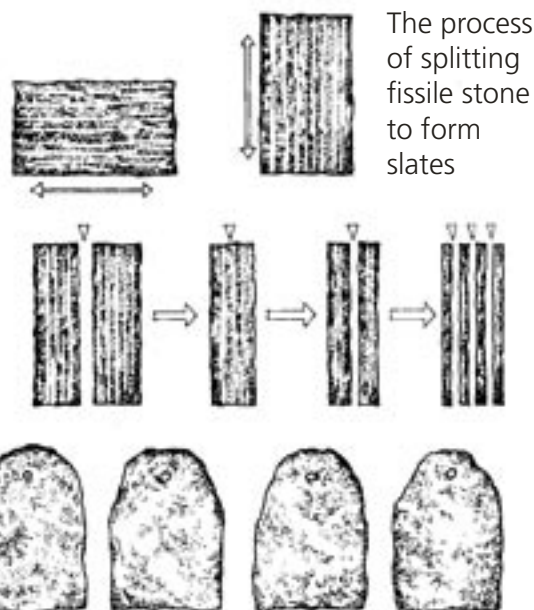
Traditional shape of a stone slate

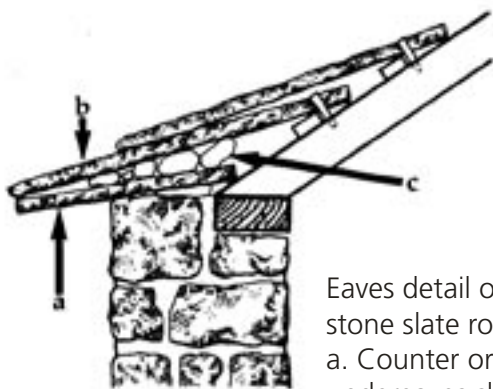
Eaves detail of stone slate roof
 a. Counter or undereaves slate
 b. House course
 c. Stone wedges

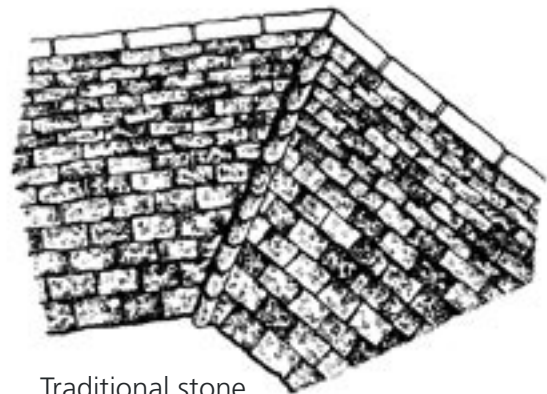
Traditional stone valley detail showing pointed valley slates

Roof valleys were a particular problem on stone slate roofs, as it was particularly difficult to achieve a swept or laced valley as was possible with thin Cotswolds limestone slates or plain tiles and which meant that the coursing of the stone covering was not drastically interrupted. In Derbyshire, and in the Pennines, the valleys were formed by laying stout boards in the valley space to provide support for chevron ended valley slates which were laid to form a stone valley. The edge slates of the two intersecting roof slopes were mitred to the required shape, and the valley was so constructed as to allow the coursing to continue from one slope to the other, although the valley course was set below the other courses and was partly oversailed by the edge slates of the adjacent roofs.

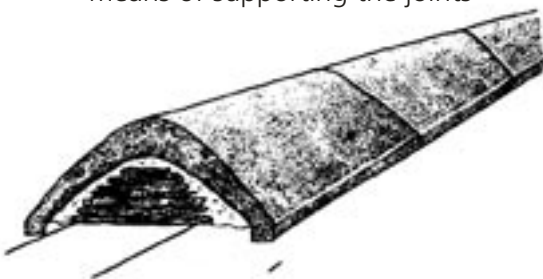
Detail of stone ridge, showing means of supporting the joints

Stone ridge tiles showing the method of support

At the ridge, the roof was finished with ridge stones cut from the solid with pick and chisel or, later, sawn. Farey makes reference to 'Coburn Quarry' on South Winfield Park where 'Ridging Stones, a substitute for Ridge Tiles, are

prepared. They are sawn out like an angular 'trough', whilst at 'Mansfield, Nottinghamshire and at Kinder in Glossop, they are hewn out for rough buildings'. Sometimes the ridges were bedded on mortar, sometimes they were laid dry, but in other instances the joint between two ridge stones was bedded onto a small pile of broken slate, with mortar, to give the area some support. The ridge stones varied in size and angle, according to the pitch of the roof. On a gabled building, unless the wall was finished with coping stones, the stone slates were carried onto, and sometimes beyond, the line of the outer stonework, but obviously copings would have made a more satisfactory finish.

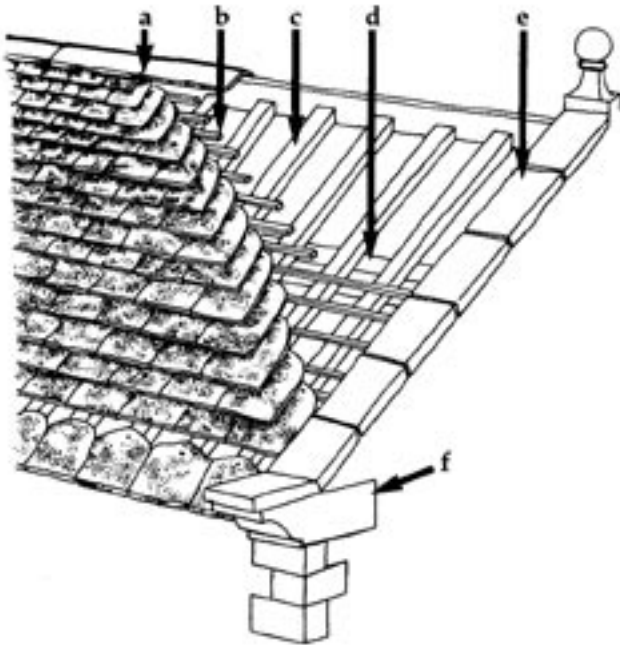
The components of a stone slate roof (with eaves course exposed and second course omitted to show lap).

- a. stone ridge
- b. laths or battens
- c. spars
- d. purlin
- e. coping
- f. kneeler

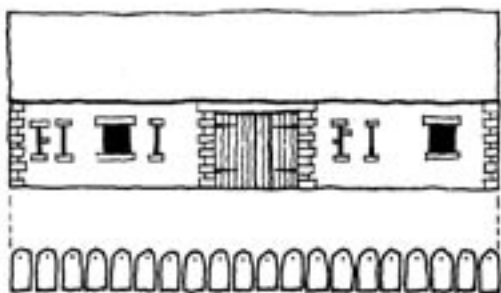
Stone slates, stacked for grading to thickness

When the slates have been graded for size they should then be graded for thickness, a process which is facilitated if the slates are standing on their heads. The thickness of slate can then be observed and sorting into thick, medium and thin can then take place, so that as the slater works along the length of a course he uses the thicks then the mediums, then the thins to prevent unevenness throughout the course.

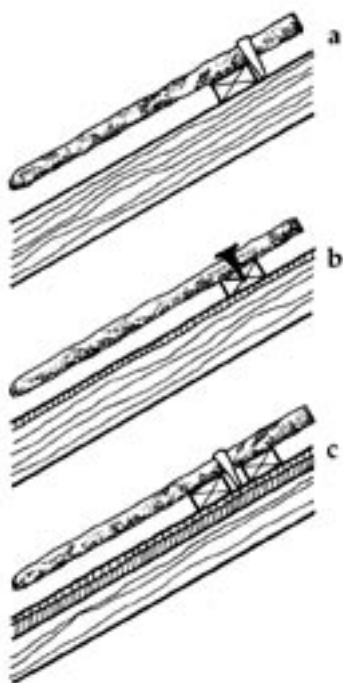
- Methods of fixing stone slates:
- pegged slate on single batten.
 - nailed slate.
 - pegged slate, using double battens

As has been shown, stone slates were traditionally hung using oak pegs, although other materials, notably animal bones, were used and there are even references to stones being bedded in mortar rather than hung. Today, with the use of underfelts and membranes, the pegging of slates is impracticable, unless the roof is counter battened that is, battens laid onto the backs of the spars, over the top of the felt, prior to the slating battens being fixed. This gives sufficient depth in which the pegs carrying the slates can be accommodated without harming the felt. The use of pegs is obviously the most acceptable method of hanging slates from a traditional viewpoint but there are the disadvantages of shrinkage, twisting and slipping associated with the use of wooden pegs, and there is a school of thought which contends that unless torching is used in conjunction with pegging it will not be possible to ensure that the pegs are secured.

The problem of shrinkage and slipping can be partly overcome by using double battens, one above the other, to prevent vertical movement of the peg. A lighter batten is nailed above the peg carrying batten with sufficient space left for the wooden peg to be driven between the two. However, the cost of having the oak pegs cut and the two sets of extra timber laid prior to the slating taking place may deter all but the most enthusiastic owner from employing the traditional form of slate hanging. In general modern stone slaters will nail the slates to the battens, using copper or alloy nails which are strong yet light. Galvanised nails should not be used for when they are being hammered the coating may be damaged allowing water to penetrate and begin the process of rusting which under the great weight of the roofing slate may cause the nail to shear. In some cases where the eaves courses are especially large, double nailing is advisable in the same way as double pegging was formerly employed on eaves courses. More recently, an alloy peg has been produced to allow the slate to be hung rather than nailed.
