DERBYSHIRE COUNTY COUNCIL

# East Clune HOP

## Condition Survey

January 2019

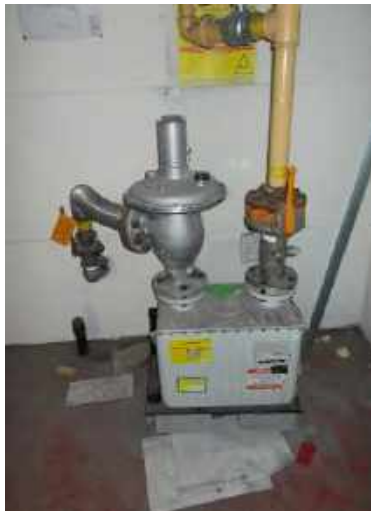
Photograph No 1 – Incoming Gas meter located in the main boiler house (room No 002).

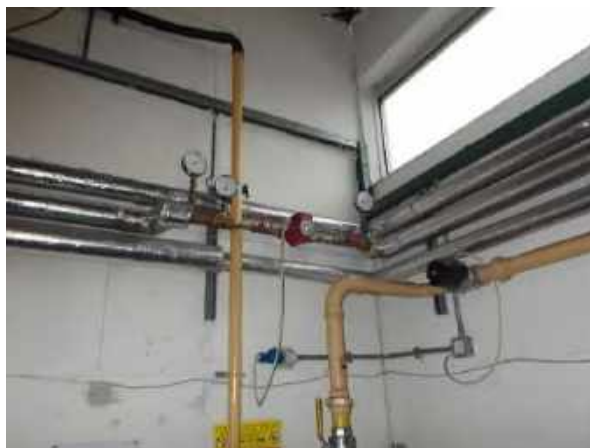
Photograph No 2 – Boiler Gas supply with solenoid valve to the boilers.

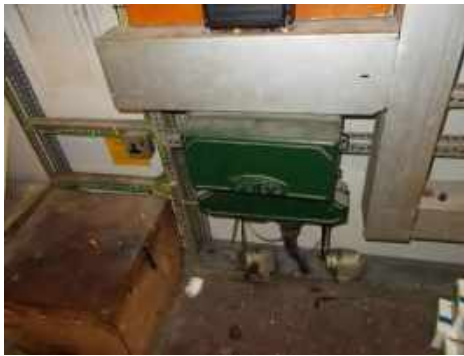
The electrical incoming utility supply enters the building in room 035 and terminates into a 100A Siemens service head, this room contains the incoming service head and utility meter and also acts as the main switchroom and lift machine room. The nursing home appears to have a 3 phase 100A supply as the meter is a direct reading meter. The last test was undertaken on 22<sup>nd</sup> August 2018.

Photograph No 4 – The Incoming electrical utility supply is located in room 035.

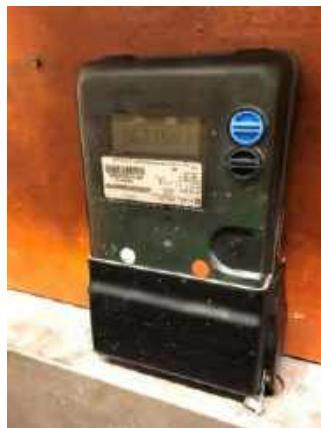
Photograph No 5 – The incoming utility meter for the care home.

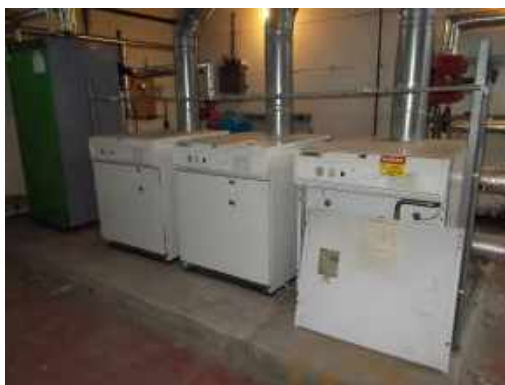
Photograph No 7 – Typical Boiler within the boiler plantrooms.

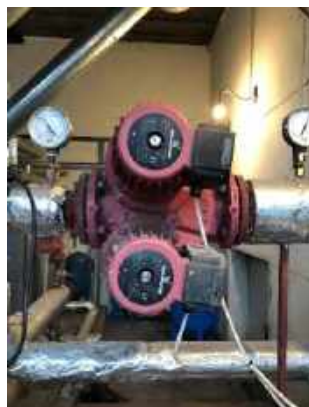
Photograph No 8 – Main VT heating circulation pumps.

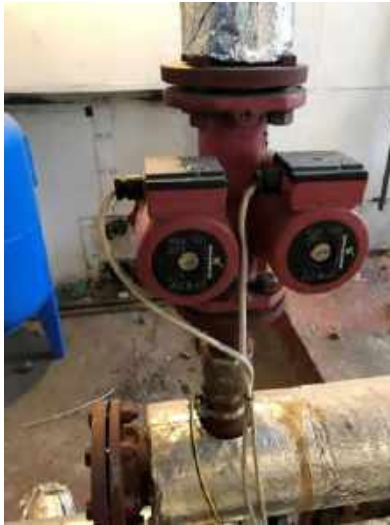
Photograph No 9 – HWS Primary circulation pumps.

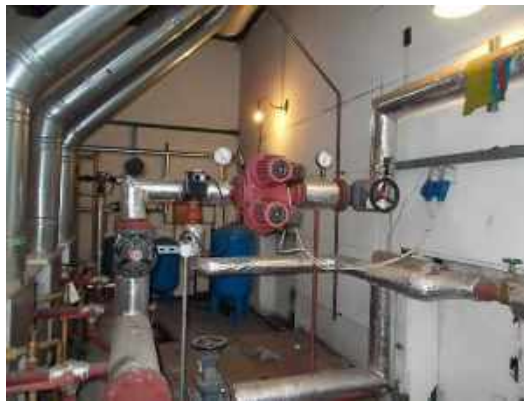
Photograph No 10 – VT heating circuit. Photograph indicating the VT mixing valve in the foreground.

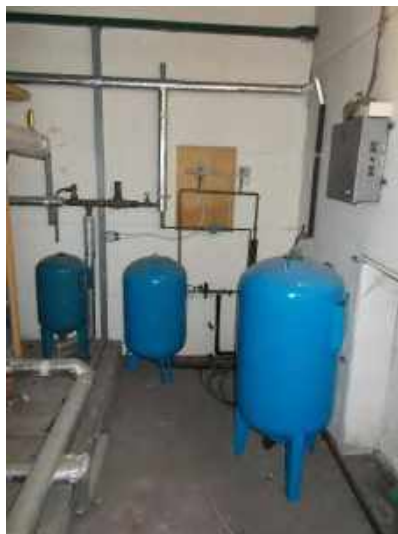
Photograph No 11 – Heating pressurisation vessels located behind the boilers.

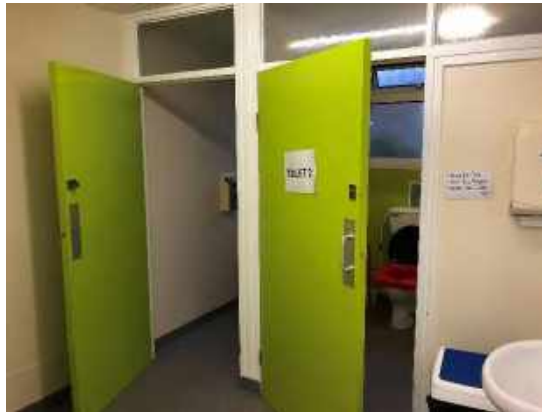
Photograph No 13 – Typical toilet cubicles in the male/female toilets. Note ground floor toilet room 036 did not have any heating installed in the room which was very cold at the time of our inspection.

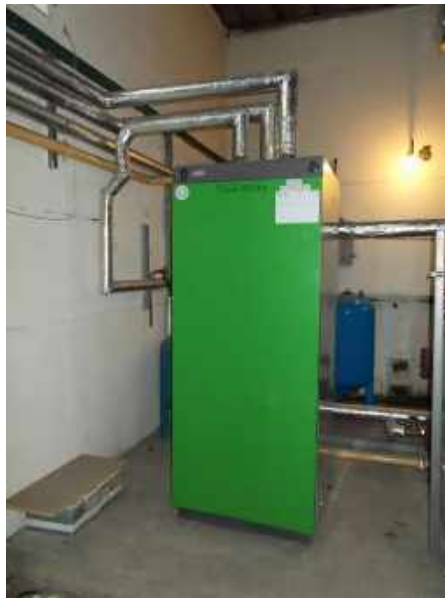
Hot water is provided by a central 600 litre LTHW heated HR Benson calorifier, this is located within the main boiler house. This unit is of a similar age to the boilers but in a reasonable condition. The calorifier is coming to the end of its life and should be considered to be replaced in 3-4 years. The calorifier has a diverting valve on the heating system from the boiler to maintain the temperature in the calorifier.

Photograph No 14 – Typical Beeston HR Calorifier for the domestic HWS generation.

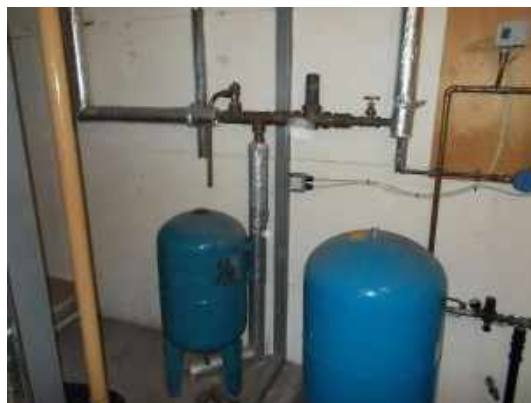
All of the pressure relief pipework discharges water onto the floor rather than being taken to a gully.

Photograph No 15 – Calorifier pressure relief discharge pipework not fully pipped up to a drain and discharging directly onto the floor.

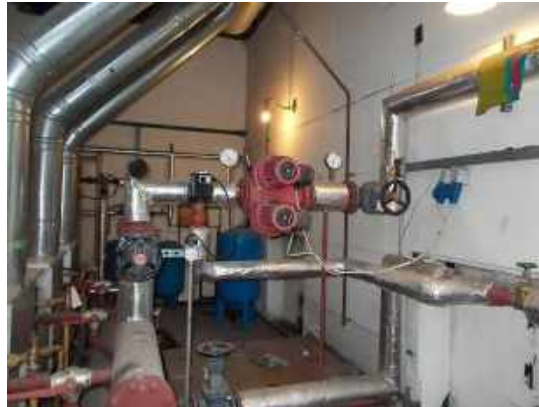
Photograph No 16 – LTHW control diverting valve to control the Calorifier temperature. Please note, the mixing valve is located in the background by the boiler flues.

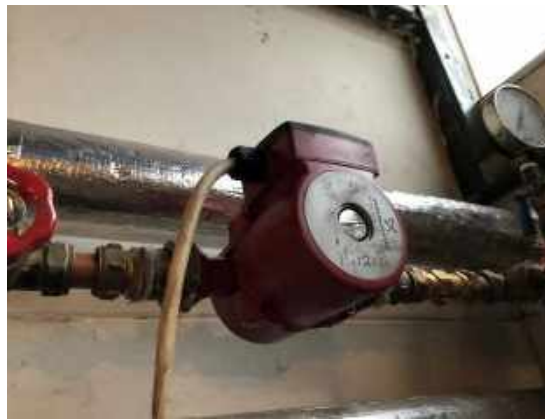
Photograph No 17 – Typical HWS secondary pump installed within the boiler houses.

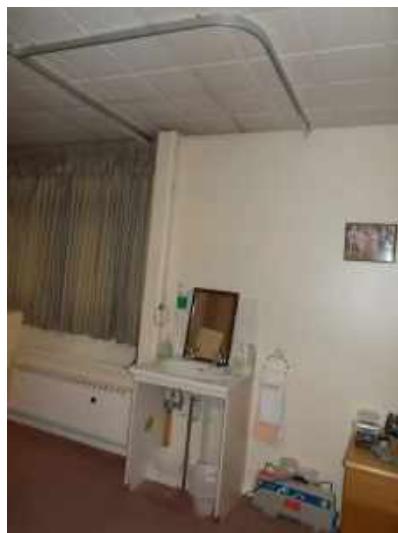
Photograph No 18 – Typical bedroom sink with thermostatic mixing valve installed below the sink.

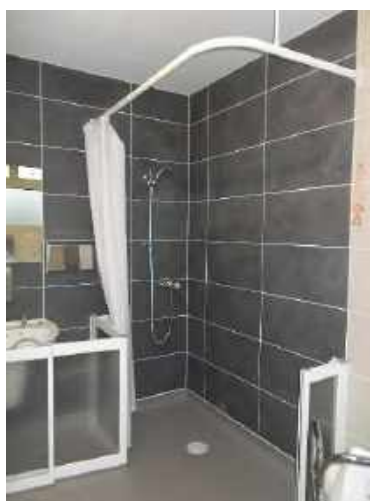
Photograph No 21 – Refurbished assisted shower room on 1<sup>st</sup> floor (room No 111).

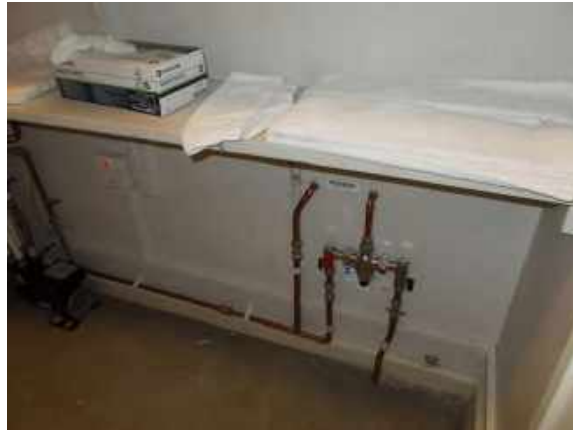
Photograph No 22 – Refurbished assisted shower pump and WHB blending valve in adjacent store (room No 135).

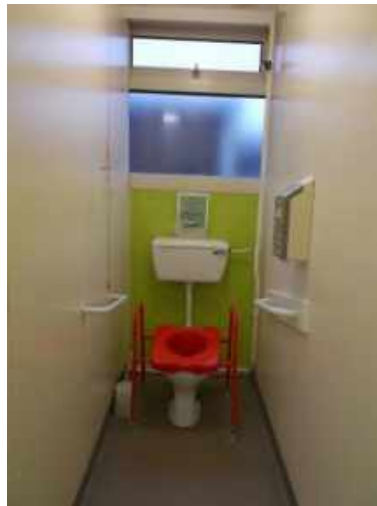
Photograph No 23 – Typical smaller ambulant toilet cubical, note there is no heating in the cubical.

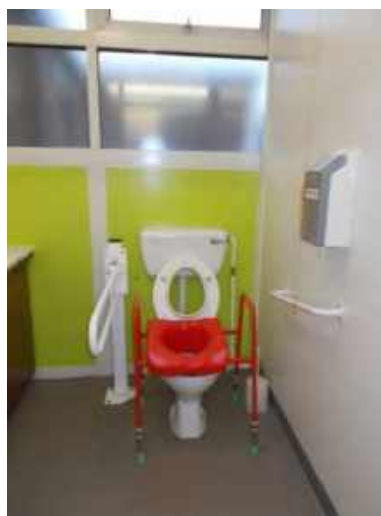
Photograph No 24 – Typical larger ambulant toilet cubical, note there is no heating in the cubical.

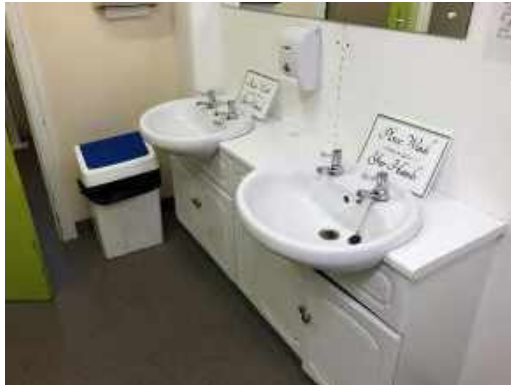
Photograph No 25 – Typical ambulant toilet hand wash basins. We have assumed that any blending valves have been installed in the pipework boxing out at the far end of the vanity unit.

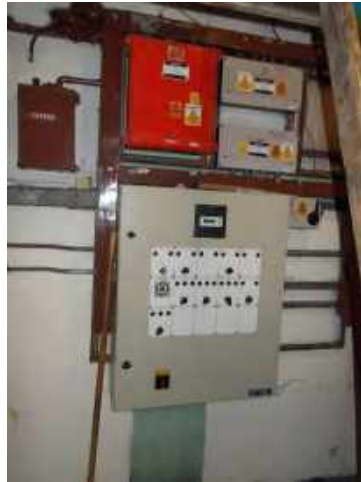
Photograph No 27 – Typical boiler and HWS plant control system.

Consideration should be given to replacing the controls with a more up to date and efficient controls system that incorporates optimisation software, a new variable temperature heating system. It may also be worth investigating if the provision of EC variable speed pumps would benefit the EPC certificate for the building.

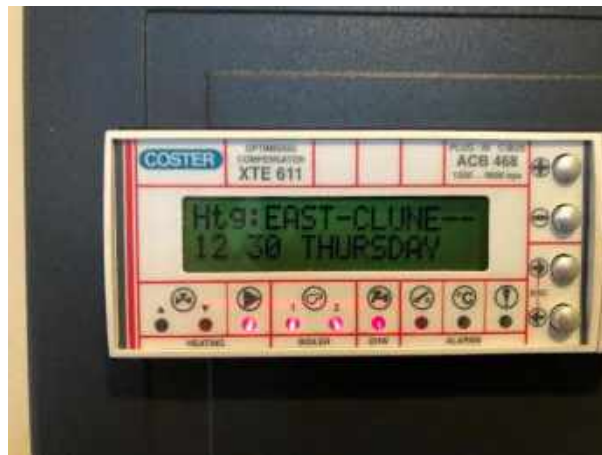
Photograph No 28 – Coster RTE 611 Plant Controller.

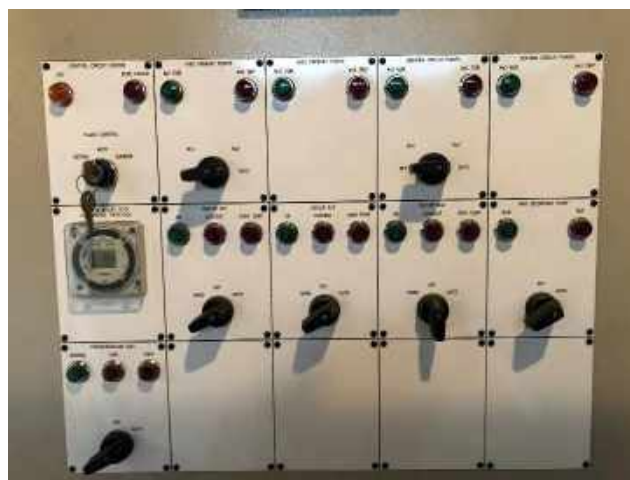
Photograph No 29 – Plant control panel, it was not possible to understand which item of equipment was operational as the lamps were not working and there is no lamp test switch.

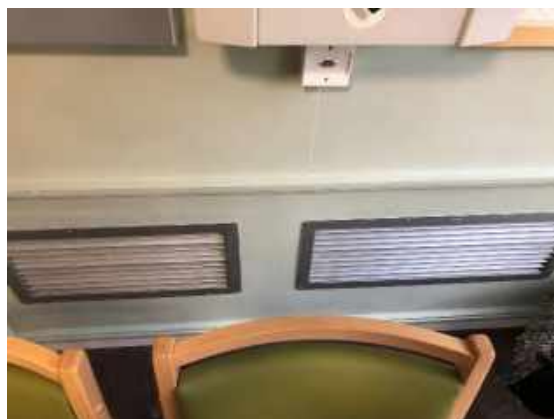
Photograph No 31 – Typical recessed fan convector units utilised in the main entrance and all common rooms.

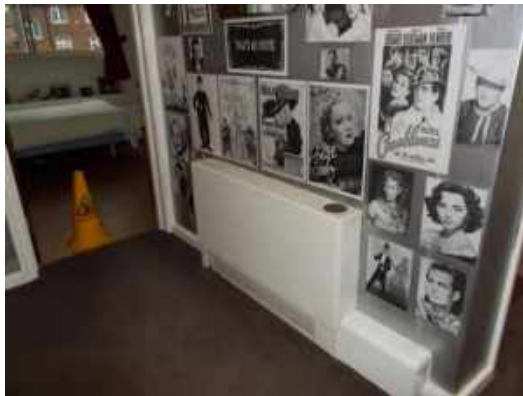
Photograph No 32 – Typical Floor mounted corridor LST radiator.

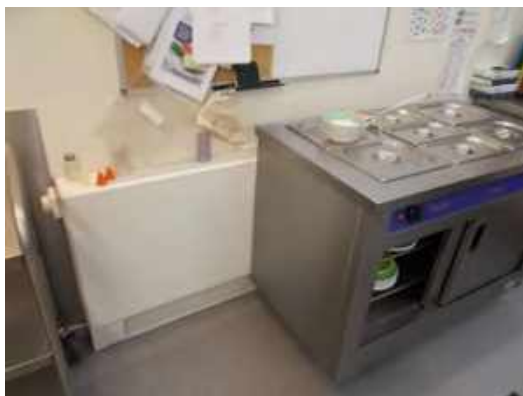
Photograph No 33 – The kitchen has a LTHW wall mounted fan convector in the office area of the kitchen.

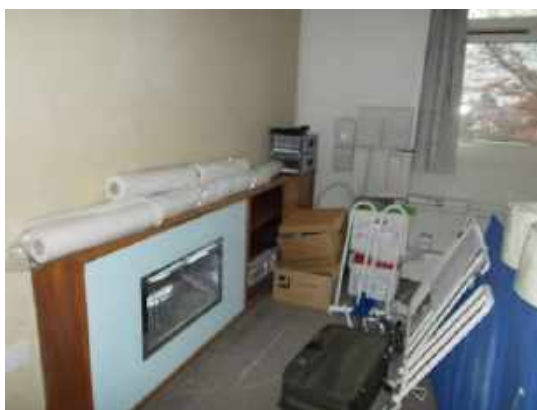
Photograph No 34 – The 1<sup>st</sup> floor flat has been provided with a wall mounted electric fire.

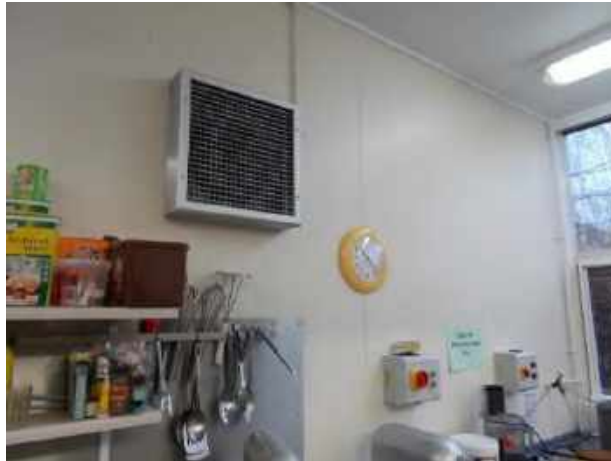
Photograph No 37 – This is the supply fan through the wall from outside, this fan has a filter fitted.

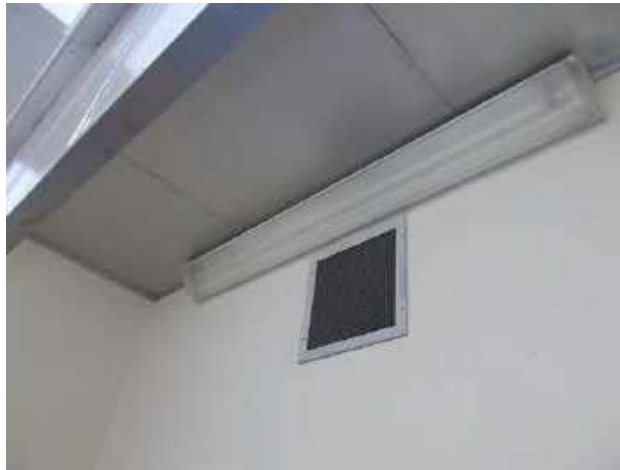
Photograph No 38 – Dishwasher extract grille installed under the dishwasher bulkhead.

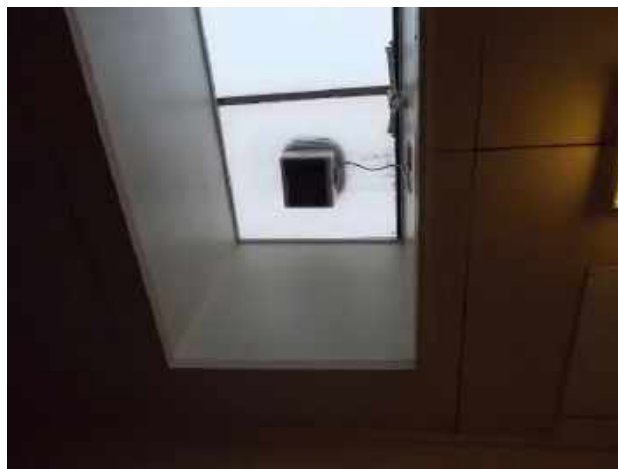
Photograph No 39 – There are additional extract fans installed through the roof lights.

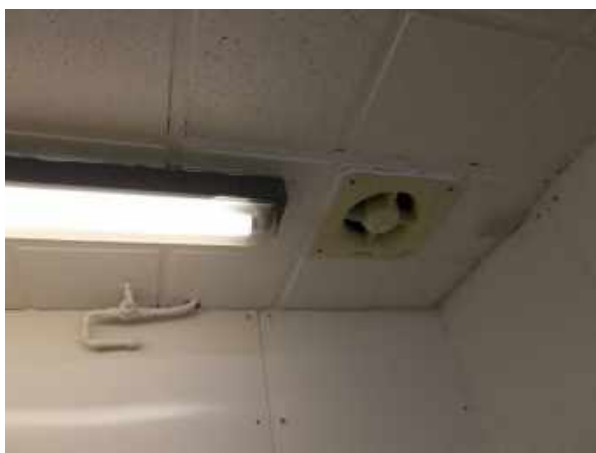
Photograph No 41 – Typical communal toilet extract fans, not sure if these were working at the time of our inspection.

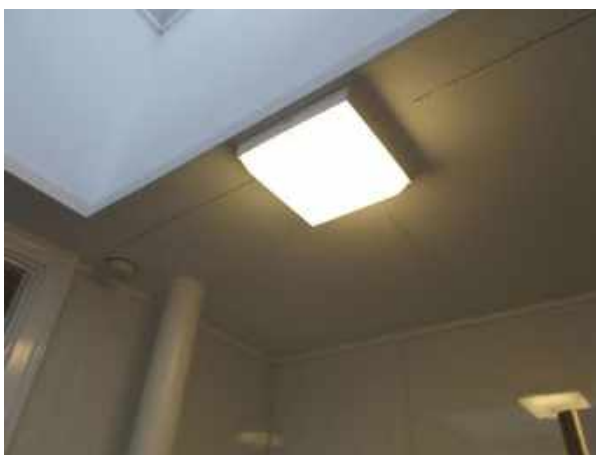
Photograph No 42 – The sluice rooms are typically not. The rooms would benefit from an extract fan operating on a trickle vent system with PIR controlled boost function.

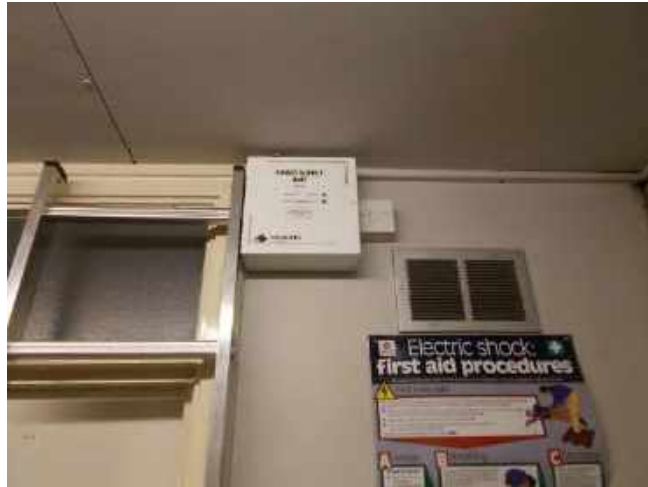
Photograph No 43 – Power supply for the main switchroom/lift motor room door grilles.

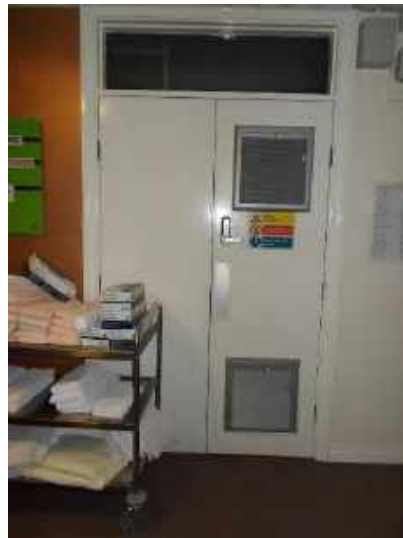
Photograph No 44 – Main switchroom/lift machine room access doors with vent grilles fitted.

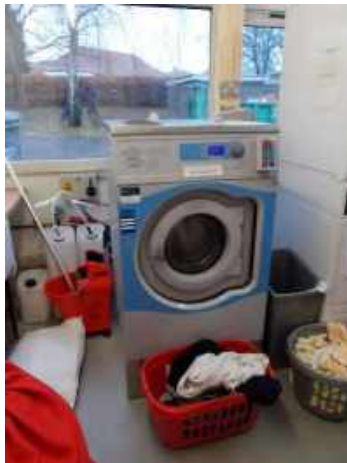
Photograph No 45 – Typical Laundry washing machines.

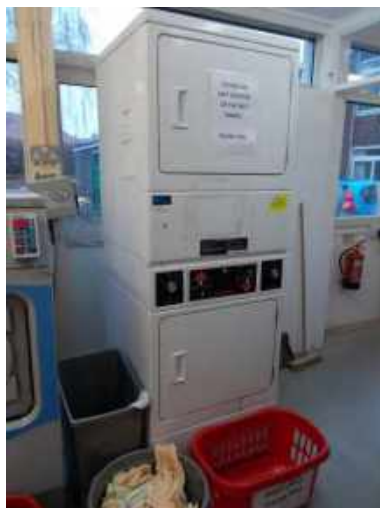
It is not clear if the circular ducts have been cleaned to ensure that there is no build-up of lint within the ducts restricting the discharge of air from the dryer. The ducts should be provided with access panels to make cleaning easier.

Photograph No 46 – Double stacked Speed Queen SSEM electric dryer.

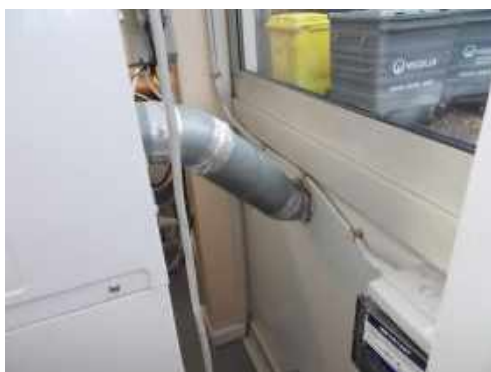
Photograph No 47 – Laundry Dryer extract air duct and make-up air grille. Note dryer ducts extract onto the roof. Not sure if there is an issue with discharge or if the ductwork requires cleaning.

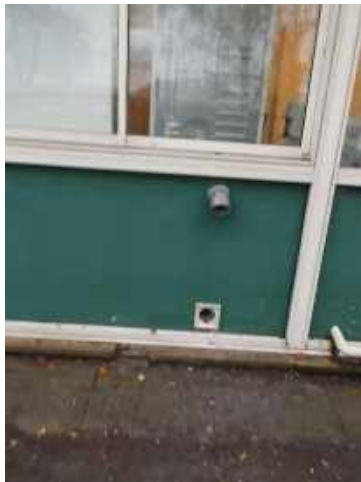
Photograph No 48 – Laundry Dryer extract air ducts to outside, note there are no grilles or protective mesh to stop birds from entering the ducts.

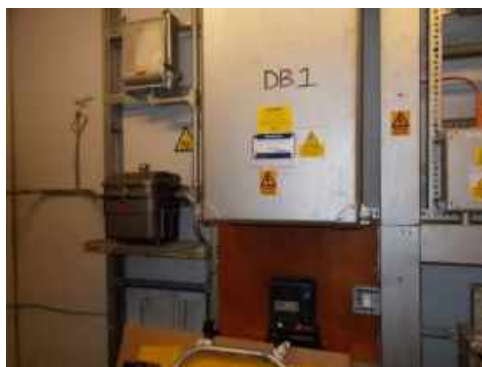
Located within the electrical cupboard (room 035) is the main electrical distribution board, this is an old Bill fuse board, this distribution board feeds a series of distribution boards located throughout the building. Generally the distribution boards have been manufactured by Bill, but there is a Crabtree C50 distribution board in the laundry and Square D Consumer unit in store (Room 055). All of the remote fuse boards should be replaced with modern MCB/RCBO distribution boards. The electrical installation was last tested on 22<sup>nd</sup> August 2018.

Photograph No 50 – Bill Red Spot main fuse board DB1.

Fuse board DB 1 should be replaced with a new MCCB panel board to ensure the correct discrimination between the main switchboard and the remote distribution boards.

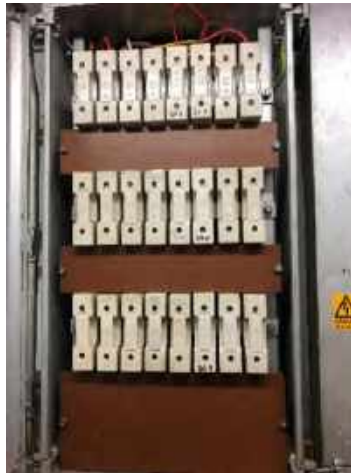
Photograph No 51 – Main Distribution board DB1 this is a rewirable fuse board.

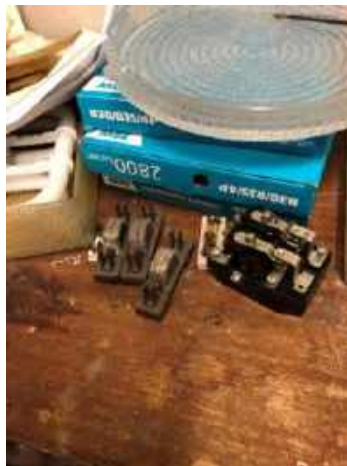
Photograph No 52 – Spare rewirable fuses sitting on the bench in the switchroom, please note the possibility of asbestos tape under the fuse wire.

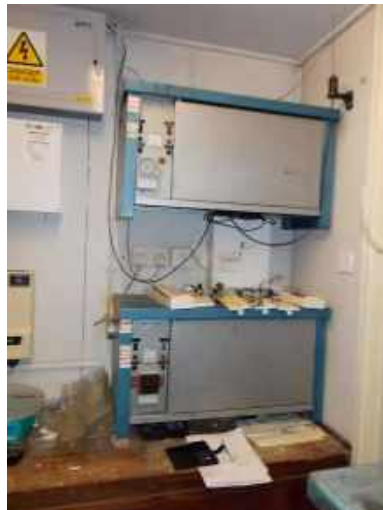
The central battery units appear to be a lead acid system and their age and battery life is not fully known. Looking at the age of the units they appear to be in a reasonable condition but should be nearing the end of their useful life. The overall system capacity is not known and this may not be sufficient to incorporate bedroom emergency luminaires onto the current 24V system, also the luminaires are limited in the type available for a 24V system, and the system should be replaced with self-contained luminaires off the local lighting circuits.

Photograph No 72 – Central battery emergency lighting batteries, note these units have been plugged into a local socket.

- Rewire the building to bring the electrical system in line with the latest version of BS7671.
- Replace the existing emergency lighting system with self-contained luminaires off the lighting circuits.

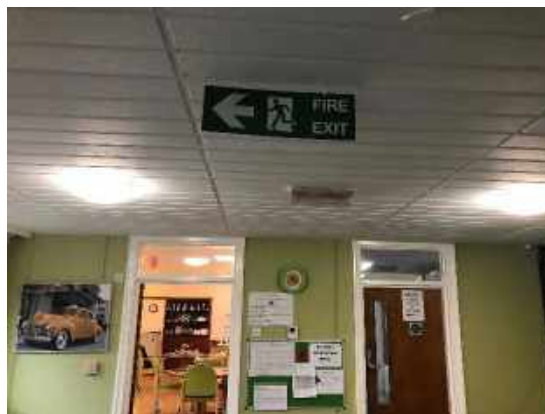
The building is lacking the correct number of illuminated exit signs to ensure that the escape routes are clearly identified. It is not clear if this building should be classified as a public building as visitors for the residents may be within the building and need directing to an emergency exit, again this should be reviewed with the Fire Officer to ensure the correct illuminated signage is installed.

Photograph No 75 – Non-illuminated Exit sign with emergency luminaire behind the sign.

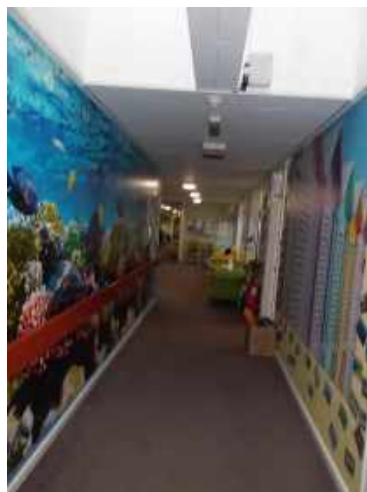
Photograph No 76 – Main Corridor with no direction emergency signage along the route.

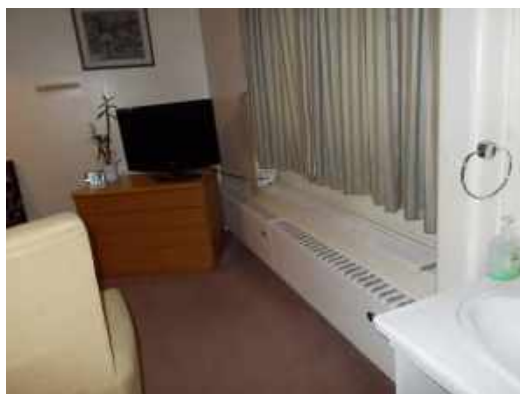
Photograph No 81 – Typical bedroom with socket for the television. This room was capable of accepting up to 4 beds, but not set up for a single occupant with dedicated TV points.

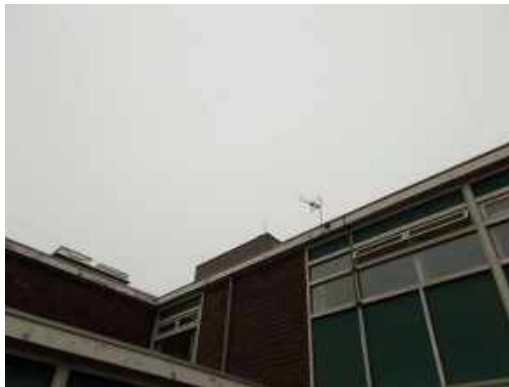
Photograph No 96 – Lightning protection earth spikes installed on roof enclosure roof. It is assumed that this is the total coverage for this building.

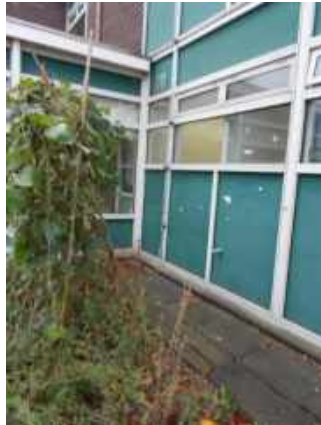
Photograph No 97 – This is the only lightning protection down tape dropping to earth rod pit that was identified on our inspection.

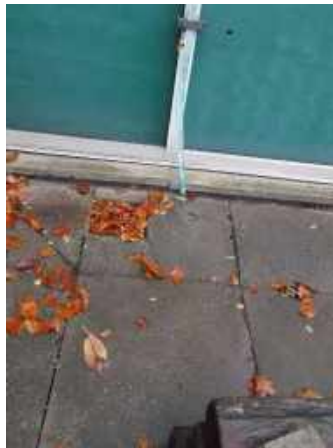
Photograph No 98 – Bare lightning protection tape drops into the ground and there is not an earth rod pit fitted. Also the tape has not been provided with a test link.

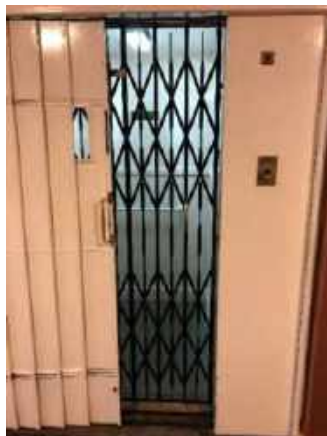
Photograph No 100 – Existing Passenger lift showing manual concertina doors.

- Replace the existing lift with a new lift, consideration should be given to getting residents from the first floor to the ground whilst the lift replacement is carried out.

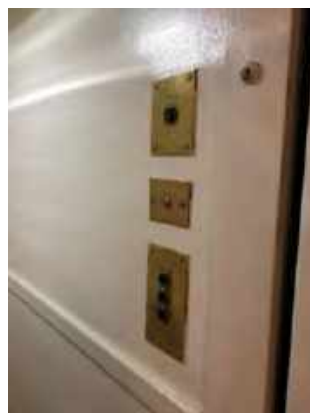
Photograph No 101 – Existing Passenger lift controls which do not comply with the latest requirements for DDA.

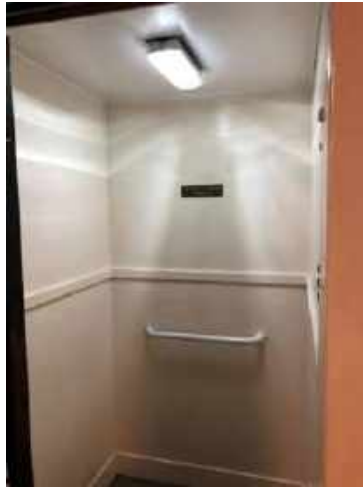
Photograph No 102 – Existing Passenger lift showing no rear mirror

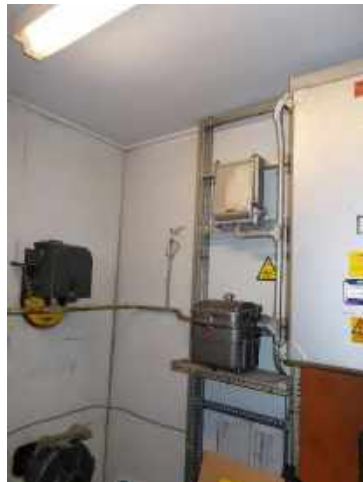
Photograph No 103 – Existing Passenger lift power supplies and control gear.

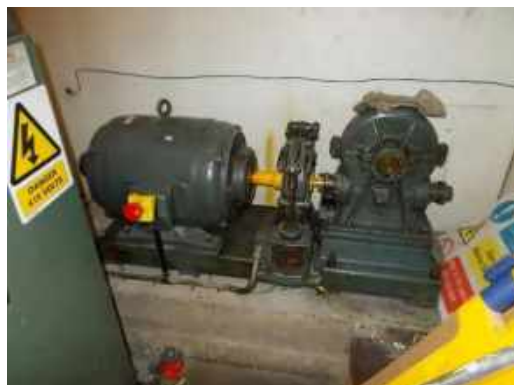
Photograph No 104 – Existing Passenger lift Drive motor, gear box and break system.

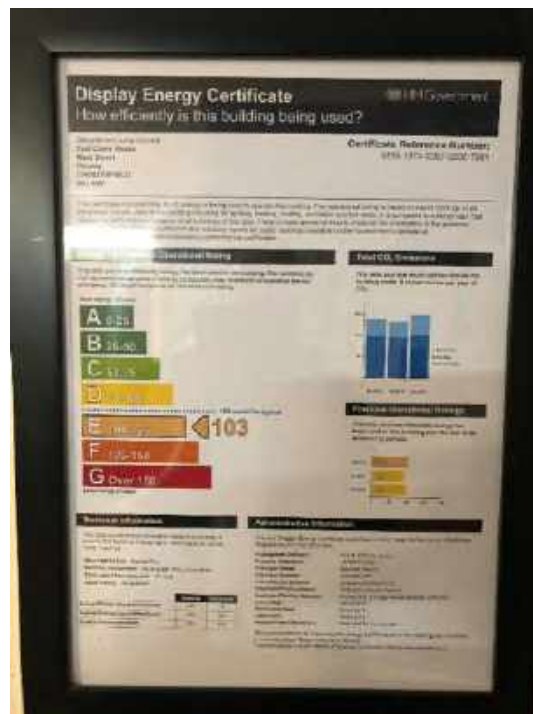
Photograph No 107 – Current EPC Certificate with a rating of E - 103

One area where it may be possible to improve the energy efficiency would be to have a look at replacing the existing boilers and Calorifier with new condensing boilers and a new high performance calorifier which is capable of accepting solar heating to reduce the cost of the domestic hot water.

Another major consideration for energy saving would be for the installation of dimmable LED lamps to all bedroom central luminaires, as this is a case of just replacing lamps providing the dimmable LED lamps can be controlled by a standard dimmer switch.

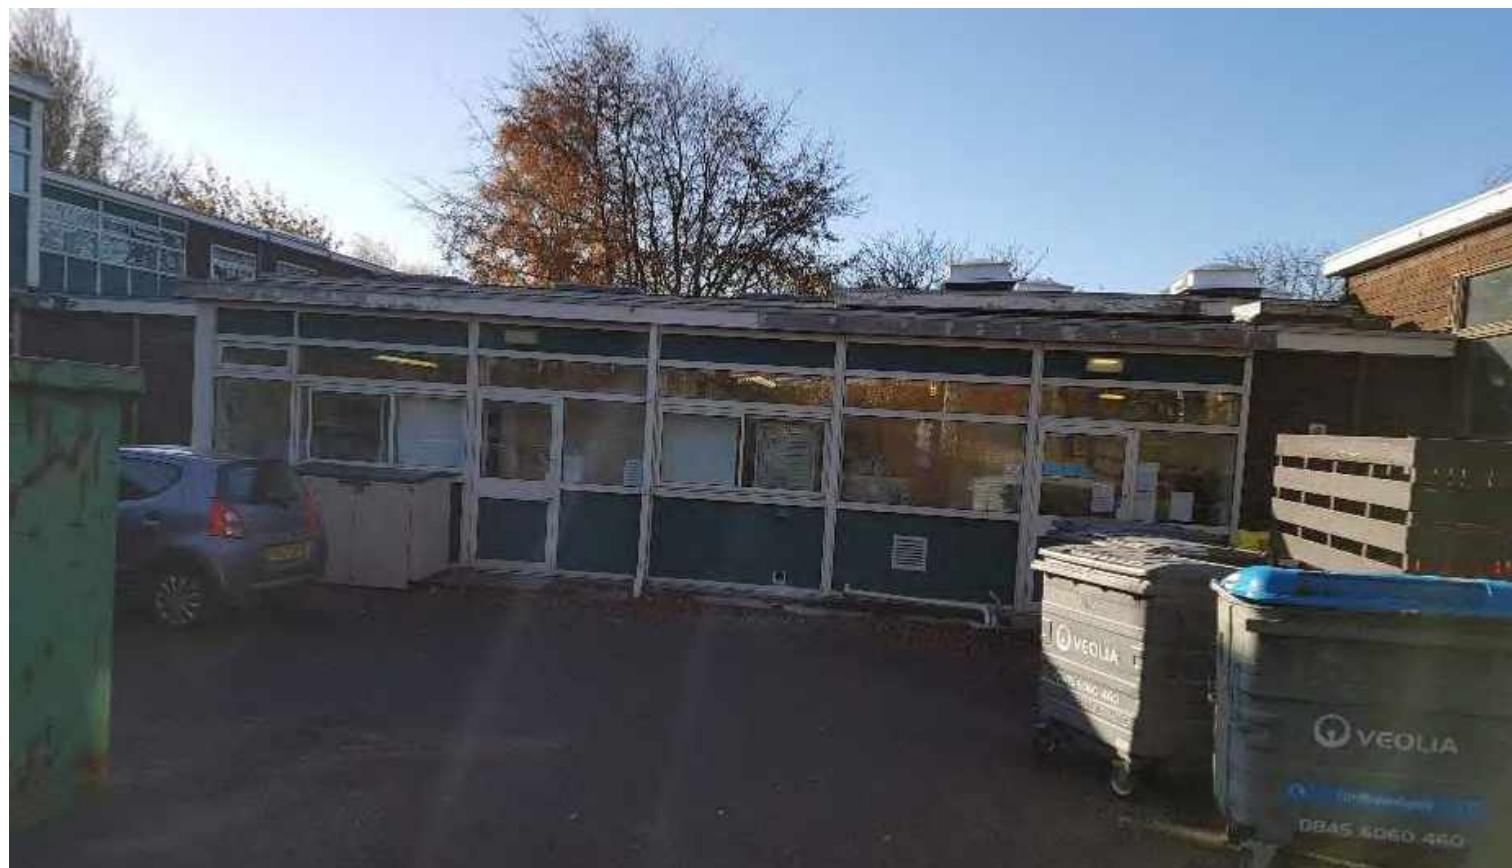
Photo 3

- 301. Flat roofs exists over the entire complex, but at different levels throughout.
- 302. There was no evidence of significant distortion to any of the eaves.
- 303. Deterioration of the timber fascia's were noted throughout. (See Photo 3)

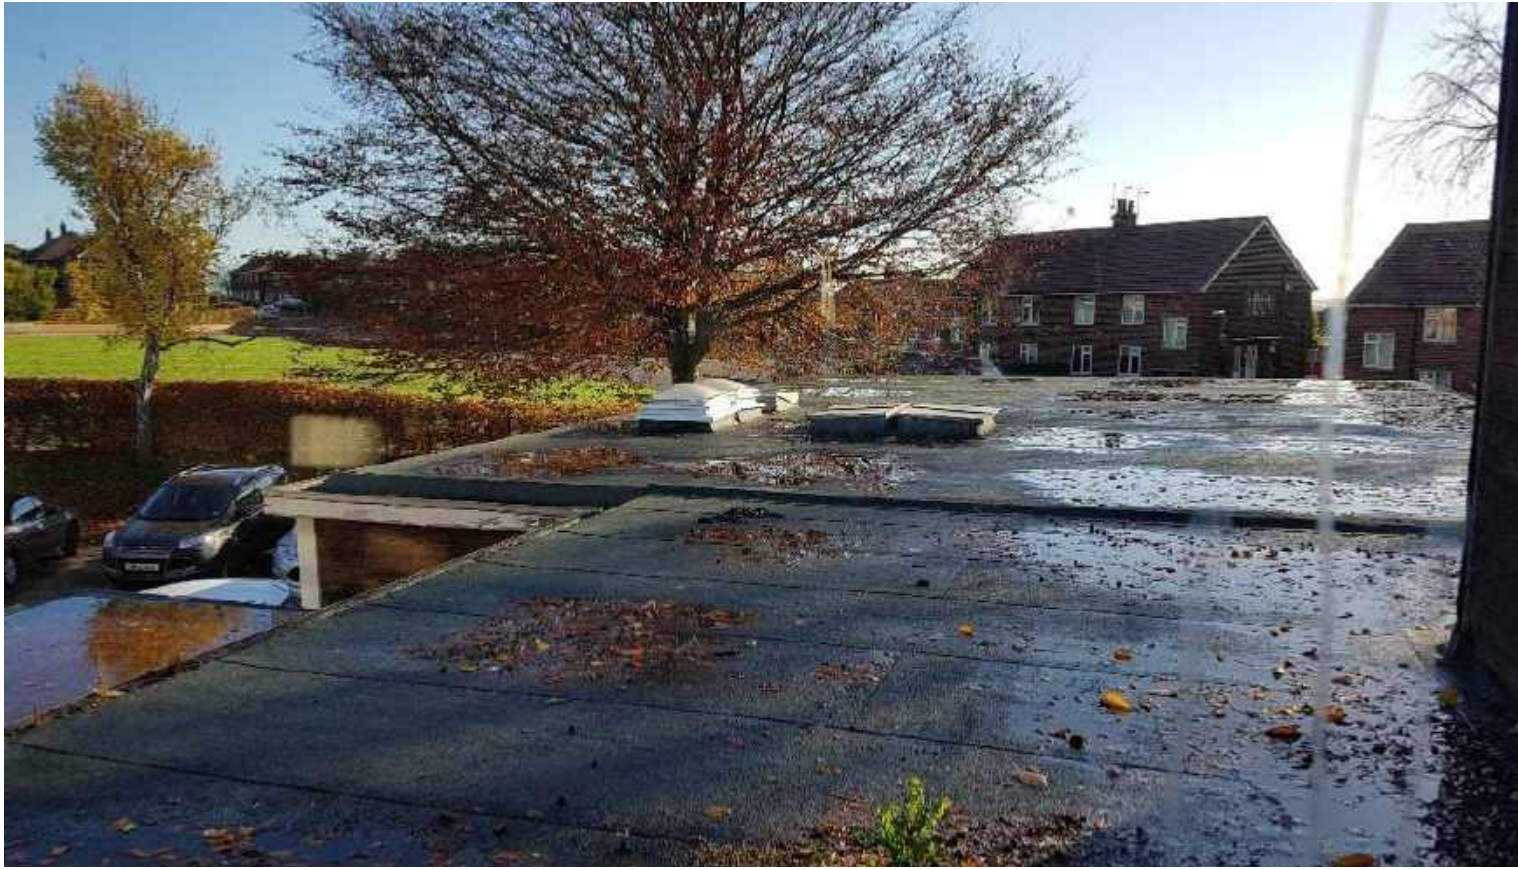
Photo 5

- 309. We identified the roofs were finished with a waterproofing felt layer. Signs of significant standing water was noted throughout. (See Photo 5)
- 310. It was apparent that remedial measures had been undertaken to the roof lights at some point.
