DERBYSHIRE COUNTY COUNCIL

Gernon Manor HOP

Six Facet Survey

22nd November 2018

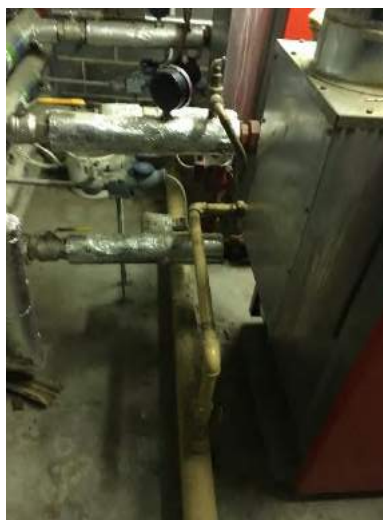
Photograph No 2 – Gas pipework serving main boilers.

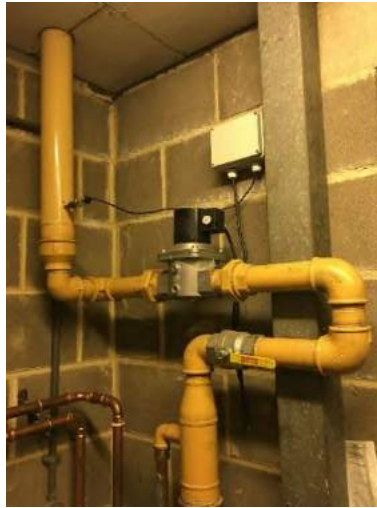
Photograph No 3 – Incoming gas supply into kitchen boilerhouse. Copper connections to serve kitchen boiler and gas enters ceiling to serve adjacent kitchen.

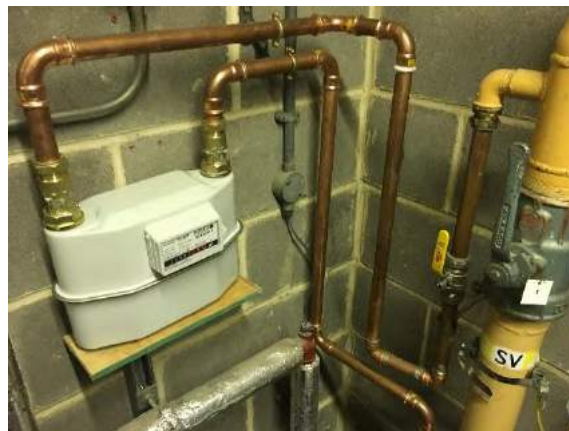
Photograph No 4 – Sub-gas meter from incoming gas main to serve kitchen boiler.

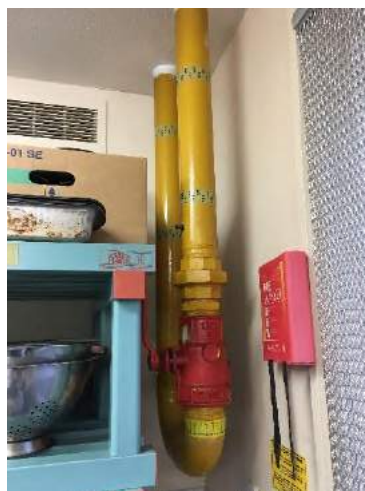
Photograph No 5 – Gas drops from kitchen ceiling with manual isolation valve before re-entering ceiling to serve central spine for catering equipment.

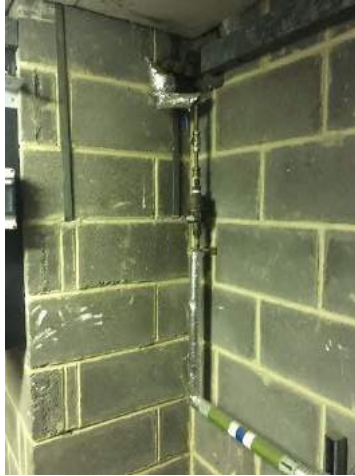
Photograph No 6 – MCWS entering main boilerhouse at high level complete with water meter.

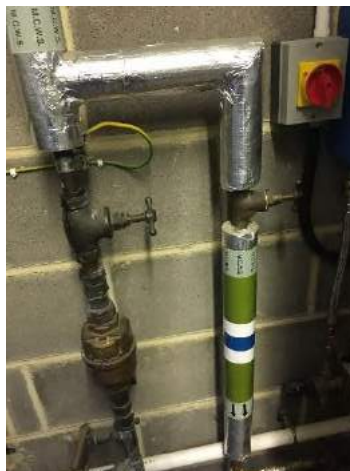
Photograph No 7 – MCWS entering Kitchen boilerhouse at low level complete with water meter.

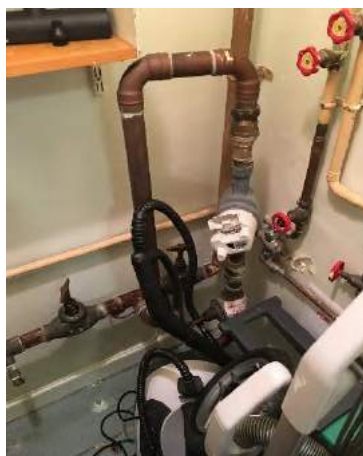
Photograph No 8 – Incoming MCWS entering Store 082 within main building complete with labelled valve and water meter.

The incoming valves were not labelled/identified, apart from the main building supply which makes it difficult to fully identify. These valves and the central incomer valve needs to be identified and incorporated into the building manual for the means to isolate the boiler houses and whole building if a leak is detected.

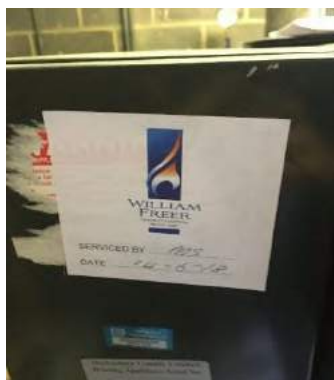
Photograph No 11 – Latest service notice on boilers in main boilerhouse dated 14/6/18

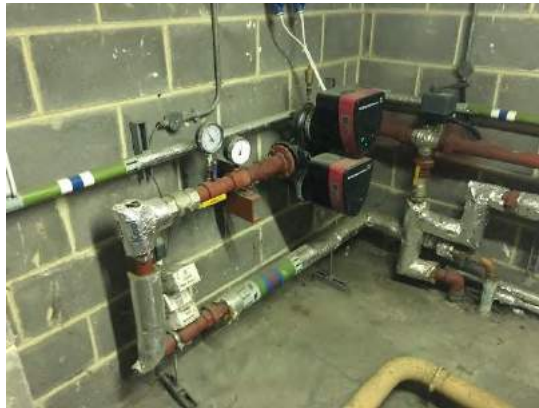
Photograph No 12 – Grundfos pumps on Compensated heating circuit.

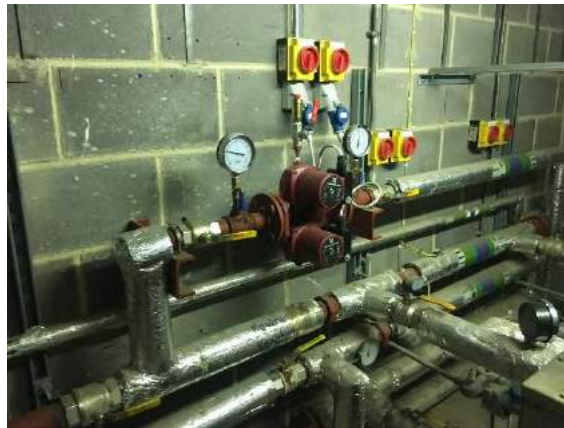
Photograph No 13 – Grundfos pumps on Primary HWS heating circuit.

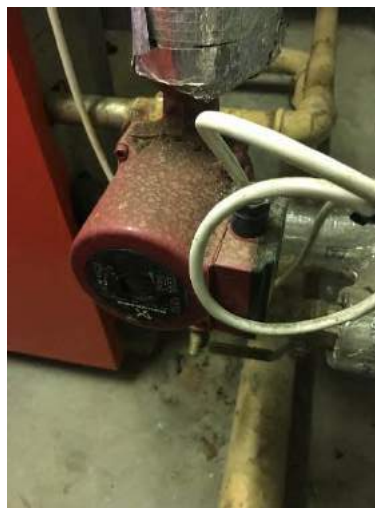
Photograph No 14 – Typical Grundfos boiler shunt pump.

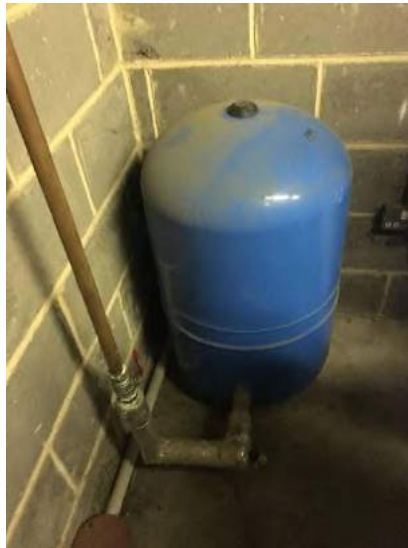
Photograph No 15 – Typical heating system expansion vessel in main boilerhouse

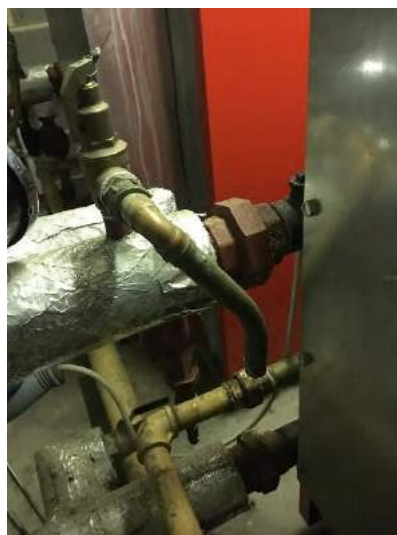
Photograph No 16 – Safety valves discharges onto floor and pipework below and not into a drain/gully

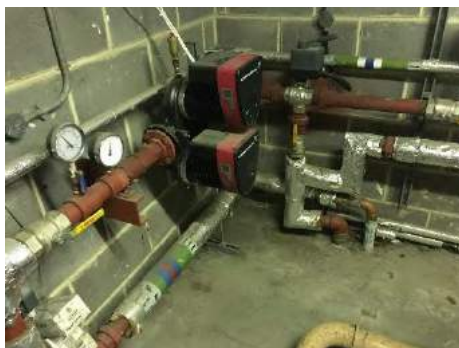
Photograph No 17 – Existing pipework not insulated within boilerhouse.

Both circuits are provided with twinhead pumps to give run and standby facility. The pumps serving the compensated circuit have been replaced at some point with newer inverter driven pumps. In quite a few instances within the boilerhouse there is insulation missing on existing pipework or it is damaged and requires replacement and there are no insulated valve covers currently installed, these need to be installed.

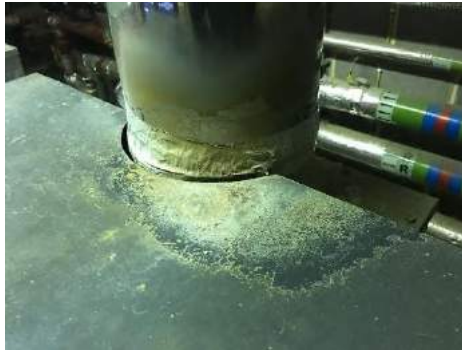
Photograph No 18 – Possible ingress of rainwater onto boiler from unsealed flue as it through roof.

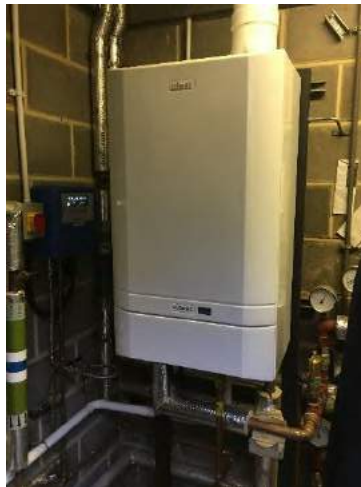
The boiler appears to be in good condition although it is unknown as to whether it has been regularly maintained as no test results were attached to the casing.

Photograph No 19 – Wall mounted Ideal boiler in kitchen boilerhouse.

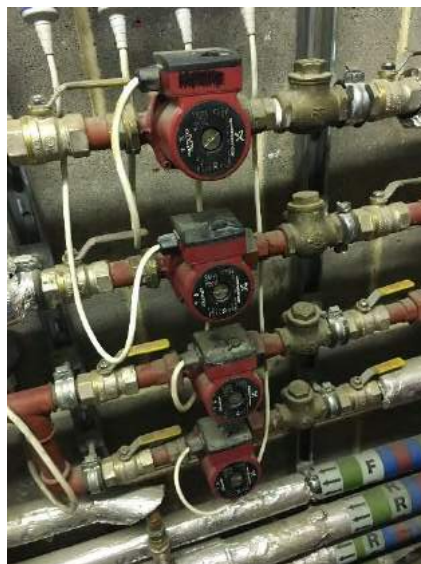
Photograph No 20 – Grundfos single head pumps serving compensated heating (top) and HWS primary heating (bottom).

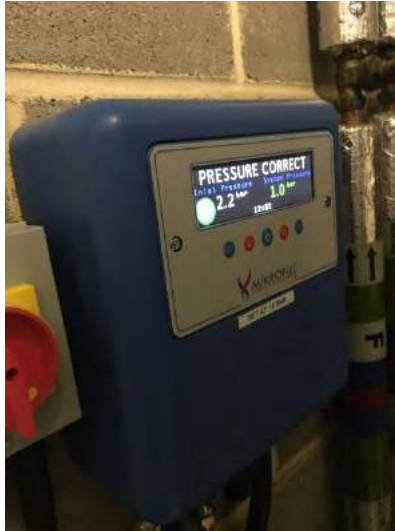
A Mikrofill filling unit and associated expansion vessel has been installed on the boiler system and appears in good condition. The flexible filling loop has not been detached and the tundish has not been connected to any pipework to drain away to a gully.

Photograph No 21 – Mikrofill unit pressurisation filling point on heating system.

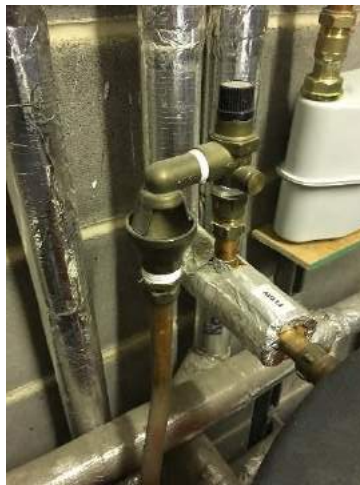
Photograph No 22 – Pressure relief discharge with tundish and then it discharges onto the floor.

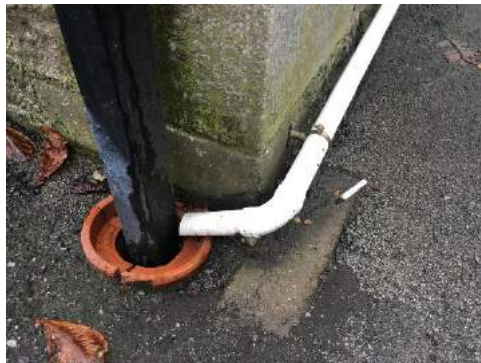
Photograph No 23 – Condensate drain from wall mounted boiler exits boilerhouse and discharges over grate.

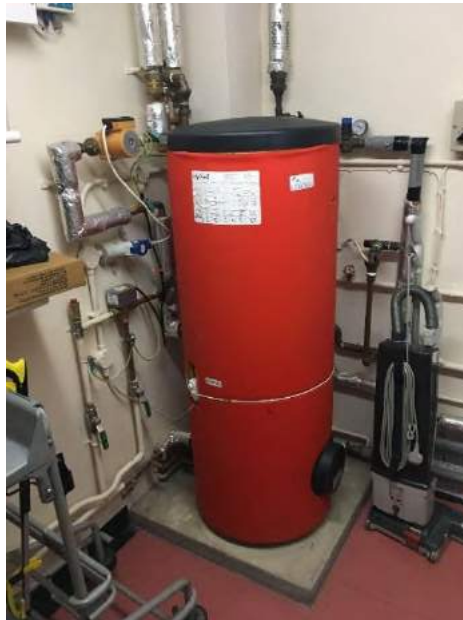
Photograph No 24 – Lathkill Wing – Remeha calorifier for the domestic HWS generation

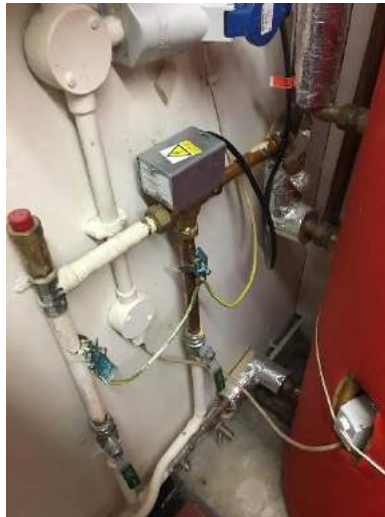
A lot of the pipework installation to the calorifiers is at least 16-20 years of age and in a fairly poor condition. A lot of the pipework is uninsulated and where insulation has been installed in many cases it is a mixture of types of insulation and damaged in places. Much of the pipework is not clearly and correctly labelled, and the isolation valves have not been labelled and there is no plantroom schematic or valve chart within any of the plantrooms.

Photograph No 25 – HWS Primary heating pipework and 3 port valve. Note no insulation pipework.

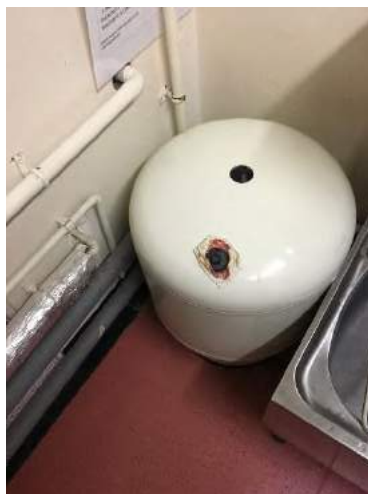
Photograph No 26 – Typical HWS expansion vessel.

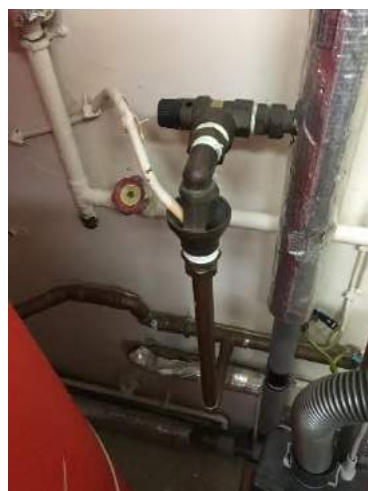
Photograph No 27 – Discharge into tundish and then into drain within room.

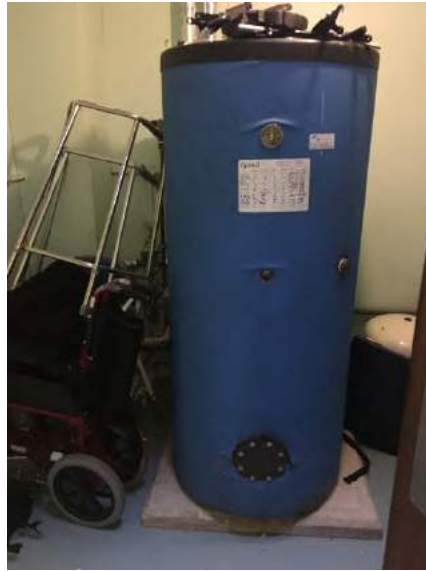
The calorifier is looking tired and approaching the end of its life but still operational. The units was last tested and flushed in 2015 with no apparent records of recent testing and therefore we are unsure as to its condition.

Photograph No 28 – Monsal Wing – Hamworthy calorifier for the domestic HWS generation.

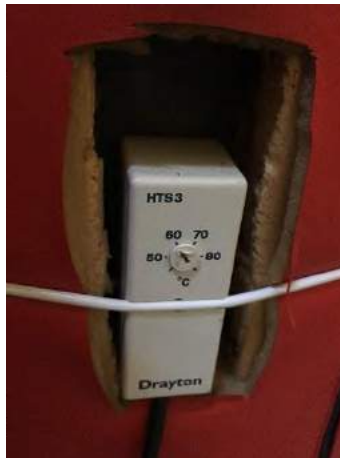
Photograph No 31 – Typical thermostat cut into side of calorifier and not re-insulated

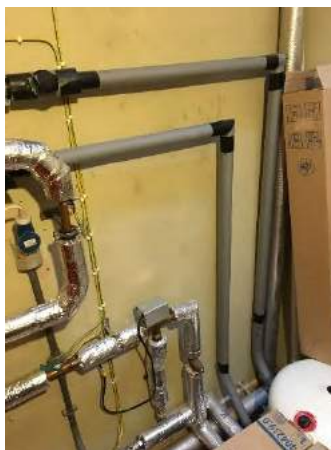
Photograph No 32 – Typical pipework installation with different quality of insulations on various pipework.

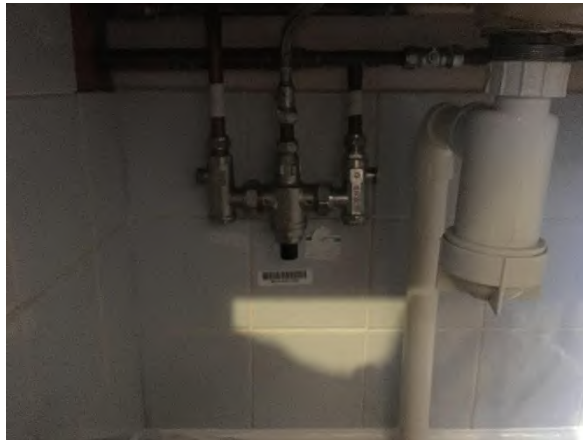
Photograph No 33 – Typical bedroom basin with thermostatic mixing valve installed below.

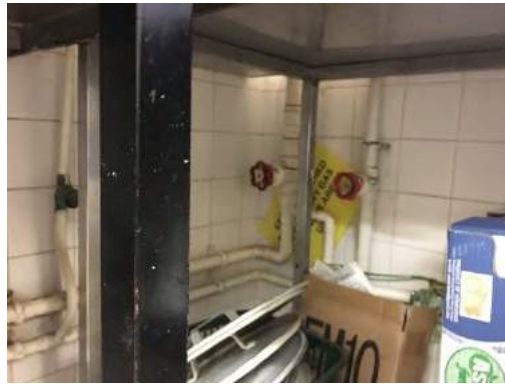
Photograph No 36 – Typical pipework in main kitchen from original installation.

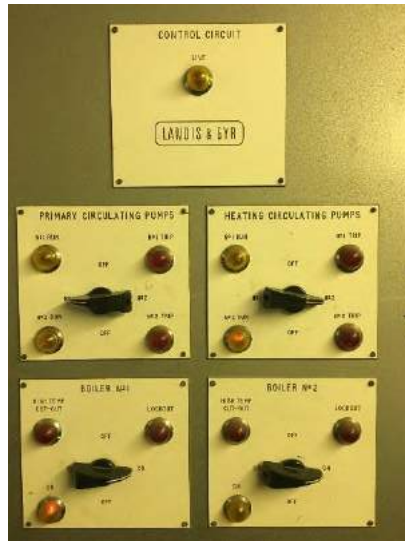
Photograph No 38 – Close up of main boilerhouse control panel.

The controls system is at the end of its life and should be replaced with a more energy efficient BMS controls system and this should be incorporated during a boiler and HWS plant replacement programme.

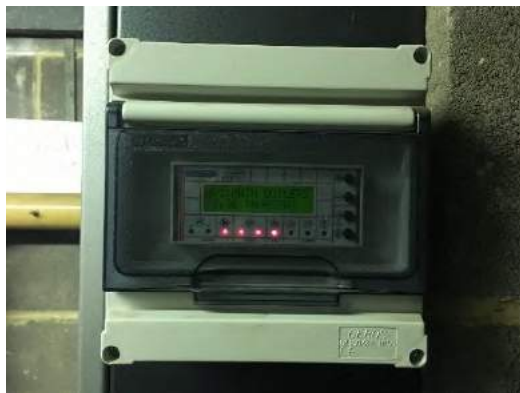
Photograph No 39 – Boiler and HWS controller incorporated on main boilerhouse panel.

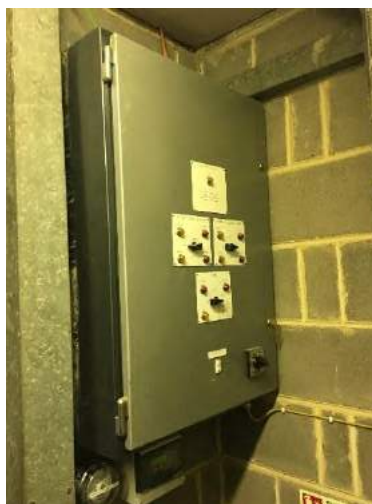
Photograph No 40 – Boiler and HWS plant control panel located in kitchen boilerhouse.

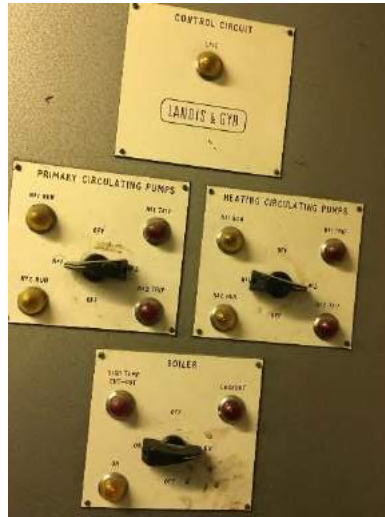
Photograph No 41 – Close up of kitchen boilerhouse control panel.

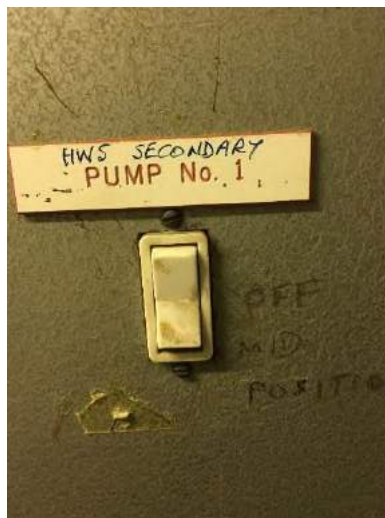
Photograph No 42 – Close up of HWS pump controller on kitchen boilerhouse control panel.

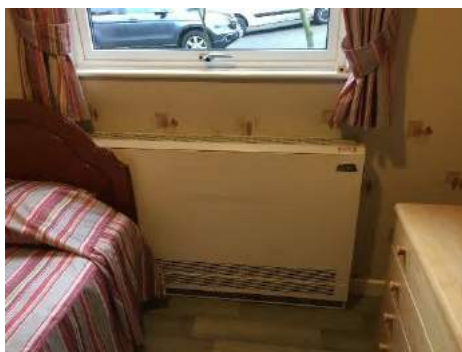
Photograph No 46 – Typical fan convector installed in Bedrooms with thermostatic controller on side of radiator for occupant to alter temperature.

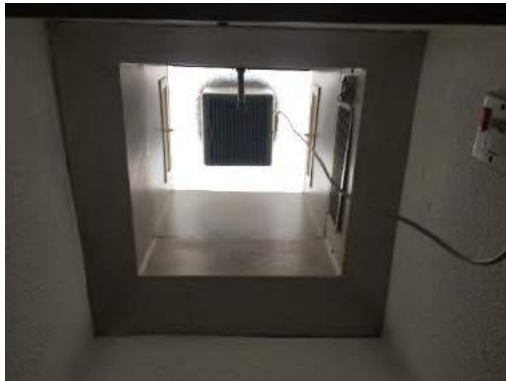
Photograph No 47 – Typical fan in rooflight in certain rooms i.e. sluice room, bathroom.

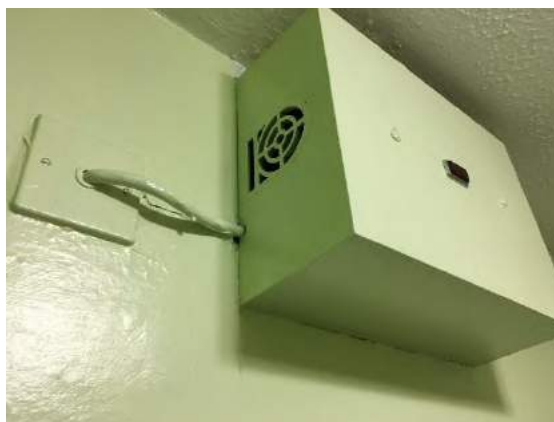
Photograph No 48 – Typical original extract fan serving 2 No. toilets. Air intake on side of fan, also serves adjacent toilet (see below)

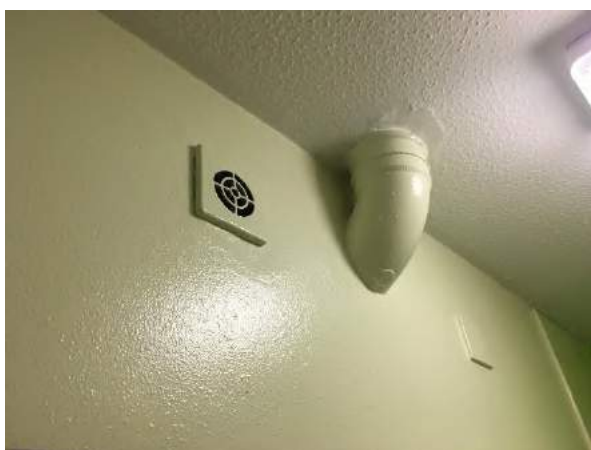
Photograph No 49 – Original extract fan – air intake in wall to fan with old discharge duct passing through roof to discharge.

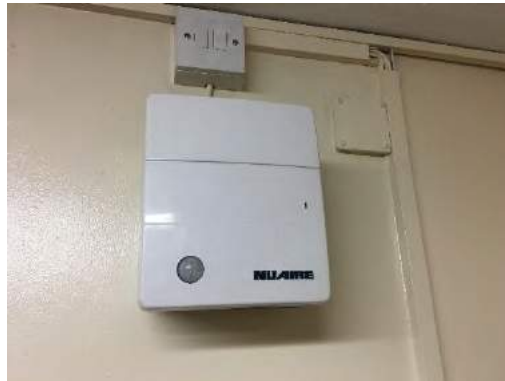
Photograph No 50 – Typical wall mounted extract fan with integral PIR in newer fitted out areas.

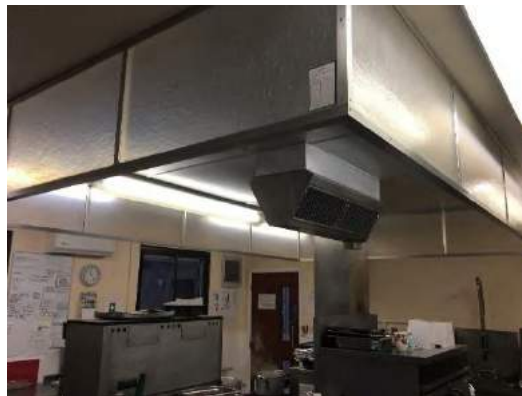
The kitchen extract ventilation is interlocked with the kitchen gas system. Although the kitchen ventilation does not fully comply for a modern kitchen.

Photograph No 51 – Kitchen extract canopy with extract point in centre.

Ideally a kitchen supply ventilation system should be installed into the main kitchen to suit the requirements of the catering equipment installed. The whole ventilation system should then be automatically interlocked with the gas system within the kitchen as is the extract currently.

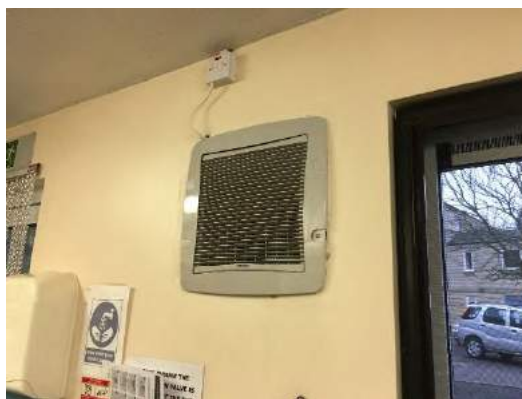
Photograph No 52 – Typical wall mounted Vent Axia fan located in kitchen.

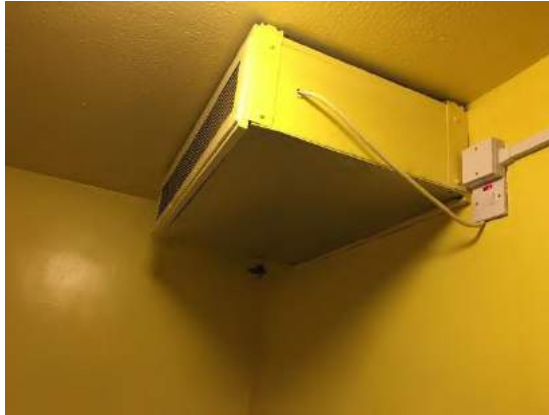
Photograph No 53 – Air transfer duct passing from kitchen store into kitchen.

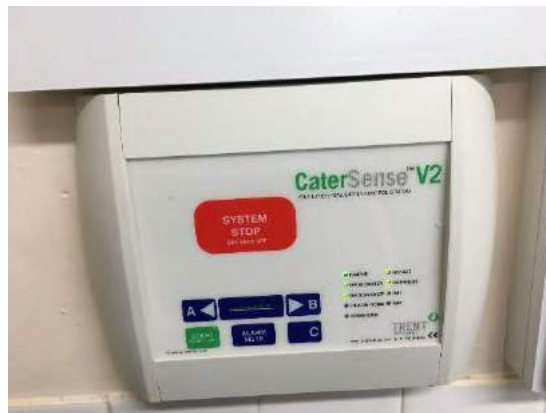
Photograph No 54 – gas and ventilation interlock panel.

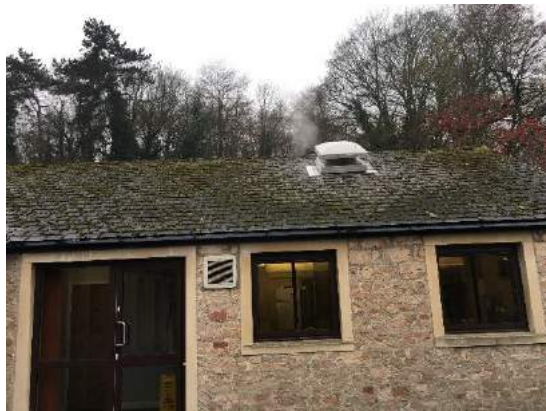
Photograph No 55 – Kitchen extract fan and discharge on roof. Also Vent Axia fan in wall of kitchen.

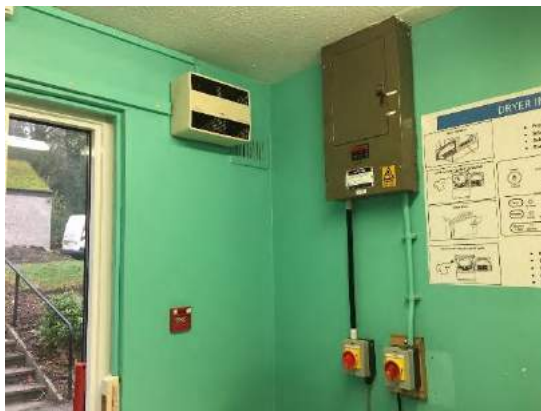
Photograph No 57 – Laundry wall mounted extract fan. Note this is the only mechanical ventilation.

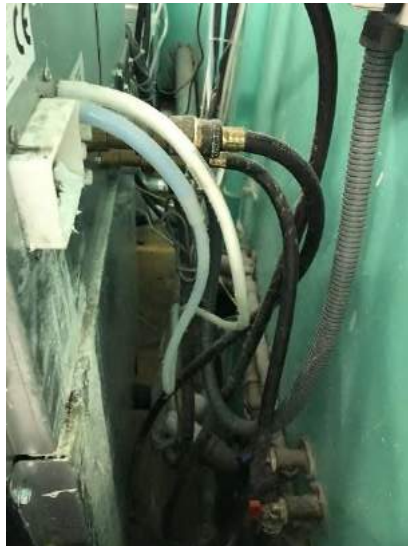
Photograph No 58 – Services at the rear of the washers and dryers.

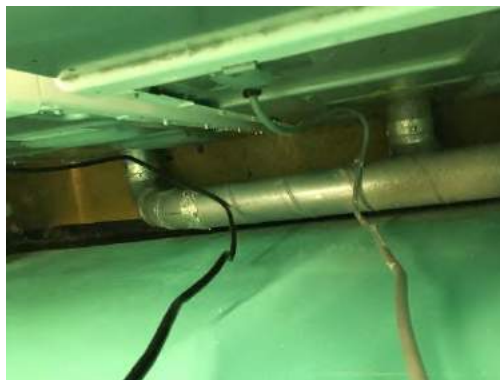
Photograph No 59 – Discharge ducts from the two dryers at low level behind units.

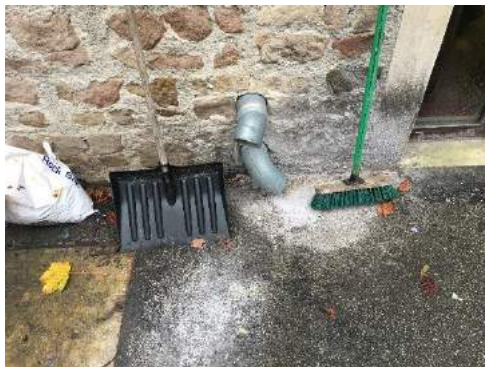
Photograph No 60 – Laundry dryer exhausts with clear build-up of fibres discharged onto floor.

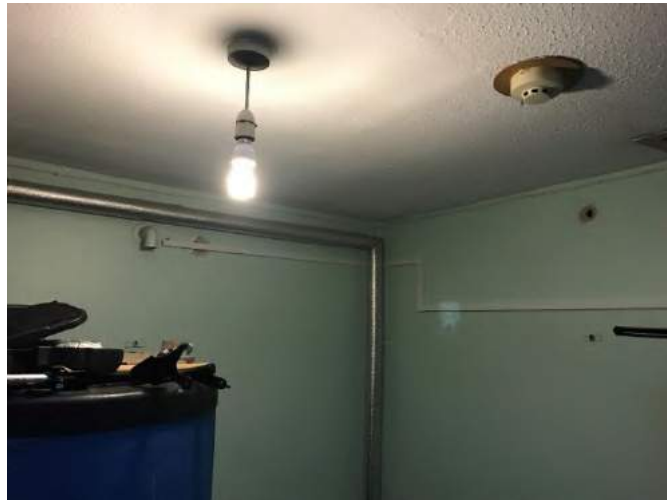
Photograph No 81 – Example of smoke detector installed

It is recommended that the whole fire alarm system is replaced with a modern addressable system.

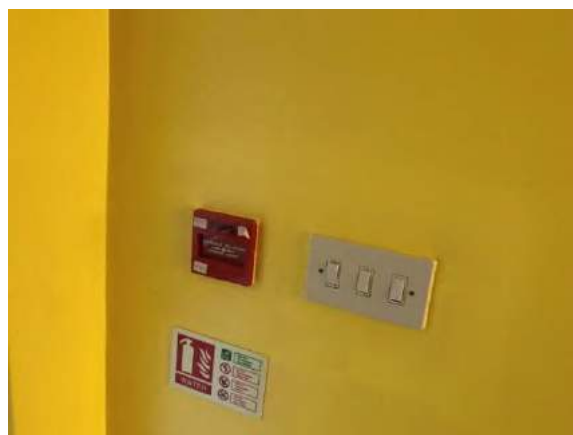
Photograph No 82 – Manual call points are not fitted with covers

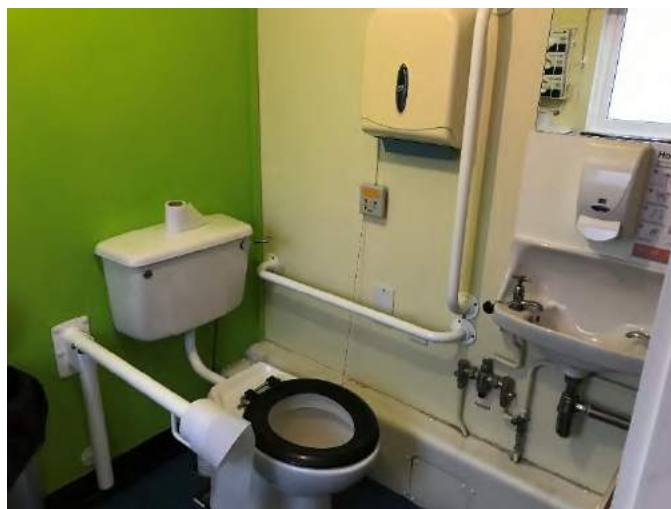
Photograph No 85 – Nurse call point within WC

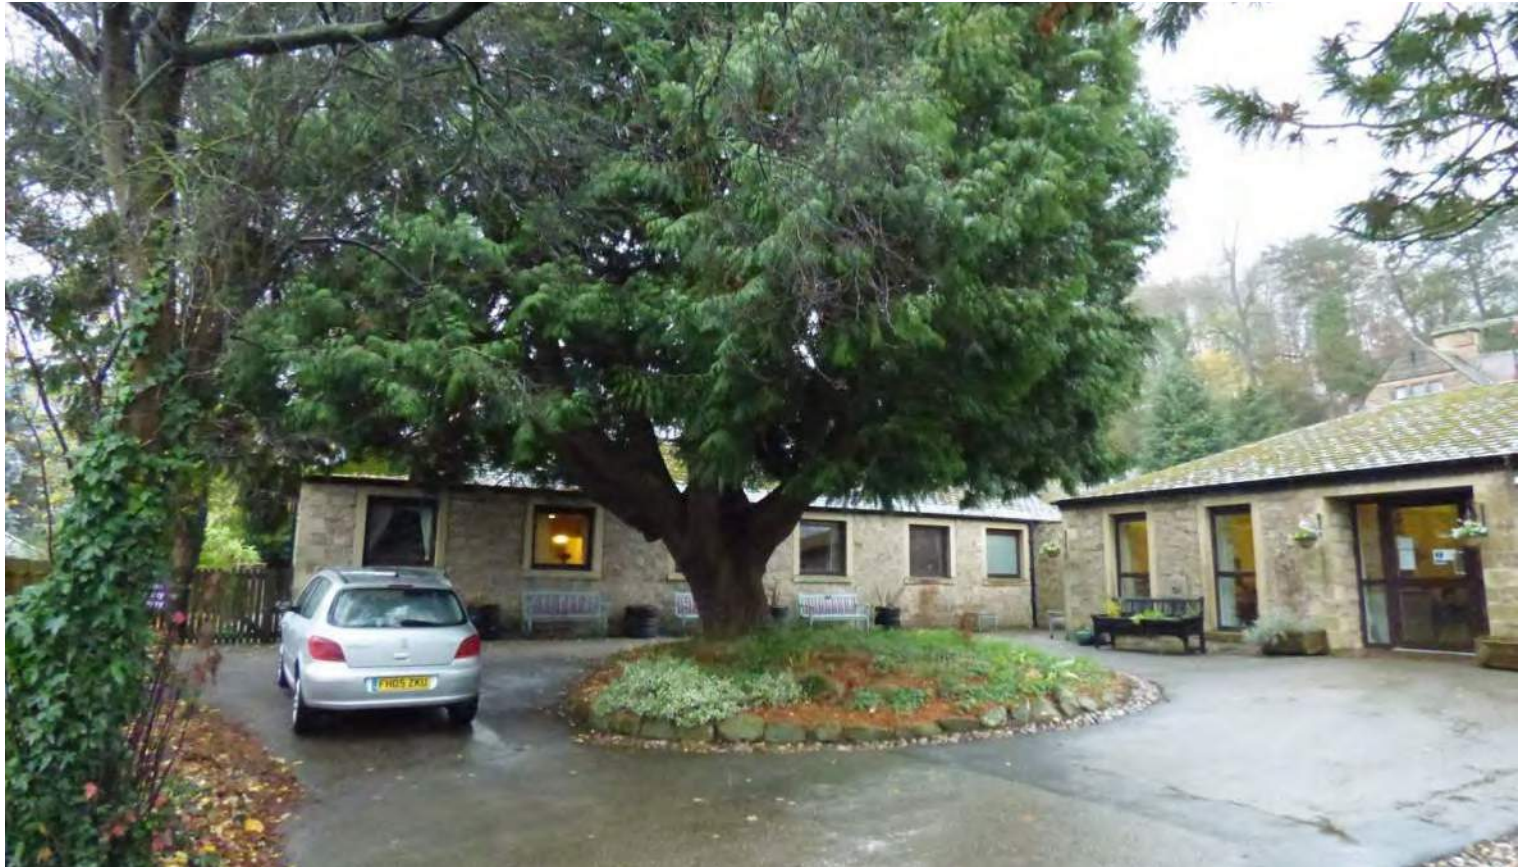
Photo 01

- 204. There is a bitumen paved access and carpark area with an island adjacent to the front elevation of the central block. **(See Photo 01)**
- 205. The roofs over the wings comprise duo-pitched, hipped and flat roofs, the pitched roofs are slated.

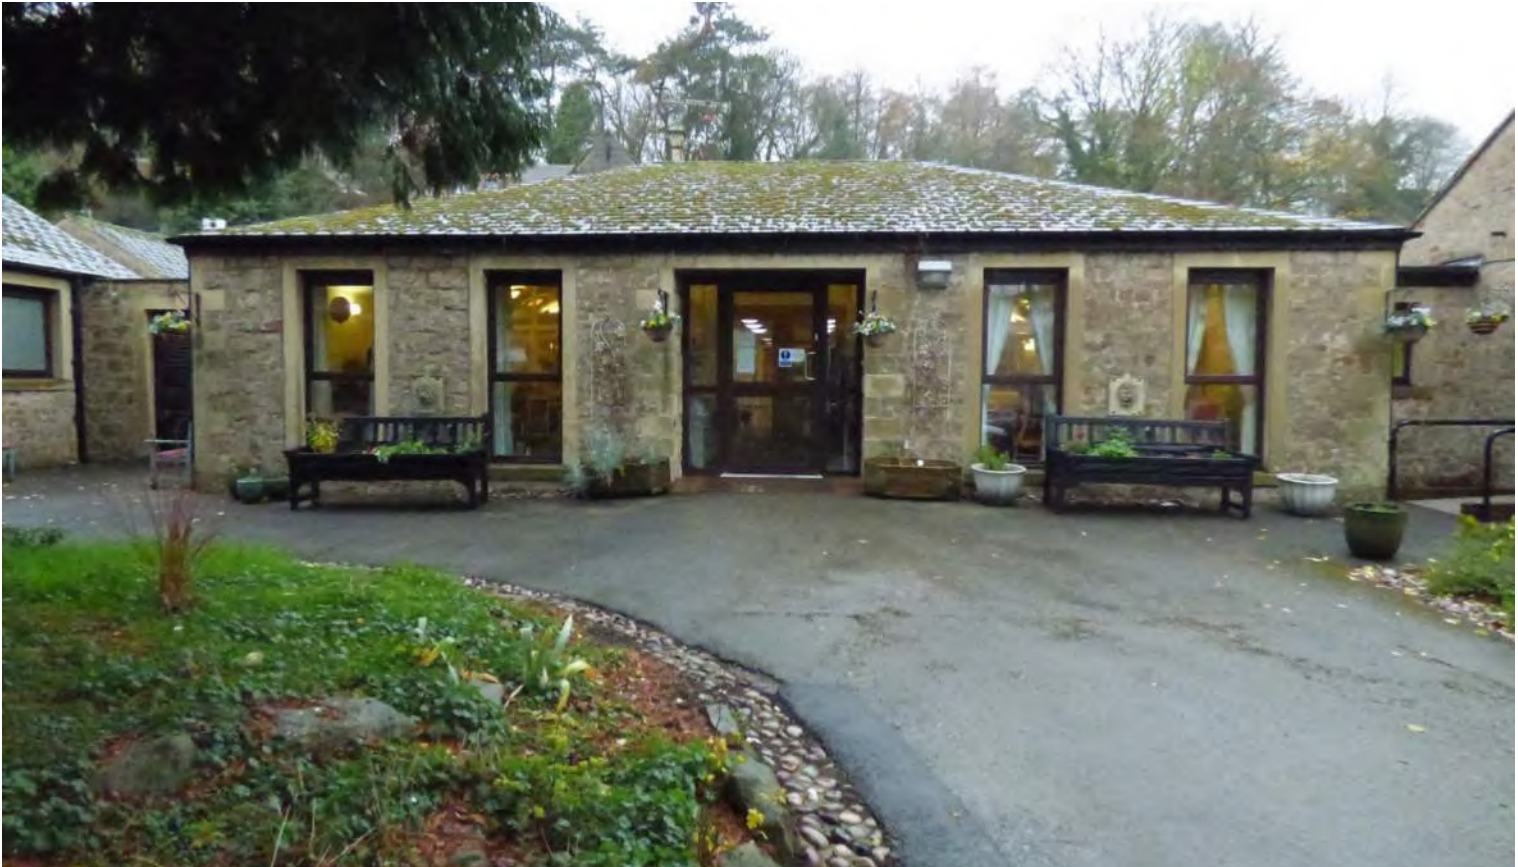
Photo 02

- 301. The slated hip roof over the section shows no evidence of significant distortion, however it has been overgrown with moss. **(See Photo 02)**
- 302. There is no evidence of significant distortion to the stonework at the eaves of the front and rear elevations.
- 303. There is a large tree on the island adjacent to the block which is some 12m to the front elevation. **(See Photo 01)**

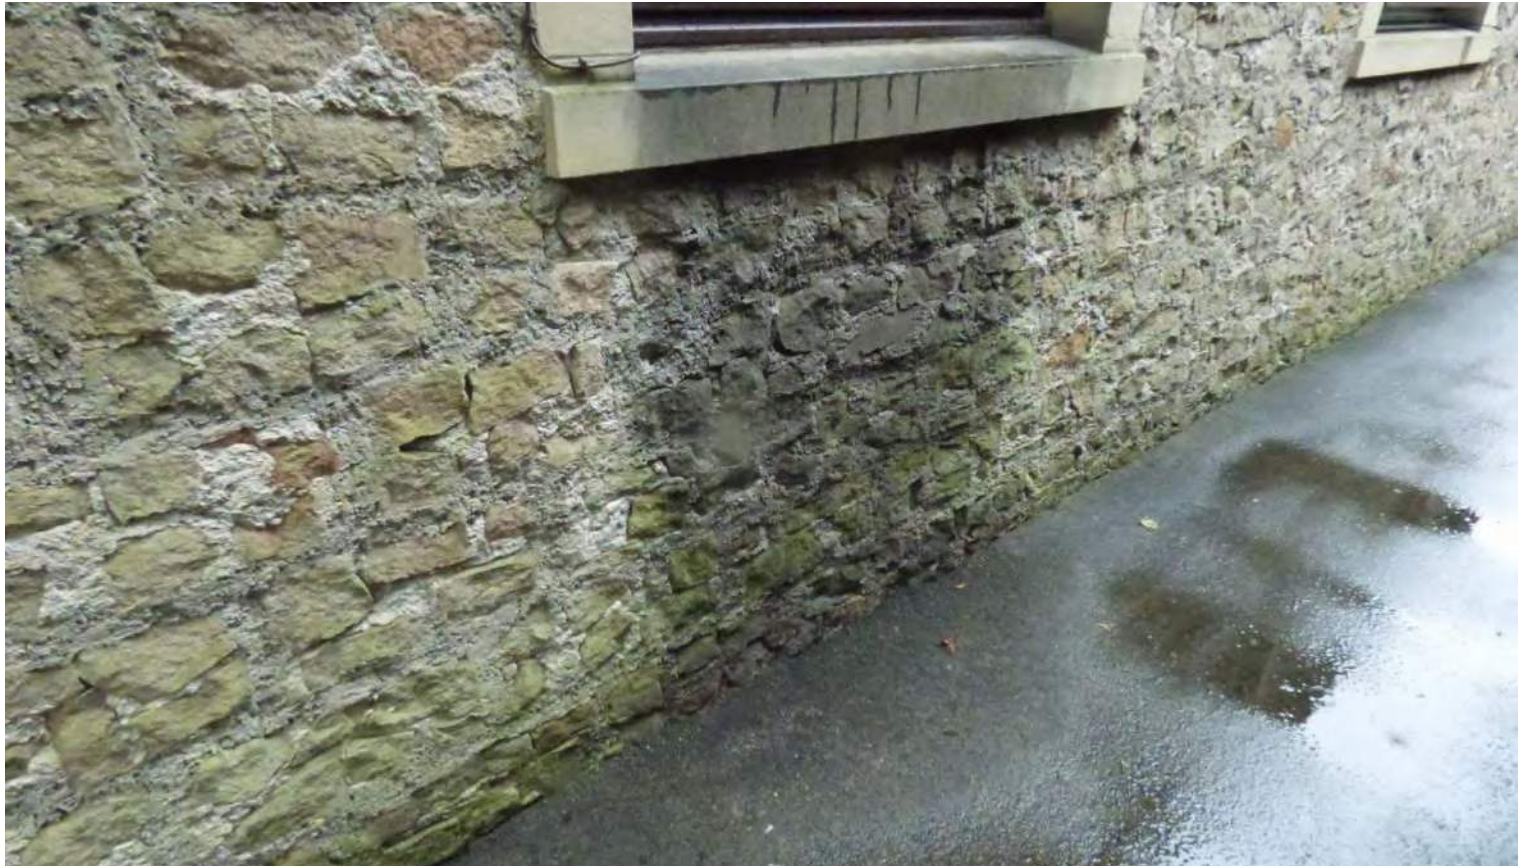
Photo 03

- 309. The slated roof shows no evidence of significant distortion to the ridge line however it is overgrown with moss.
- 310. The left end of the roof is hipped and the right end a gable, there is no evidence of significant distortion to the side elevations.
- 311. The masonry panel below the central window in the front elevation has damp stains which may be due to leakage of the rainwater goods on the elevation. **(See Photo 03)**

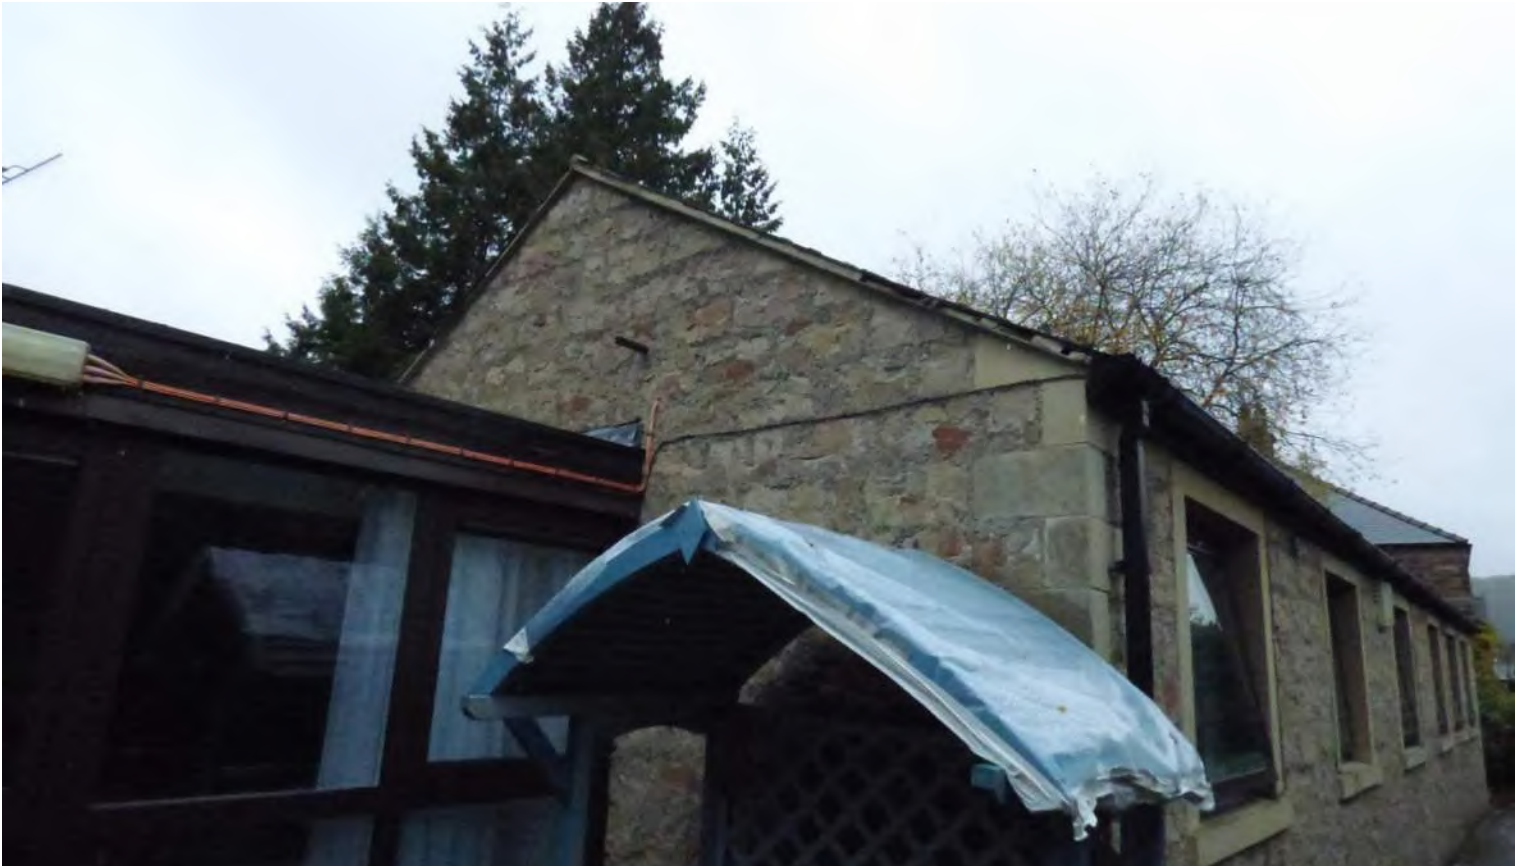
Photo 04

- 312. The slated roof shows no evidence of significant distortion to the ridge and hip lines however it is overgrown with moss.
- 313. The right end of the roof is hipped and the left end a gable, there is no evidence of significant distortion to the side elevations, however there is minor spalling of the pointing on the gable verge. **(See Photo 04)**

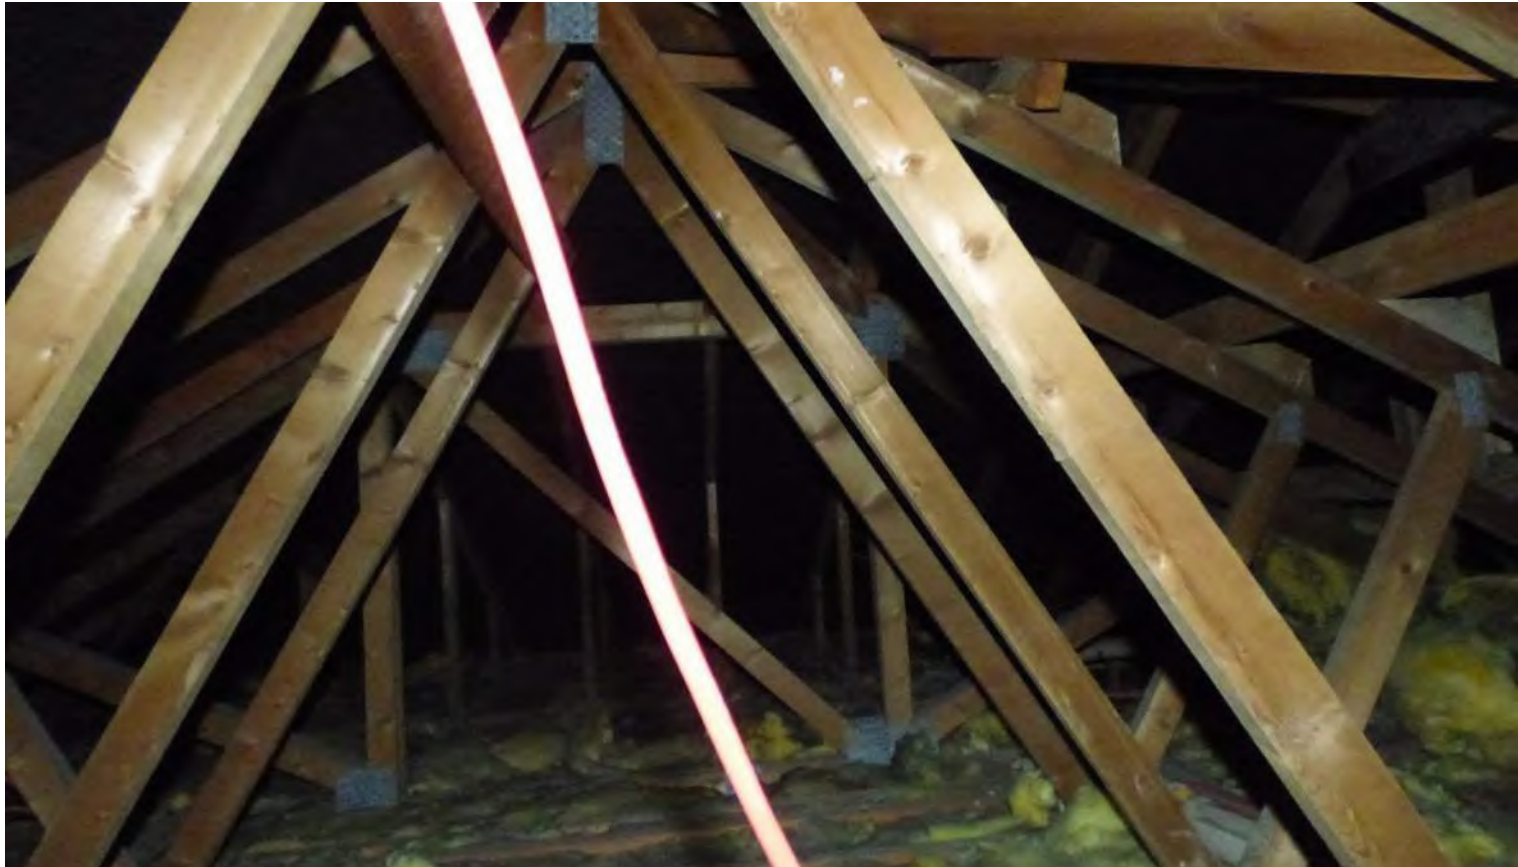
Photo 05

402. The roof space was accessed through a hatch in Room 5 at the front right hand end. The hipped end comprises light timber proprietary trusses spaced at approximately 600mm centres and is underdrawn with sarking felt. **(See Photo 05)**
403. The duo-pitched rear section was viewed through a hatch door in an internal firewall within the roof space, **(See Photo 06)** which revealed light timber proprietary trusses spaced at approximately 600mm centres and is underdrawn with sarking felt.
404. There are no longitudinal bracings apart from a single line near the truss ridge, however there is no evidence of racking. **(See Photo 07)**
405. Although we have not been able to inspect the opposite gable end, it is likely it has limited timber bracing similar to that noted in the South-West/East wings.

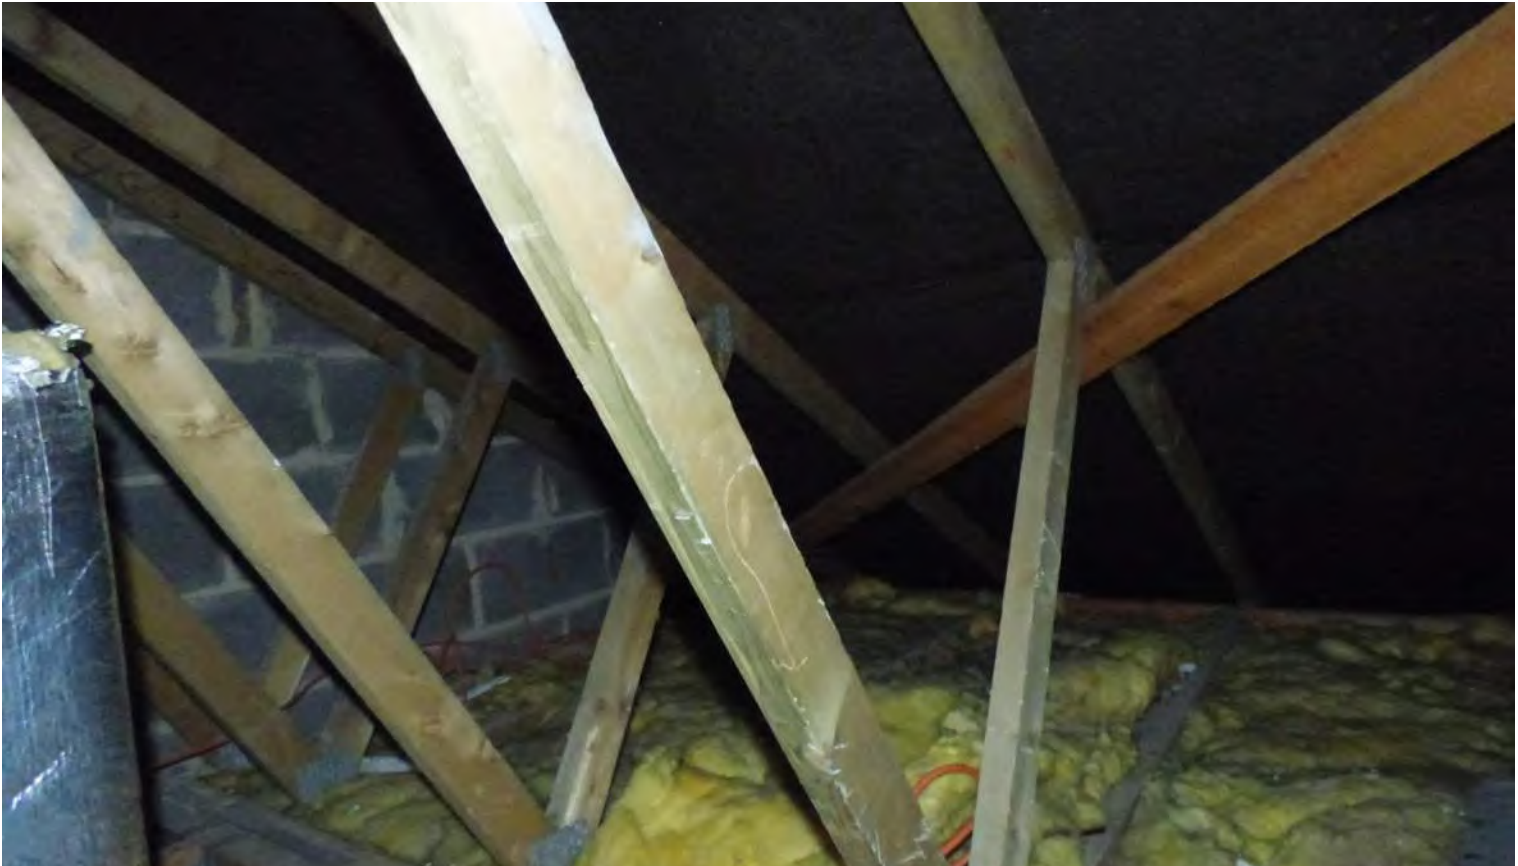
Photo 08

410. The roof space was accessed through Room 25. The roof comprises light timber proprietary trusses spaced at approximately 600mm centres and is underdrawn with sarking felt.
411. There are no longitudinal bracings apart from a single line near the truss ridge.
412. It has a diagonal plan bracing across six bays of timber trusses, and there is a mild steel metal tie between the single longitudinal brace and the gable. **(See Photos 08 & 09)**
413. We have not found evidence of racking.

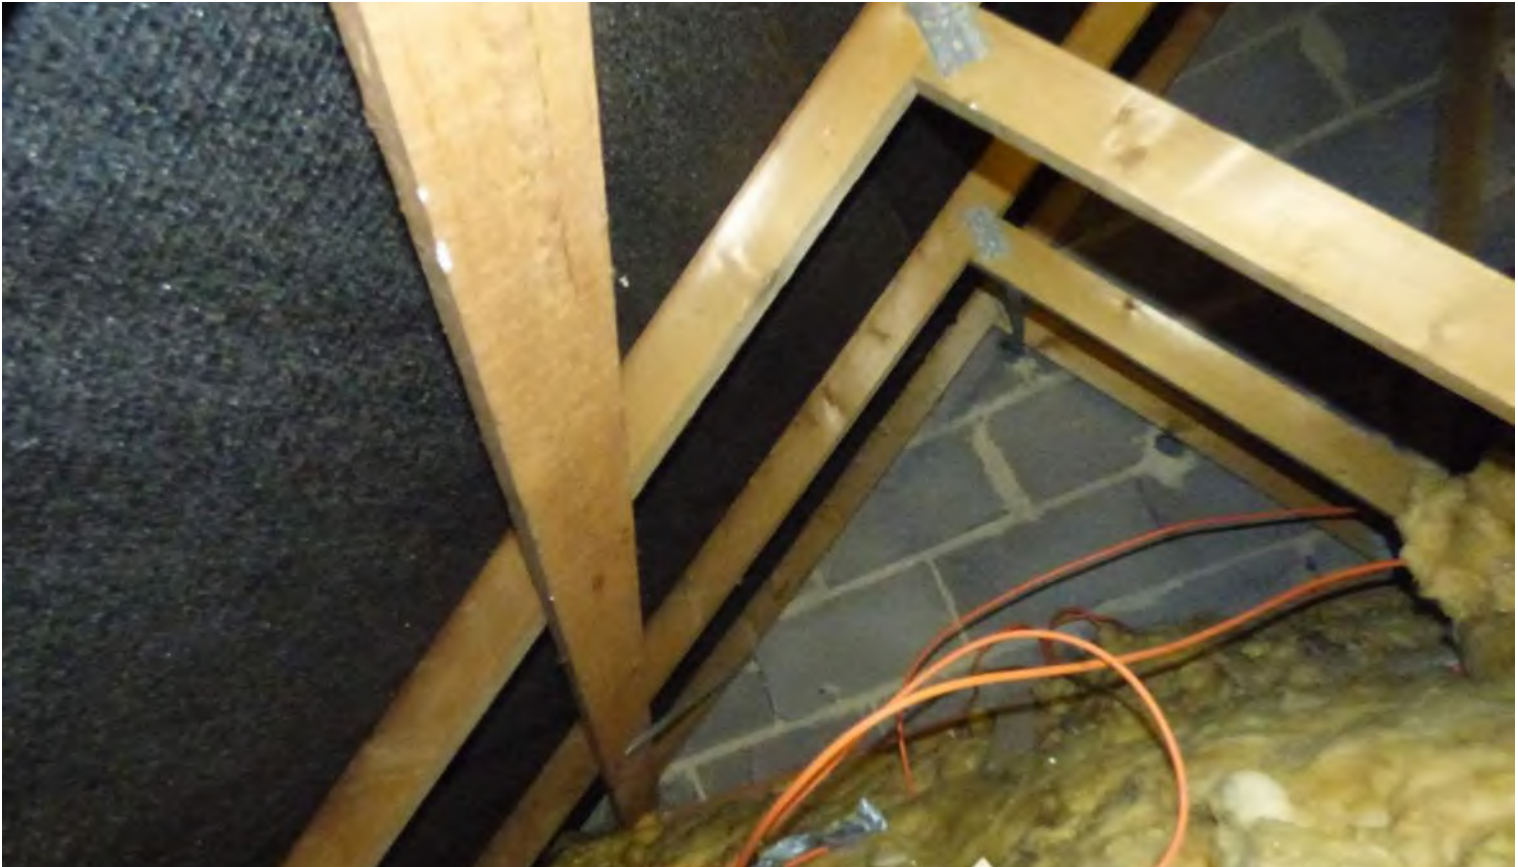
Photo 10

-
- 415. There are no longitudinal bracings apart from a single line near the truss ridge
 - 416. It has a diagonal plan bracings across six bays of timber trusses and there is a mild steel metal tie between the single longitudinal brace and the gable. (**See Photo 10**)
 - 417. We have not found evidence of racking.
