DERBYSHIRE COUNTY COUNCIL

Goyt Valley House HOP

Condition Survey

November 2018

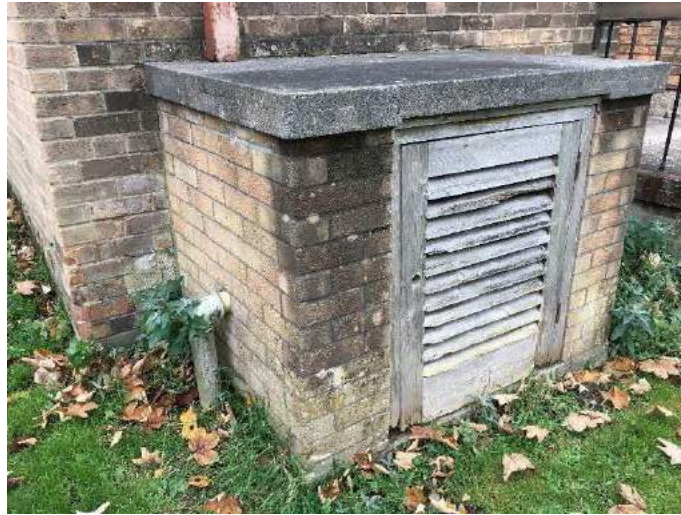
Photograph No 1 – Gas meter house with incoming gas from Jubilee Gardens.

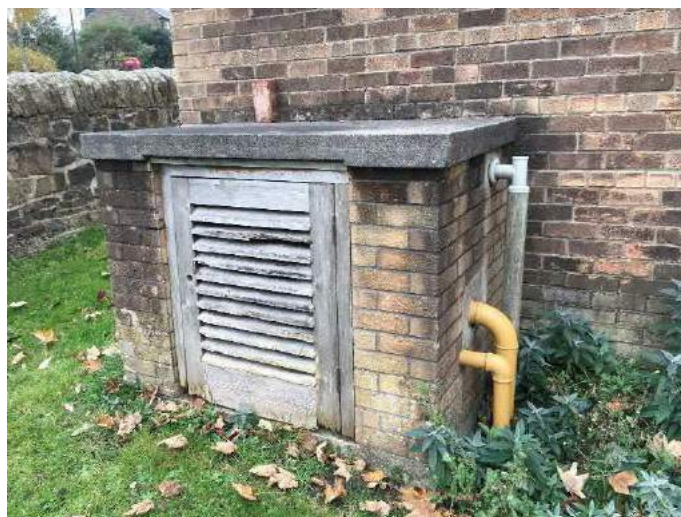
Photograph No 2 – Gas meter house with 2 No. gas supplies after meter entering ground.

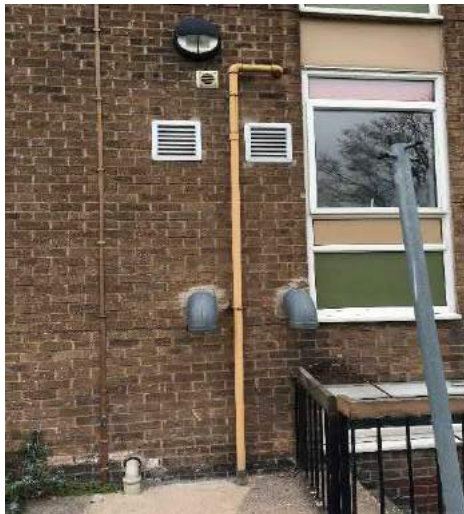
Photograph No 3 – Gas supply entering boilerhouse at low level and gas rising to enter Laundry

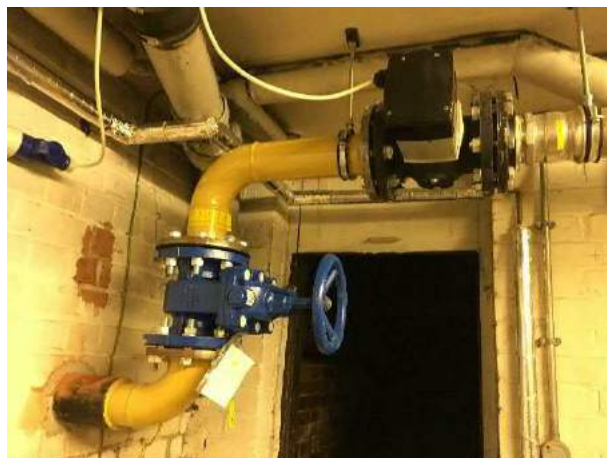
Within the boilerhouse the gas supply is installed with a manual shut off valve and an automatic shut off valve linked to an emergency gas shut off button located adjacent to the exit. The gas pipework has been modified in 2015 within the boiler house and incorporates a section of Geberit Mapress Stainless Steel push fit pipework.

Photograph No 4 – Gas entering boilerhouse with manual valve and automatic shut off valve.

The gas distribution system within the building is a manual system only and appears not to be linked to the fire alarm system to shut off the gas under fire conditions. An automatic shut off system should be considered to shut the gas system off under fire conditions in all areas including Boilerhouse, Laundry and Kitchen.

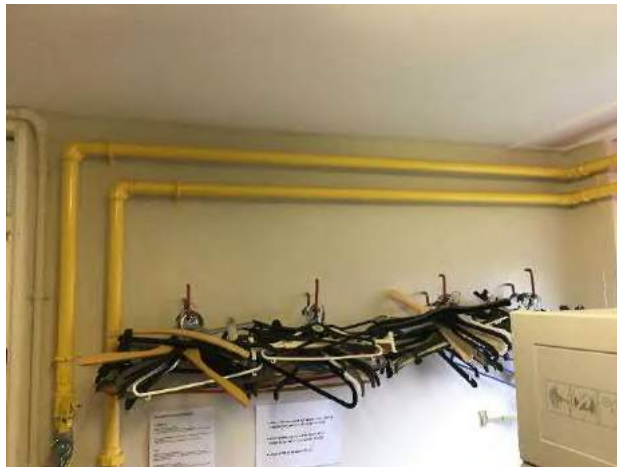
Photograph No 7 –Gas pipework in Laundry drop to manual shut off valve.

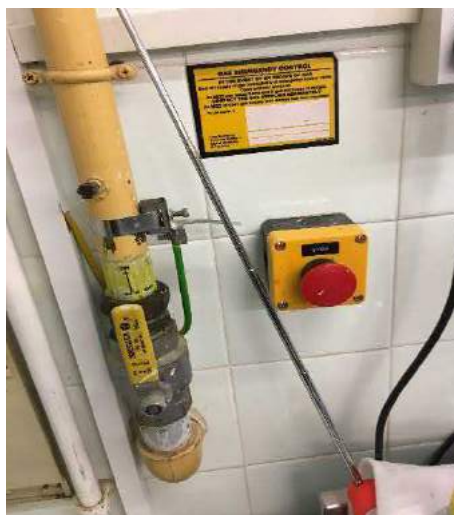
Photograph No 8 –Gas pipework enters Kitchen at low level with manual shut off valve.

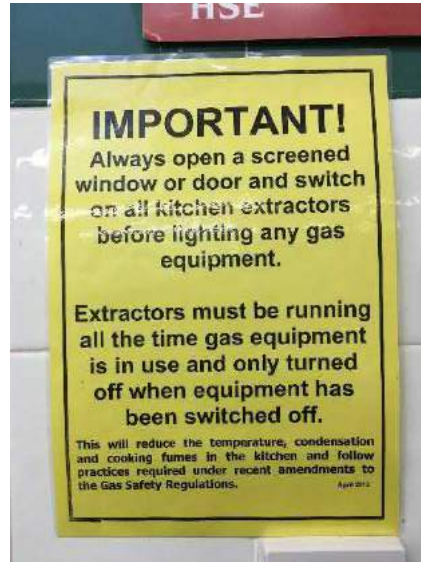
Photograph No 9 – Sign in Kitchen requesting windows/doors to be open and extract fans to be switched on prior to lighting gas.

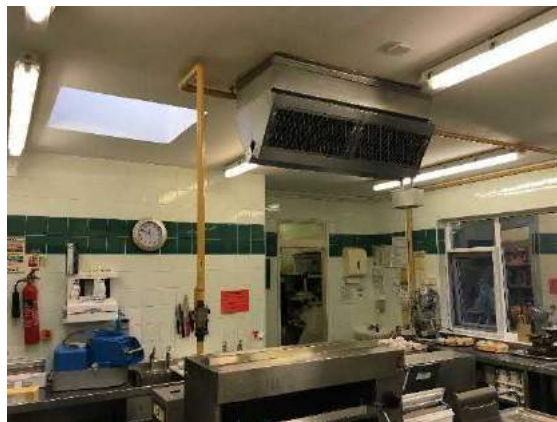
Photograph No 10 – Gas route from incomer to central cooking range.

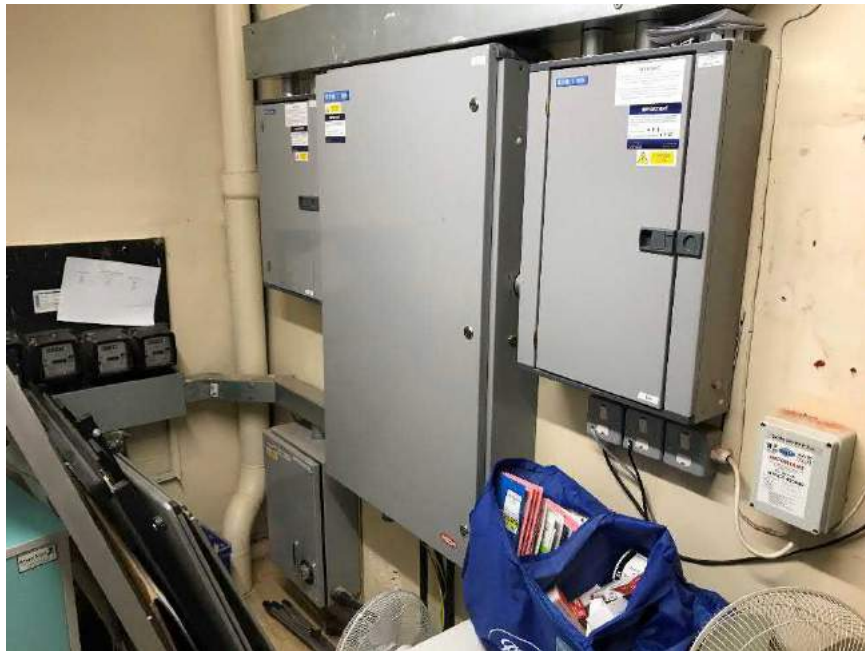
The electrical incoming utility supply enters the building in a switchroom located centrally on the ground and contains the incoming service head and utility meters. The building has a 3 phase 100A supply with the three single phase meters measuring the incoming supply with a separate direct reading meter for the kitchen.

Photograph No 11 – Incoming electrical utility supply.

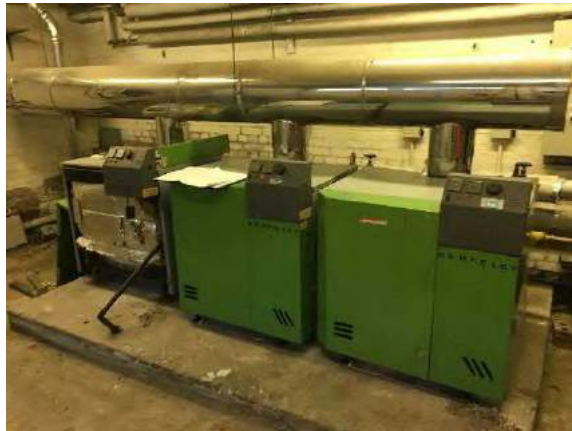
One of the boilers connected to the system, which was used as the HWS primary boiler during the Summer period, was in a state of disrepair and had been disconnected from the heating system and is now redundant although left in situ. This has been replaced with a new wall mounted Ideal Instinct Heat 40 condensing boiler installed in 2009. This solely serves the HWS calorifier whilst the two remaining existing boilers serve the buildings heating requirements.

Photograph No 13 – Existing heating boilers with a boiler redundant and disconnected (left)

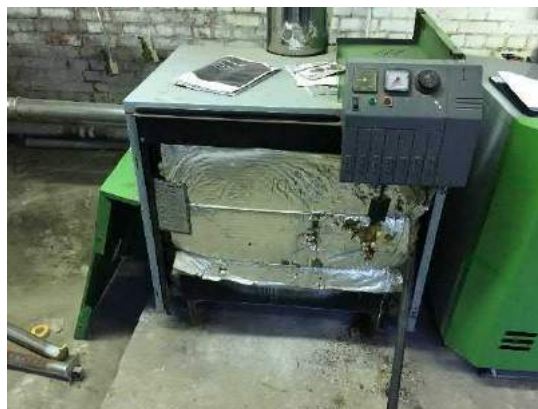
Photograph No 14 – Redundant boiler disconnected and left in situ.

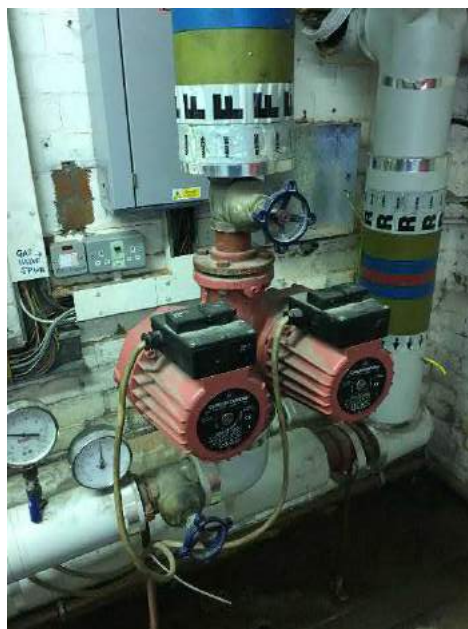
The mechanical services we believe were installed in the early 1990's and the services were in varying states of condition. The boilers and ancillary equipment such as pumps are in a fairly tired condition and coming to the end of their life expectancy. The HWS calorifier appears to be more recent and is in a fairly good condition and operational at the time of the inspection.

Photograph No 15 – Main twinhead constant temperature heating pumps serving building heating system.

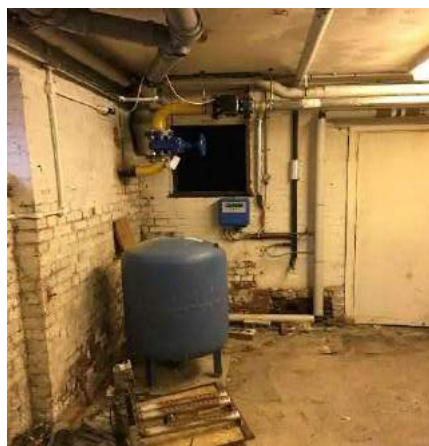
Photograph No 18 – Heating expansion vessel from 1996 and newer Mikrofill unit on wall at rear.

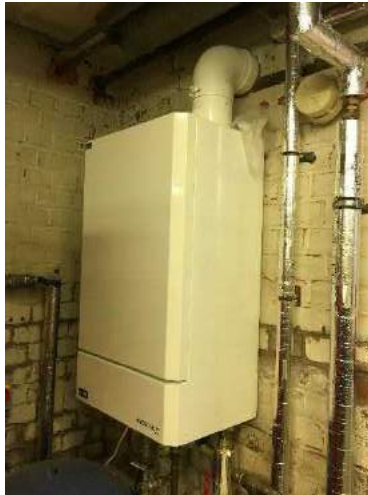
Photograph No 19 – Wall mounted condensing boiler (2009) serving HWS Calorifier.

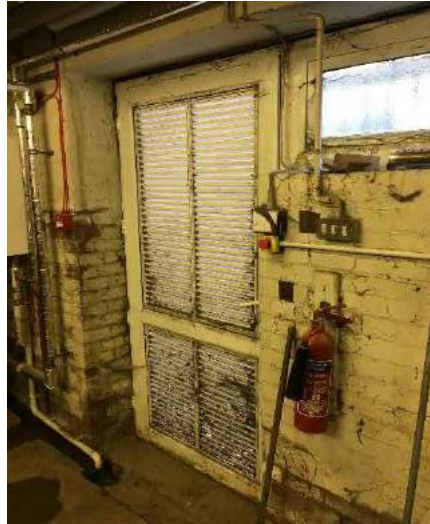
Photograph No 22 – Louvered door for combustion/fresh air clogged up and requires cleaning.

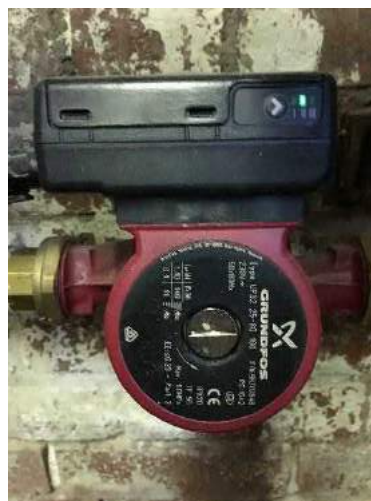
Photograph No 23 – Grundfos pump from wall mounted condensing boiler serving the Calorifier.

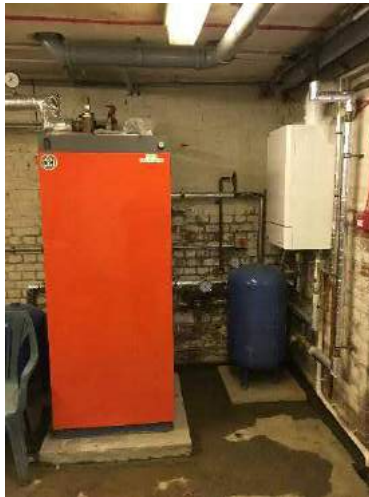
The age of the unit is unknown but it has recorded testing on the unit as far back as 2005 and could be possibly older. The unit appears to have last been tested in 2015 with no records since. The unit is in a fair condition but approaching end of life.

It was noted that the plantroom floor around the calorifier was very wet and it was not known if this was from a recent or current leak as there appeared to be no obvious signs of water egress from the system or plant.

Photograph No 24 –Central calorifier located in boilerhouse serving the building.

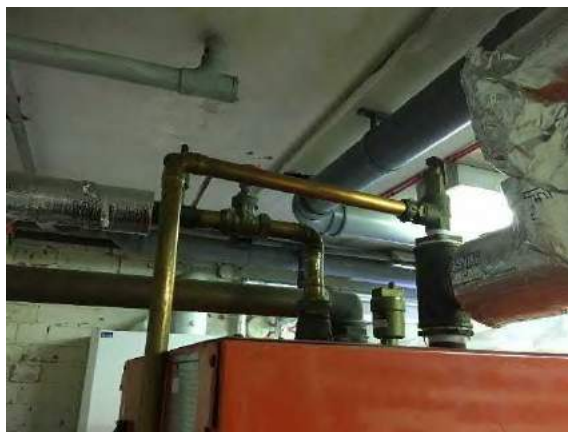
Photograph No 25 – Calorifier pressure relief discharge pipework discharges directly onto the floor and is unsupported.

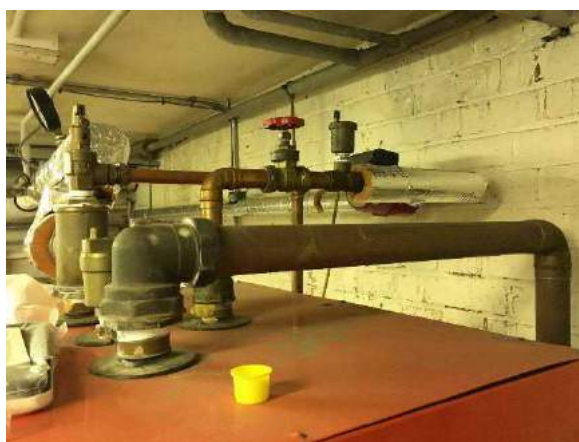
Photograph No 26 – Pipework connection on top of calorifier with no insulation installed.

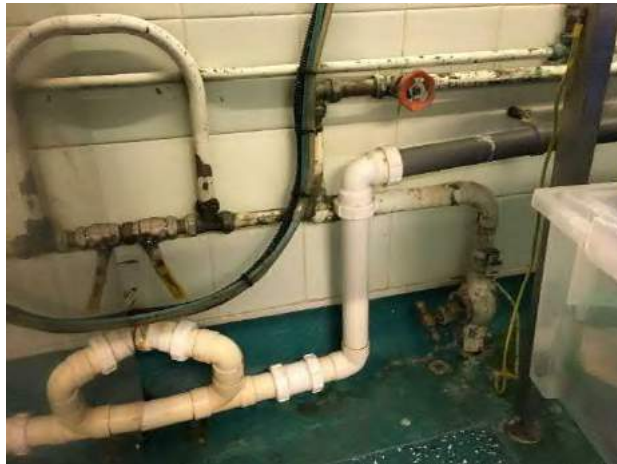
Photograph 33 – Typical pipework in main kitchen from original installation.

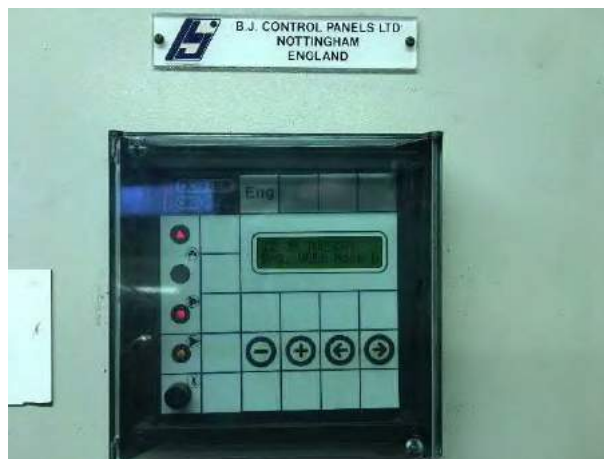
The controls system is at the end of its life and should be replaced with a more energy efficient BMS controls system and this should be incorporated during a boiler replacement programme.

Photograph No 35 – Close up of the control panel controller

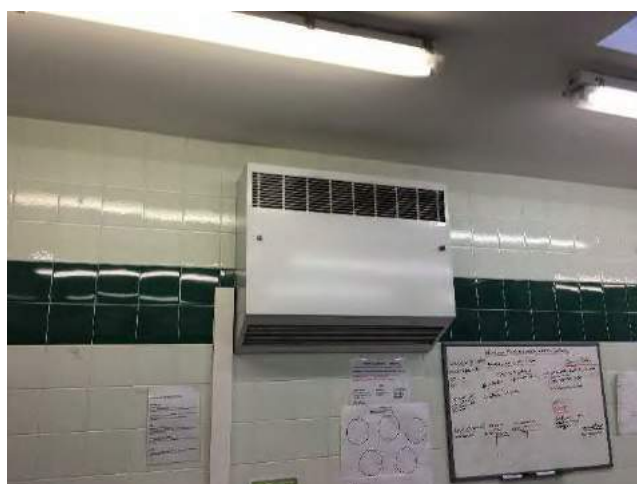
Photograph No 40 – High level fan convector heater in kitchen.

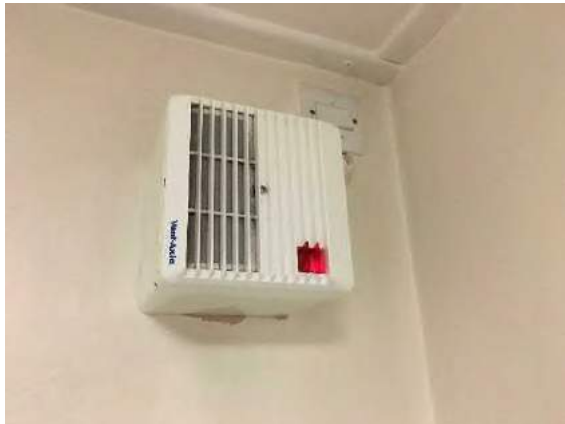
Photograph 41 – Typical older style wall mounted fan located in toilets – note fan is installed vertically rather than horizontally.

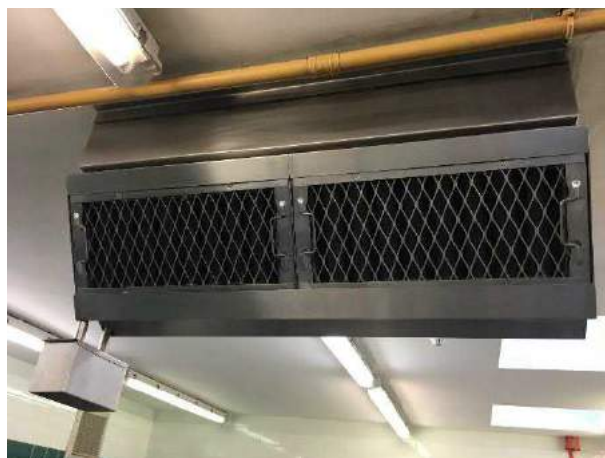
The kitchen ventilation does not comply for a modern kitchen and is not interlocked with the kitchen gas system. There are signs around the kitchen stating that prior to gas equipment being switched on that extract fans must be switched on and window and doors should be opened to aid in ventilation to the kitchen.

Photograph No 45 – Extract located above kitchen cooking range with no hood.

A purpose made cooker hood and a kitchen supply and extract ventilation system should be installed into the main kitchen to suit the requirements of the catering equipment installed. The ventilation system should then be automatically interlocked with the gas system within the kitchen.

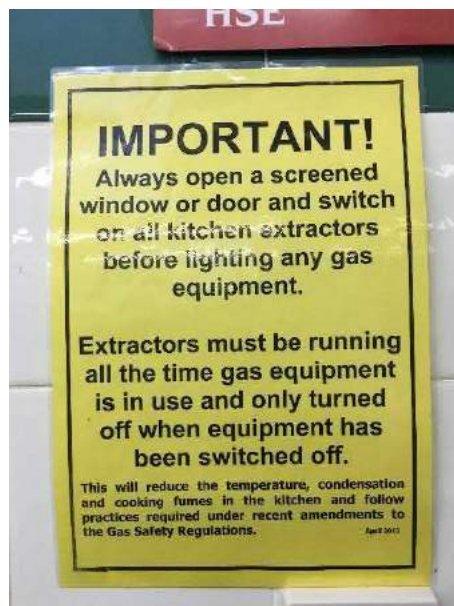
Photograph No 49 – Sign in kitchen regarding operation of ventilation and gas.

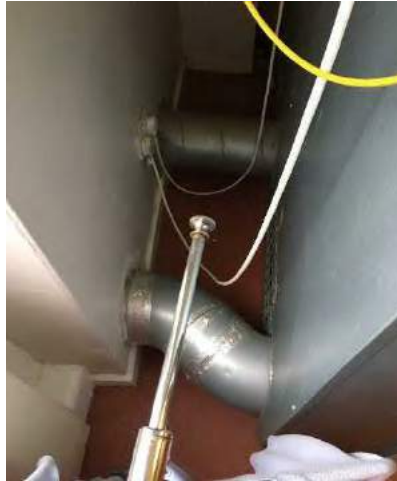
The ductwork discharges externally directly onto the floor below the ducts. It is not clear if the circular ducts have been cleaned to ensure that there is no build-up of lint within the ducts restricting the discharge of air from the dryer.

Photograph No 52 – Laundry dryers with ductwork discharging through wall.

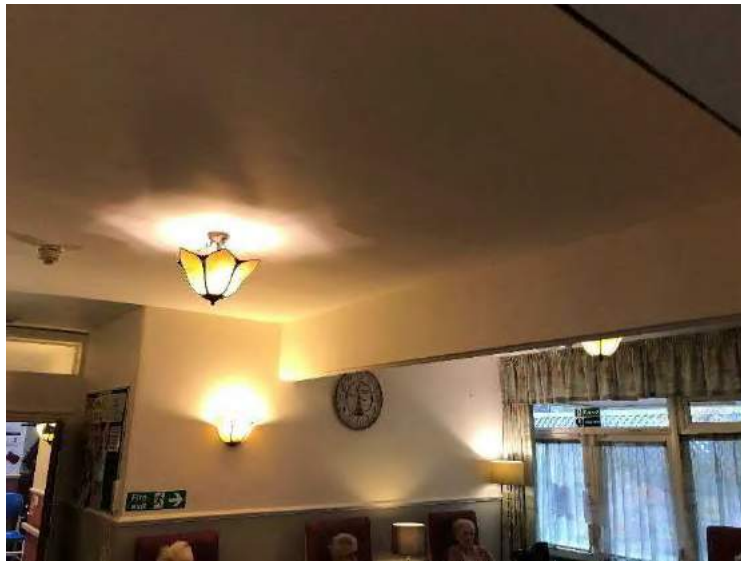
Photograph No 64 – Dayroom lighting levels are poor

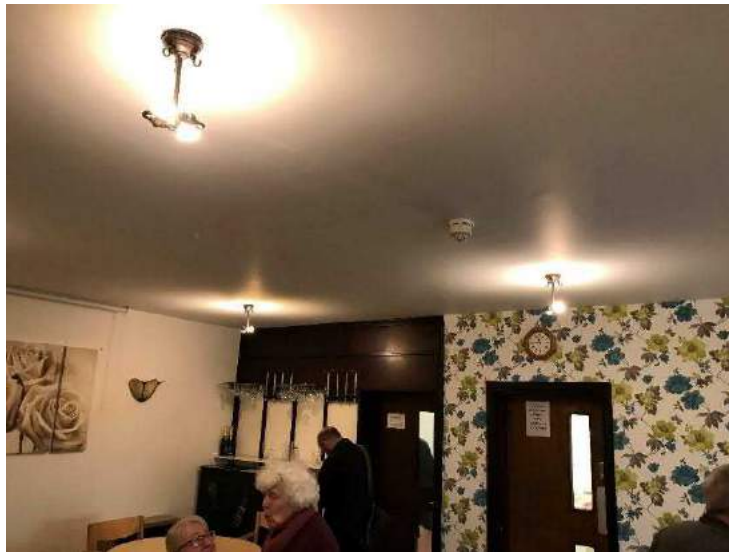
Photograph No 65 – Living room lighting with shades removed to improve lighting level

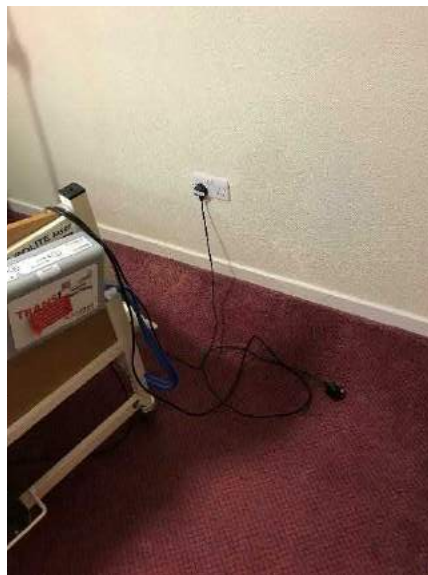
Photograph No 70 –Bedroom sockets could be increased in height off the floor.

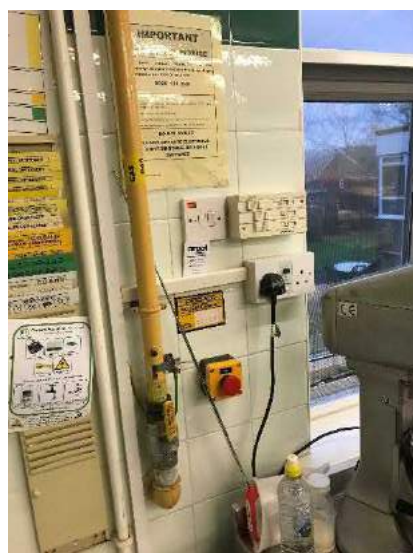
Kitchen power is operated via a contactor controlled by emergency stop buttons. Laundry equipment is fed from a 3 phase distribution board via local isolators.

Photograph No 71 – Kitchen equipment via local isolator with emergency stop button

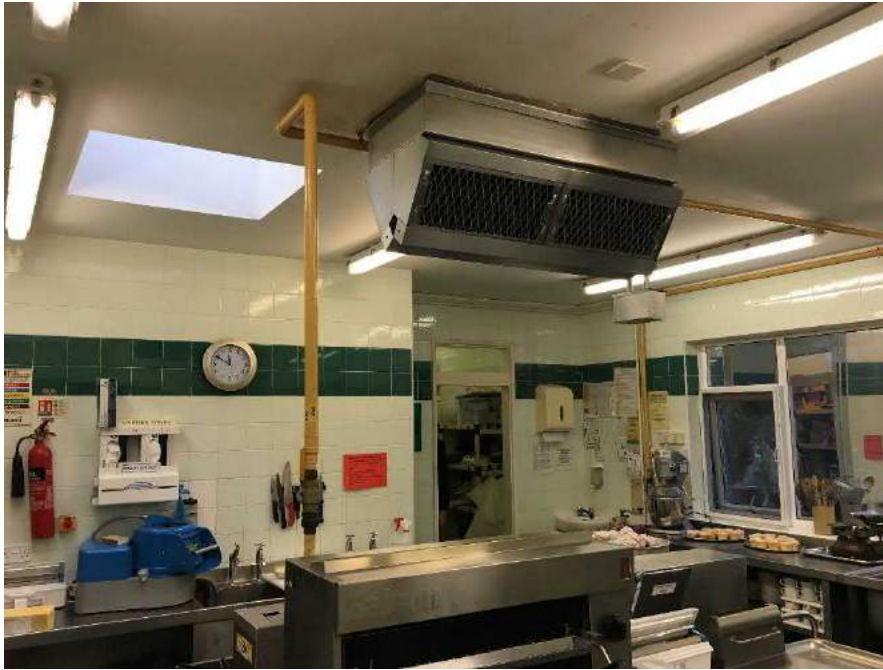
Photograph No 72 – Various power supplies within kitchen

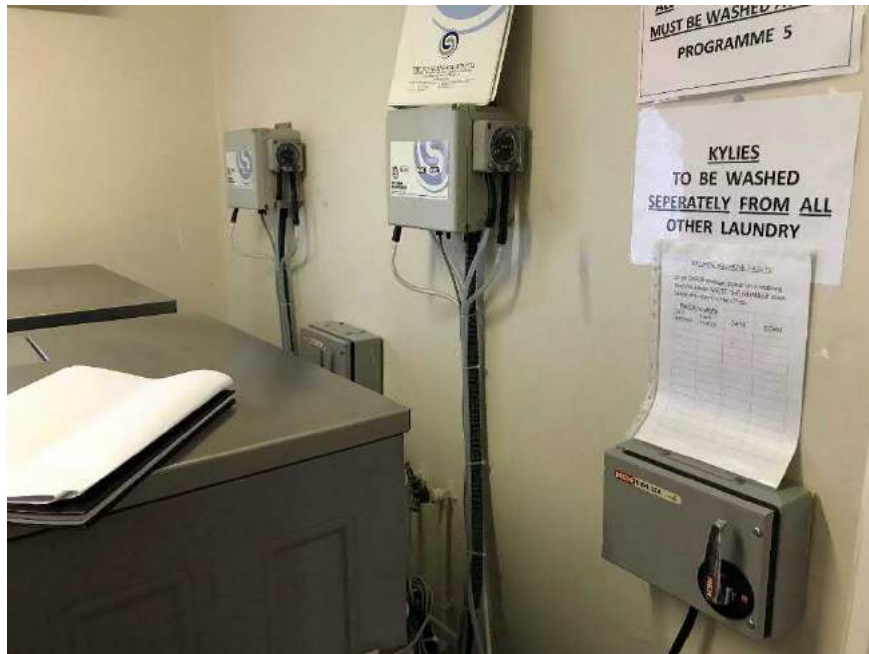
Photograph No 73 – Isolators supplying laundry equipment

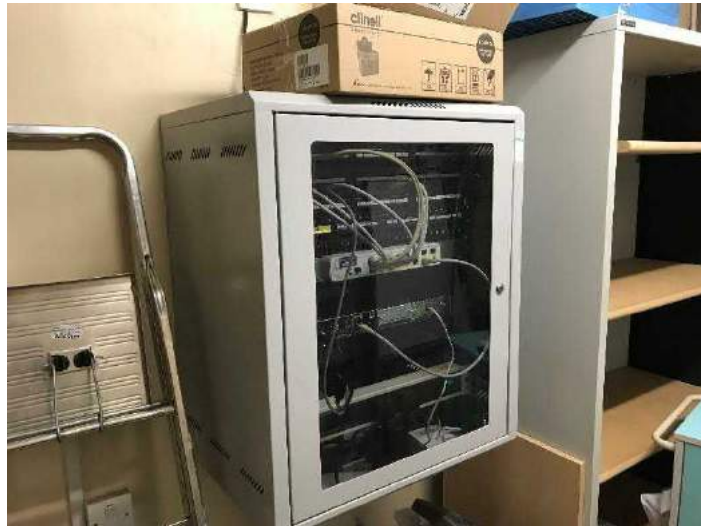
The building is provided with data points from a data rack in the main switchroom and consists of cable installed in a similar way to the small power outlets. These are mainly confined to staff areas and bedrooms are not provided with internet access. There is no Wi-Fi available within the home.

Photograph No 74 – Data rack installed in switchroom.

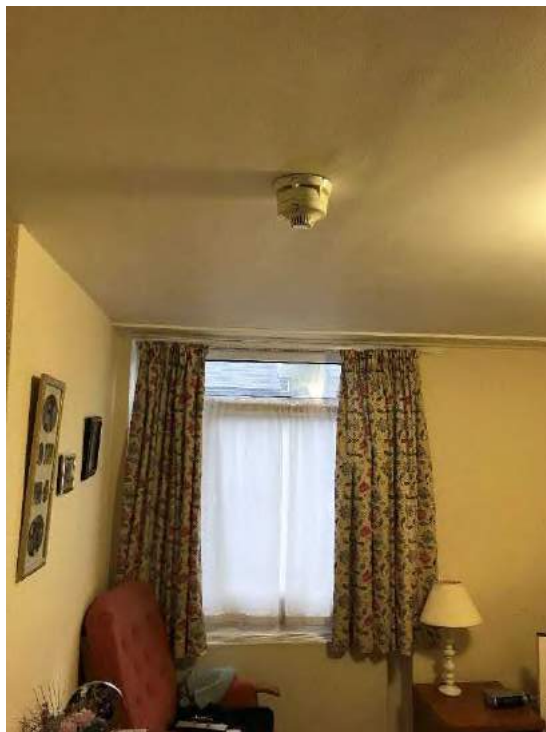
The building appears to have been designed to a standard of L1 + M, with all areas being provided with smoke detection, manual call points and electronic sounders. All detectors appear in good condition, free from damage, dirt and conditions likely to interfere with its correct occupation.

Photograph No 76 – Example of smoke detector installed in bedroom

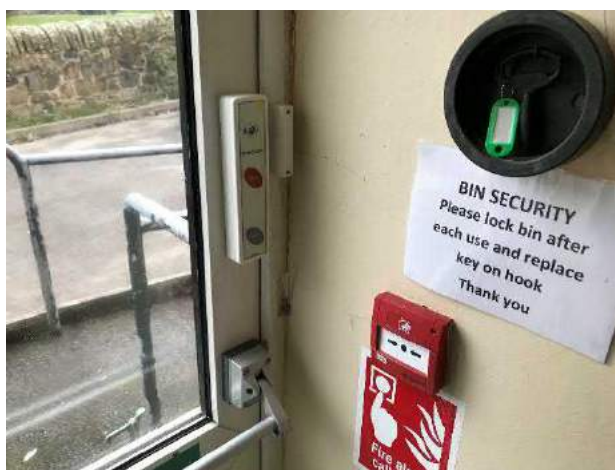
A First Q Wander guard system is installed on all external doors to monitor if a person opens an external door which is linked back to the staff office.

Photograph No 77 – Exit door with a call point & First Q Wander Guard alarm fitted.

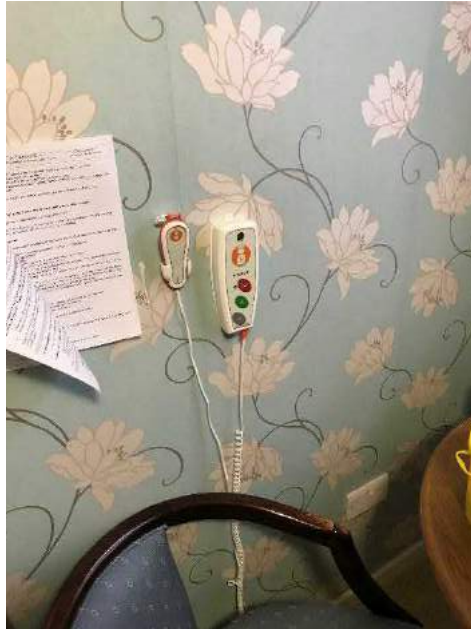
Photograph No 78 – Nurse call point within activity room

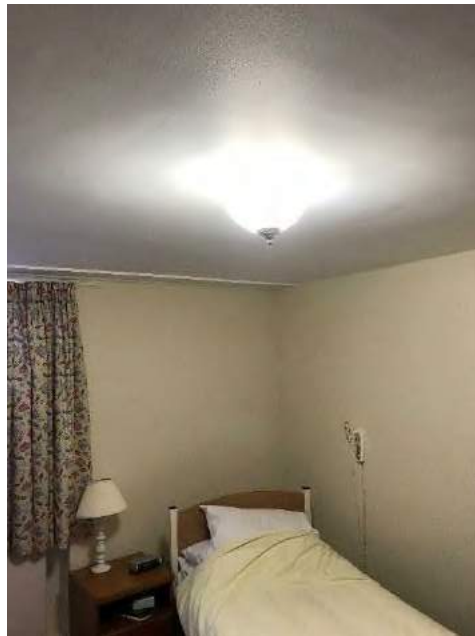
Photograph No 79 – Nurse call point within bedroom

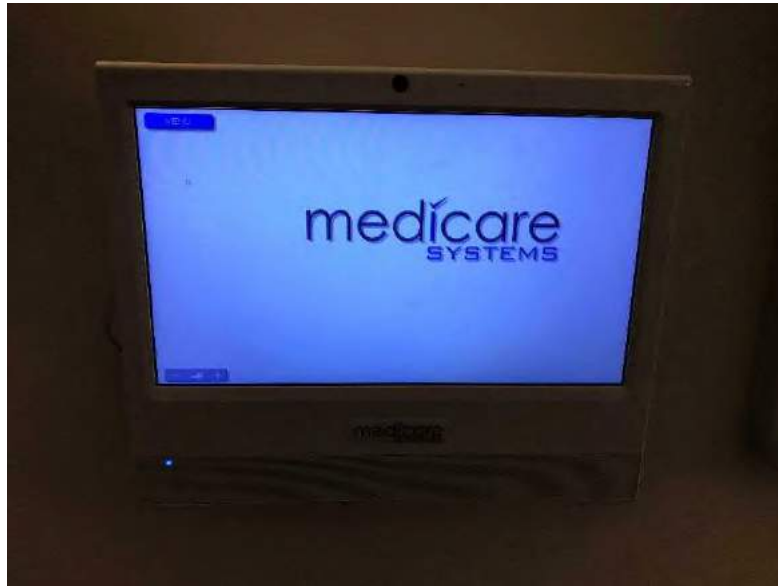
Photograph No 80 – Master Nurse Call system monitor located ground floor corridor.
