DERBYSHIRE COUNTY COUNCIL

Holmlea HOP

Condition Survey

November 2018

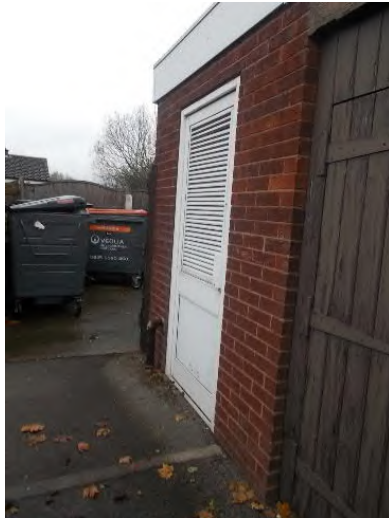
Photograph No 1 – Incoming gas meter in a brick built enclosure forming part of the garage.

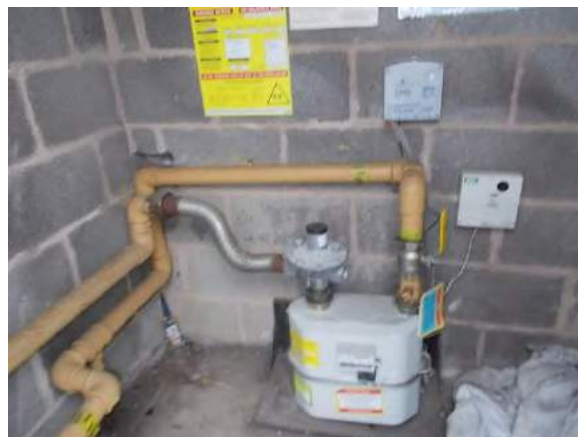
Photograph No 2 – The gas mains entering and leaving the meter cupboard.

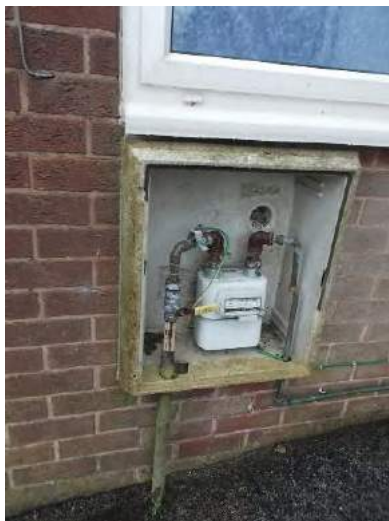
To the rear of the building there is a separate meter for the bungalow which has been capped off and the cover door is missing.

Photograph No 3 – Capped off gas supply to the bungalows to the rear of the building.

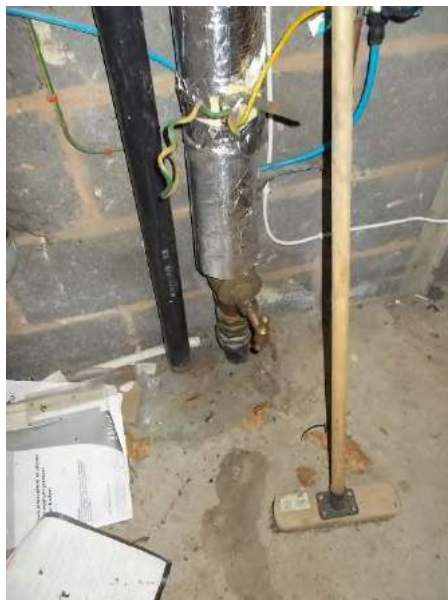
Photograph No 5 – The Incoming MCWS appears to enter the building in the boiler house (room No 054), there was no evidence of a water meter.

The MCWS appears to enter the building in boiler house (room No 054) but there is no water meter inside the building. The incoming valve was not labelled/identified, which makes it difficult to fully identify if this is the main incoming valve. This valve needs to be identified and incorporated into the building manual for the means to isolate the whole building if a leak is detected.

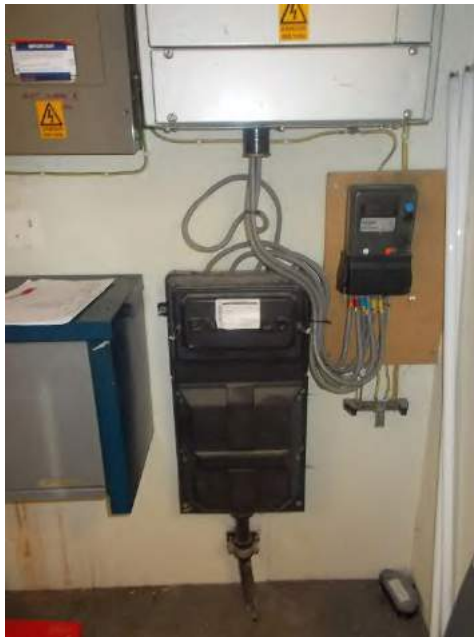
The electrical incoming utility supply enters the building in the cupboard off the corridor (room 042) and terminates into an old Enfield service head, this room contains the incoming service head, utility meter and main switch, main distribution board, 2 No sub-main distribution boards and an emergency lighting central battery system. The nursing home appears to have a 3 phase 100A supply as the meter is a direct reading meter.

Photograph No 7 – The Incoming electrical utility supply is located in a cupboard off corridor (room No 042).

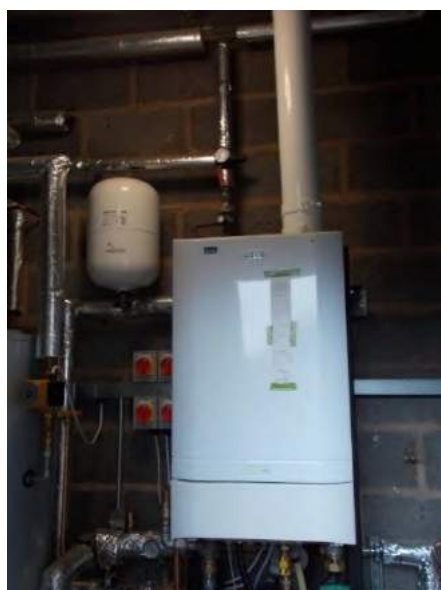
Photograph No 10 – Typical Boiler houses – Typical heating boiler.

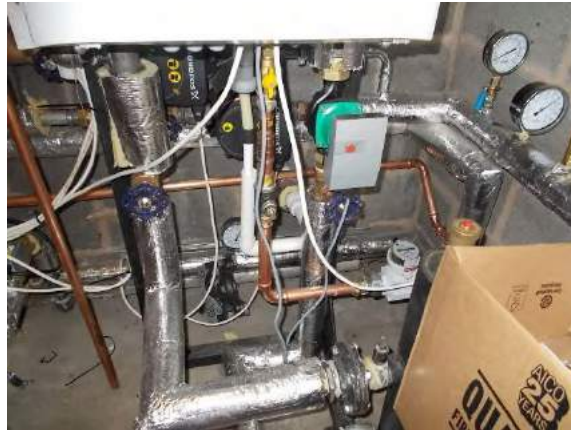
Photograph No 11 – Typical boiler houses - Wilo boiler shunt pump.

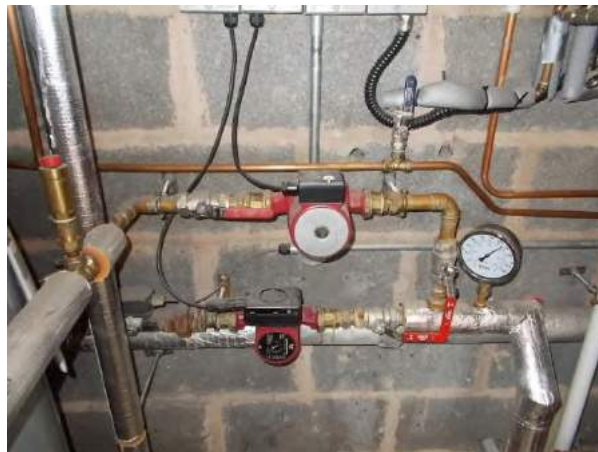
Photograph No 12 –Typical Boiler Houses – Typical HWS primary heating pump and main heating pump.

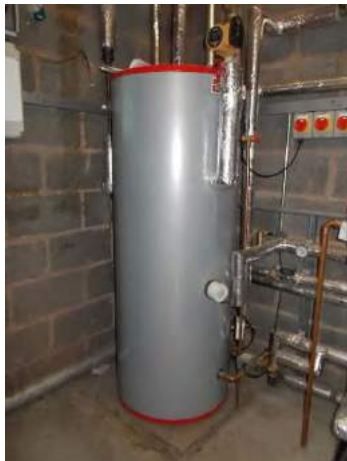
Photograph No 17 – Typical boiler house – BOSS 300L Calorifier for the domestic HWS generation

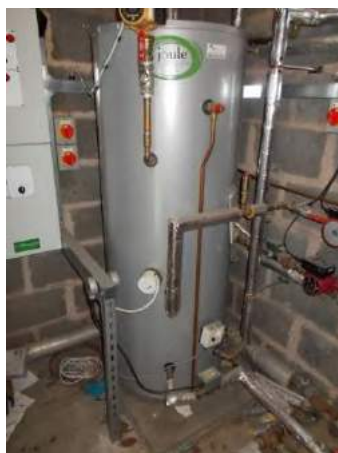
Photograph No 18 – Typical boiler house – Joule Cyclone CY300L Calorifier for the domestic HWS generation

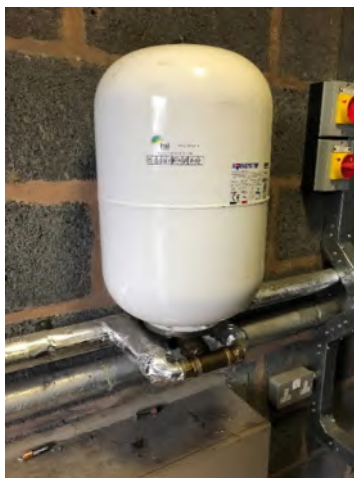
The domestic HWS systems have been provided with expansion vessel. It is not clear if the domestic HWS vessel has been provided with the correct number of valves and drain off points to allow the vessel to be cleaned correctly. This needs to be reviewed and all HWS and any MCWS pressure vessels provided with the correct valves and drain down facilities.

Photograph No 19 – Typical boiler house – MCWS expansion vessel to the HWS calorifier.

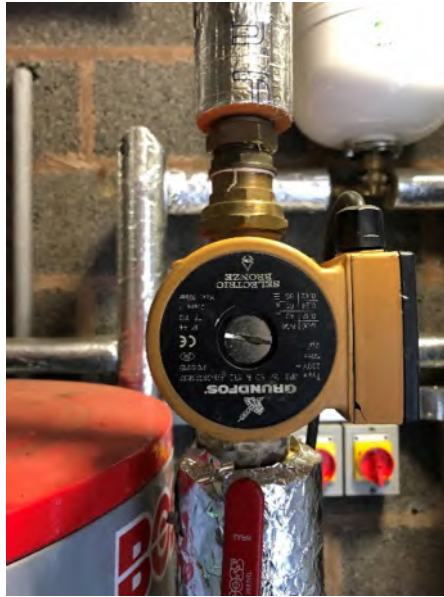
Photograph No 20 – Typical boiler house secondary HWS pump.

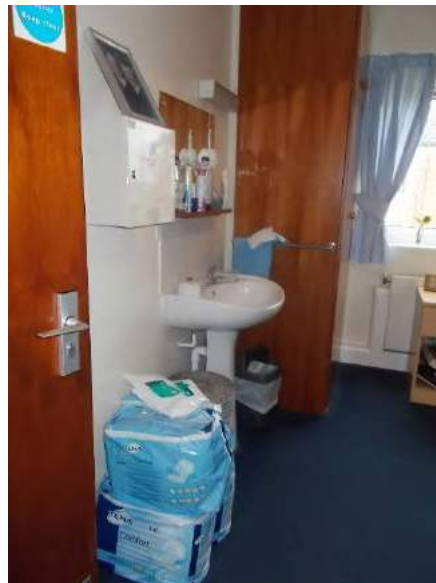
Photograph No 21 – Typical bedroom sink with thermostatic mixing valve installed below the sink.

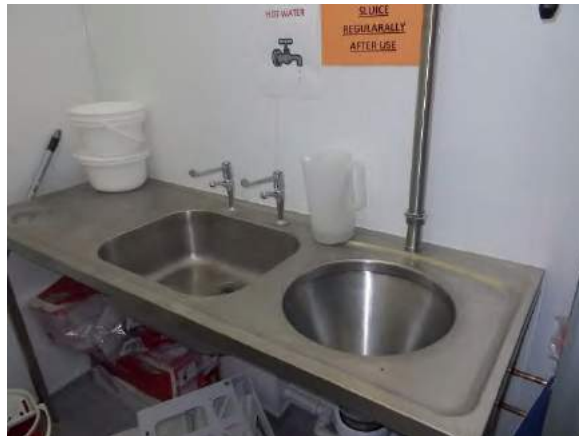
Photograph No 22 – Typical stainless steel sluice in sluice rooms.

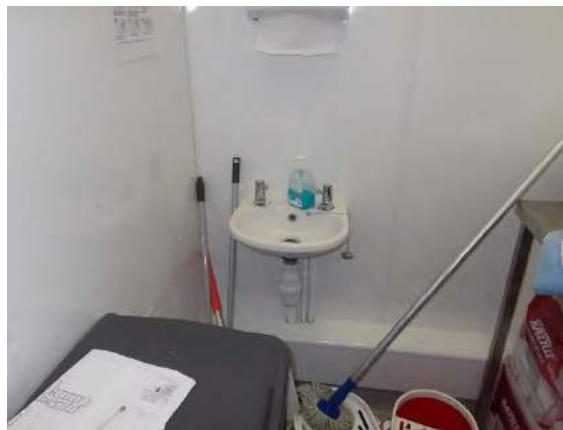
Photograph No 23 – Typical ceramic wash hand basin in sluice rooms.

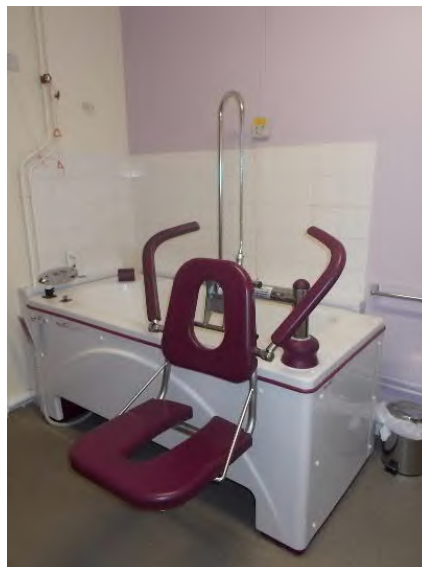
Photograph No 24 – Typical refurbished motorised assisted bathrooms.

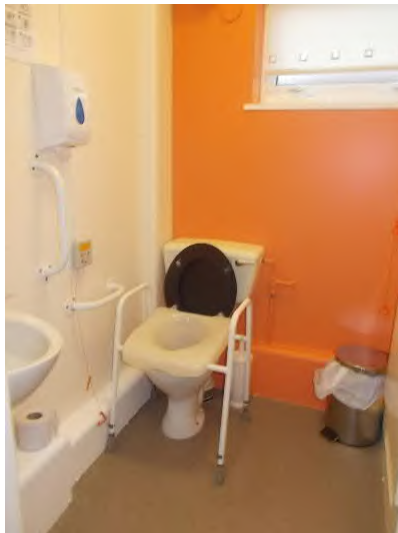
Photograph No 25 – Typical refurbished toilet.

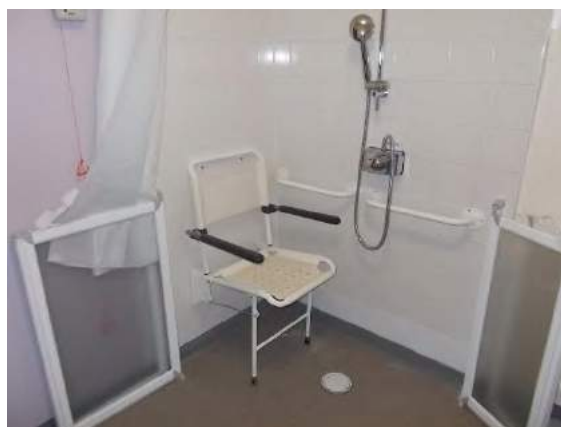
Photograph No 26 – Typical refurbished assisted shower room.

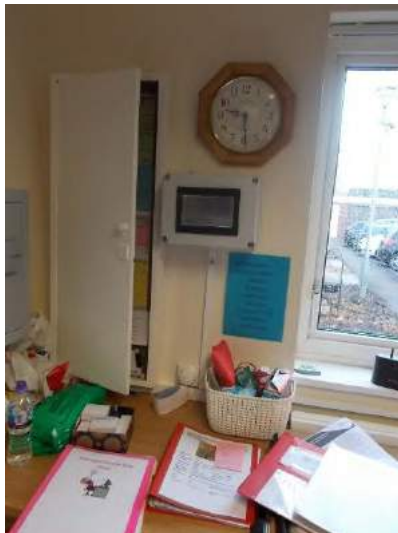
The boiler controls are currently being updated and new control panels being installed. The system is a networked system back to a common/master control panel installed within the office (room No 045). The Controls have been manufactured by Fieldwell.

There were no controls schematics fitted within the plantrooms indicating how the controls operate and where the control devices are located.

Photograph No 27 – Master plant control panel located within the office (room No 045).

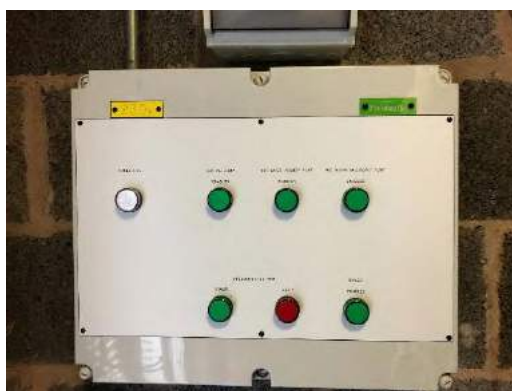
Photograph No 29 –Typical new boiler control panel.

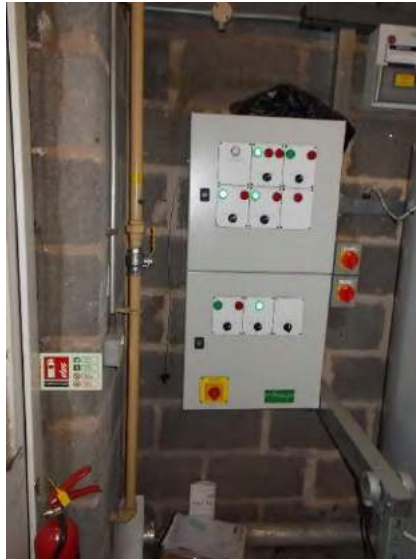
Photograph No 30 – Boiler house No 082 - Boiler and HWS plant control system.

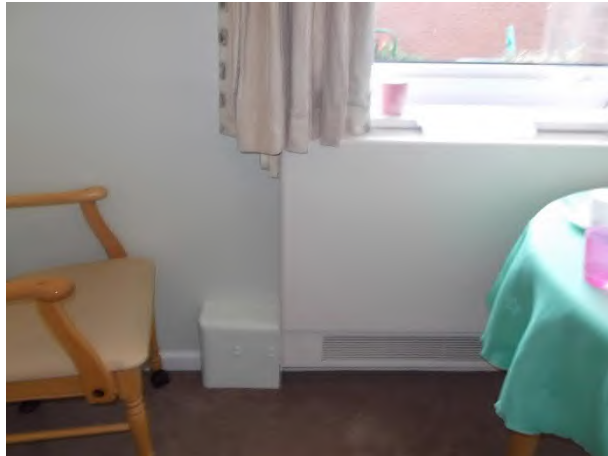
Photograph No 31 – Common room/dining room wall mounted LST radiator with pipework boxed out.

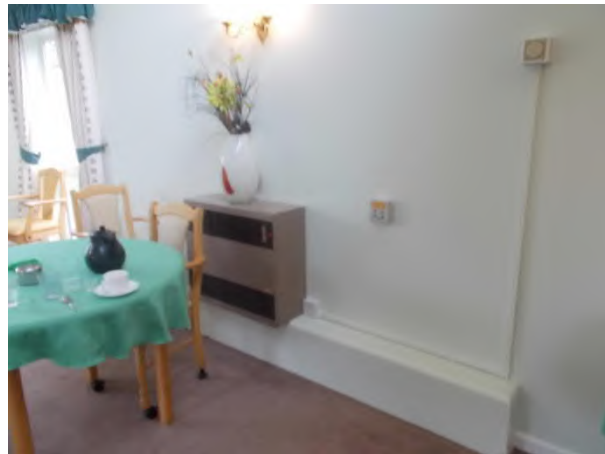
Photograph No 32 – Typical Floor mounted LST radiator.

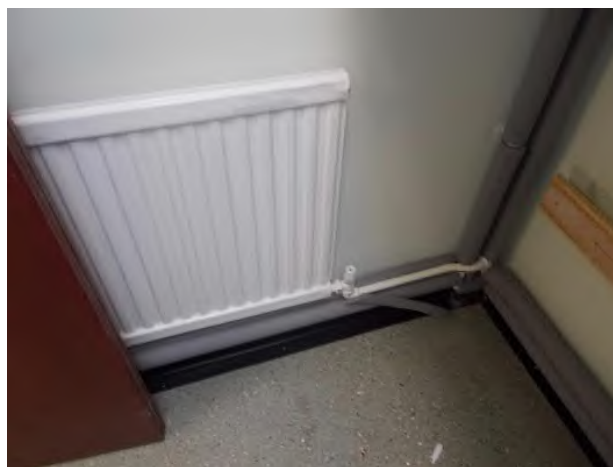
The heating within the building is generally LST radiators, although in other areas accessible by the staff the radiators are of a standard steel panel type and not LST. Due to the age of this system it would be beneficial to replace the heating pipework to ensure that the building has been provided with a 2 pipe flow and return system.

Photograph No 33 – Panel radiator installed in the medical room.

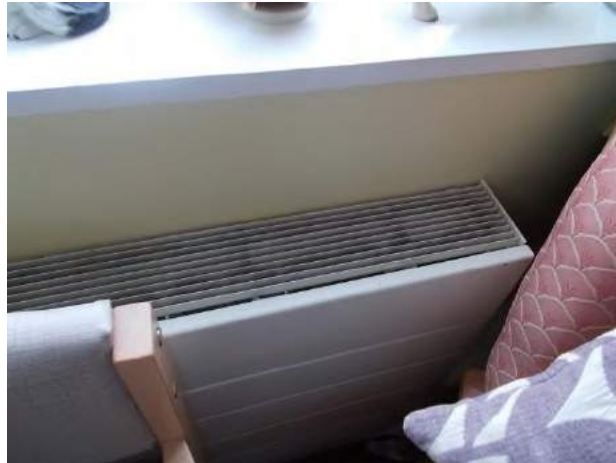
Photograph No 34 – Typical Bedroom LST Radiators with thermostatic control valve.

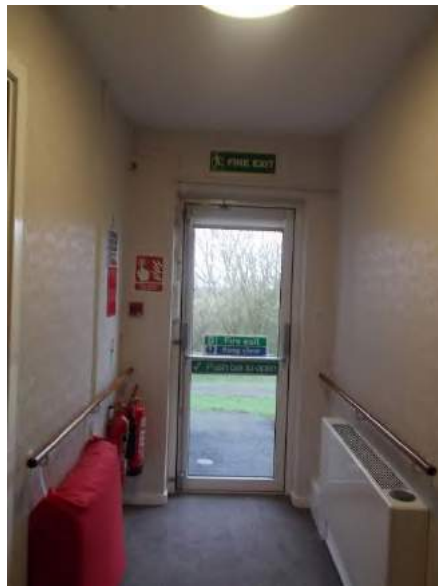
Photograph No 35 – Typical corridor LST Radiators with thermostatic control valve.

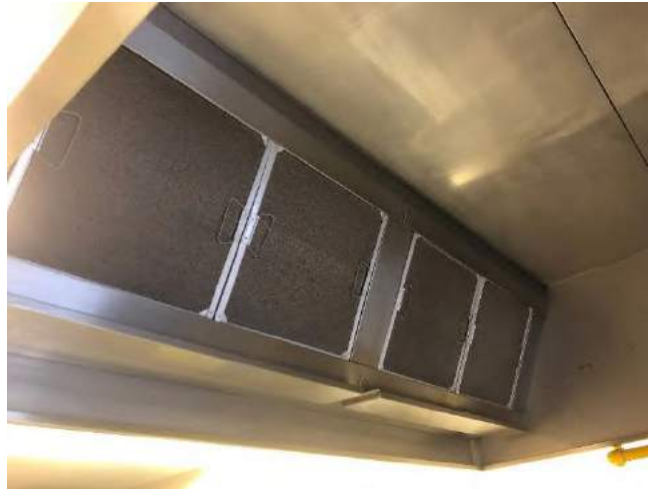
The kitchen ventilation comprises of an extract only stainless steel cooker hood with high level extract fans through high level windows.

Photograph No 36 – Kitchen hood currently installed in the main kitchen.

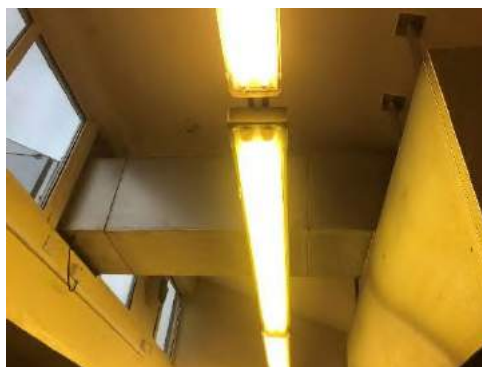
Photograph No 38 – Cooker hood extract ductwork passes onto the roof to the extract fan.

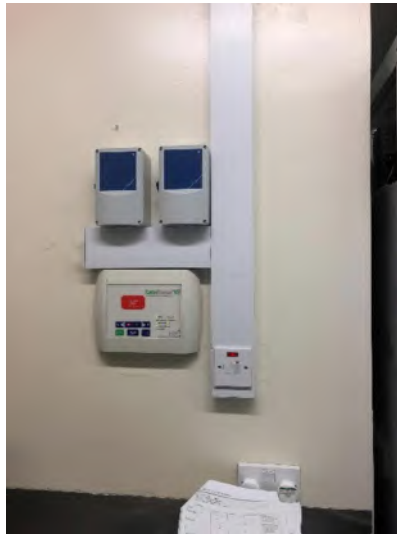
Photograph No 39 – Kitchen gas/ventilation interlock system in main kitchen.

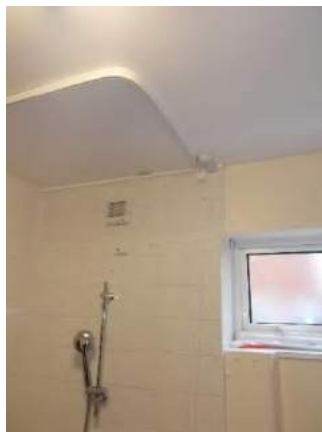
Photograph No 40 – Typical toilet and bathroom wall mounted extract fan.

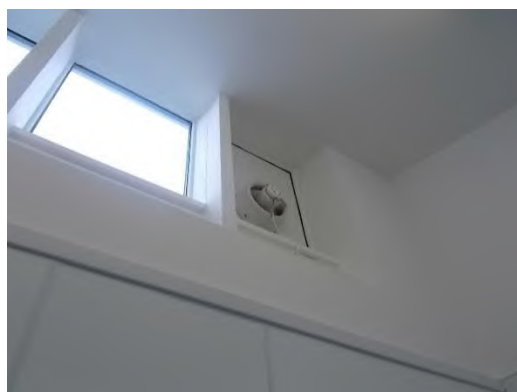
The sluice rooms have high level fans taken through one of the high level windows, these are manually switched. We noted that one of the fans was not working when switched on, this needs to be checked for operation.

Photograph No 41 – Typical Sluice room high level window mounted extract fan. Not all of the fans were operational at the time of our inspection.

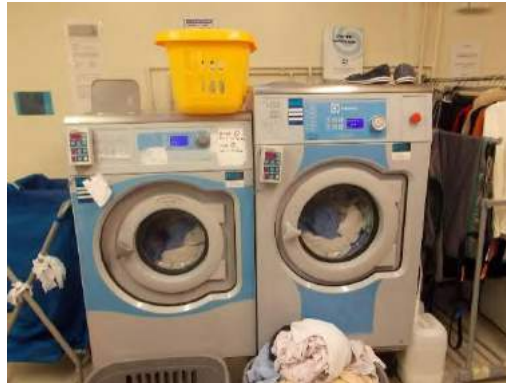
Photograph No 42 – Laundry washing machines.

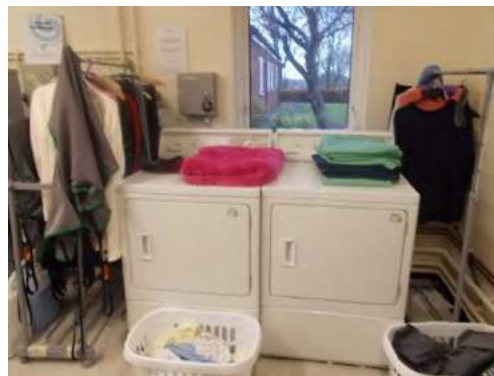
Photograph No 43 – Laundry Electric Dryers

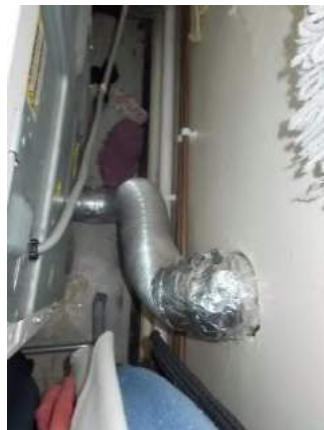
Photograph No 44 – Laundry electric dryer flexible connection to outside.

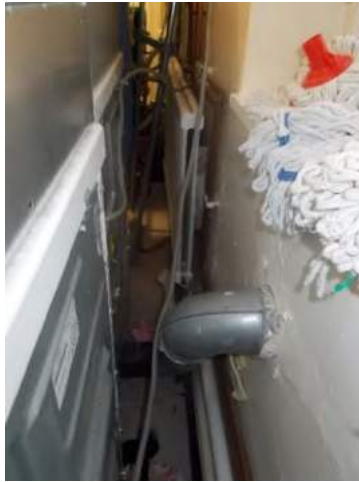
Photograph No 45 – Laundry electric dryer connection to outside.

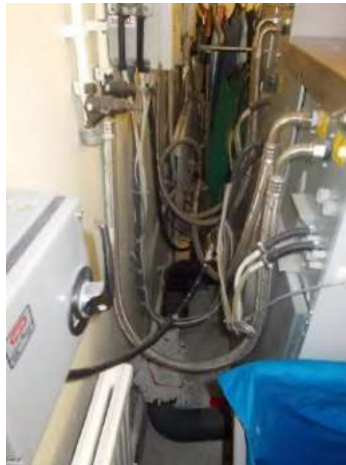
Photograph No 46 – Washing machine connections behind the units, note the lack of access to the drainage U-bends and lack of rodding points.

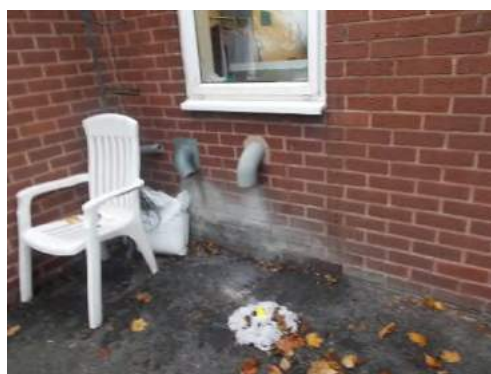
The building has a laundry currently installed for washing the resident's cloths. The laundry consists of 2 No industrial washing machines, these are an Electrolux W465H and a W5105S and 2 No electric dryers manufactured by Huebush. The dryers have been ducted to atmosphere by the use of metal circular ductwork. The ductwork discharges externally directly onto the floor below the ducts, there is evidence of fibres being deposited on the floor, it is not clear if the circular ducts have been cleaned to ensure that there is no build-up of lint within the ducts restricting the discharge of air from the dryer.

Photograph No 47 – Laundry Dryers with fibre deposits on the floor, the ducts from the dryers to atmosphere should be checked for build-up of fibres in the ductwork especially where there are 90° bends in the ducts behind the dryers.

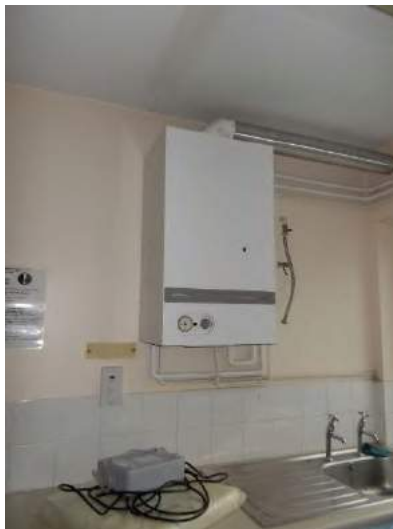
Photograph No 48 – Wall mounted gas boiler – boiler not operational with heating system drained down.

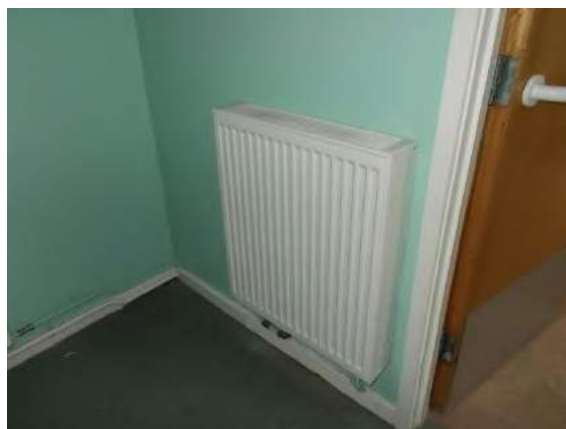
Photograph No 51 – Bungalow typical LST radiator

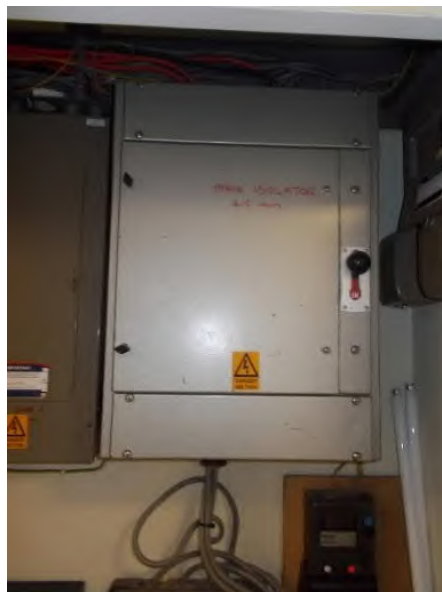
Photograph No 53 – Building incoming main switch installed in electrical cupboard off corridor No 042.

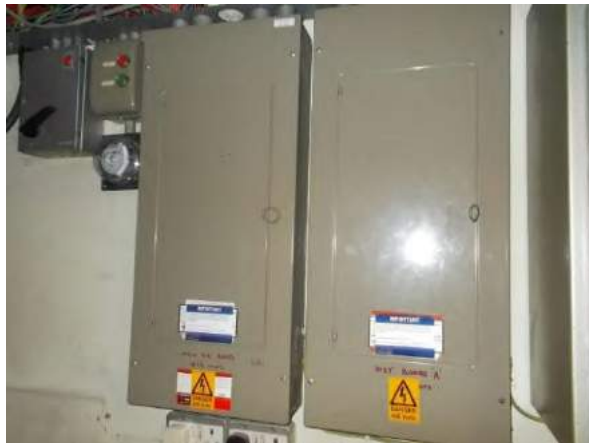
Photograph No 54 – Crabtree C50 main distribution board with distribution board A. Distribution board A is fed from a 50A MCB in the main distribution board.

- Upgrade the fire alarm system to bring the system up to a residence where persons are sleeping to BS5839.
- Replace the existing Crabtree C50 main distribution board with a new MCCB panel board.

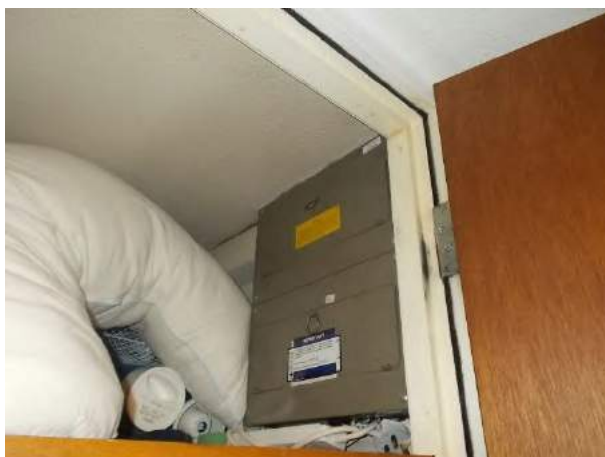
Photograph No 55 – Bedroom wing distribution boards installed in the linen cupboards. Boards are difficult to reach without the need to use a pair of steps.

- Replace all of the remote distribution boards with new distribution boards.
- Install distribution board charts and test sheets to the main panel board and all distribution boards.

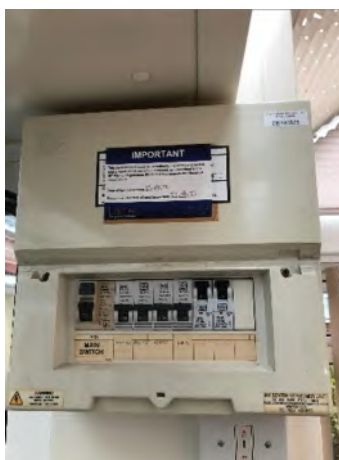
Photograph No 56 – Plastic MK consumer unit installed in conservatory (room No 049). The distribution board has no lock and is in an accessible location.

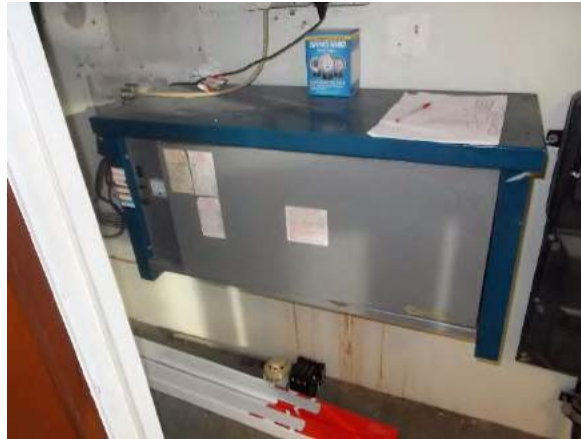
Photograph No 57 – There is an old central battery system which appears to be switched on and operational. It is not clear if this is still being used. It is assumed that as work was still in progress on this system. Note this unit is connected to a socket outlet.

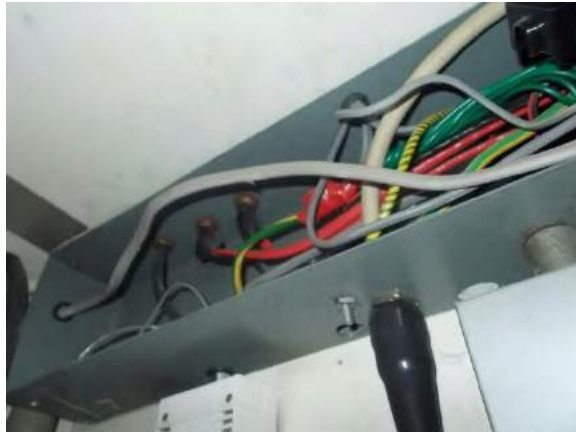
Above the main distribution boards the trunking lid is missing and is revealing cabling of an age that is nearing the end of its useful life. There are a number of joints in the cables which are not identified as to which distribution board they are connected to. There is a series of earth cables wrapped together and jointed to a single cable which connects to the trunking sides. The building should be rewired to ensure that the circuits are correctly earthed and all cables are clearly identified, thus allowing the use of RCBO's to any new boards.

Photograph No 60 – The old solid green earths in the trunking appear to have been twisted together and extended by the use of a single newer green/yellow cable which connects to the trunking side.

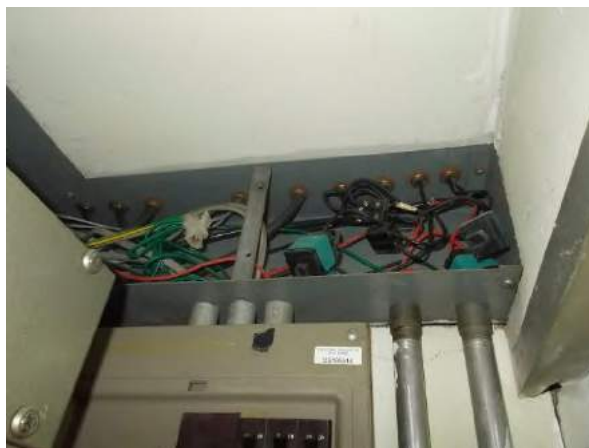
Photograph No 61 – A further example of the use of connection strips for extending cabling. The cables have not been identified and it is not clear which distribution board these are associated with.

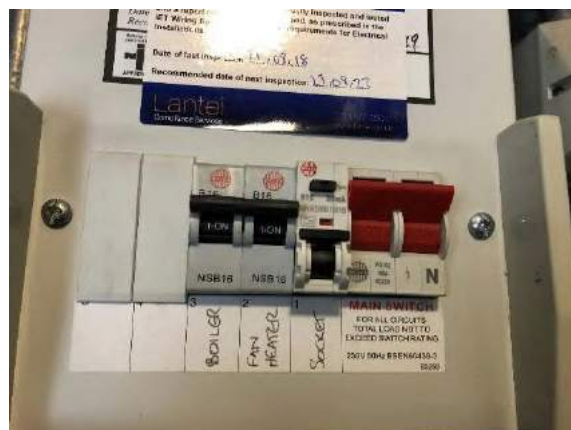
Photograph No 62 – Typical boiler house Wylex consumer unit.

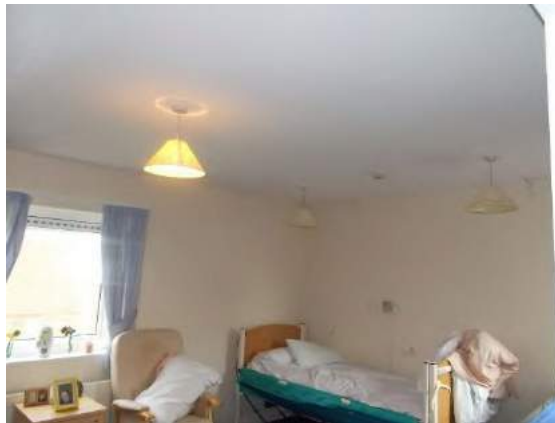
Photograph No 63 – Typical bedroom central pendant luminaires

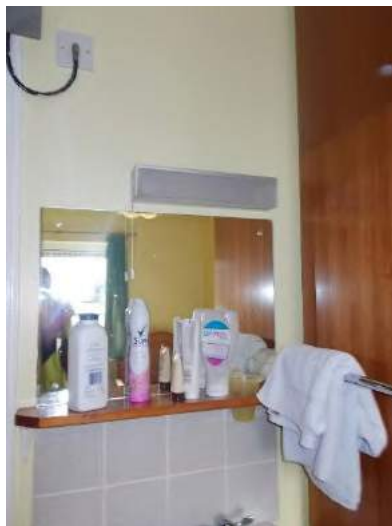
Photograph No 64 – Typical bedroom mirror luminaire.

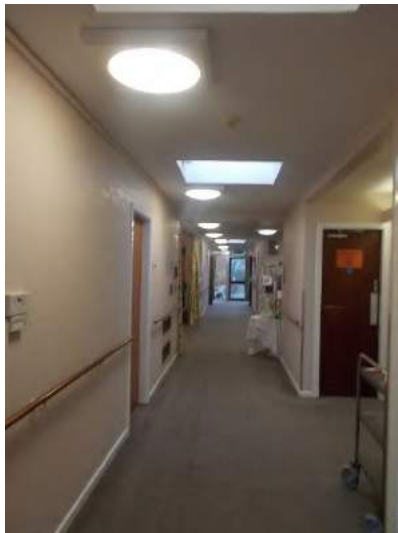
Photograph No 65 – Typical corridor lighting.

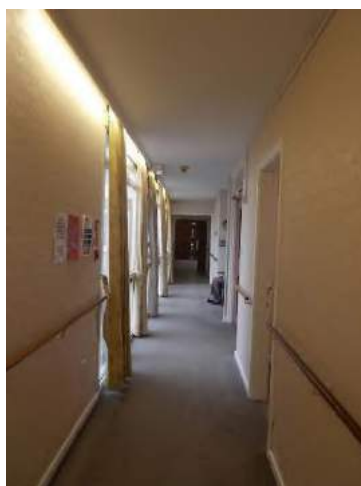
Photograph No 66 – Corridor pelmet lighting.

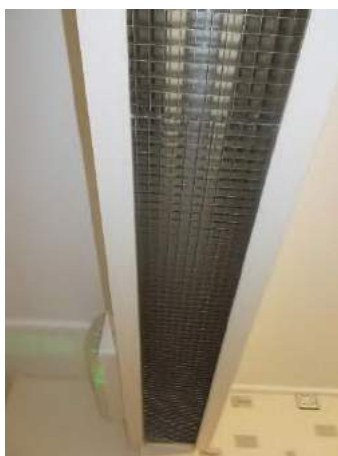
Photograph No 67 – Corridor/kitchenette pelmet lighting.

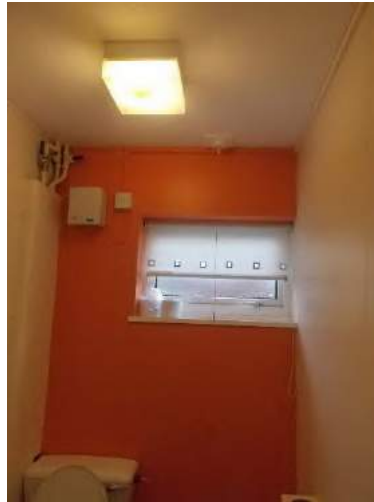
Photograph No 68 – Typical ambulant toilet lighting.

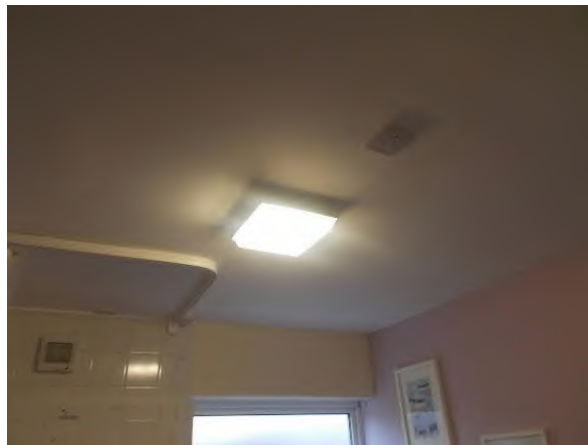
Photograph No 69 –Assisted shower room No 016 lighting.

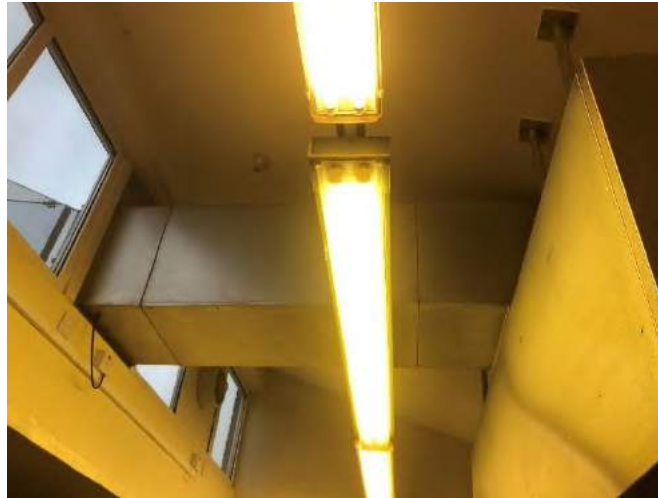
Photograph No 71 – Main Kitchen Lighting.

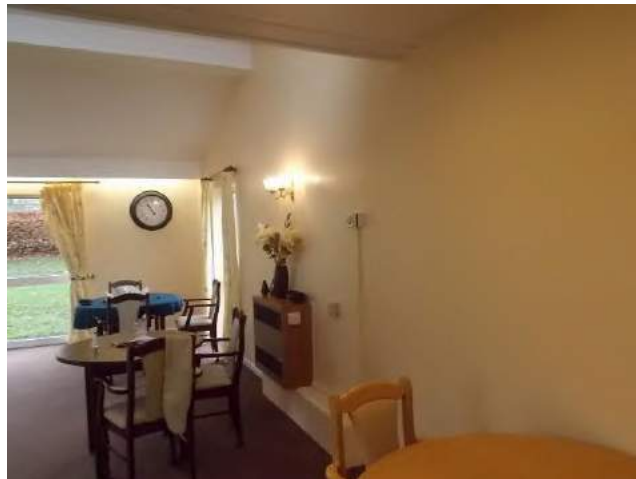
Photograph No 72 – Dining room wall lighting and pelmet lighting.

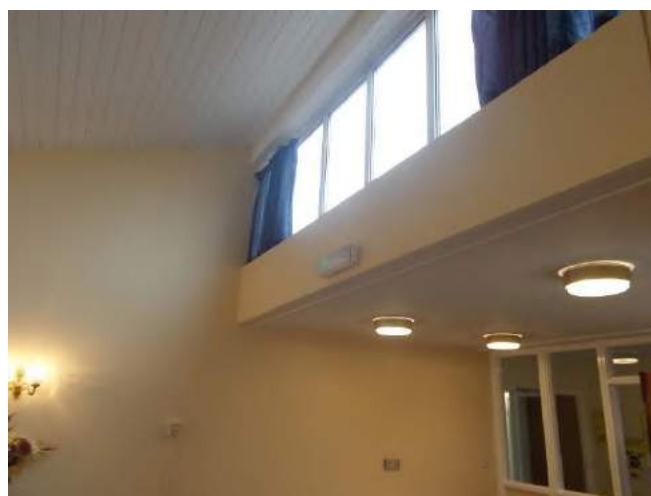
Photograph No 73 – Dining room low level lighting.

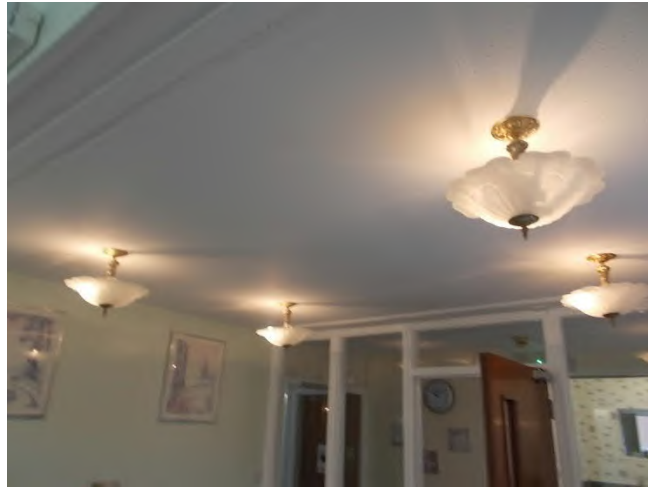
Photograph No 74 – Dining room low level lighting.

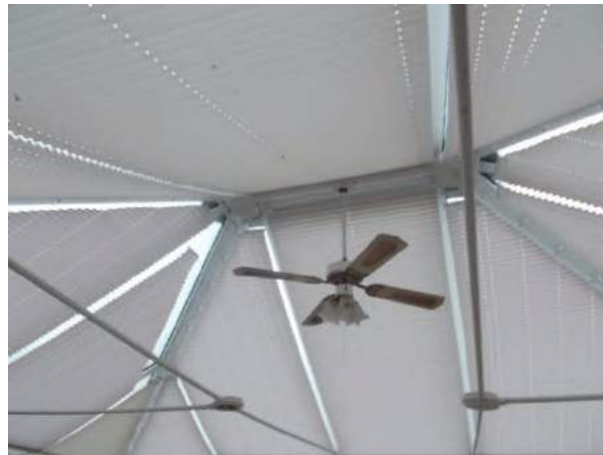
Photograph No 75 – Conservatory lighting cooling fan with lights.

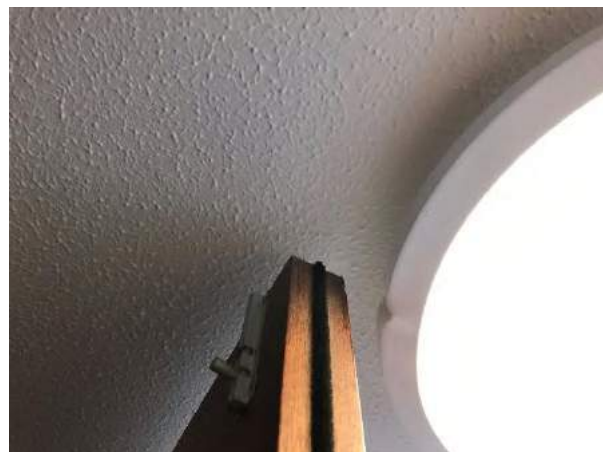
Photograph No 76 – In a number of instances the linen cupboard is hitting the lighting and damaging the fitting.

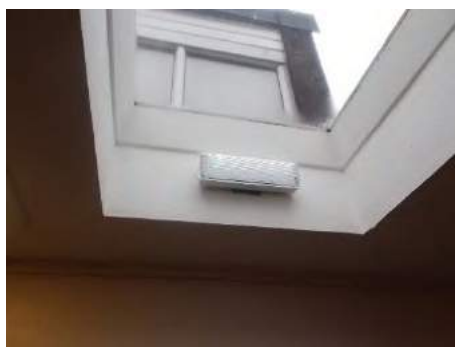
Photograph No 78 – There are a number of emergency luminaires installed within the roof light recesses, this reduces the effectiveness of the emergency light.

With the escape routing around the building, emergency luminaires need to be installed to ensure that sufficient illumination is provided to get elderly patients or persons with limited sight to get out of the building in the middle of the night.

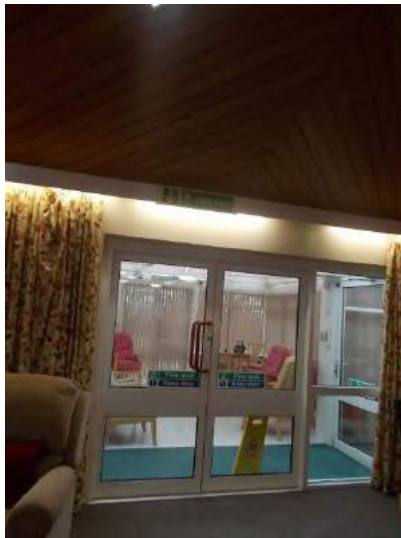
Photograph No 79 – Escape doors into the conservatory high level sign on the pelmet is above the emergency luminaire installed in the pelmet.

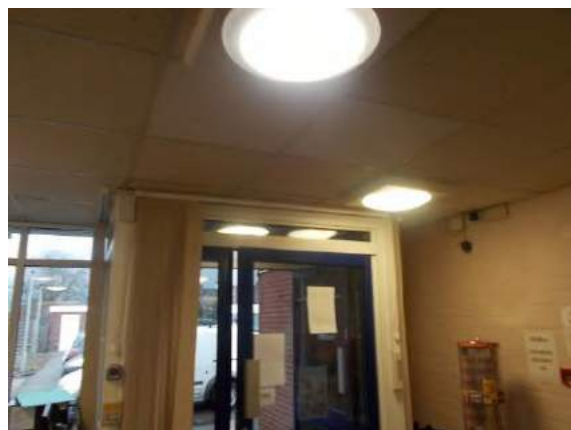
Photograph No 80 – Main entrance door with no exit signage over the door.

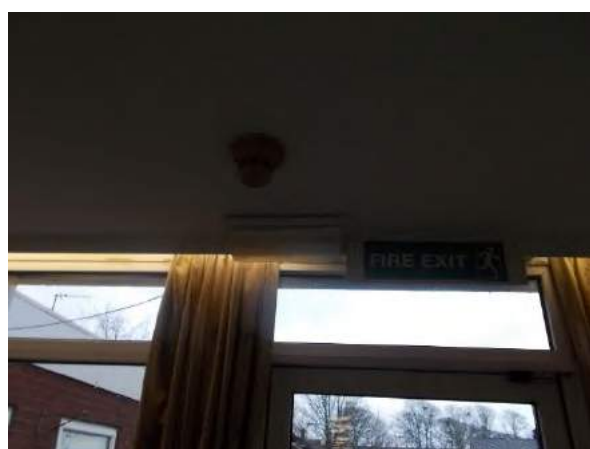
Photograph No 81 – Fire exit door with exit sign and an emergency luminaire door with no exit signage over the door.

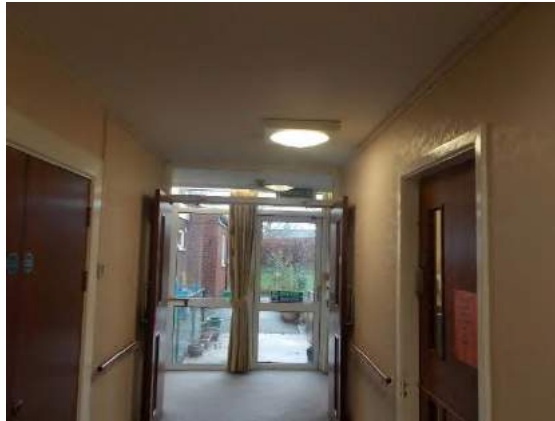
Photograph No 82 – With the fire doors open the fire exit is visible, however when the doors are closed the exit signage is very difficult to see.

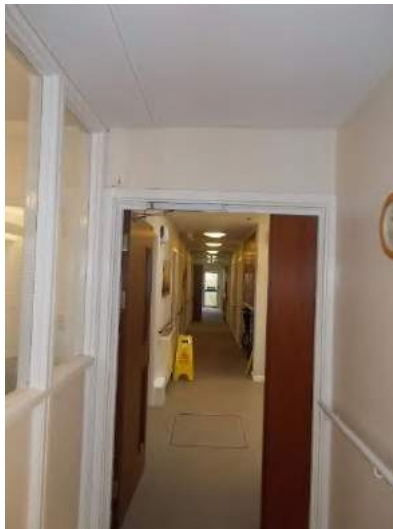
Photograph No 83 – With the fire doors open the fire exit is visible, however when the doors are closed the exit signage is very difficult to see.

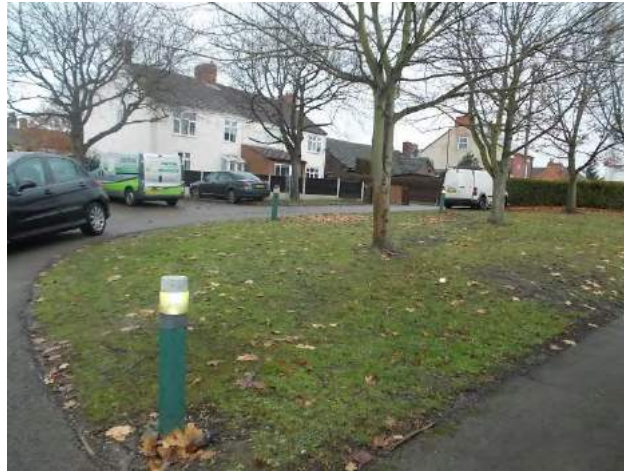
Photograph No 84 – Low level bollard lighting on the main entrance drive into the site.

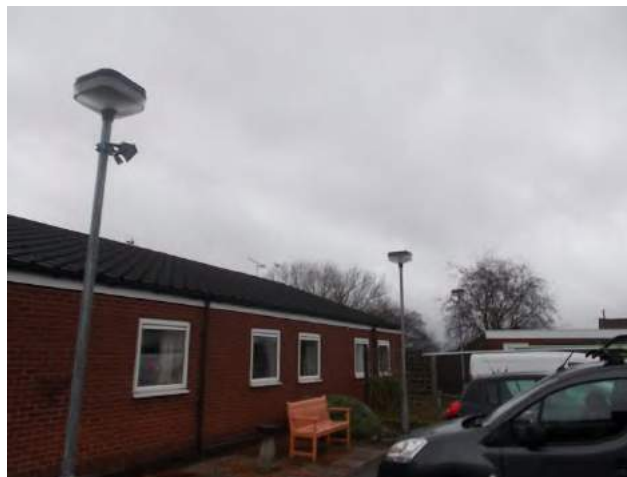
Photograph No 85 – Column mounted luminaires by car parking bays, note one column has been provided with a PIR controlled floodlight.

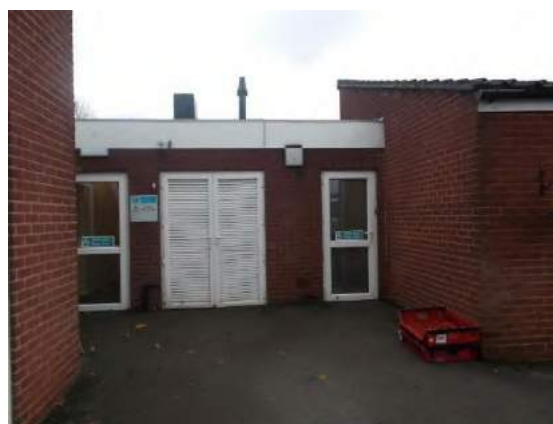
Photograph No 86 – Wall mounted luminaires over escape doors it was not clear if both luminaires were emergency backed.

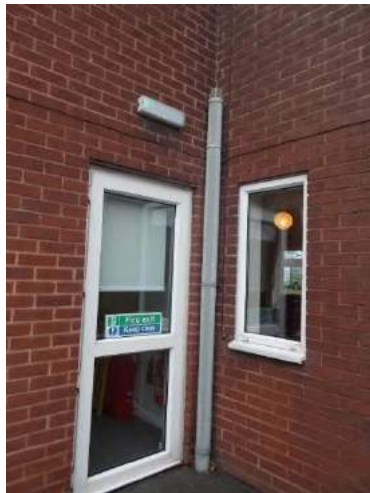
Photograph No 87 – Typical wall mounted emergency luminaires over escape doors.

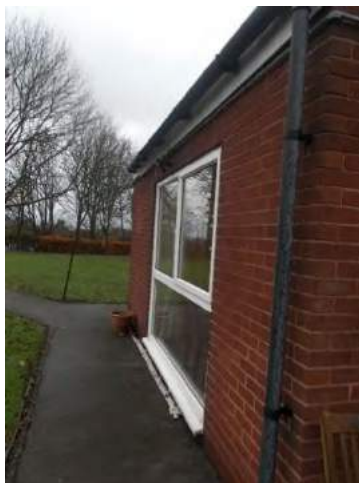
Generally, around the building there are a number of emergency luminaires over the escape doors, and a few LED floodlights with PIR controls fitted, but no general lighting to get residents out of the building to an emergency muster point.

Photograph No 88 – Generally there are no luminaires around the perimeter of the building, there are a few PIR controlled LED flood lights.

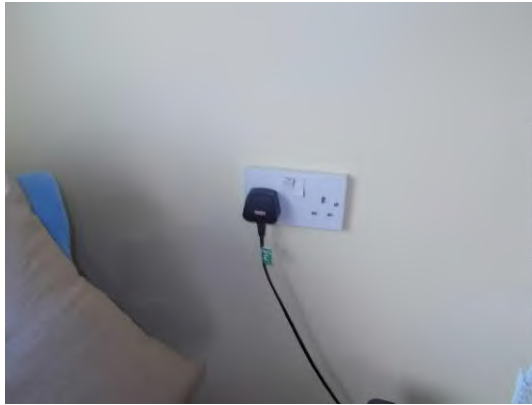
Photograph No 89 – Typical bedroom socket in the room.

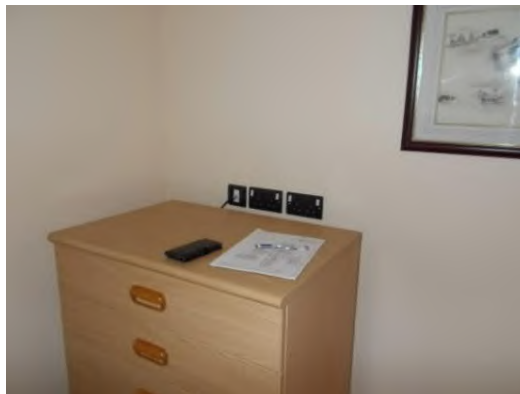
Photograph No 90 – Refurbished bedrooms with sockets for a television and possibly a desk.

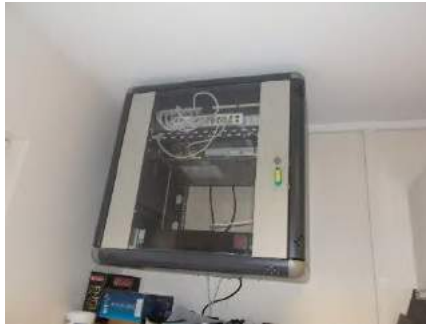
Photograph No 92 – Data rack installed in room No 045 of the social services offices.

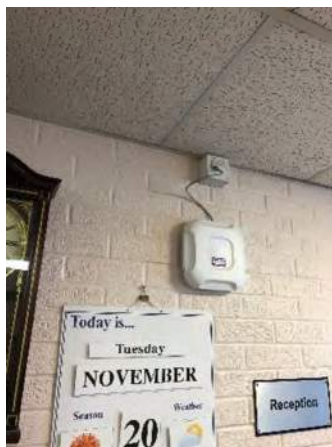
Photograph No 93 – Centralised Wi-Fi unit located in the main reception area room No 042.

Located in the corridor (room 042) there is a of Wi-Fi unit. Consideration should be given to installing additional twin data outlets to each of the bedroom wings for the future use of Wi-Fi units. These will be required for the District Nurses to use their electronic recording devices in the residents bedrooms, also in the future residents will be using computers and mobile phones and Wi-Fi internet access will become utilised on a more regular basis.

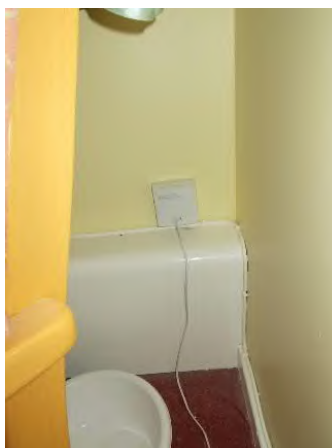
Photograph No 94 – Where residents pay for a telephone to be installed these are installed directly into the respective bedroom.

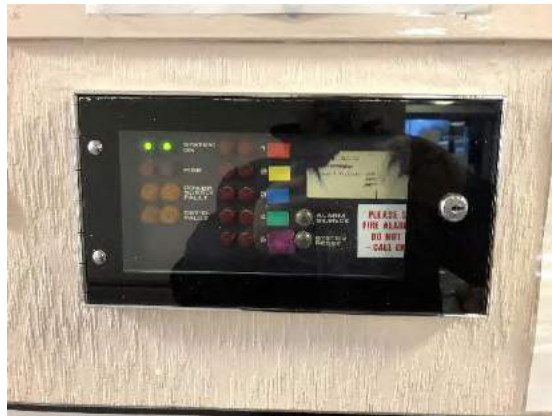
The fire alarm control panel does not comply with EN54 for the control panel and it is not clear how long the battery autonomy is rated at. This panel has reported issues which cannot be resolved as the panel is obsolete and should be replaced with a new addressable system.

Photograph No 95 – Conventional fire alarm panel located in the main entrance.

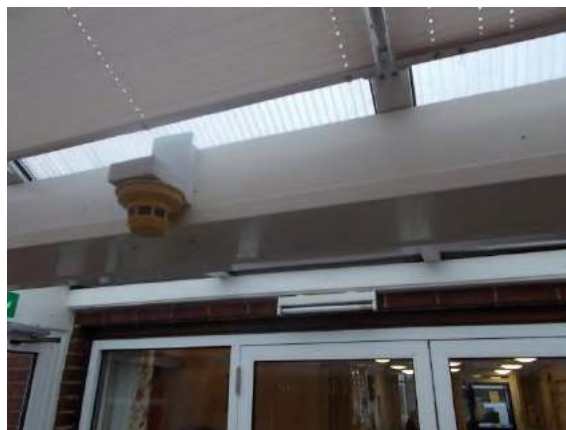
Photograph No 96 – Conservatory smoke detection not located at highest point of the room.

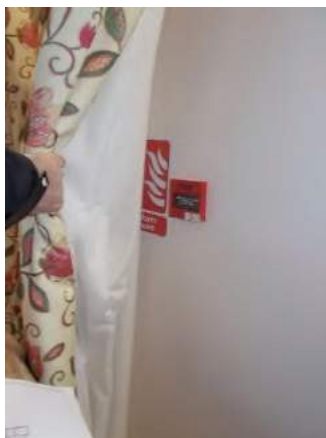
Photograph No 97 – Manual fire alarm break glass units located behind curtains and not easily visible to persons not familiar with the layout of the building.

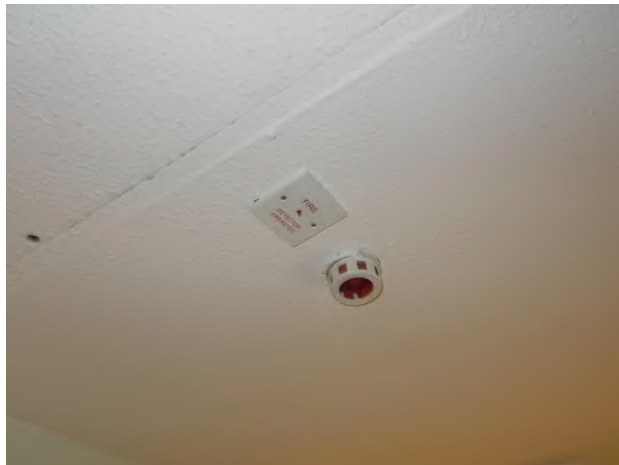
Photograph No 98 – Fire alarm siren partially buried in the ceiling with remote automatic detector, it was not clear where the actual detector was located and how access for testing was achieved, this needs to be checked and verified.

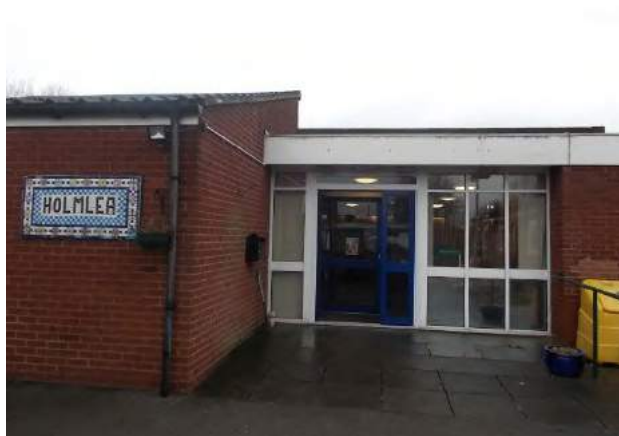
The internal entrance lobby door to the reception area restricts access into the main part of the building by an access controlled system, consisting of an intercom and card reader. In the entrance with there is a further card reader to get out of the building. There is no green emergency break glass had been installed on the secure side of the door and on the reception desk there is a door open switch.

Photograph No 99 – The internal entrance door was provided with an intercom system and card reader. On the inside, there is an intercom and a card reader however no green emergency break glass unit was installed. No keypad or intercom on the outside of the main entrance just a bell push.

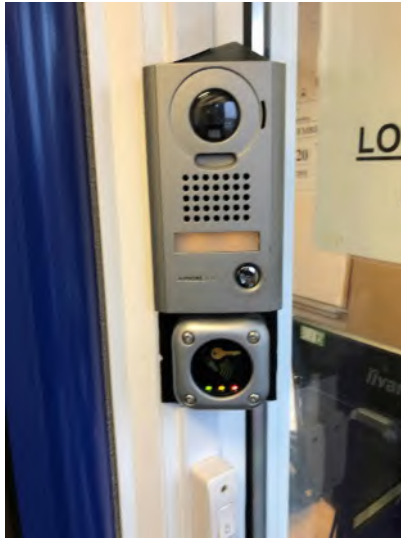
Photograph No 100 – Internal lobby door intercom and proximity access system

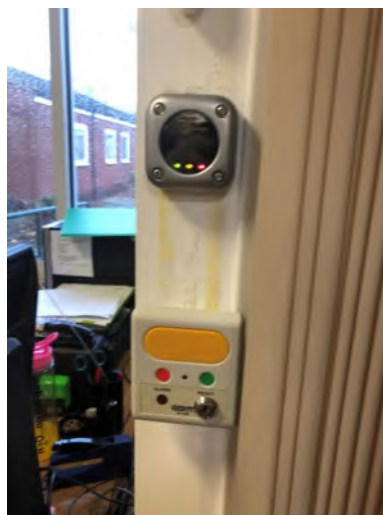
Photograph No 101 – Internal lobby door proximity access system there is a switch under the reception desk to get out of the building.
