DERBYSHIRE COUNTY COUNCIL

Holmlea HOP

Condition Survey

November 2018

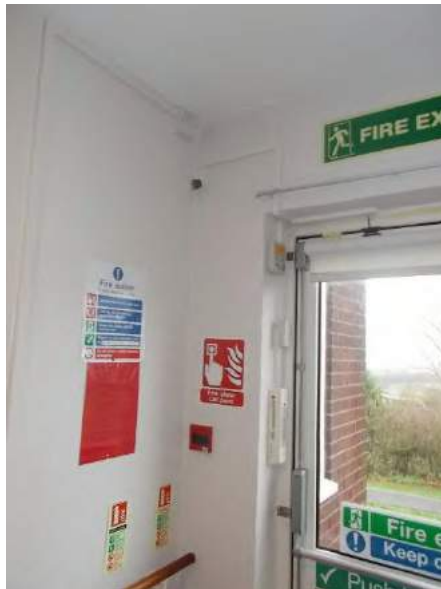
Photograph No 102 – Fire exit door with a FirstQ Wander guard + ARM Nurse Call system fitted.

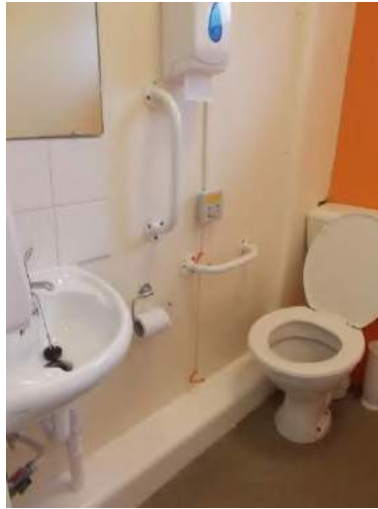
Photograph No 104 – Toilet and bathroom nurse call system.

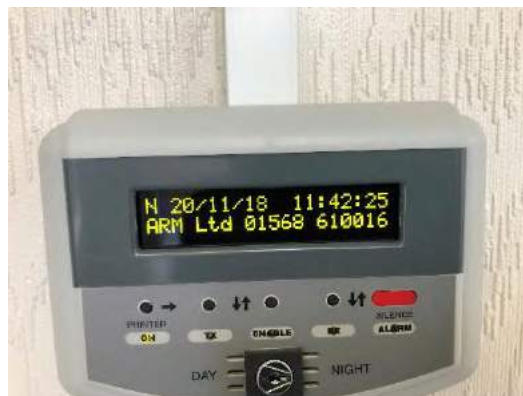
Photograph No 105 – Remote nurse call system monitor located by each of the bedroom wings.

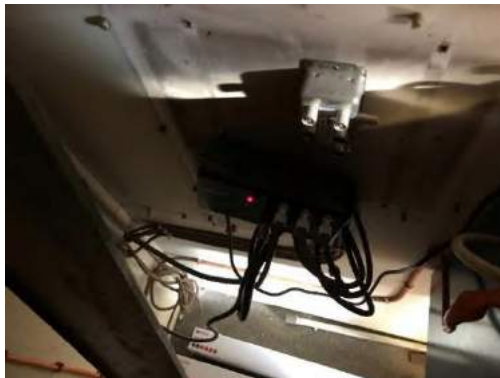
Photograph No 106 – In the electrical cupboard there is a small centralised TV aerial system.

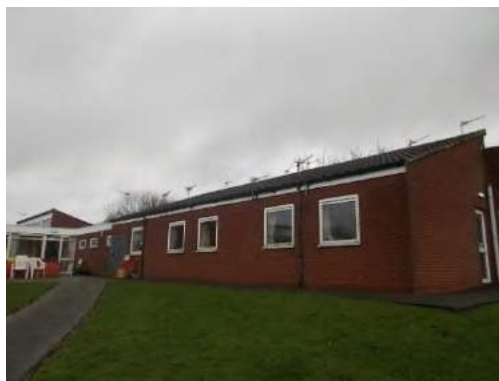
Photograph No 107 – Typical TV aerial system, it appears to be a separate aerial for each bedroom.

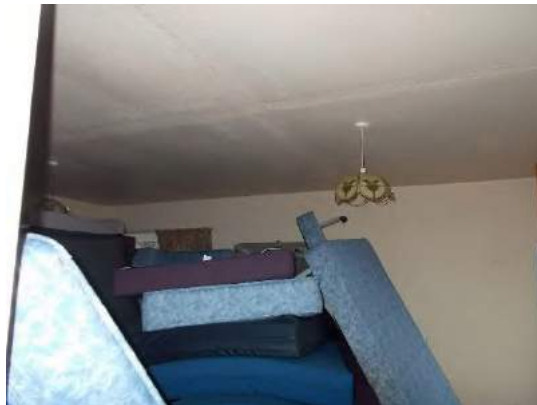
The bungalows have a mixture of GLS pendant luminaires and fluorescent bulkhead lights and a cat 2 louvered luminaire. All lights are manually switched.

Photograph No 108 – Typical room pendent lights.

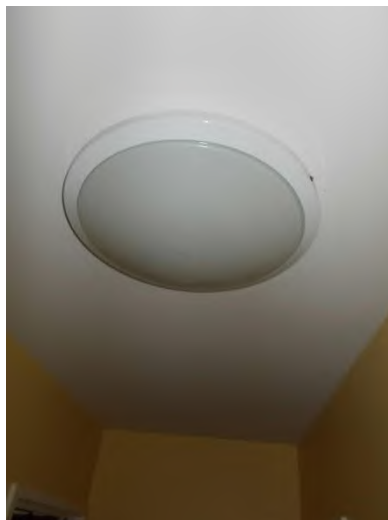
Photograph No 109 – Typical corridor/staircase lights.

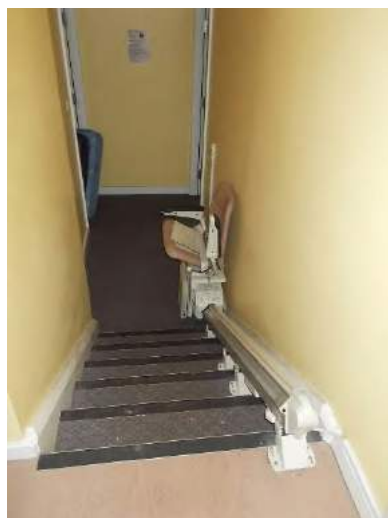
Photograph No 110 – Stair disabled persons lift.

There is a short staircase in each bungalow which have been provided with a stair lift, these will need to be inspected, tested and certified before being reused.

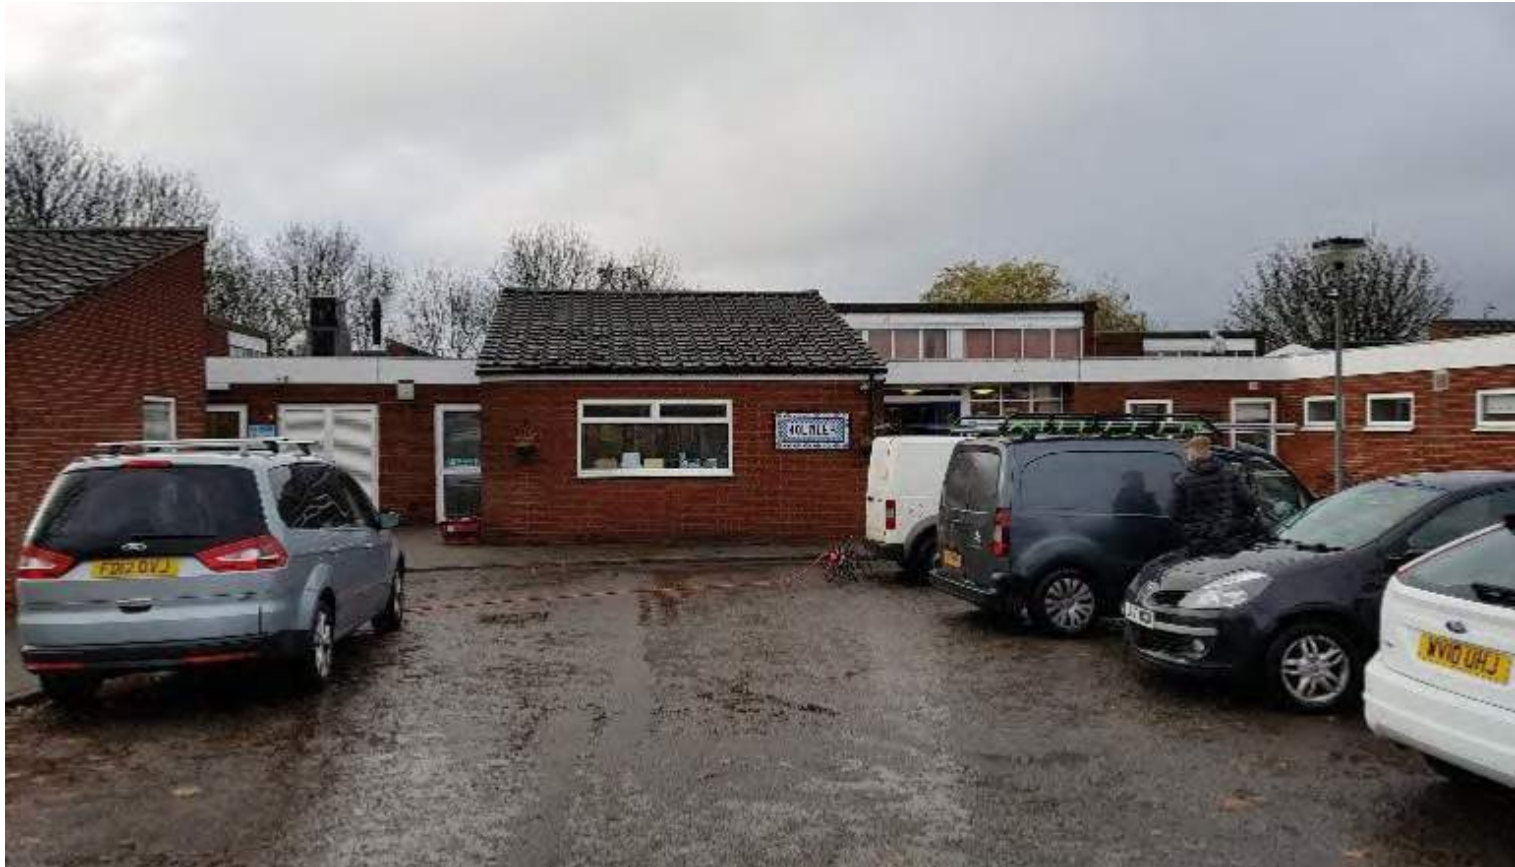
Photo 1

202. The premises comprise a single storey hub area with general amenities, dining rooms and lounge area along with four identical bedroom wings leading off the central hub area primarily built from load bearing masonry. (See photo 1)

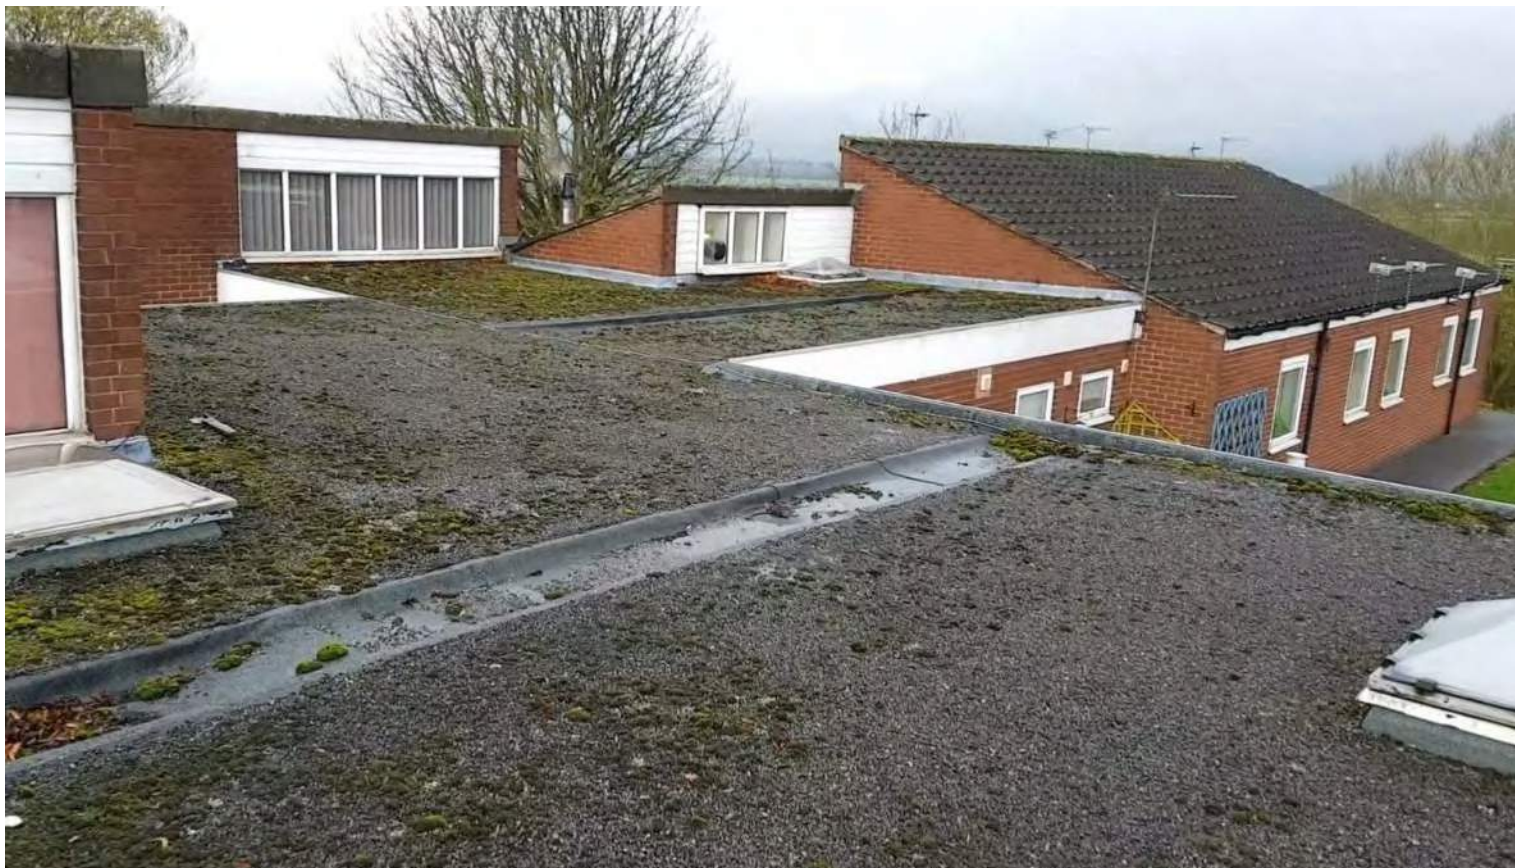
Photo 3

- 301. Over the central hub exists a timber roof finished with felt. (See photo 3)
- 302. There are gutters running centrally across the length of the roof. They appear to be in serviceable condition but require maintenance and cleaning.
- 303. No significant structural defects were identified.

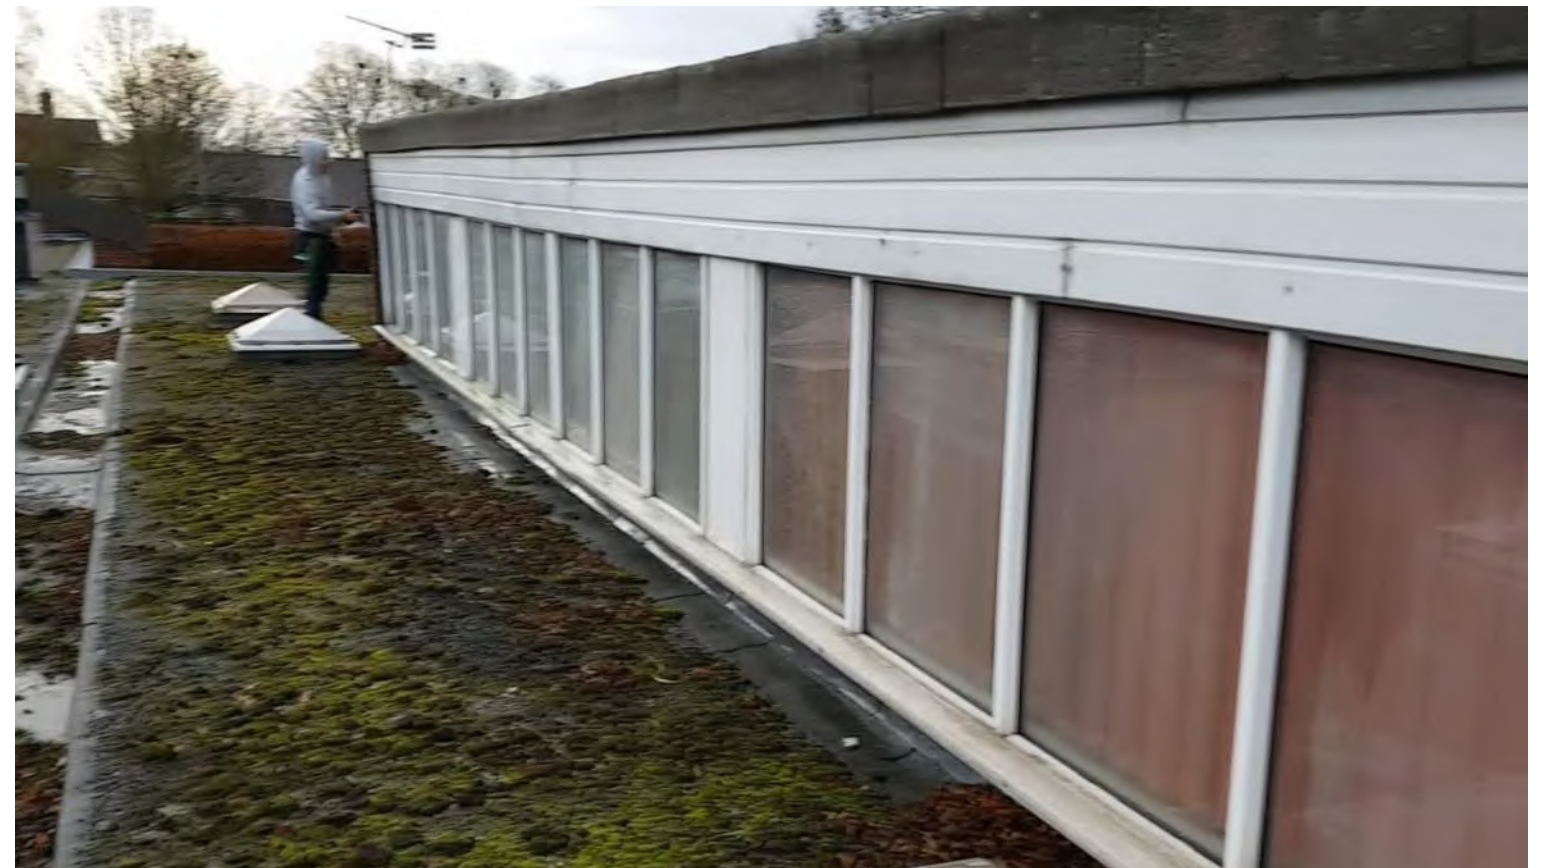
Photo 4

- 304. It was not possible to determine the construction of the roof over the kitchen however it is thought that the roof was constructed from timber.
- 305. The walls to the high end of the vaulted roofs were typically in-filled with curtain walling with approximately 1m long masonry return.
- 306. In most instances it is thought that the roofs to the vaulted spaces achieve stability by positive connectivity between the bearing of the roof structure on to masonry walls or piers beneath.
- 307. It was not possible to determine the stability system to the roof over the main lounge as no masonry walls or piers exist to the elevation to the high end of the roof. (See photo 4).
