DERBYSHIRE COUNTY COUNCIL

Ladycross House HOP

Condition Survey

1st October 2018

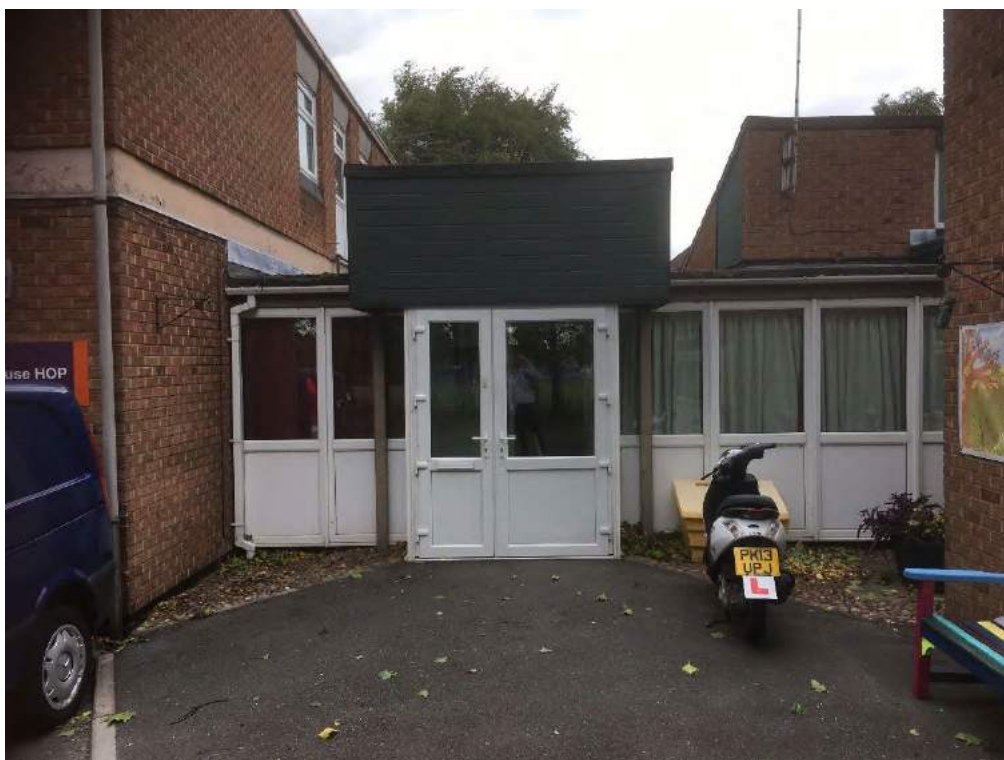
Photo 1 – Main Entrance

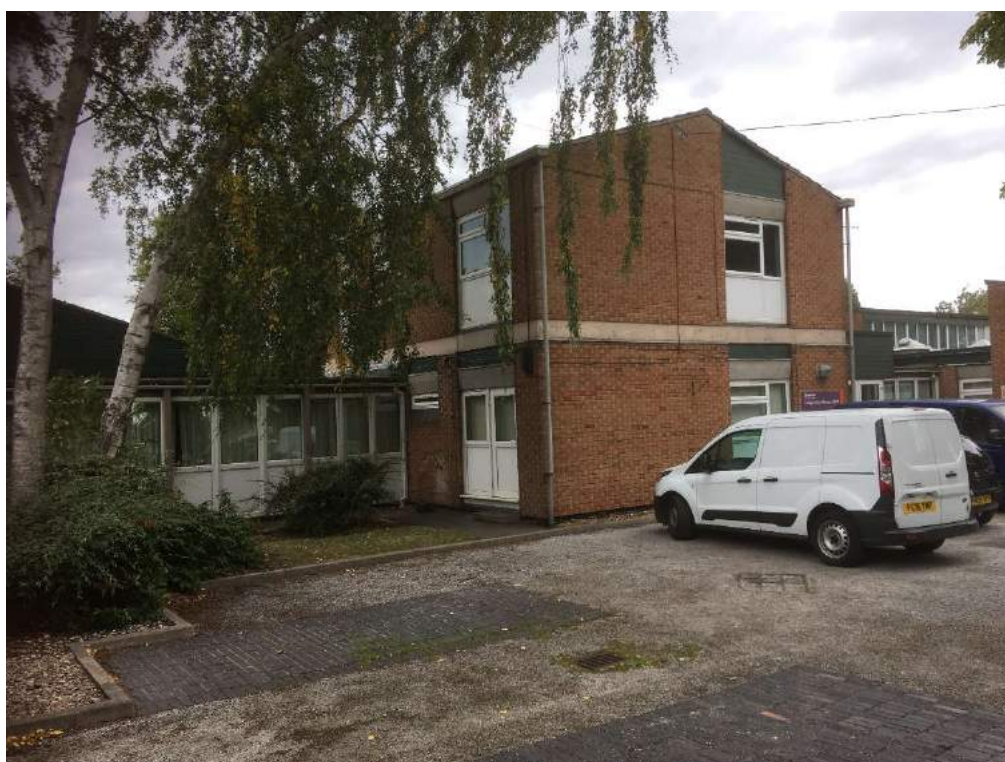
Photo 2 – Car Park

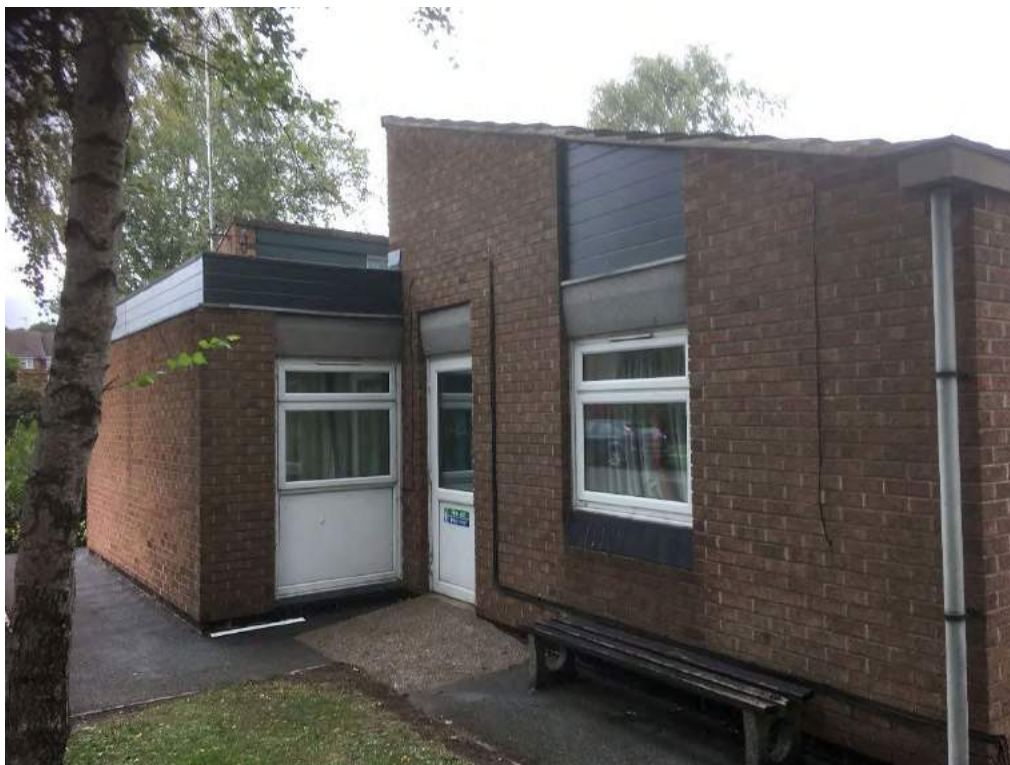
Photo 3 – General Elevation

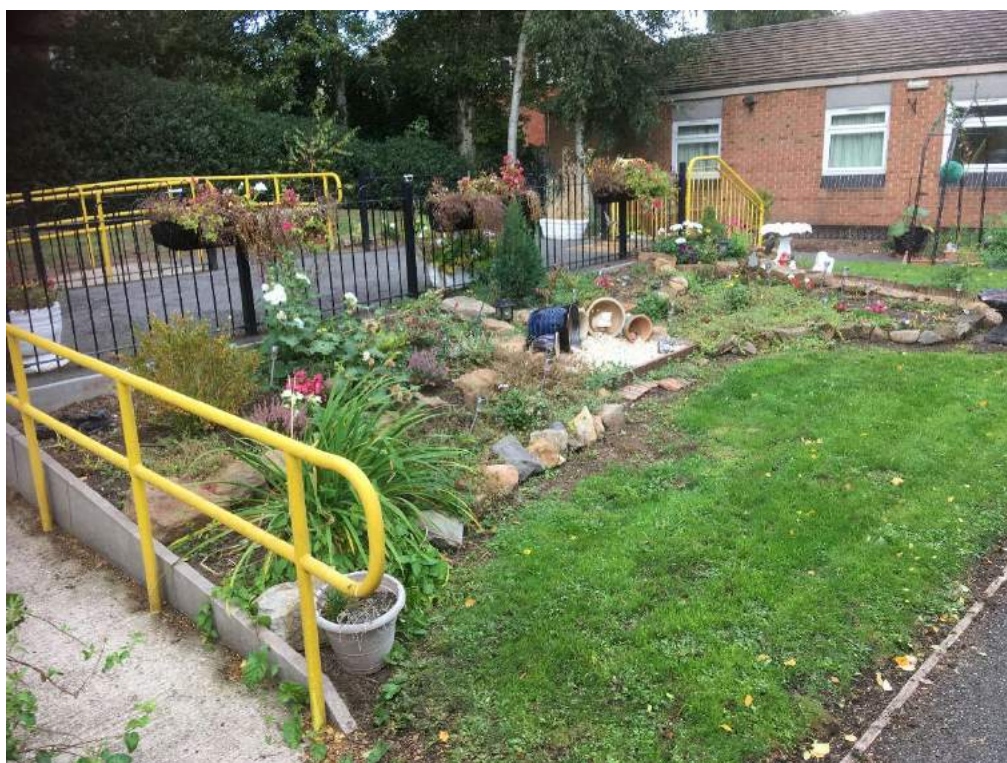
Photo 8 – General view of outdoor space

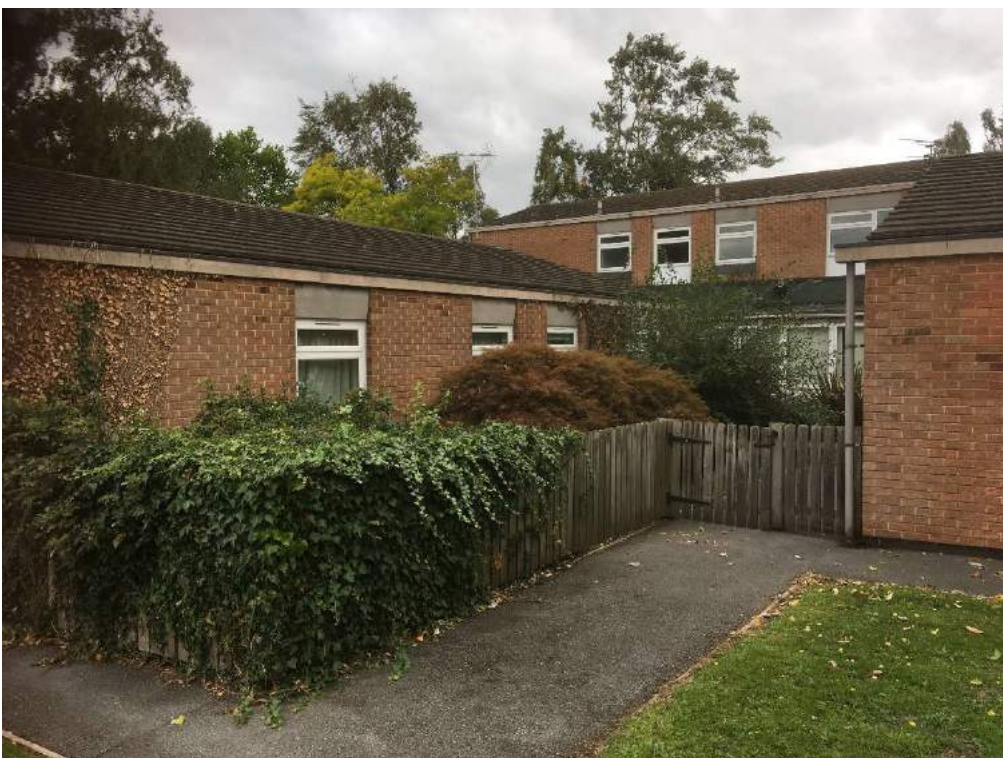
Photo 10 – General external view

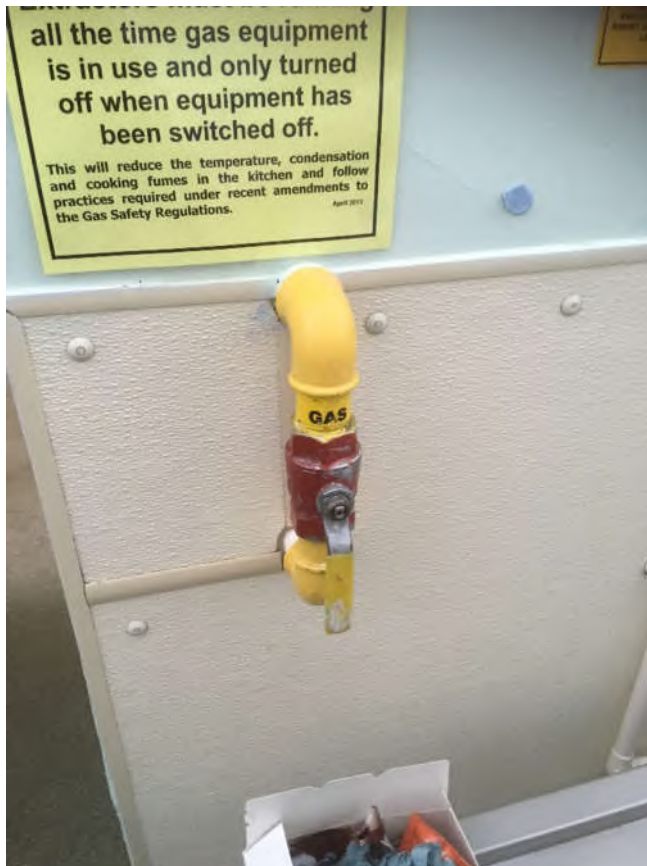
Photo 11 – Current gas safety shut off

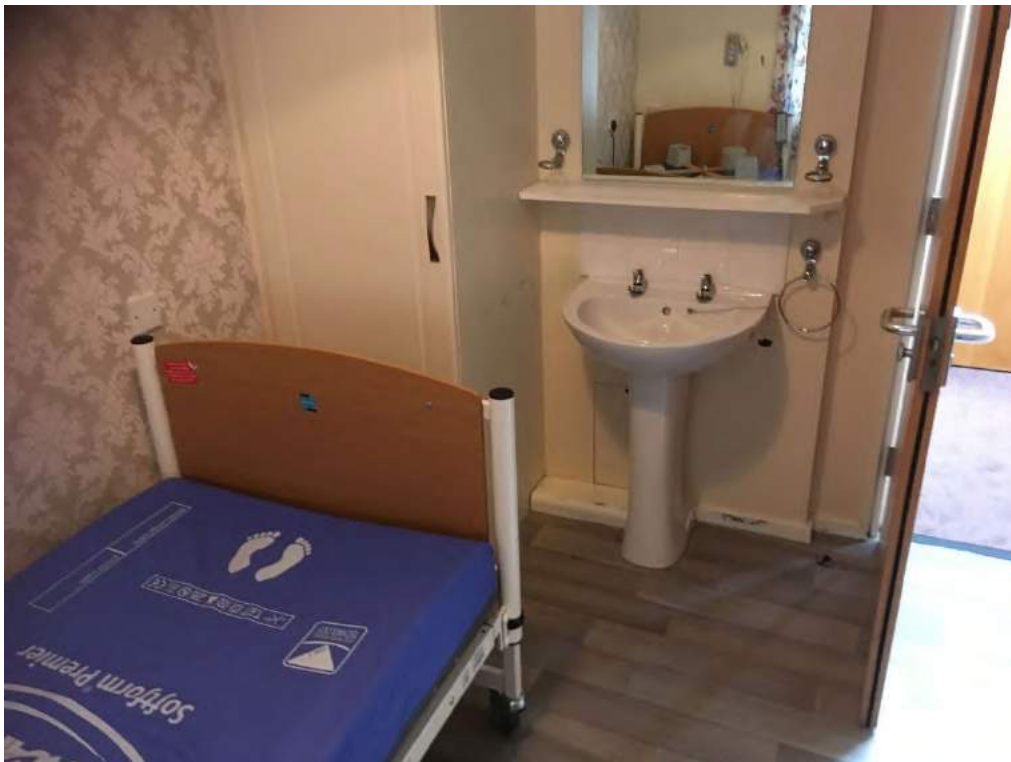
Photo 12 – Typical bedroom

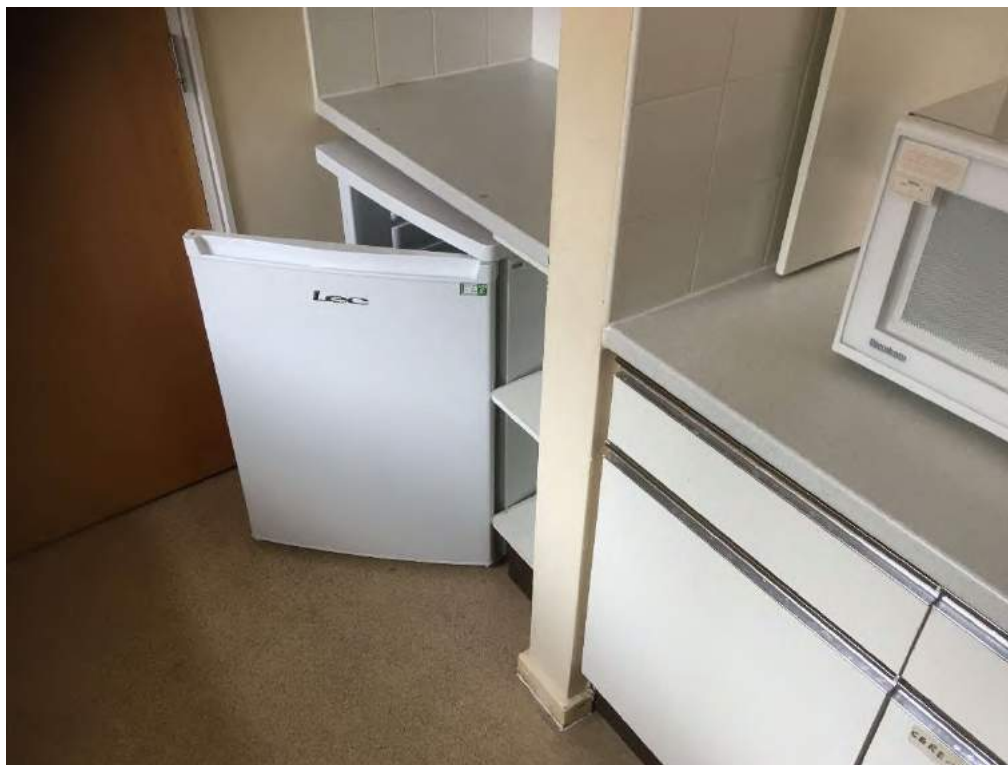
Photo 13 – Typical fixed furniture

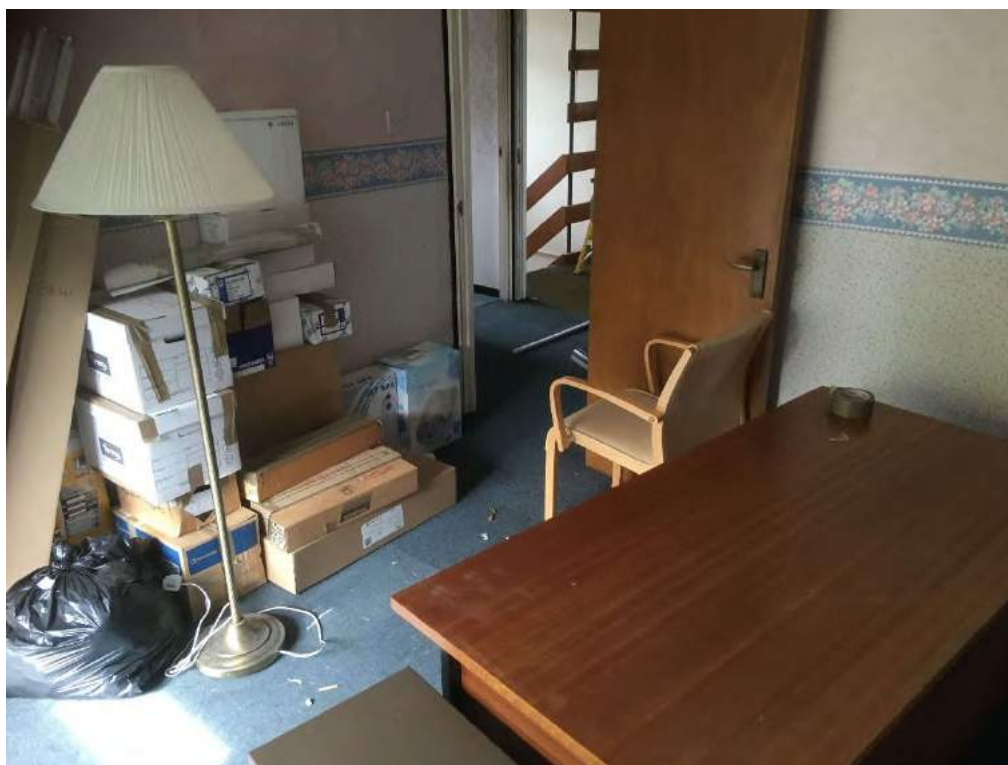
Photo 14 – First floor disused space

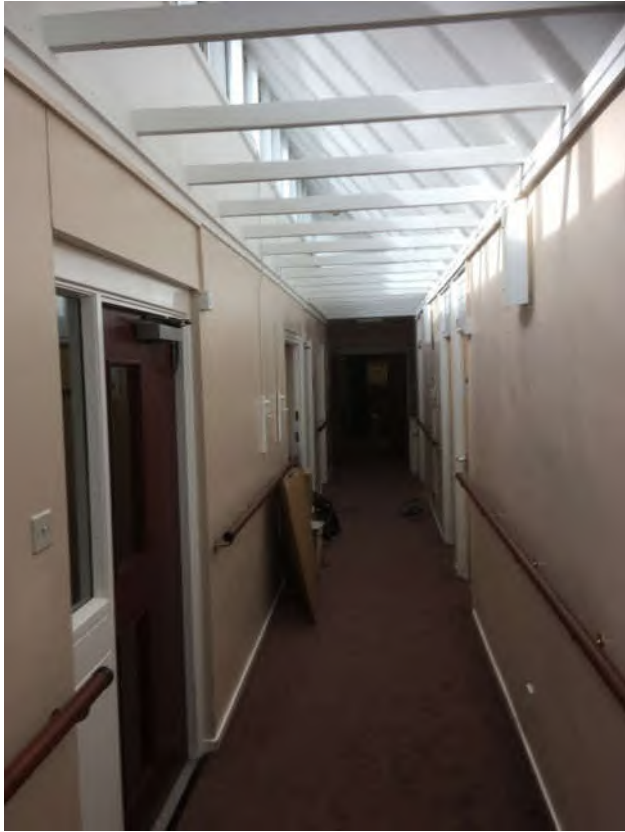
Photo 15 – Typical circulation corridor

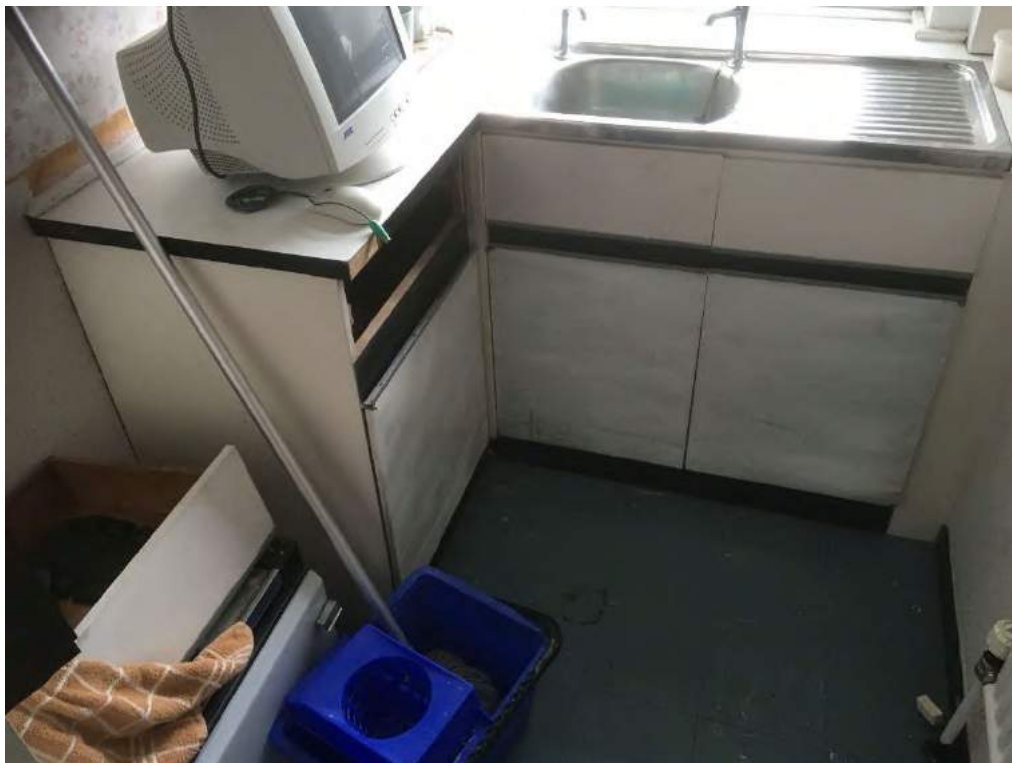
Photo 16 – First floor kitchen

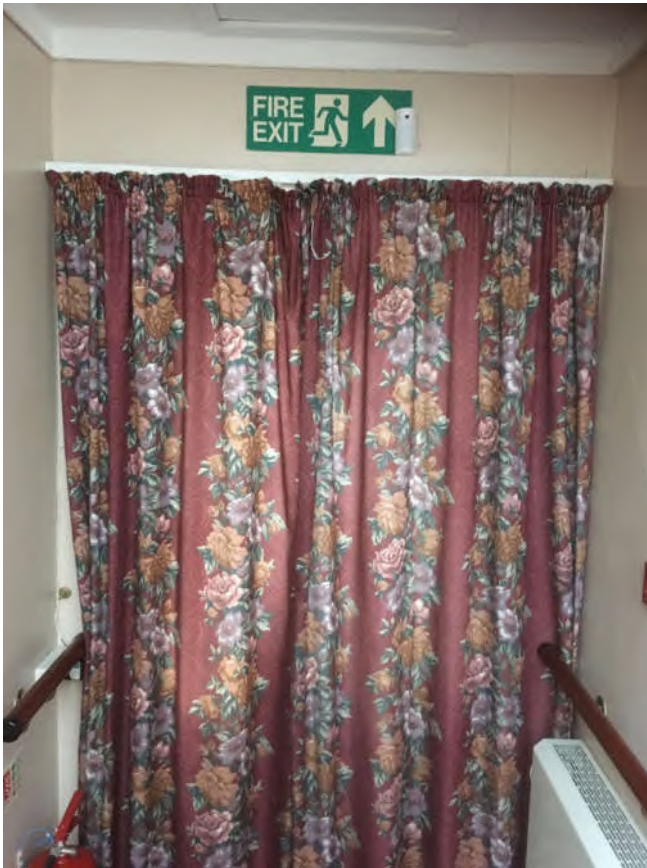
Photo 17 – Typical fire exit

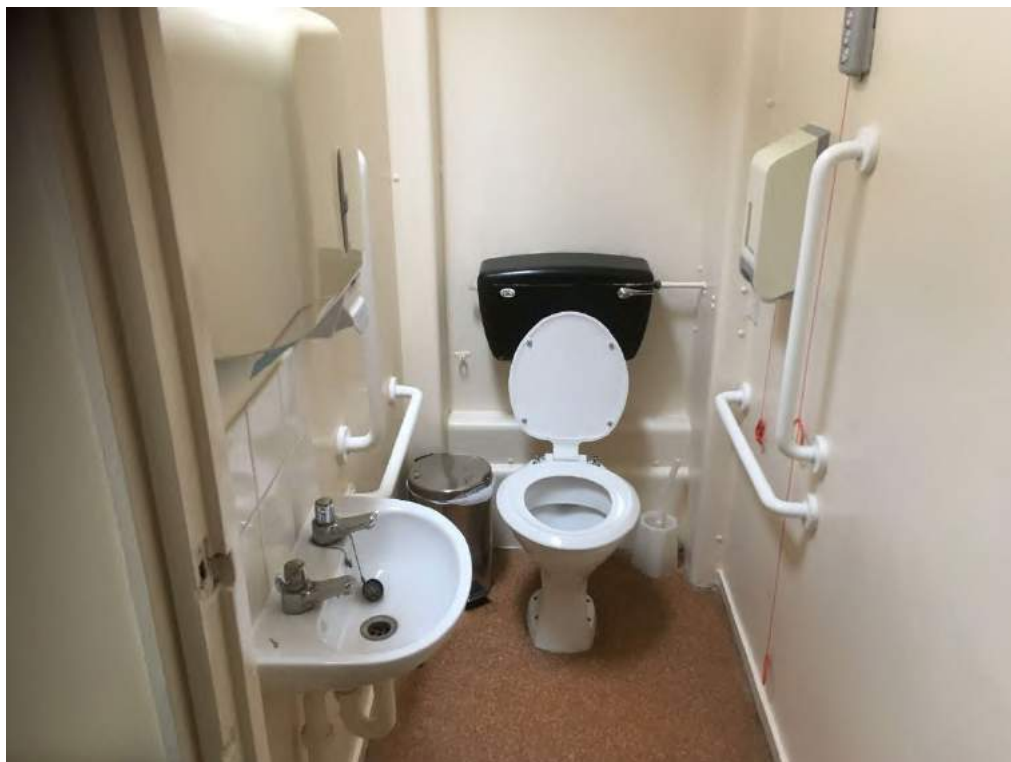
Photo 19 – Typical toilet provision

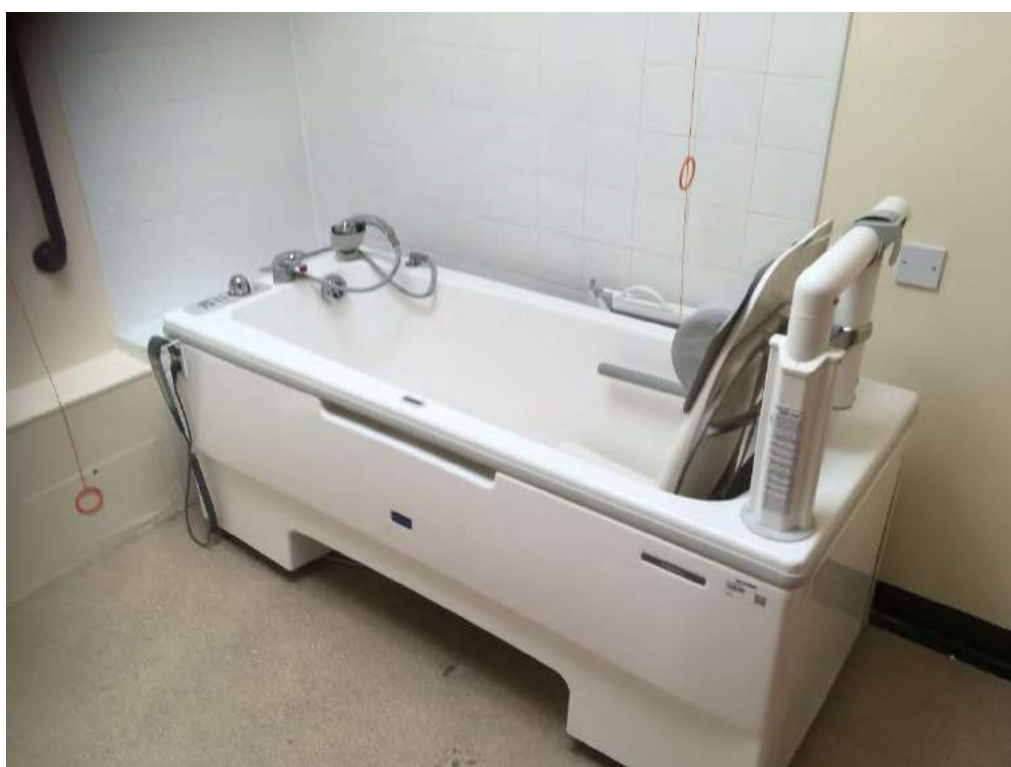
Photo 20 – Typical bathroom

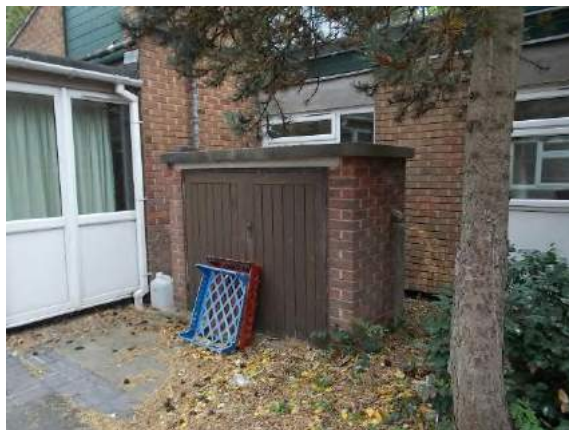
Photograph No 1 – Incoming Gas meter cubical.

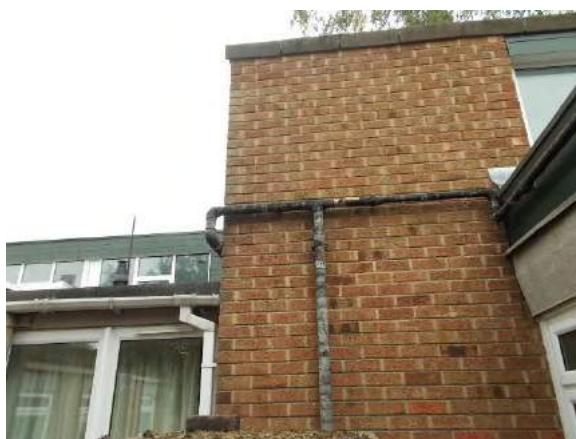
Photograph No 2 – The Gas mains exiting the gas meter room has been wrapped and needs to be labelled correctly.

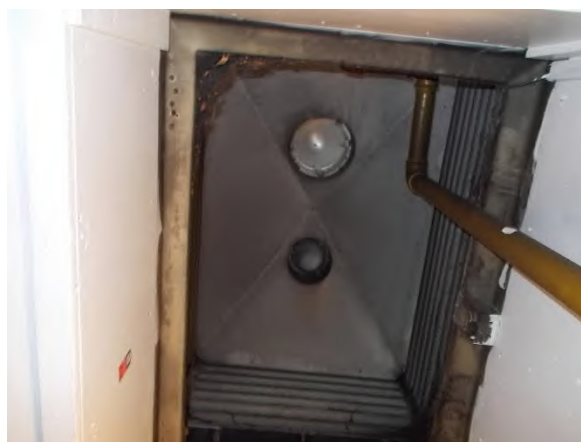
Photograph No 3 – Typical Gas pipework entering the plantrooms is routed through the penthouse ventilation housing and has a manual gas isolation valve in the boiler house.

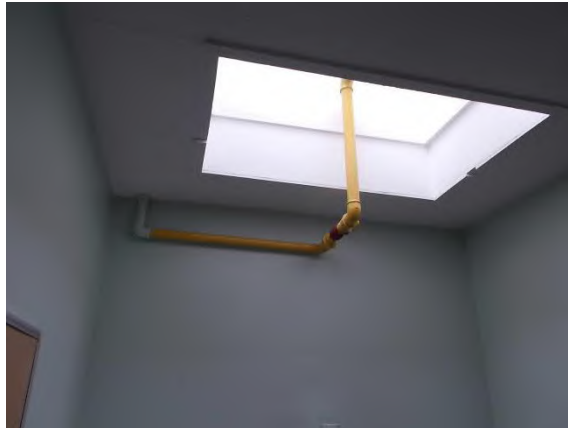
Photograph No 4 – The Gas enters into the main kitchen via a roof light note there is an isolation valve located at high level.

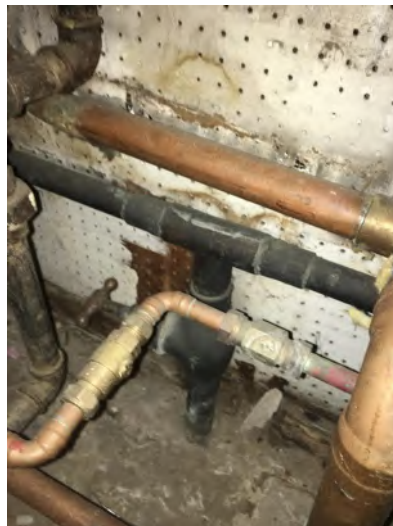
Photograph No 5 – The Incoming MCWS appears to enter the building in the central boiler house (room No 099), there was no evidence of a water meter.

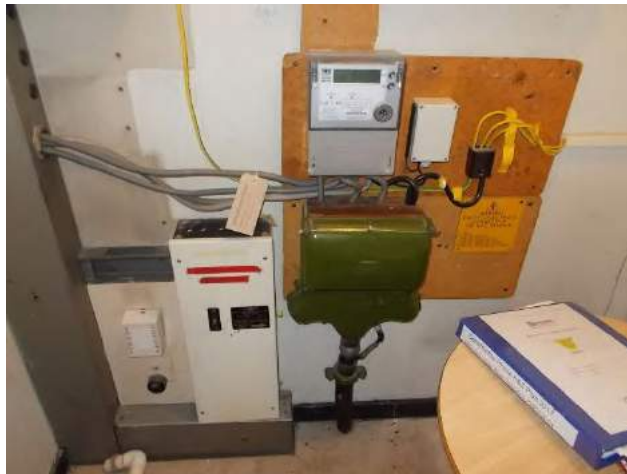
The electrical incoming utility supply enters the building in room 098 and terminates into an old Lucy service head, this room contains the incoming service head and utility meter. The nursing home appears to have a 3 phase 100A supply as the meter is a direct reading meter. The meter tails have not been supported from the meter to the mains trunking and have been left hanging.

Photograph No 6 – The Incoming electrical utility supply is located in room 098.

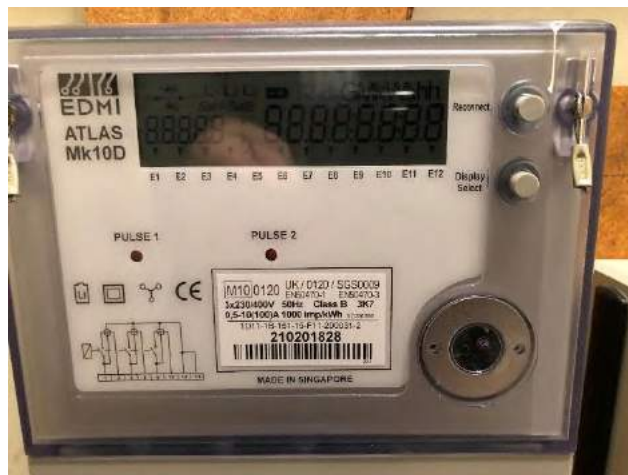
Photograph No 7 – The incoming utility meter for the care home.

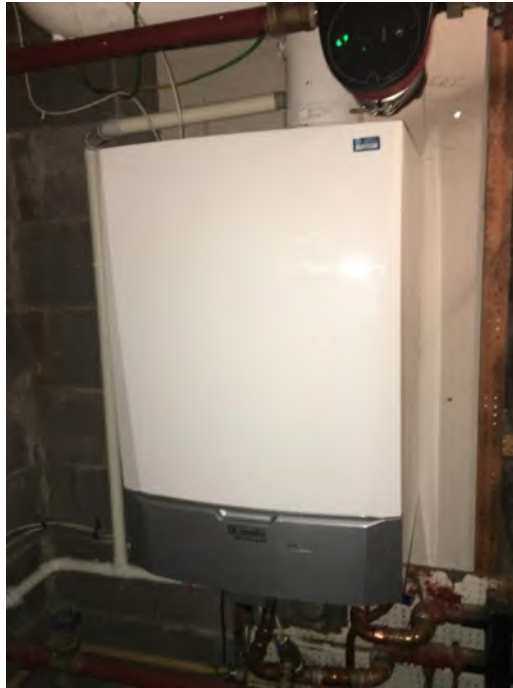
Photograph No 8 – Typical Boiler within the boiler plantrooms

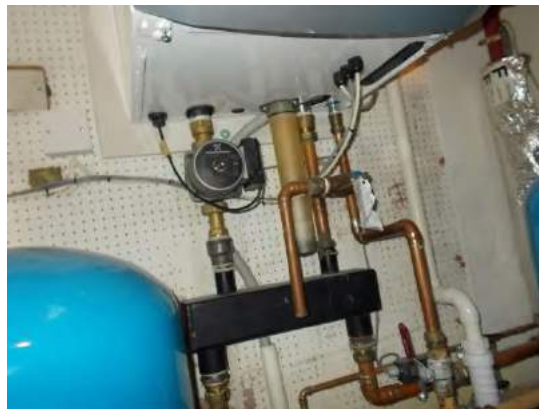
Photograph No 9 – Grundfos Boiler shunt pump - Note the pressure relief pipework discharging onto the floor.

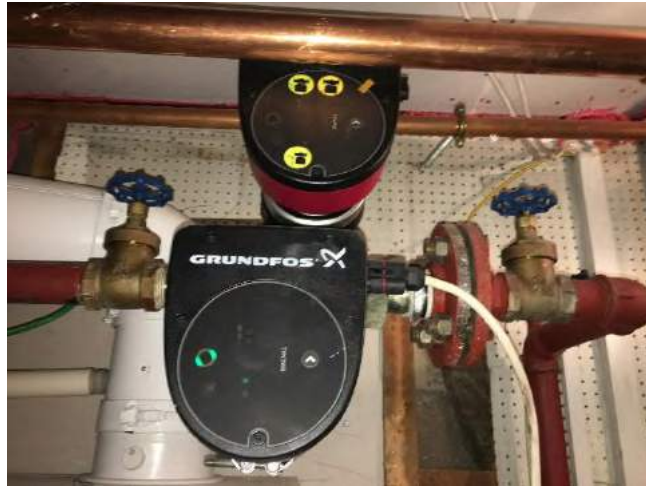
Photograph No 10 – Radiator Circulation Pumps

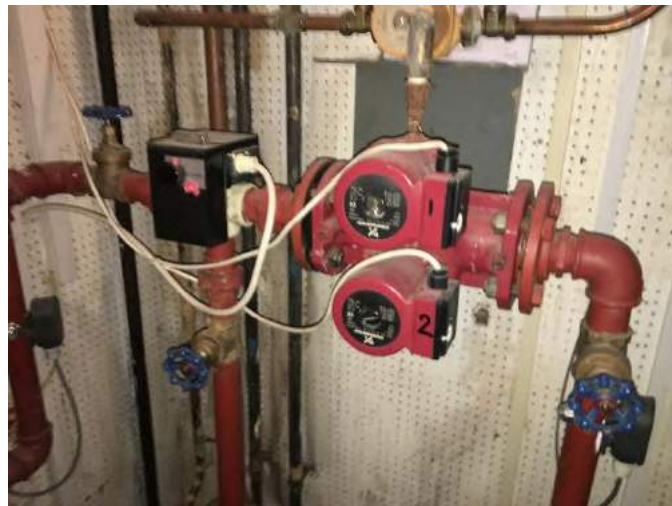
Photograph No 11 – HWS Primary Circulation Pumps

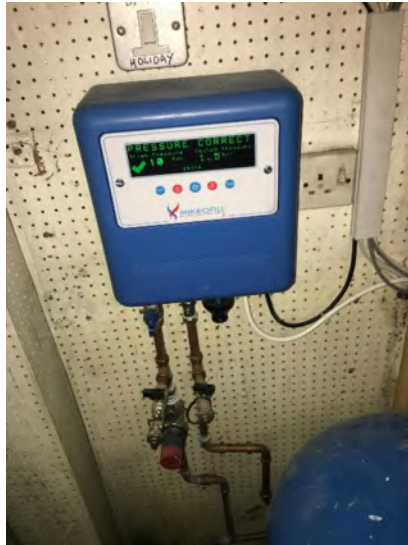
Photograph No 12 – Mikrofill EFD heating system pressurisation unit – Note water drain off pipe not correctly connected to any pipework

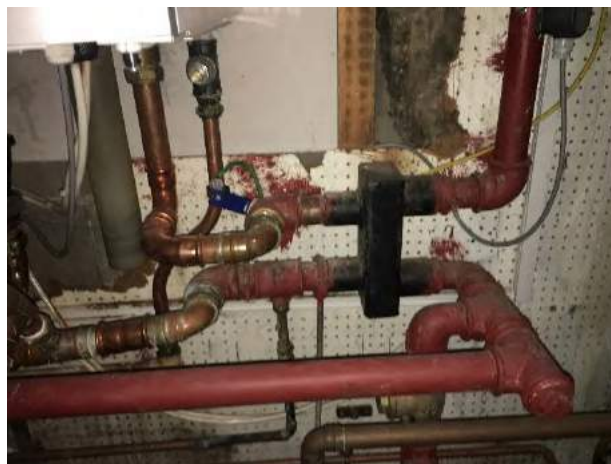
Photograph No 13 – Boiler connected to a small low loss header, note no insulation installed to pipework

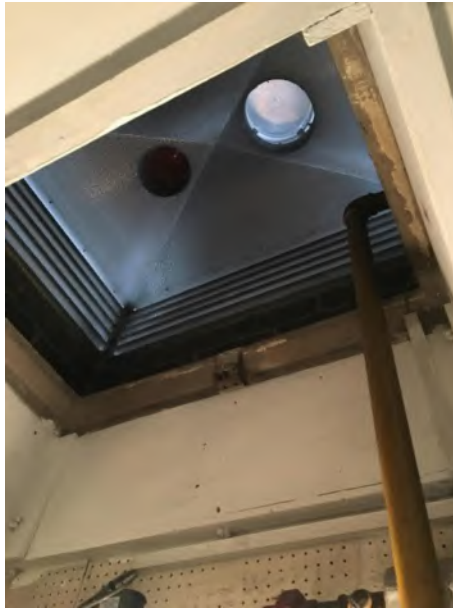
Photograph No 14 – High level penthouse ventilation housing to each boiler house. There is no low level ventilation into the room through the corridor doors.

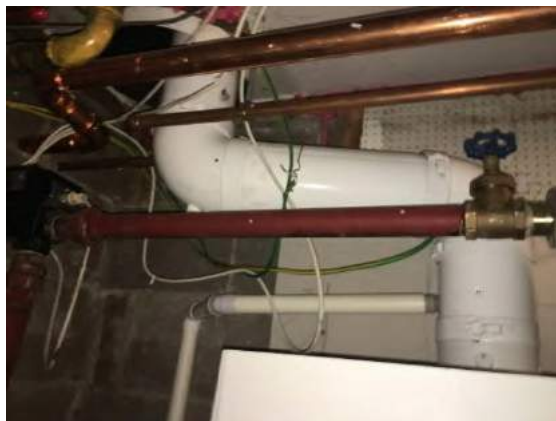
Photograph No 15 – Typical boiler flue installation through old flue and onto roof.

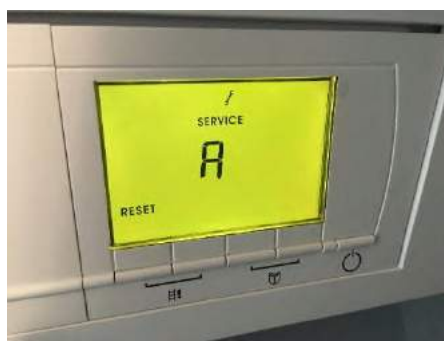
One of the boilers (Boiler House BP010) within the Buckingham Bungalow is in fault and calling for a service. It is not clear as to when the boilers were last serviced and it would be a recommendation that all of the boilers and the boiler pipework should be serviced and all test results taped to the boiler casing after inspection as well as being logged in the site log books.

Photograph No 16 – Boiler in plantroom No BP010 has service alarm indicated on the boiler control panel. This boiler needs to be serviced.

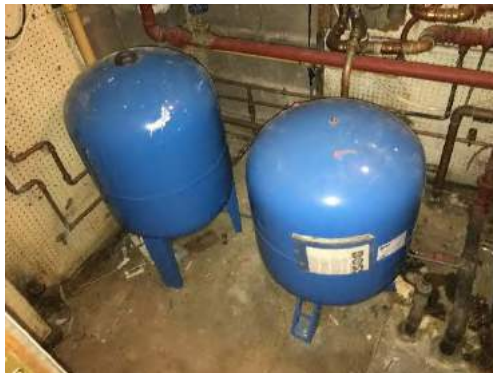
The LTHW heating and domestic HWS systems have been provided with expansion vessels. It is not clear if the domestic HWS vessel has been provided with the correct number of valves and drain off points to allow the vessel to be cleaned correctly. This needs to be reviewed and all HWS and any MCWS pressure vessels provided with the correct valves and drain down facilities.

Photograph No 17 – LTHW and domestic hot water expansion vessels installed within the boiler houses.

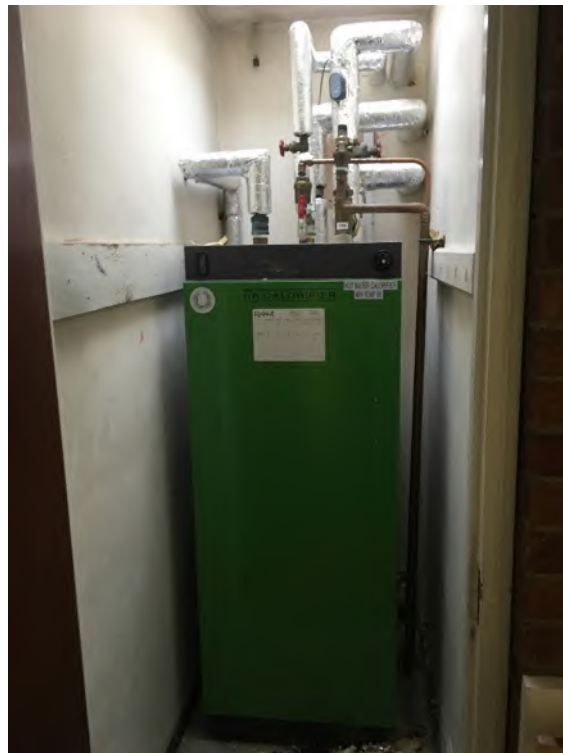
Photograph No 19 – Typical Beeston HR Calorifier for the domestic HWS generation

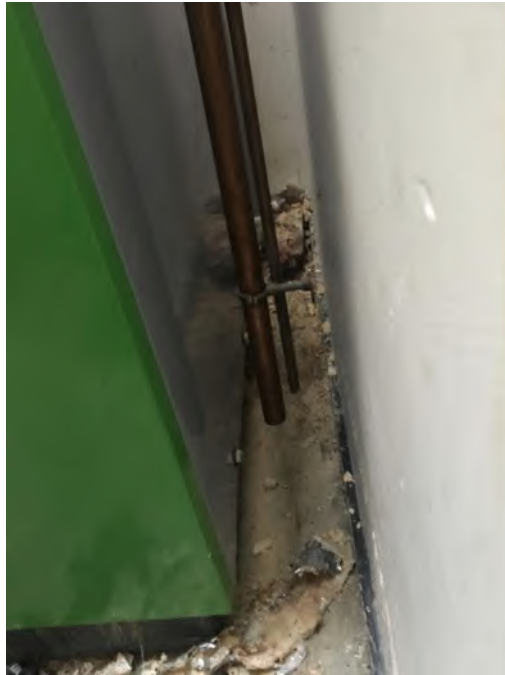
Photograph No 20 – Calorifier pressure relief and automatic air vent discharge pipework draining directly onto the floor and unsupported.

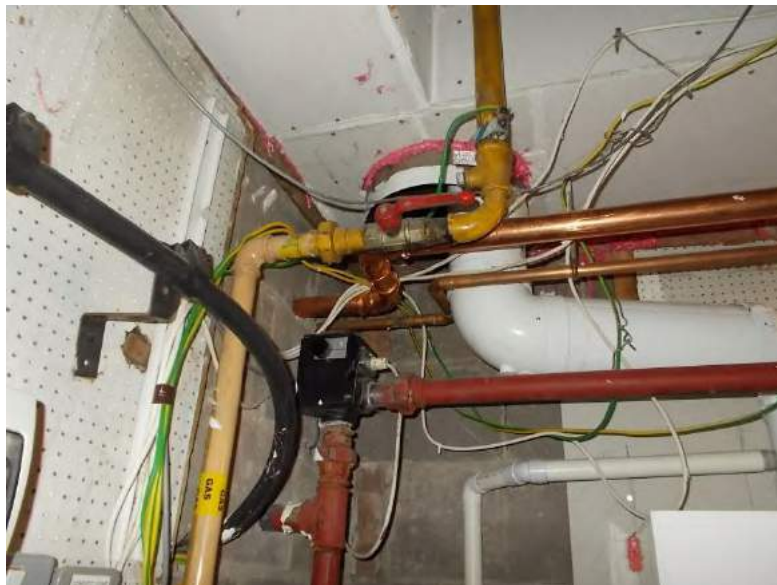
Photograph No 21 – LTHW control diverting valve to control the Calorifier temperature. Please note, that the LTHW steel pipework and the domestic HWS copper pipework is not adequately insulated or labelled.

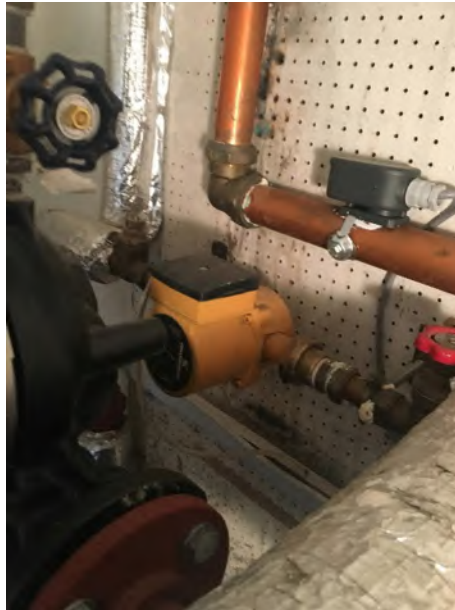
Photograph No 22 – Typical HWS secondary pump installed within the boiler houses, note there is some scale forming by the pipework joints

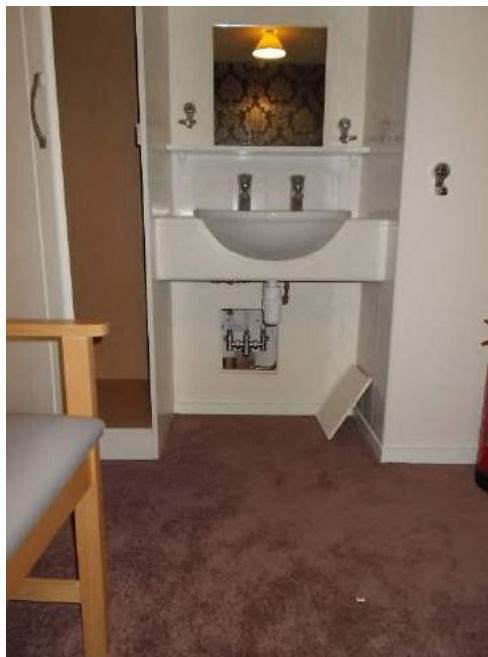
Photograph No 23 – Typical bedroom sink with thermostatic mixing valve installed below the sink.

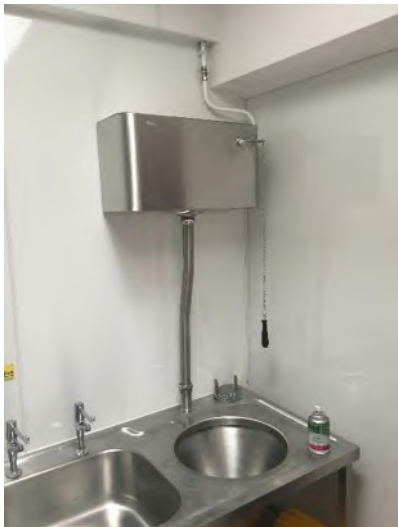
Photograph No 24 – Typical stainless steel sluice in sluice rooms.

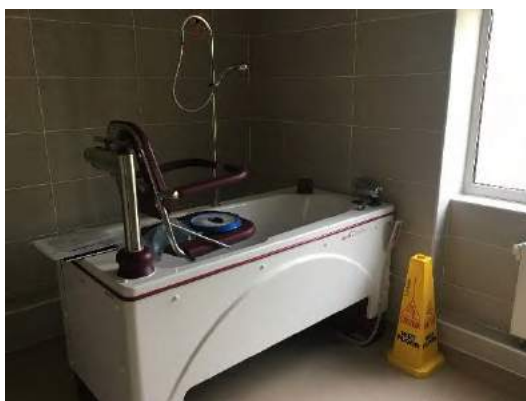
The Amenity block has been provided with a laundry (this room was not inspected as the room could not be accessed) and each bedroom wing has a central bathroom with motorised bath and a sluice room. One bathroom has a defective motorised bath and the remaining bathrooms have been refurbished.

Photograph No 25 – Typical motorised baths in bedroom block central bathrooms.

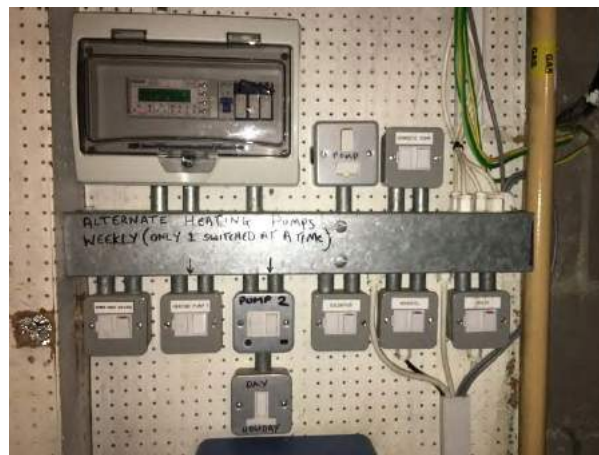
There were no controls schematics fitted within the plantrooms indicating how the controls operate and where the control devices are located.

Photograph No 27 – Typical boiler and HWS plant control system

Consideration should be given to replacing the controls with an efficient controls system that incorporates optimisation software, a new variable temperature heating system, pump switching for equal loads and operation. It may also be worth investigating if the provision of EC variable speed pumps would benefit the EPC certificate for the building.

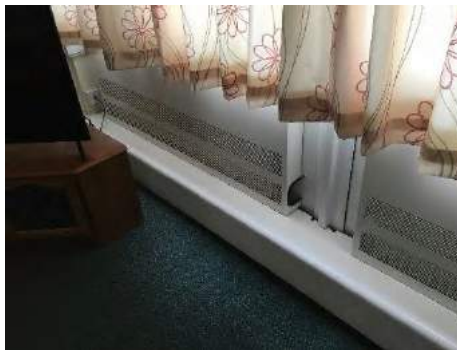
All of the radiators appear to be from the original install and in a poor condition and should be replaced with new LST radiators with new thermostatic valves sized for the rooms and a flow bypass system installed so that when all of the thermostatic valves shut down, water can still flow through the system.

Photograph No 29 – Typical wall mounted LST radiators with pipework boxed out.

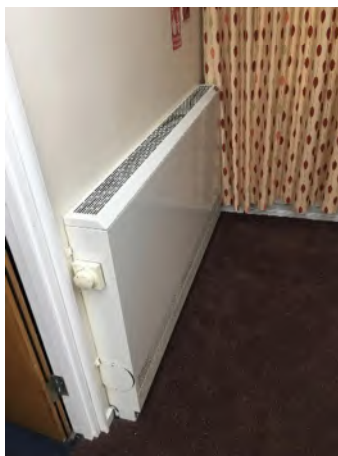
Photograph No 30 – Typical Floor mounted corridor LST radiator.

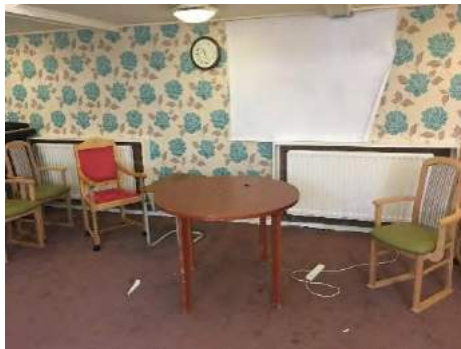
Photograph No 31 – Panel radiators installed in the amenity common room.

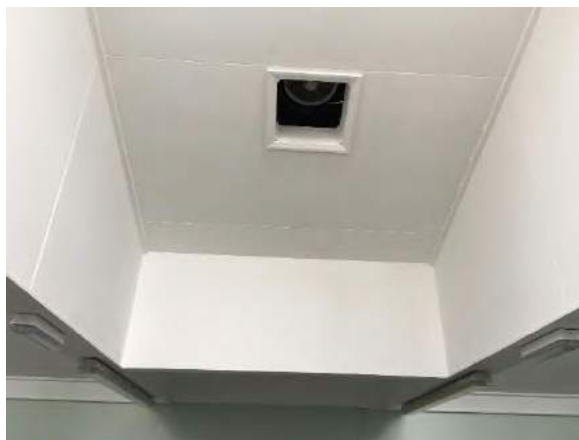
The kitchen ventilation does not comply for a modern kitchen and is not interlocked with the kitchen gas system. A cooker hood and a kitchen supply and extract ventilation system needs to be installed into the main kitchen. This should then be interlocked with the gas system in the kitchen.

Photograph No 32 – This photograph indicates ceiling mounted kitchen extract fan. Note there is no cooker ventilation hood currently installed.

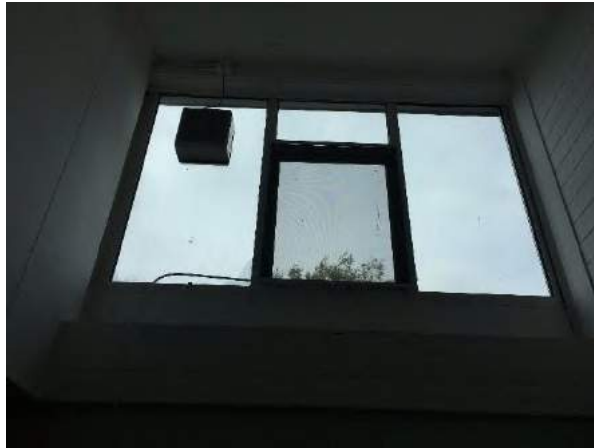
Photograph No 33 – Window mounted additional kitchen extract fans. Note that the openable window has been provided with an insect screen so that the openable window can be opened for additional ventilation.

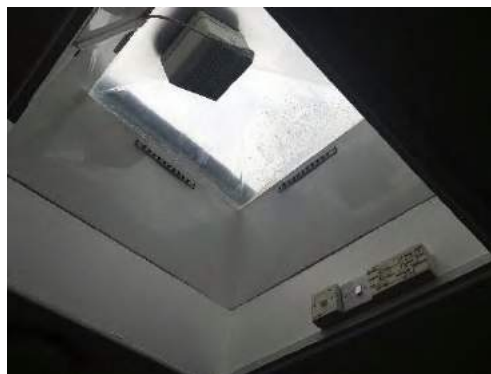
Photograph No 34 – Typical toilet and bathroom extract fan.

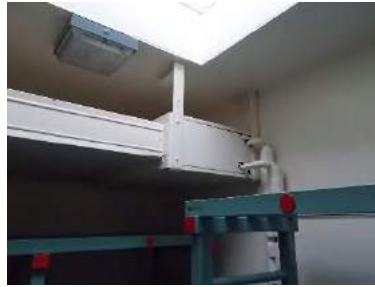
Photograph No 36 – Kitchen make-up air duct with LTHW heater installed.

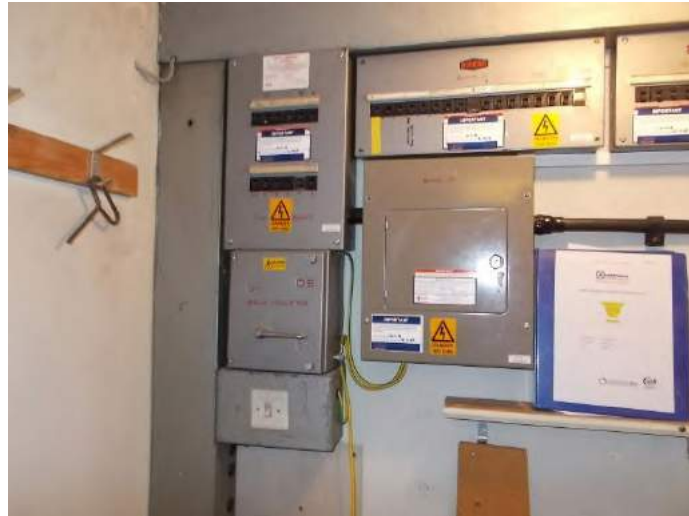
Photograph No 37 – Main MEM distribution board located within the boiler house showing MCB sizes.

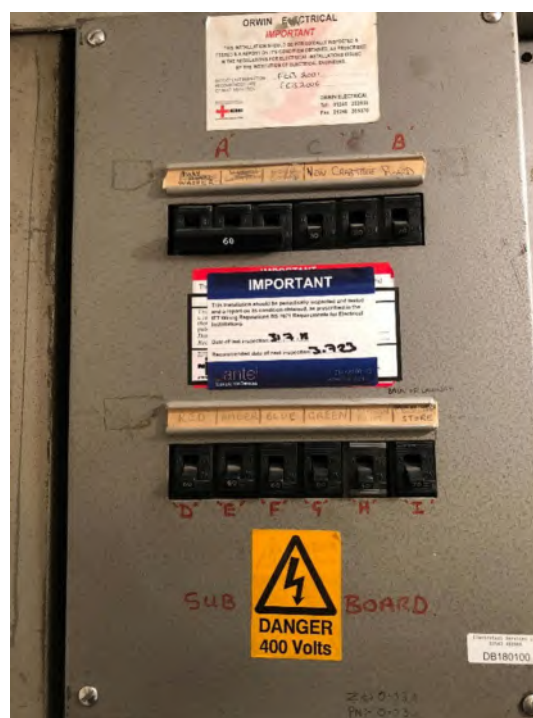
Located within the electrical cupboard (room 098) is the main electrical distribution board, this is an old outdated Dorman MCB distribution board, this distribution board feeds a series of distribution boards located throughout the building. Generally the distribution boards have been manufactured by Dorman, but there is a couple of Crabtree C50 range of distribution boards currently installed in the electrical cupboard and possibly within the Laundry (we did not have access to the laundry to verify). A couple of the distribution boards have been replaced in the week of our inspection and works were being carried out on the electrical installation to bring parts of the system up to standard as indicated in line the test report dated 1st August 2018.

Photograph No 38 – Sub-board - Dorman main distribution board. Note - fire alarm panel supply is not fed from this board. Fire alarm supply fed from distribution board B

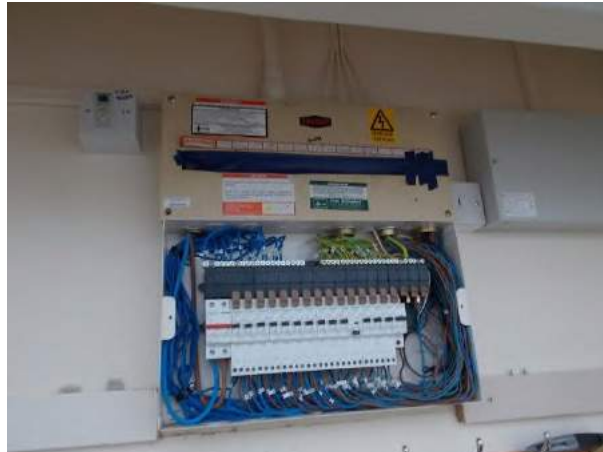
It was noted that the existing wiring had been extended from the existing distribution board into the new board, this had been carried out utilising brown and blue cabling and it was not clear how the cabling had been jointed in the old distribution board. There were signs of through crimps being utilised in the corner of the new distribution board.

Photograph No 39 – New distribution board installed directly under the original distribution board, note all but one circuit has an RCBO fitted and the cable colours are brown/blue, if you look closely in the top right corner there are through crimps installed.

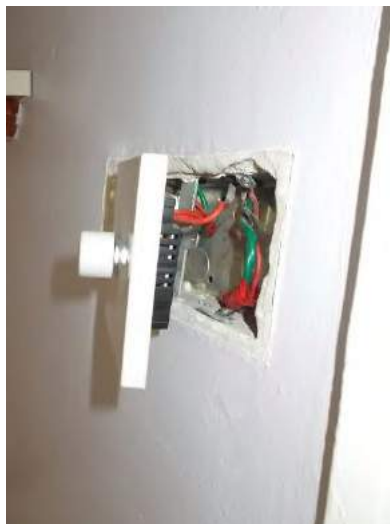
There were a few switches which had been released from the wall to carry out remedial works in one of the bedrooms, this showed that the existing twin and earth wiring appears to be solid drawn cabling in red and black colour (the earth sleeve is the old solid green colour) configuration which indicates that this is the original wiring for the building. We would recommend that, although this wiring has recently passed a condition inspection/report, that the existing cabling be replaced with new, as there have been modifications carried out on the system and these should be investigated and all redundant cabling replaced.

Photograph No 40 – Existing dimmer switch with twin & Earth cable installed, please note the earth sleeving is a sold green colour and that some of the cables have been left taped up in the back of the switch box.

It has been reported that the existing wiring has issues with certain circuits which are to be rewired. The neutrals have been found to be mixed up and with cross connections. The Earths need urgent attention as these are not up to current standards. The wiring in the building needs to be replaced as soon as possible.

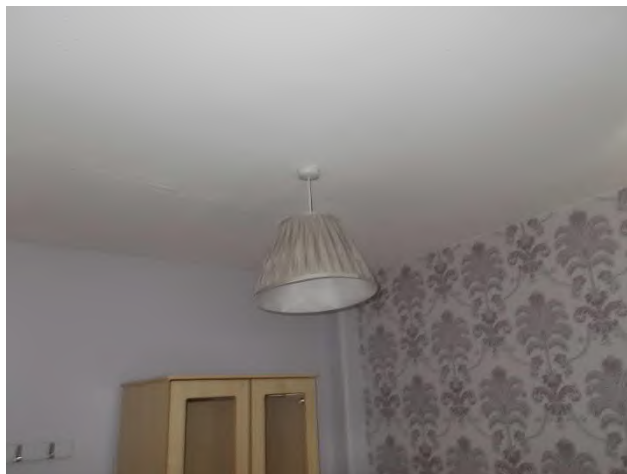
Photograph No 41 – Typical bedroom central pendant luminaire

- Install dimmable LED lamps to the central pendent luminaires and where necessary replace the dimmer switch with a suitable dimmer switch for the LED Lamps.

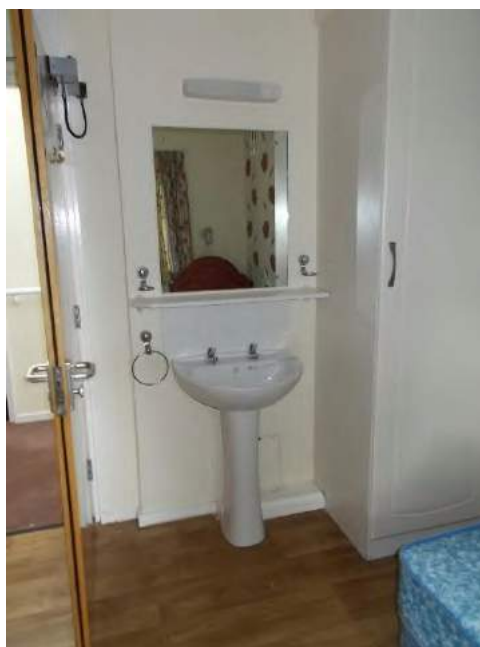
Photograph No 42 – Typical bedroom mirror luminaire.

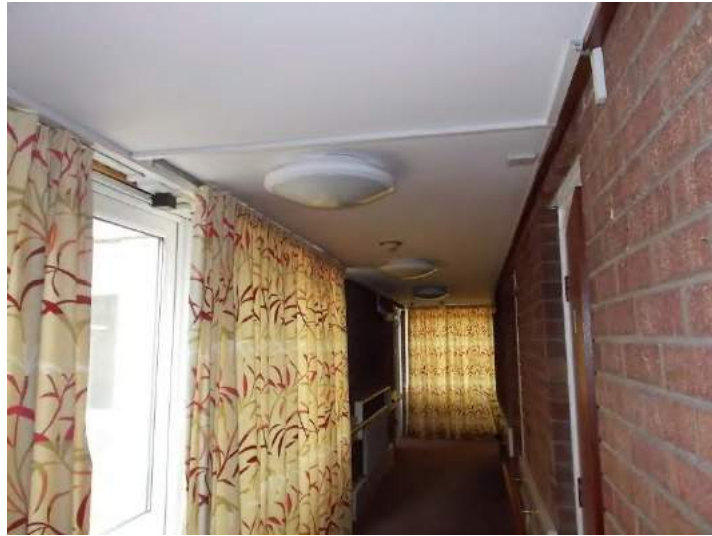
Photograph No 43 – Amenity area corridor lighting
