DERBYSHIRE COUNTY COUNCIL

Ladycross House HOP

Condition Survey

1st October 2018

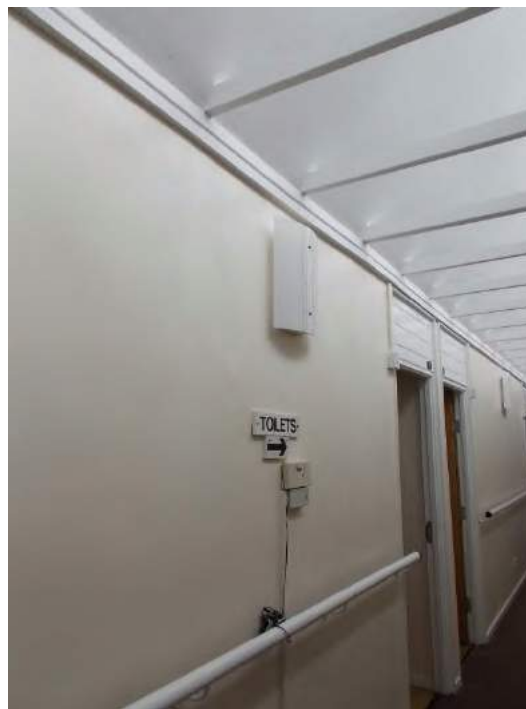
Photograph No 44 – Typical Bedroom Corridor lighting.

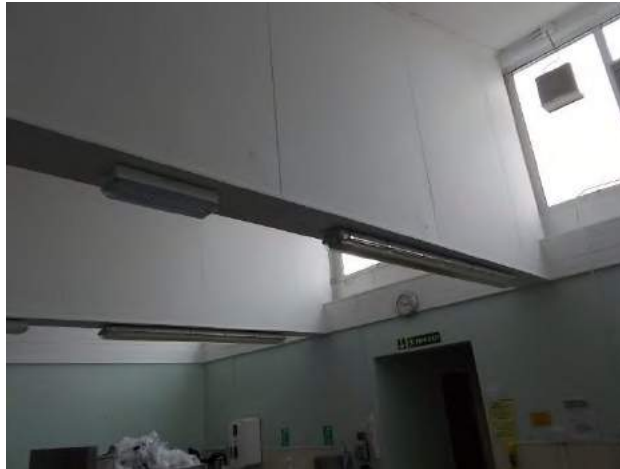
Photograph No 45 – Main Kitchen Lighting

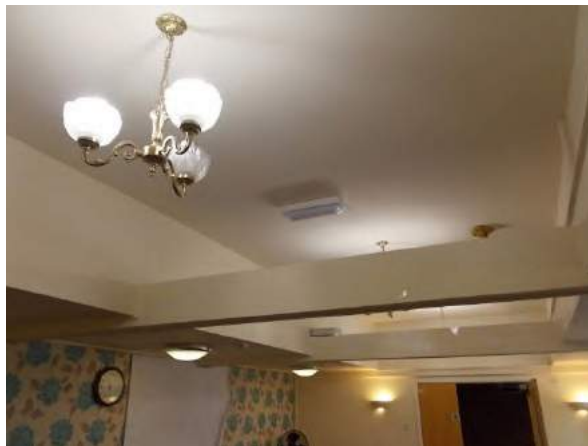
Photograph No 46 – Amenity area common room lighting.

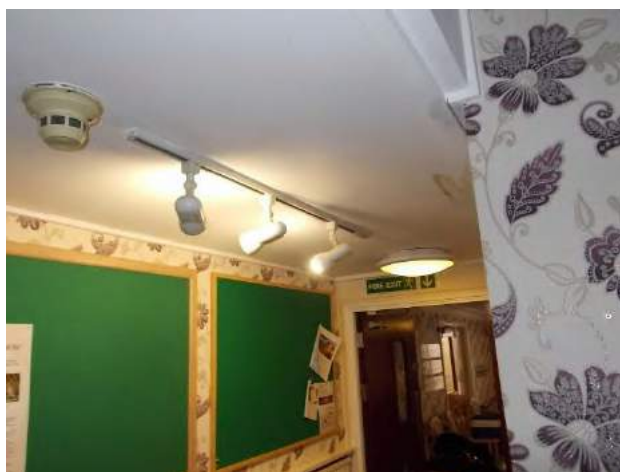
Photograph No 47 – Amenity area entrance corridor notice board lighting.

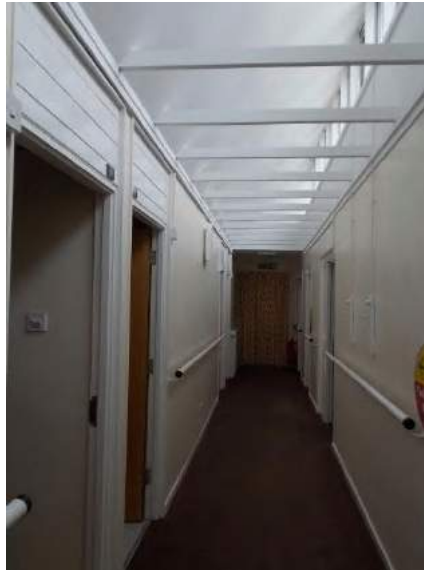
The building is lacking the correct number of illuminated exit signs to ensure that the escape routes are clearly identified. It is not clear if this building should be classified as a public building as visitors for the residents may be within the building and need directing to an emergency exit, again this should be reviewed with the Fire Officer to ensure the correct illuminated signage is installed.

Photograph No 49 – Typical corridor with curtains over the emergency exit doors. Note the sign over the door has a non-maintained emergency luminaire in front of the sign. It may not be possible to see the signs at night if the corridor lights are switched off.

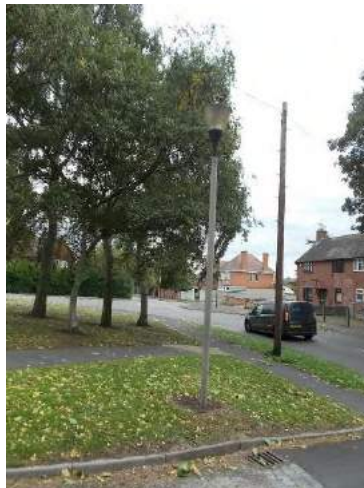
The car park has been provided with 3 no column mounted external luminaires, the lamp type was not clear at the time of our inspection while the external perimeter of the building is illuminated by wall mounted bulkhead luminaires. Although we were not able to witness the external lighting we were told it all operated satisfactory. The general external lighting is controlled via a photocell and time clock arrangement.

Photograph No 50 – There are a few lighting column on the site illuminating the main entrance areas.

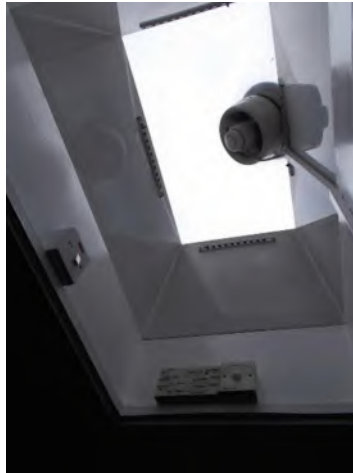
Photograph No 53 – Typical toilet extract fan power supply and controls

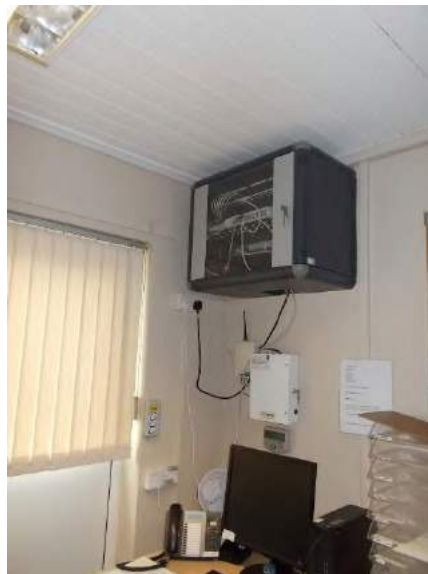
Photograph No 54 – Data rack installed in room No 080.

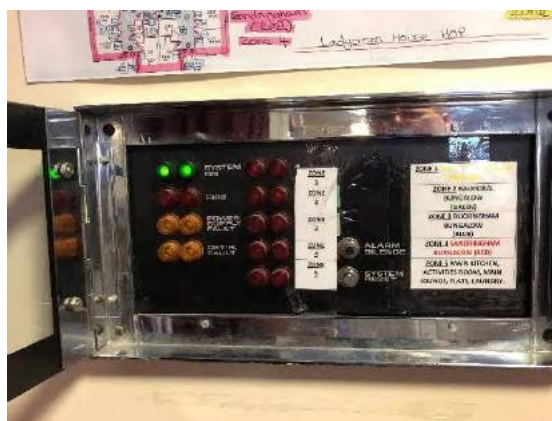
The fire alarm control panel does not comply with EN54 for the control panel and it is not clear how long the battery autonomy is rated at. This panel has reported issues which cannot be resolved as the panel is obsolete and should be replaced with a new addressable system.

Photograph No 55 – Conventional fire alarm panel located in the main entrance.

- Replace the fire alarm system to bring the system up to the current standards of BS5839.
- Replacement of the bedroom block distribution boards with new Schneider Acti9 boards.

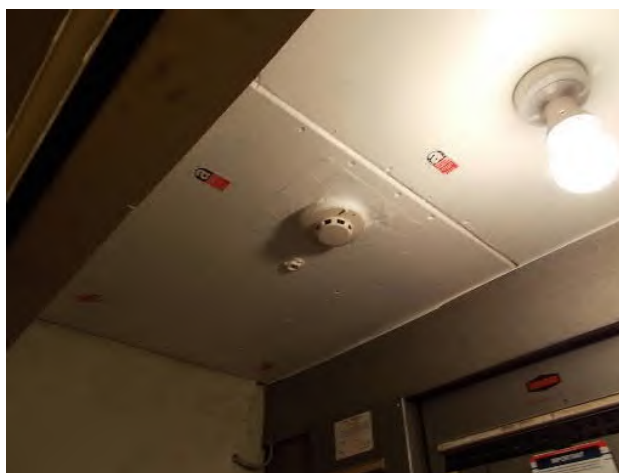
Photograph No 58 – Some of the smoke detectors have been partially recessed into a fire board, this detector is in the electrical intake room (room 099) and does not comply with BS5839 in terms of the detection head off the soffit. Note the fire board contains asbestos.

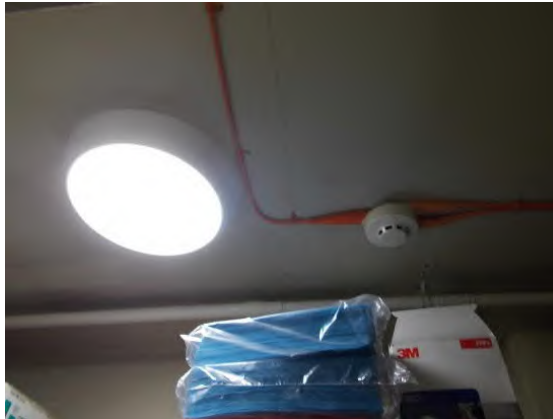
The fire alarm wiring in some instances has been extended utilising MICC cable with an orange sheath. It is not clear if the wiring is up to current standards and to ensure that the fire loops are correctly installed the fire alarm system should be rewired utilising modern enhanced fire performance cabling, this will allow any spur connections to be removed from the system and a formal loop formed for each loop to be installed.

Photograph No 59 – Fire Alarm cabling installed in orange MICC cabling in the store 090.

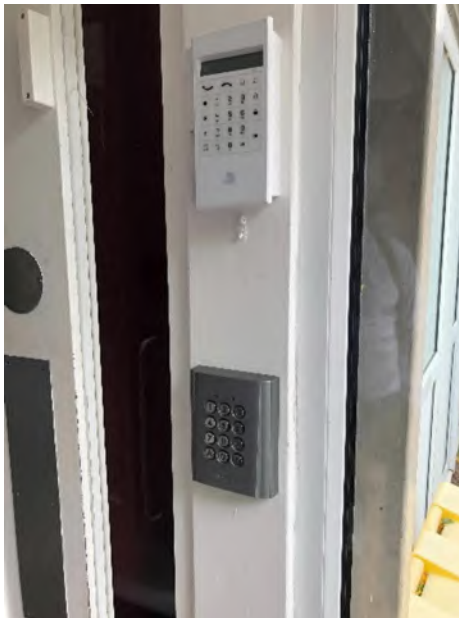
The main entrance lobby door to the reception area restricts access into the main part of the building by an access controlled system, consisting of a key pad in the entrance with a push to exit. It was not clear if a green emergency break glass had been installed on the secure side of the door. Some of the door contacts need to be re-fixed back to the structure.

Photograph No 60 – Main entrance door access system and security key pad control.

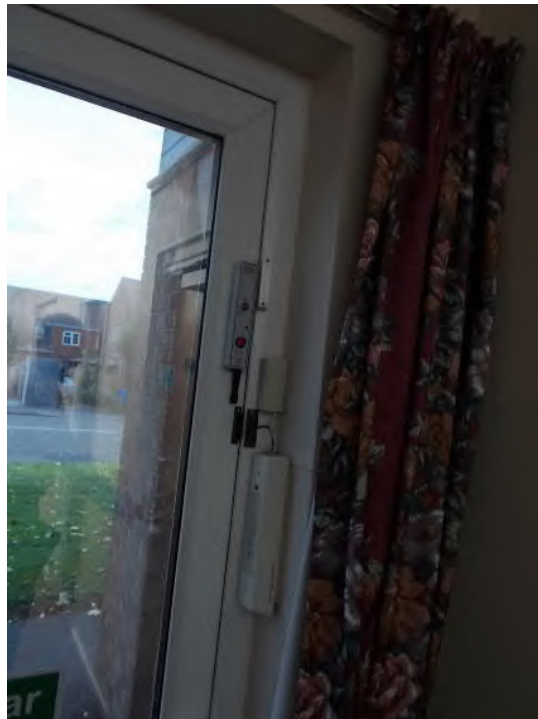
Photograph No 61 – Fire exit door with a First Q Wander Guard Alarm fitted.

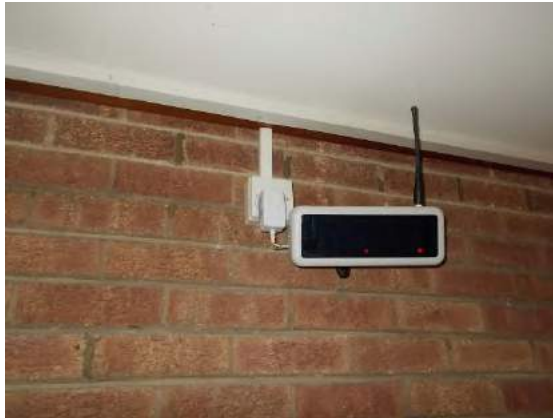
Photograph No 63 – Bedroom monitor by the entrance to each wing. It is not clear if this is for the nurse call system or the First Q Wander Guard system.

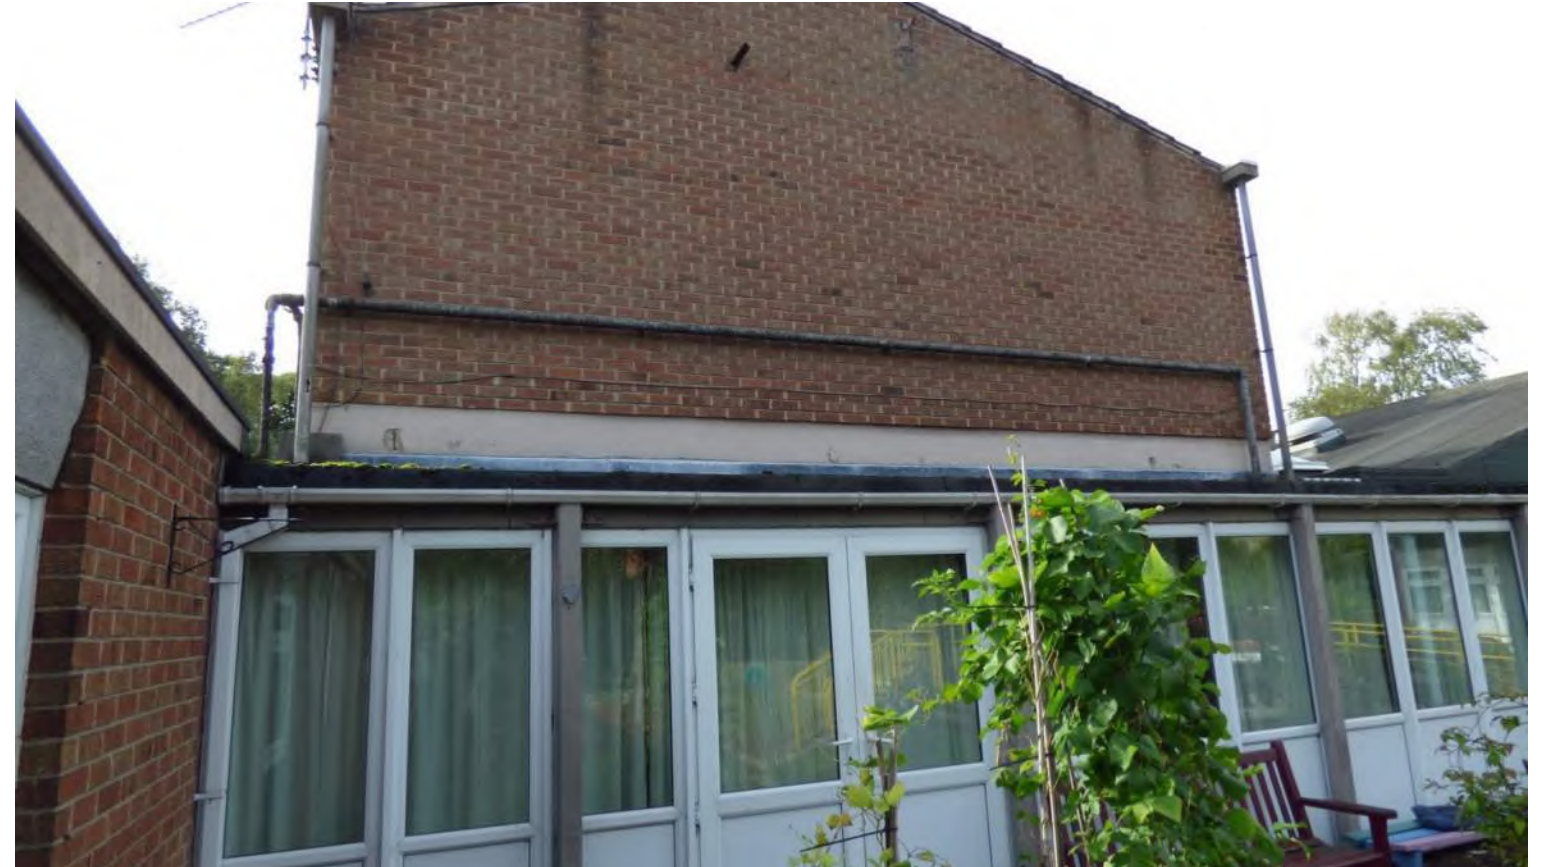
Photo 06

- 301. The duo pitch roof over the section shows no evidence of significant distortion to the ridges and pitches, however there is significant moss growth on the concrete tiles.
- 302. The front elevation is the gable and comprises one uPVC window each at ground and first floors, there is an exposed concrete string at first floor level and metal cladding panels above the windows; there are no structurally significant distortion of the front gable. **(See Photo 03)**
- 303. The left and right hand side elevations have pre-cast concrete guttering at eaves level and uPVC windows; and there is no evidence of significant distortion or bowing of the elevations. **(See Photos 04 & 05)**
- 304. The rear elevation is a gable and has no openings; and there is no evidence of bowing or significant distortion in the exposed upper gable. **(See Photo 06)**

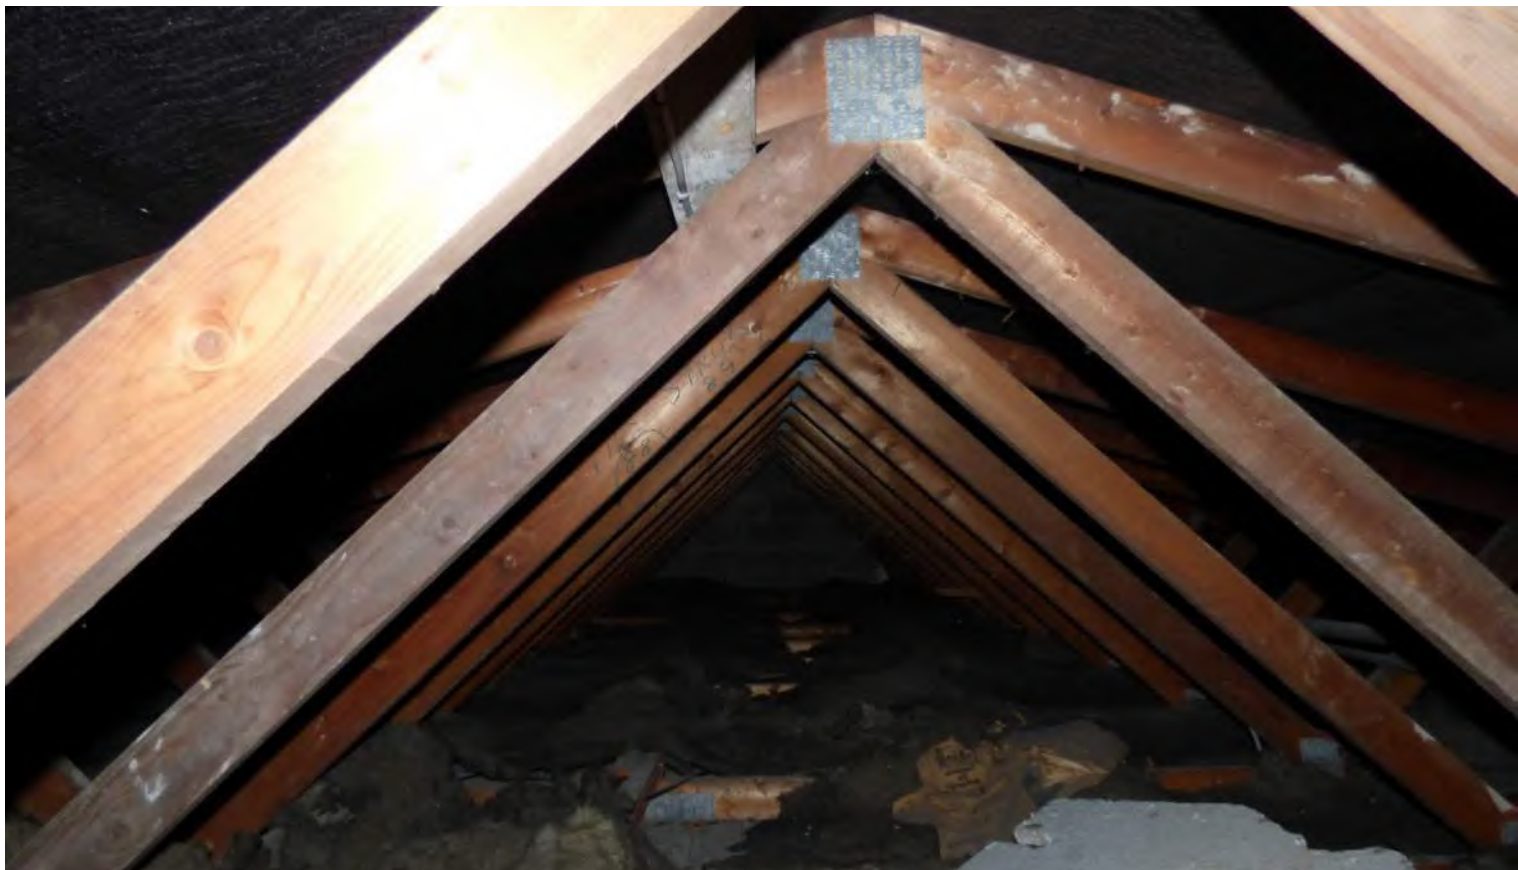
Photo 07

- 305. The roof was inspected from a hatch in the passage at first floor.
- 306. The roof is underdrawn with a plastic reinforced sarking felt and comprises proprietary light timber trusses spaced 600mm apart. The timbers of the truss are approximately 90mm deep and 30mm thick. **(See Photo 07)**
- 307. The timber truss structure is poorly insulated and does not have sufficient diagonal bracing, however there is no evidence of racking or general distortion of the structure.
- 308. The timber truss diagonal members has been modified to support metal plumbing pipes by introducing timber horizontal supports between. **(See Photo 08)**
- 309. There is a tear in the plastic sarking felt under the right hand pitch. **(See Photo 09)**

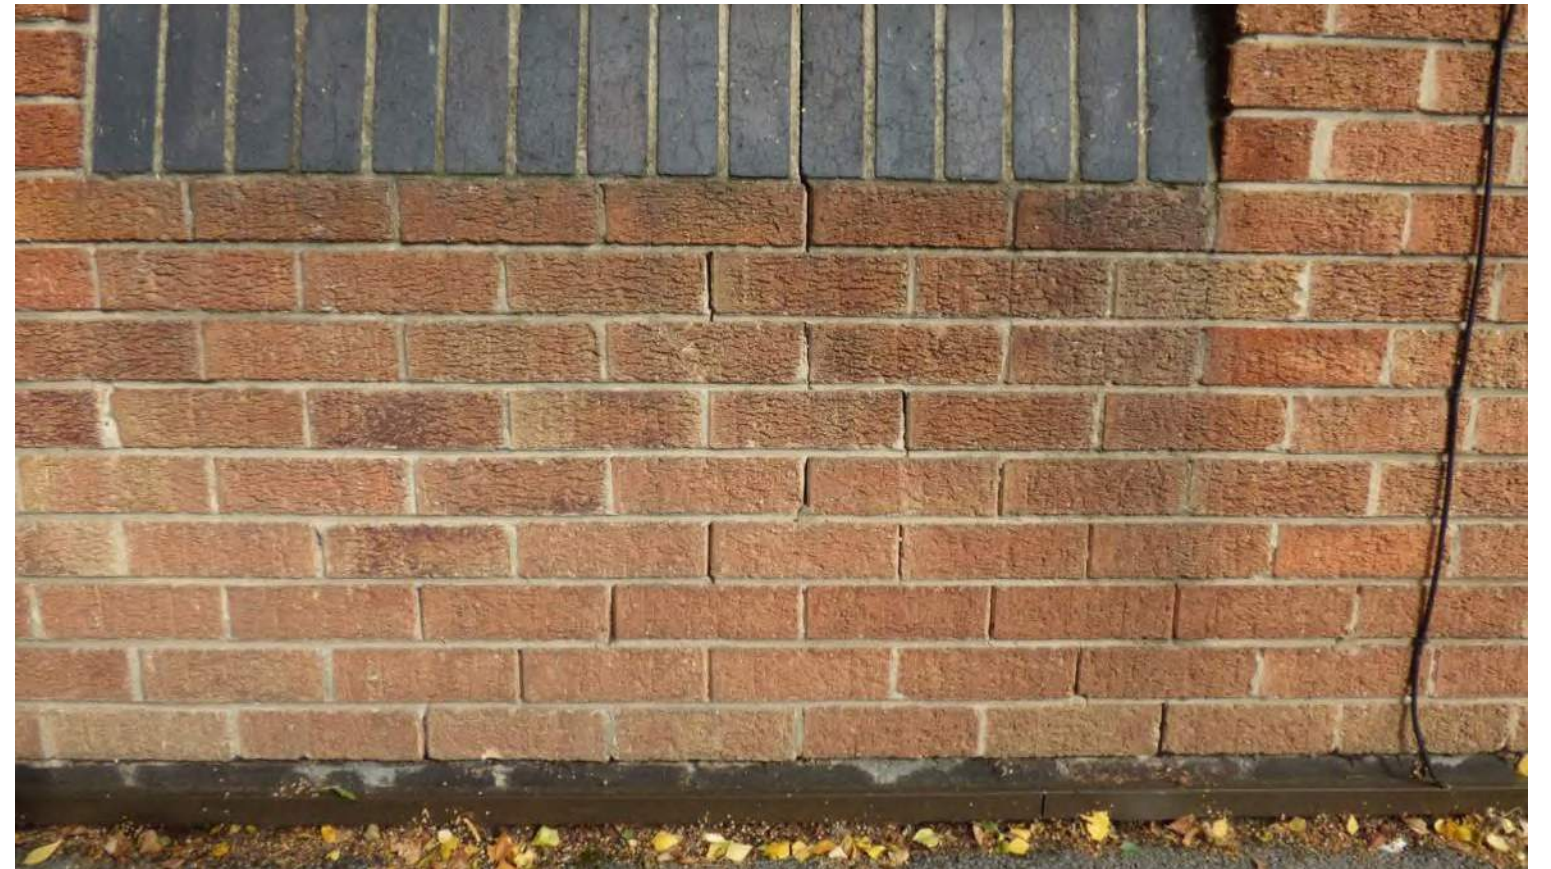
Photo 10

- 404. The elevation has been re-pointed perhaps in the last 10 years and there is a 1mm stepped crack and spalling of the repointing in the brickwork below the right hand end window **(See Photo 10)**. There is also a minor gap and spalling of the pointing at the junction between pre-cast concrete guttering units above the window **(See Photo 11)**.

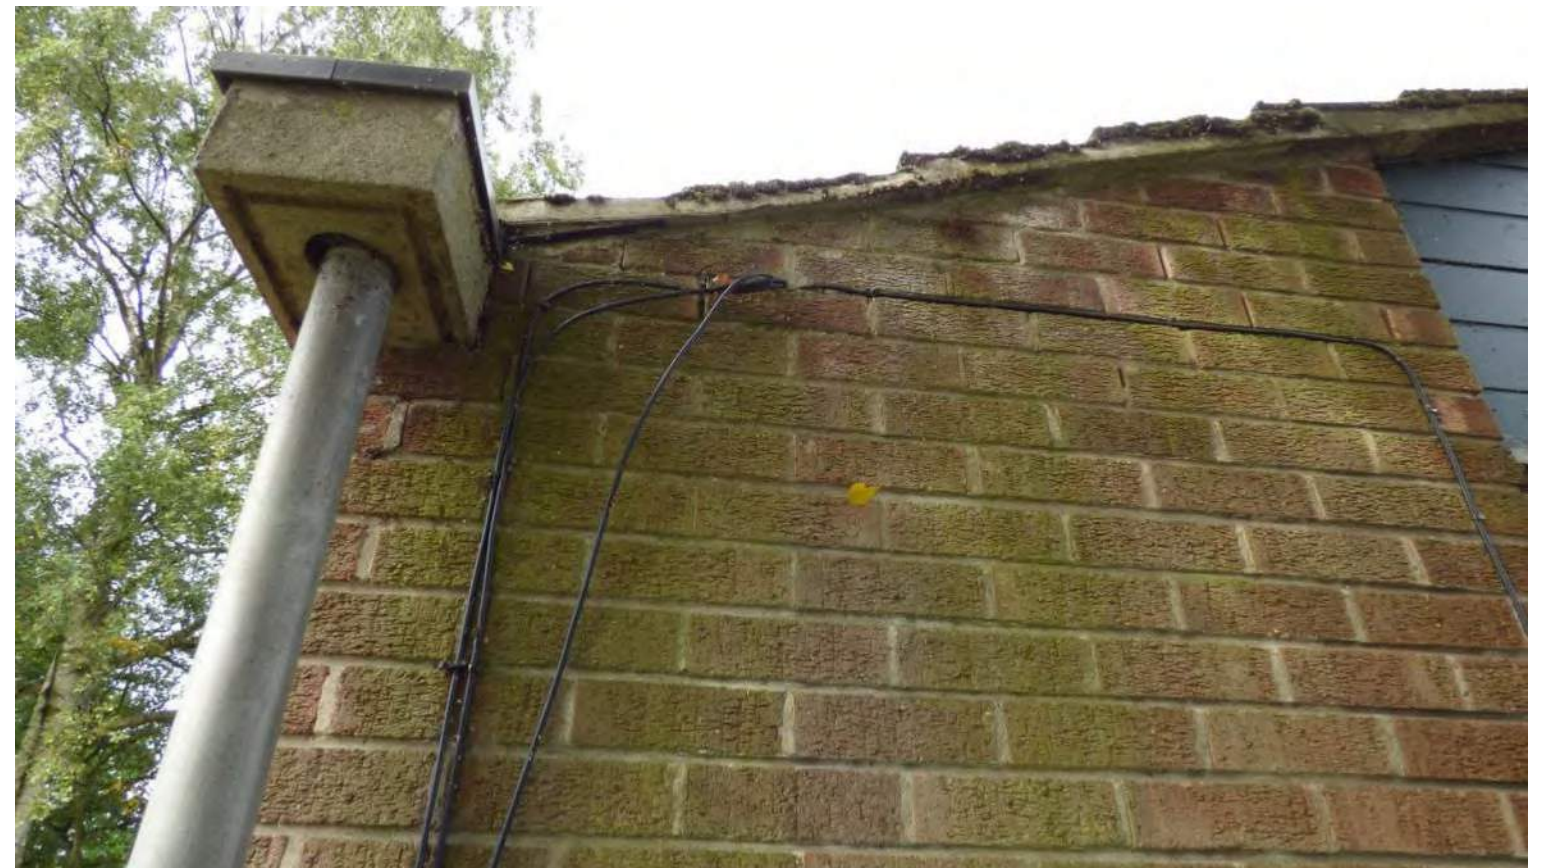
Photo 12

- 405. There is 1mm further cracking and pointing loss of the repointing at the top front panel of the right hand elevation. **(See Photo 12)**
