DERBYSHIRE COUNTY COUNCIL

New Bassett House HOP

Condition Survey

13 November 2018

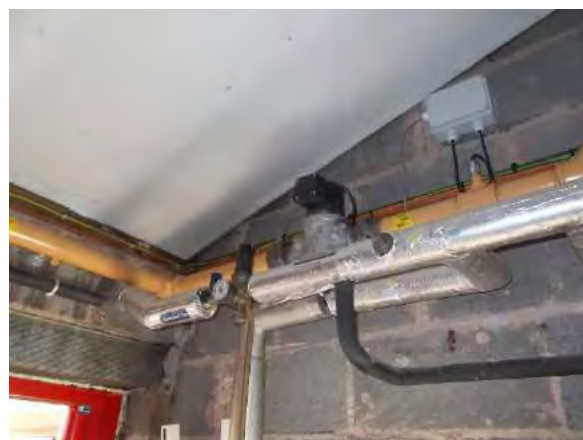
The gas distribution system within the building has a series of manual gas valves and is not linked to the fire alarm system to shut off the gas under fire conditions. Manual shut off systems have been installed in the boiler house, the kitchen has been provided with a solenoid valve to shut the gas system off under fire conditions.

Photograph No 3 – The Gas pipework inside boiler house (room No 003) showing kitchen gas shut-off valve.

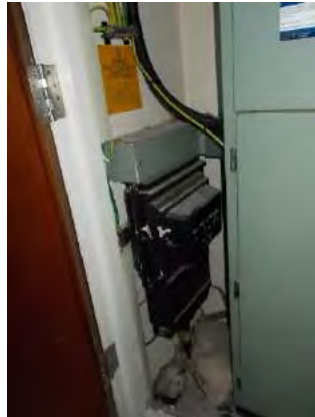
The electrical incoming utility supply enters the building in room 016 and terminates into an old Delta service head, this room contains the incoming service head and utility meter located inside the main switchboard. The nursing home appears to have a 3 phase 100A supply as the meter is a direct reading meter.

Photograph No 6 – The Incoming electrical utility supply is located in room 016.

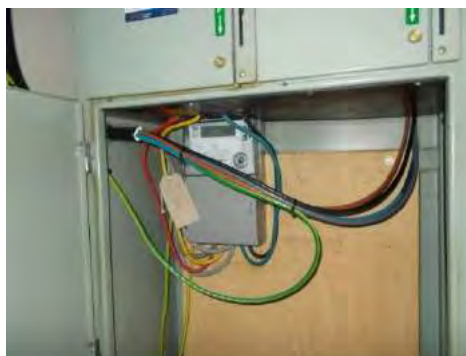
Photograph No 7 – The Incoming electrical meter located within the main LV switchboard located in room 016.

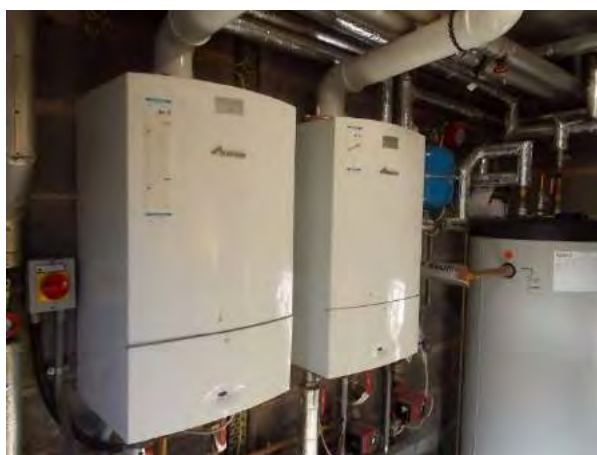
The boilers (Boiler House room No 003) within are indicating faults with one boiler calling for an “A” service and the other is calling for a “C” service.

Photograph No 9 – Typical Boiler houses - 2 No boilers – Worcester Greenstar 40CDi Conventional.

A magnetic filter should be fitted to the heating return pipework on all boiler installations to assist in the removal of any metal filings within the system. It would also be recommended that the heating systems should be provided with a chemical dosing pot to allow the systems to be dosed.

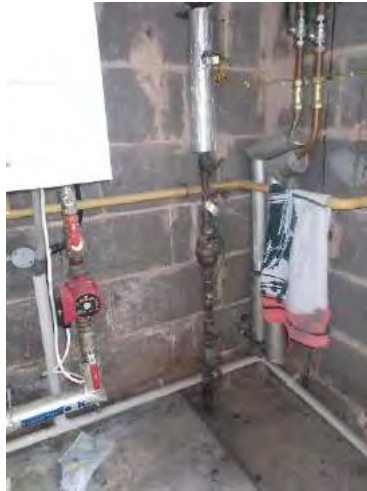
Each boiler generally has its own shunt pump, a heating pump and a primary HWS pump. In boiler house 003 there are two VT heating circuits. The pumps are mainly single pumps with no run and standby facility. In most instances the insulation is generally has sections missing and there are no insulated valve covers currently installed, these need to be installed.

Photograph No 10 – Typical Boiler house – Boiler shunt pump

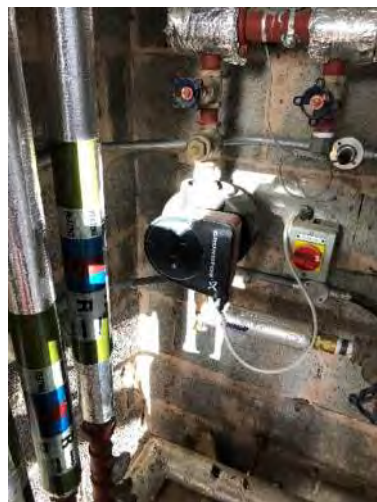
Photograph No 12 – Typical Boiler House Room – Heating pump.

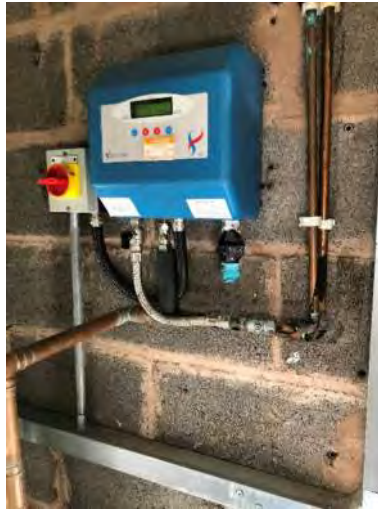
Photograph No 13 – Typical Mikrofill EFD heating system pressurisation unit – note this unit the drain has not been piped to a drain. Boiler house room No 107 has the latest electronic version installed.

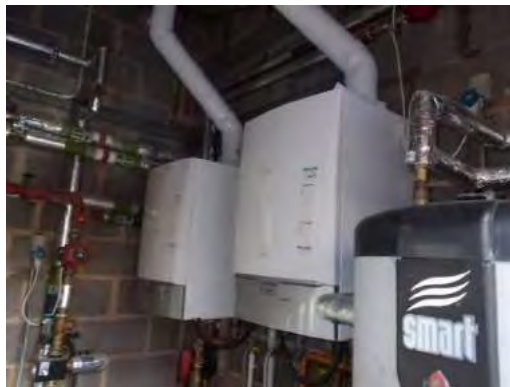
Photograph No 14 – Boiler house room No 003 - 2 No condensing boilers – Remeha Quinta Pro 45S.

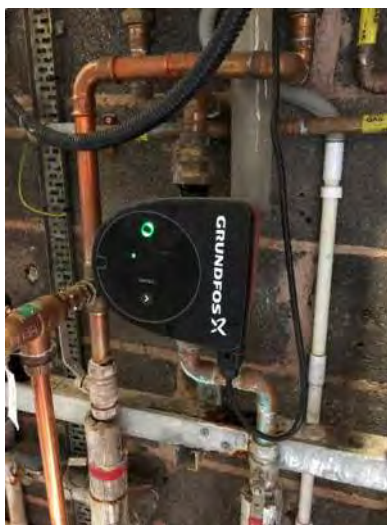
Photograph No 15 – Boiler House Room No 003 – boiler shunt pump.

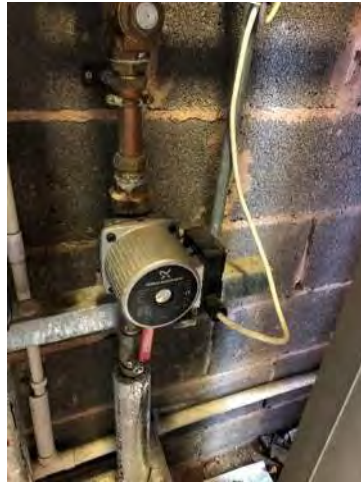
Photograph No 16 – Boiler House Room No 003 – HWS primary pump.

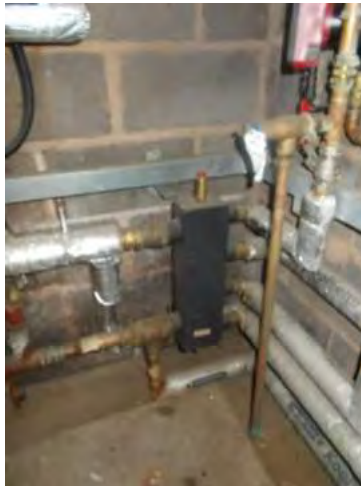
Photograph No 17 – Boiler House Room No 003 – low loss header, note this needs to be insulated.

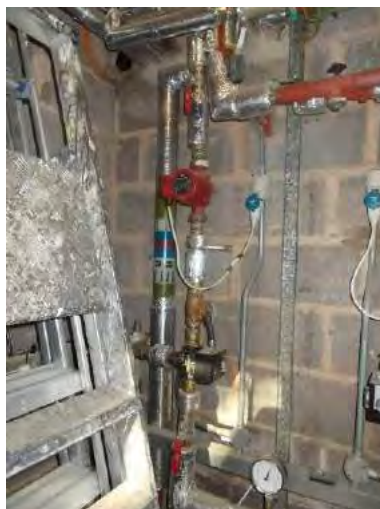
Photograph No 18 – Boiler house Room No 003 – VT heating pump (possibly underfloor heating circuit).

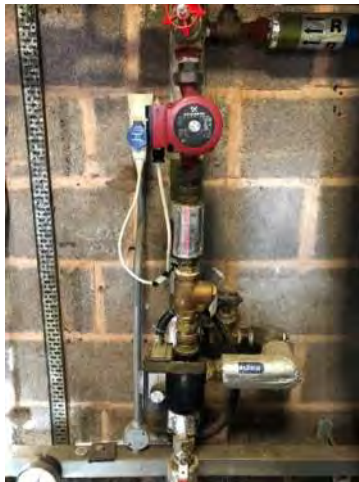
Photograph No 19 – Typical boiler house – VT heating pump (possibly radiator system).

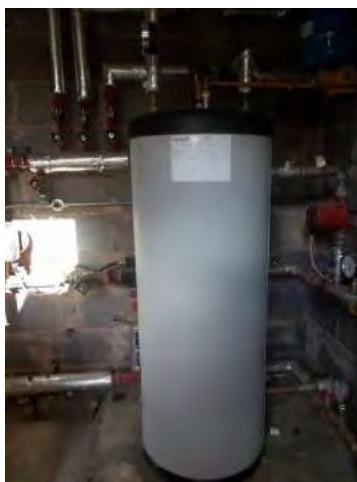
Hot water to each wing of the building is provided by an LTHW heated Calorifier, these are located within the boiler houses in each wing. These units are in good condition. The Calorifier has a diverting valve on the heating system from the boiler to maintain the temperature in the Calorifier.

Photograph No 22 –Typical boiler house – ACV Calorifier for the domestic HWS generation.

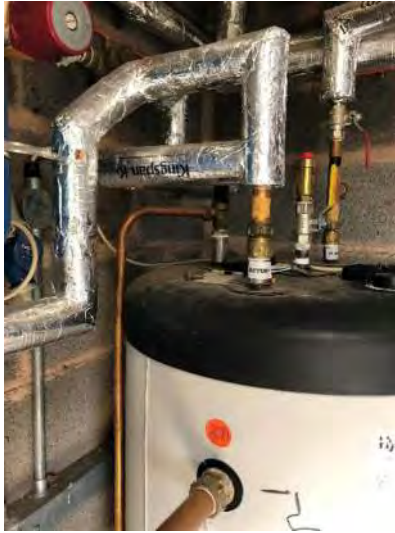
Photograph No 23 – Typical boiler house - Calorifier pressure relief and automatic air vent discharge pipework which drains directly onto the floor.

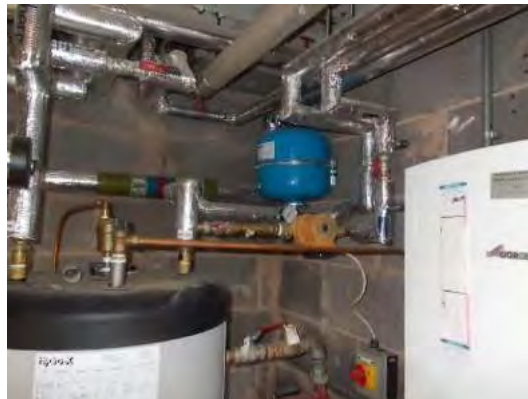
Photograph No 24 – Typical Boiler HWS secondary pump installed within the boiler houses.

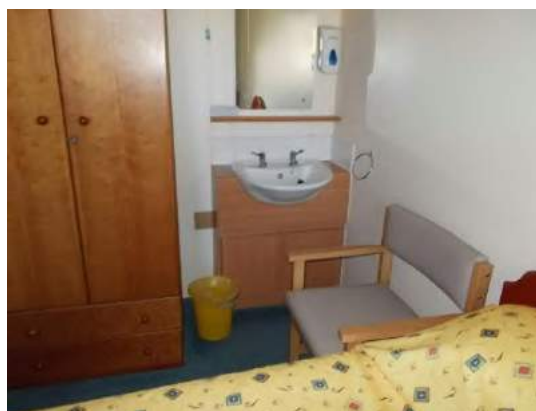
Photograph No 25 – Typical refurbished bedroom sink with thermostatic mixing valve installed below the sink.

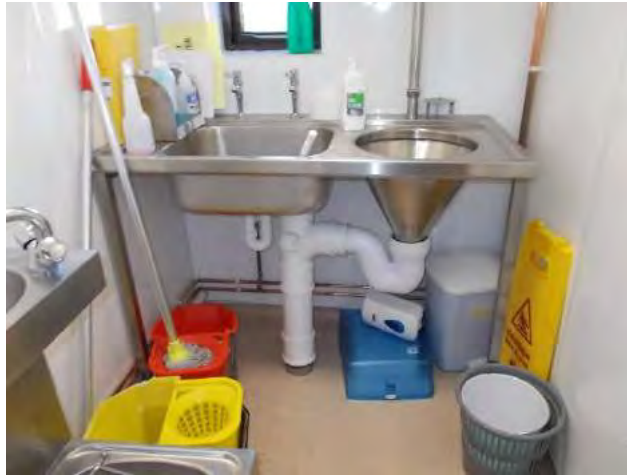
Photograph No 26 – Typical stainless steel sluice in sluice rooms.

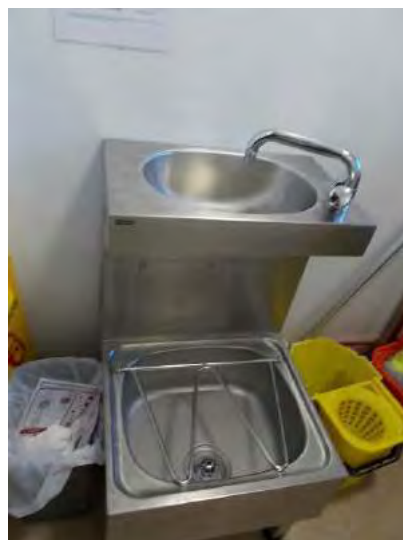
Photograph No 28 – Combined bucket sink and wash hand basin in sluice rooms.

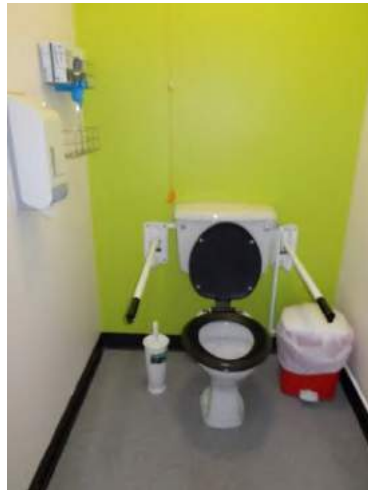
Photograph No 30 – Typical refurbished toilet.

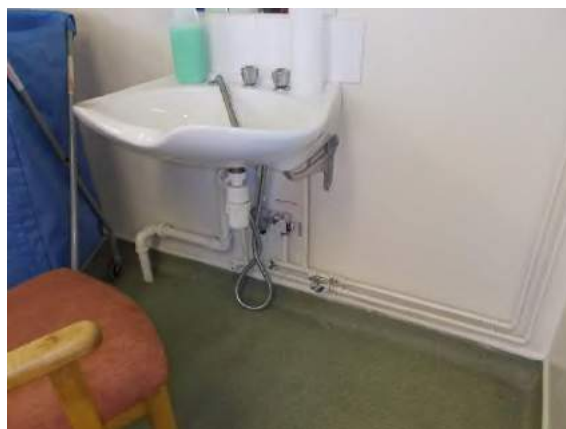
Photograph No 31 – Typical hairdressing sink in salon.

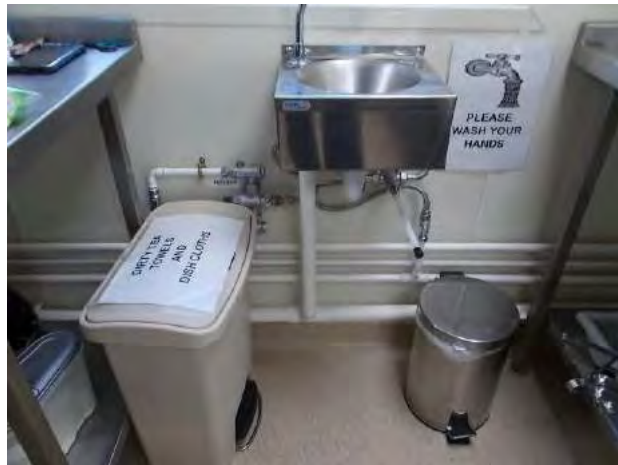
Photograph No 32 – Kitchen hand wash sink with knee operated tap system and thermostatic mixing valve.

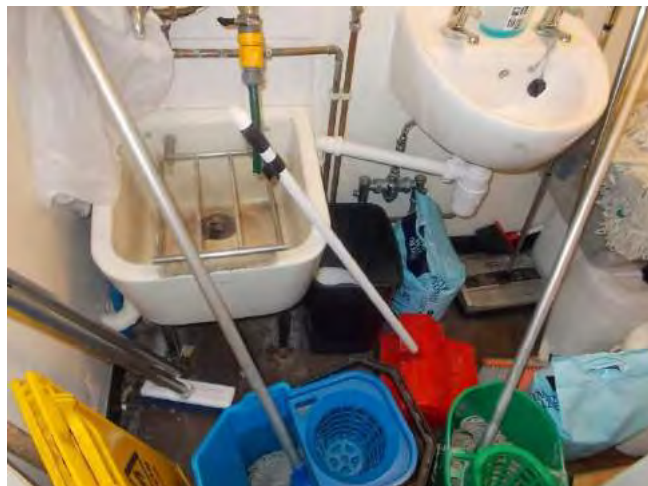
Photograph No 33 – Bucket sink and wash hand basin located in room No 004.

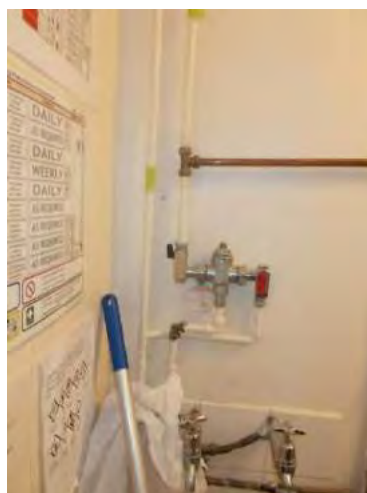
Photograph No 34 – Bucket sink with thermostatic mixing valve fitted.

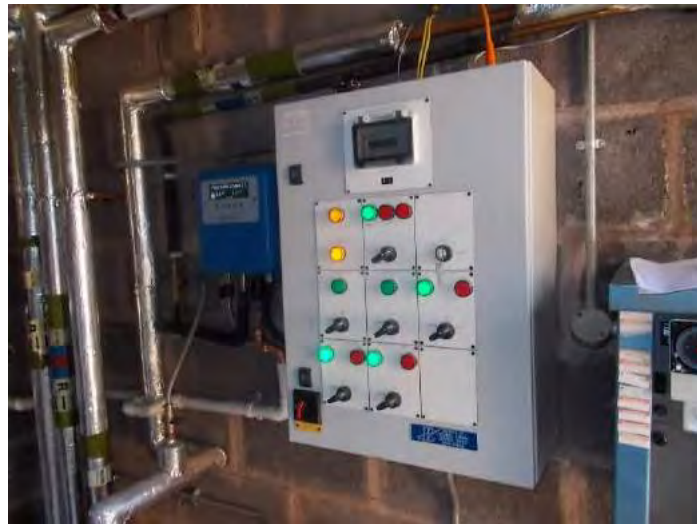
There were no controls schematics fitted within the plantrooms indicating how the controls operate and where the control devices are located.

Photograph No 35 – Typical Boiler house boiler and HWS plant control system

Consideration should be given to replacing the controls with an efficient controls system that incorporates optimisation software, a new variable temperature heating system, pump switching for equal loads and operation. It may also be worth investigating if the provision of EC variable speed pumps would benefit the EPC certificate for the building.

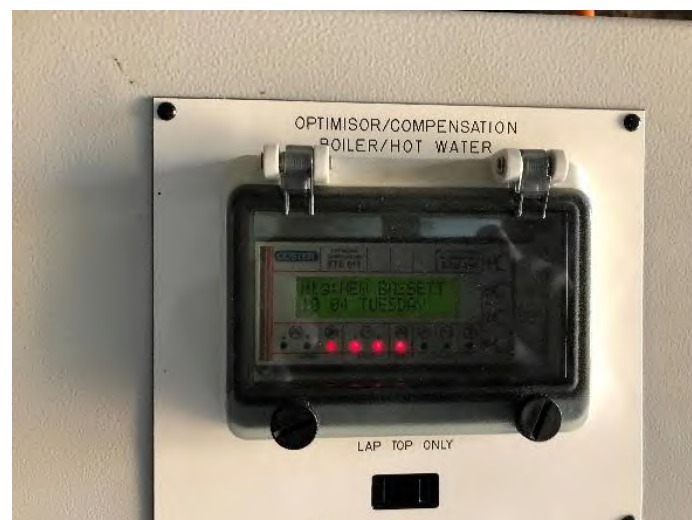
Photograph No 36 –Typical boiler house – Coster DTE 611 Controller.

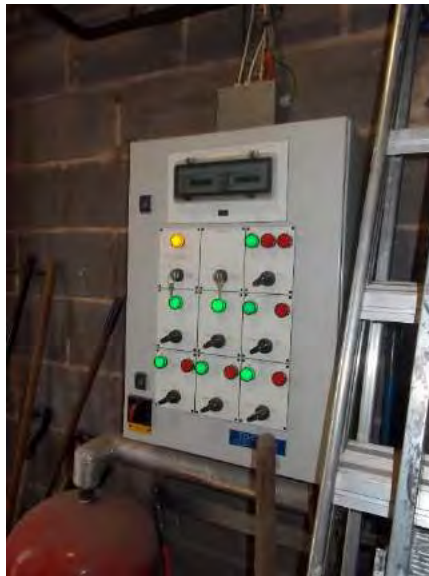
Photograph No 37 – Boiler house room No 003 - Boiler and HWS plant control system.

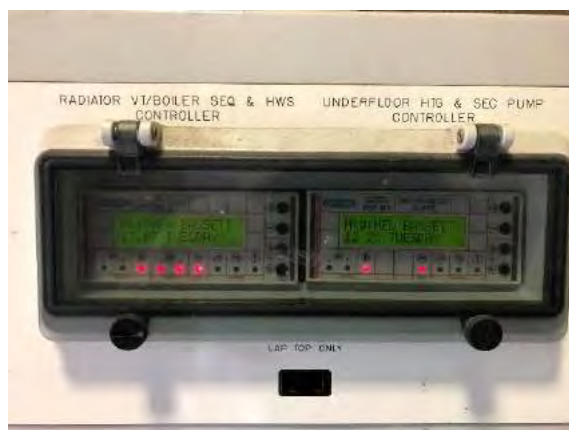
Photograph No 38 – Boiler house room No 003 – Coster DTE 611 + Coster DSE 600 Controller.

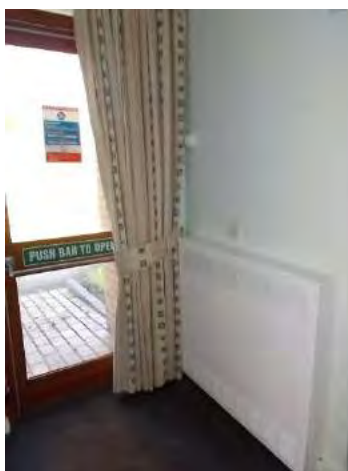
Photograph No 40 – Typical Floor mounted corridor LST radiator.

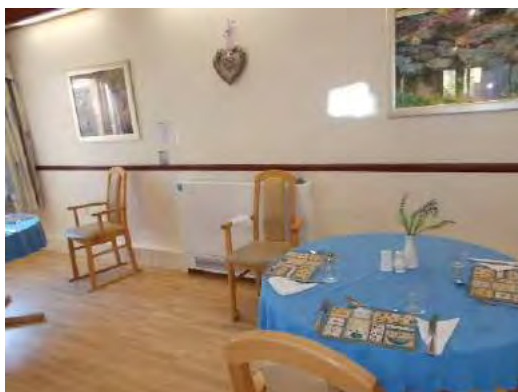
Photograph No 41 – Typical LST radiator installed in the common room.

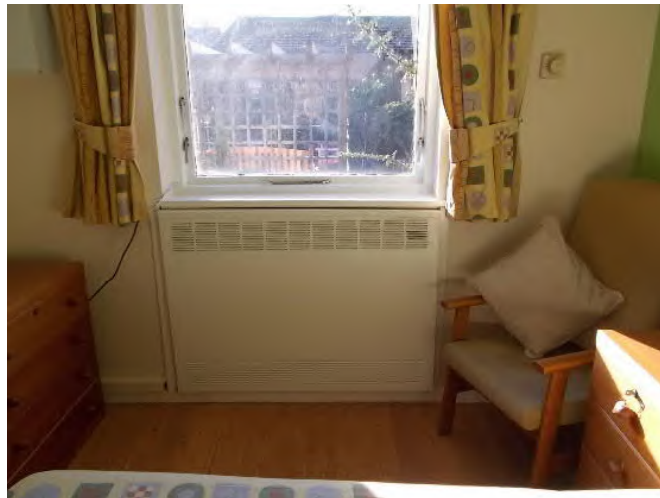
Photograph No 42 – Typical LST radiators installed in the bedrooms.

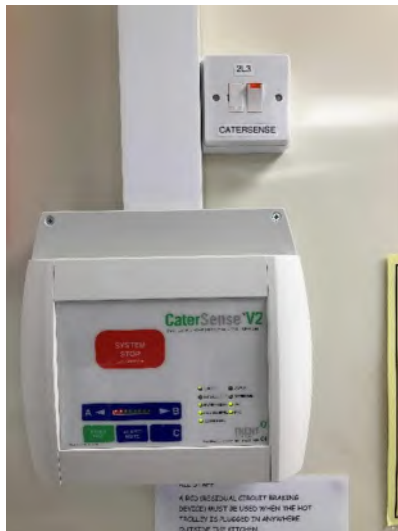
The kitchen ventilation complies for a modern kitchen and is interlocked with the kitchen gas system via a CaterSense V2 system.

Photograph No 44 – Kitchen ventilation system interlinked with Gas system by the CaterSense V2 system.

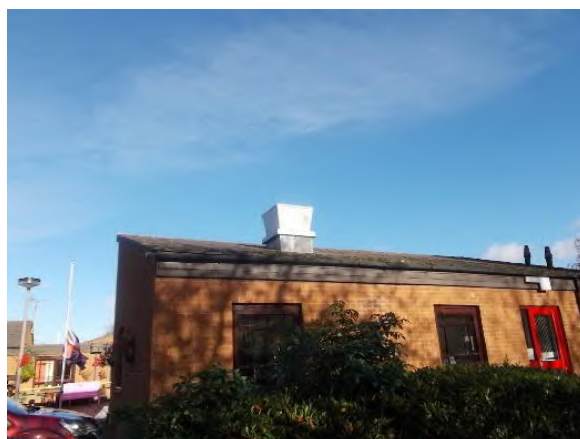
The kitchen ventilation currently operates via supply and extract fans installed above the kitchen hood. Originally the extract was taken through the roof with the supply through the gable end, but due to noise complaints from the local residents around the care home the extract has been rerouted through the gable end adjacent to the supply fan. Cooking smells can be detected outside the main entrance and with the windows open inside the building.

Photograph No 45 – Redundant kitchen extract fan through the roof.

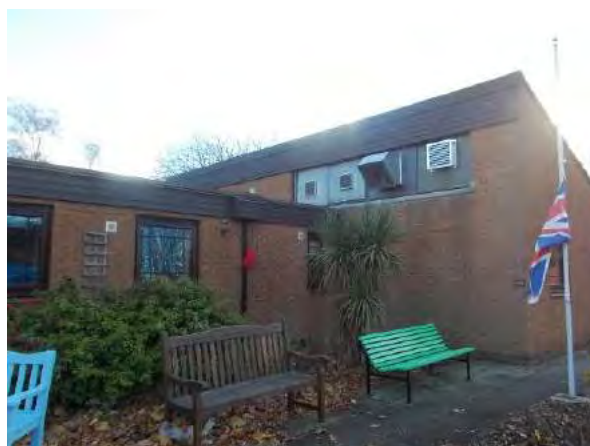
Photograph No 46 – Kitchen supply and extract fan discharges, note the kitchen supply is very close to the supply and kitchen smells were noticed coming back into the building.

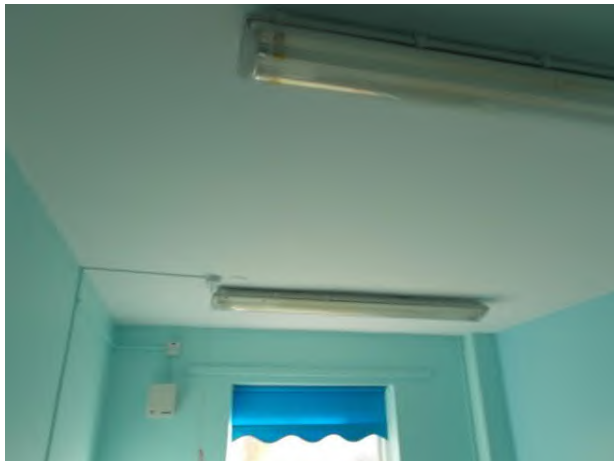
Photograph No 47 – Typical toilet and bathroom extract fan.

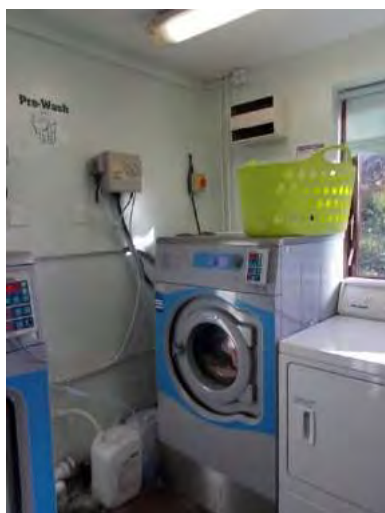
Photograph No 48 – Laundry extract fan.

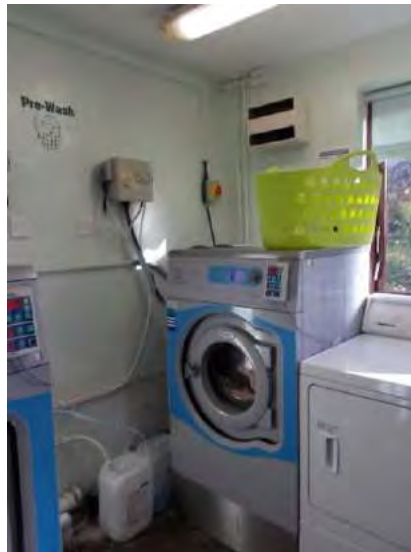
Photograph No 50 – Laundry washing machine No 1.

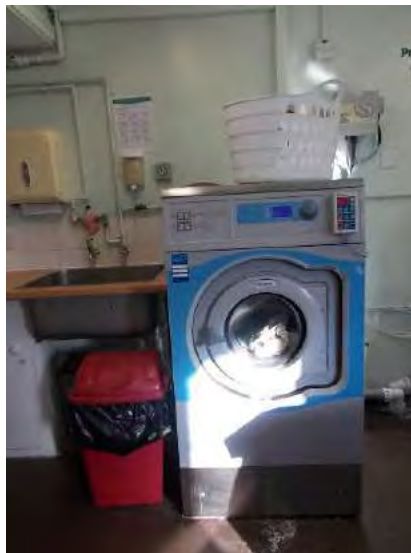
Photograph No 51 – Laundry washing machine No 2.

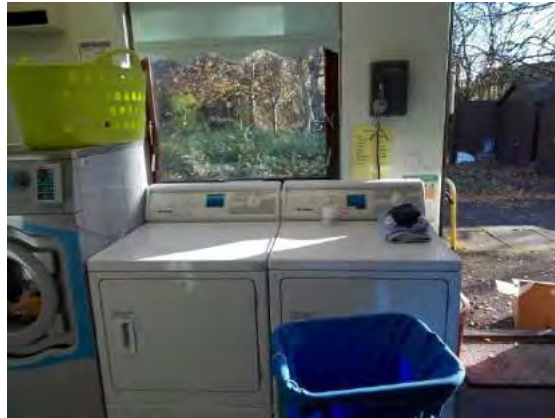
Photograph No 52 – Laundry Electric Dryers.

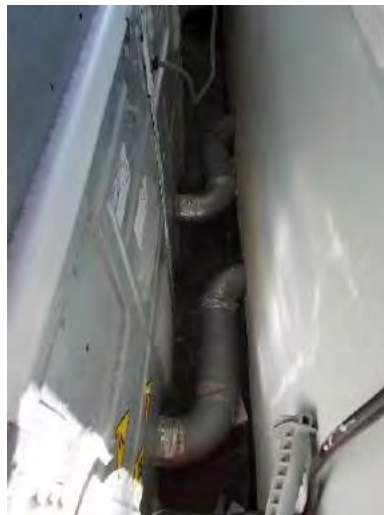
The building has a laundry currently installed for washing the resident's cloths. The laundry consists of 2 No industrial washing machines, these are an Electrolux W475H and a W465H and 2 No electric dryers manufactured by Huebush. The dryers have been ducted to atmosphere by the use of metal circular ductwork. The ductwork discharges externally directly onto the floor below the ducts, there is evidence of fibres being deposited on the floor, it is not clear if the circular ducts have been cleaned to ensure that there is no build-up of lint within the ducts restricting the discharge of air from the dryer.

Photograph No 53 – Laundry electric dryer connection to outside.

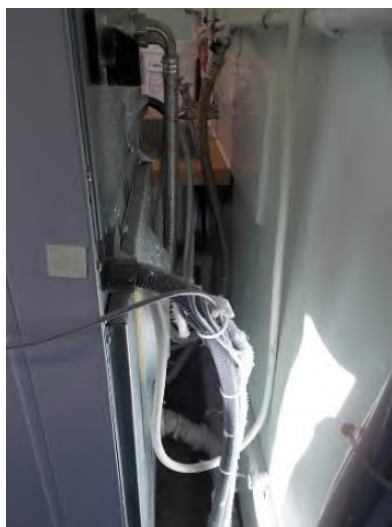
Photograph No 54 – Washing machine connections behind the units, note the lack of access to the drainage U-bends and lack of rodding points.

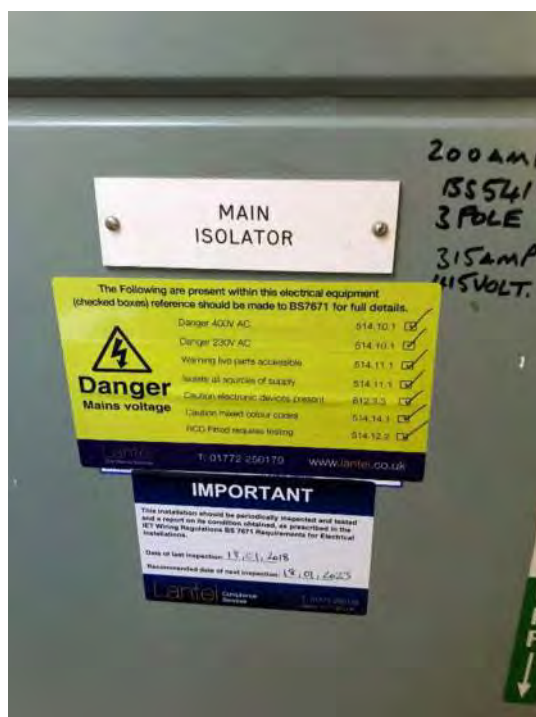
Photograph No 58 – Crabtree Main LV switchboard board incoming main switch.

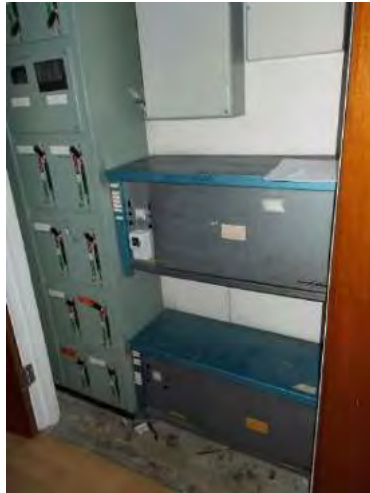
Photograph No 59 – Main LV switchboard board located within room No 016.

- Replace the main sub-board with a new Schneider panel board and rewire all of the sub-mains cabling between the new panel board and the remote distribution boards

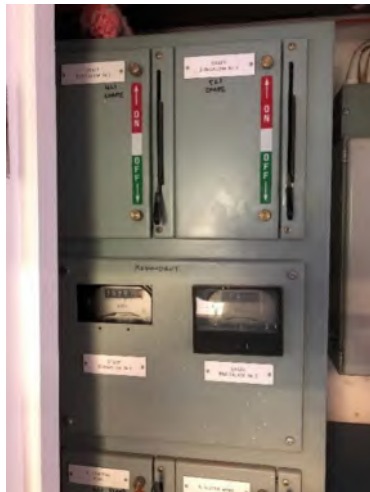
Photograph No 60 – Main LV switchboards with redundant supplies to the bungalows.

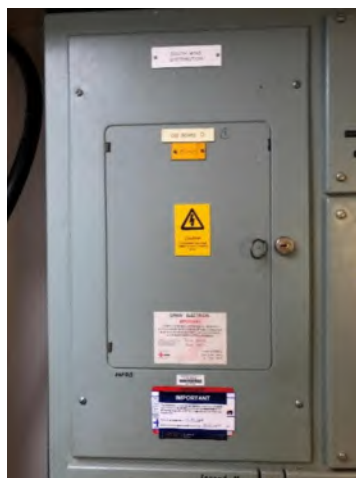
Photograph No 61 – Distribution board DB D – South wing distribution board forming part of the main LV switchboard.

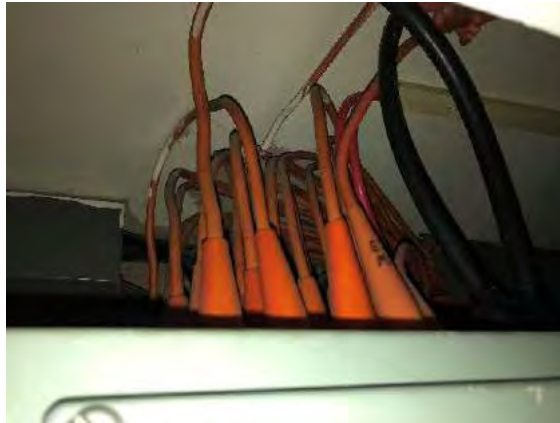
It was not possible to verify the cable installation generally throughout the building, but it was noted that at the main switchboard there was a series of orange covered MICC cables. It was not clear if this is the same for all wings of the building.

Photograph No 62 – Existing mains MICC cabling feeding services within the south wing.

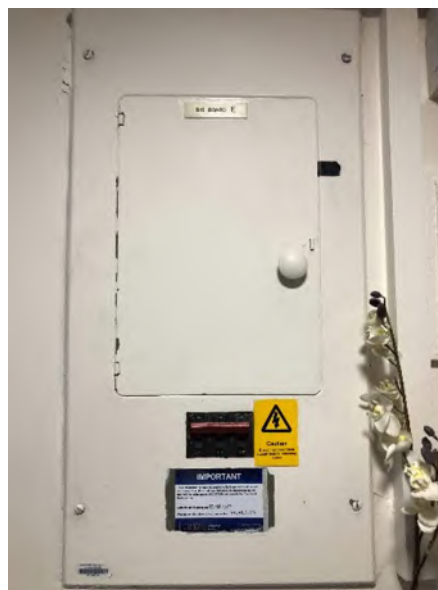
Photograph No 64 – Existing Crabtree C50 distribution board DB E installed in the corridor room No 018.

Remote Distribution Boards up to Current Standards		✓	✓	All remote distribution boards are Crabtree C50 and the boards are obsolete. There is a MK distribution board installed in the conservatory which in a plastic enclosure and requires replacement with a metal enclosure.

- Replace the fire alarm system to bring the system up to the current standards of BS5839.
- Replacement of the bedroom block distribution boards with new Schneider Acti9 boards.

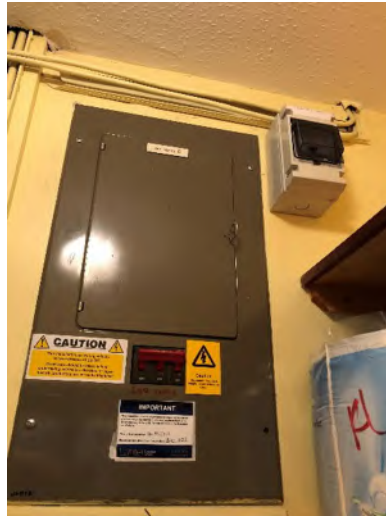
Photograph No 65 – Recessed Crabtree C50 distribution board DB B installed in the store room No 089.

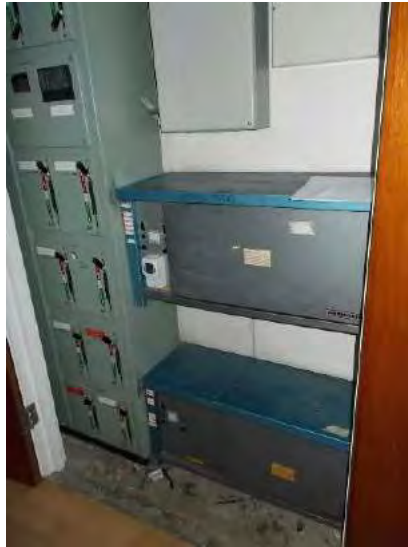
The central battery units appear to be a lead acid system and their age and battery life is not fully known. Looking at the age of the units they appear to be in a reasonable condition but should be nearing the end of their useful life. The overall system capacity is not known and this may not be sufficient to incorporate bedroom emergency luminaires onto the current 24V system, also the luminaires are limited in the type available for a 24V system, and the system should be replaced with self-contained luminaires off the local lighting circuits.

Photograph No 79 – Emergency lighting central battery units located in room 016.

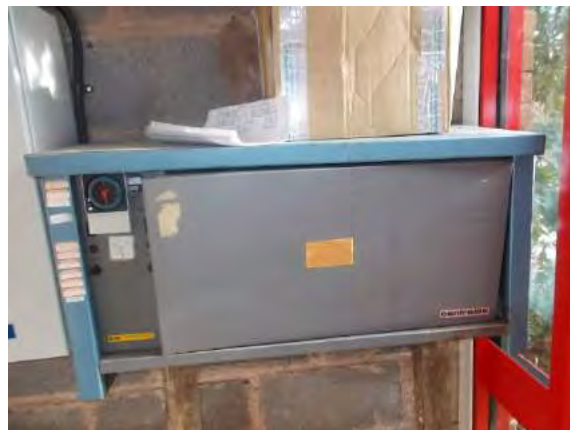
Photograph No 80 – 2 No emergency lighting central battery units located in plantrooms 056 & 107.

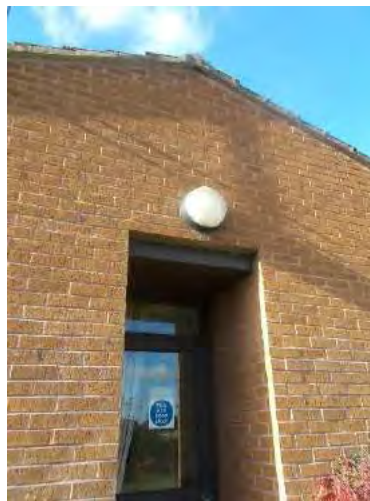
Photograph No 88 – Typical wall mounted bulkhead luminaire over some of the fire exit doors. It was not clear if these were fully operational and working off the central battery system.

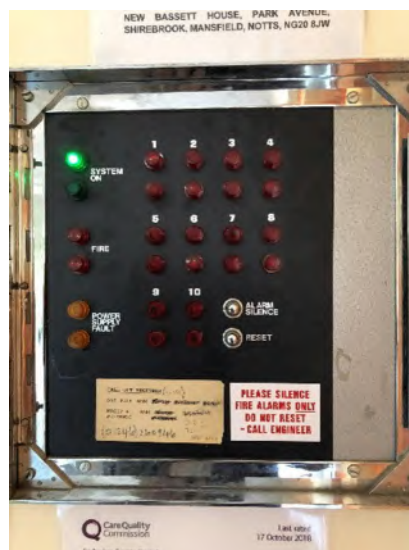
The fire alarm control panel does not comply with EN54 for the control panel and it is not clear how long the battery autonomy is rated at. This panel has reported issues which cannot be resolved as the panel is obsolete and should be replaced with a new addressable system.

Photograph No 96 – Conventional fire alarm panel located in the main entrance.

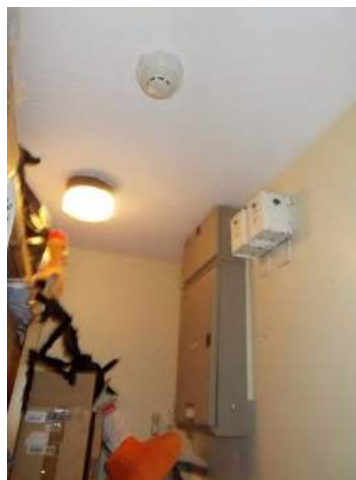
Photograph No 100 – Fire Alarm detector installed in in the store 090.

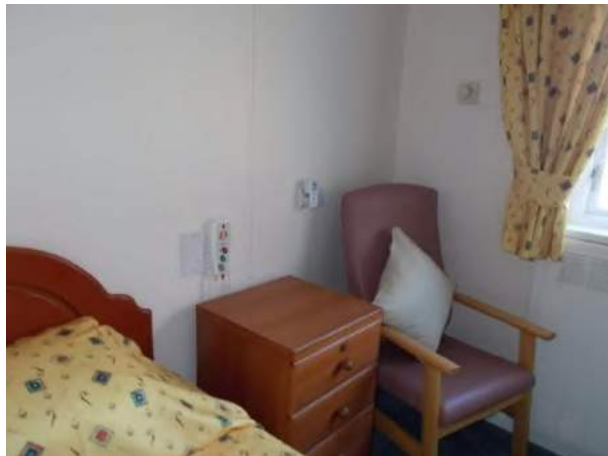
Photograph No 103 – Typical bedroom showing nurse call system.

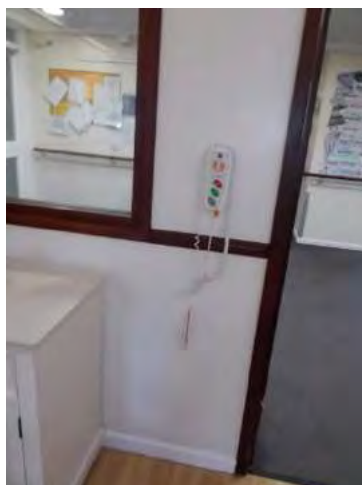
Photograph No 105 – Typical nurse call system located in dining areas/common rooms.

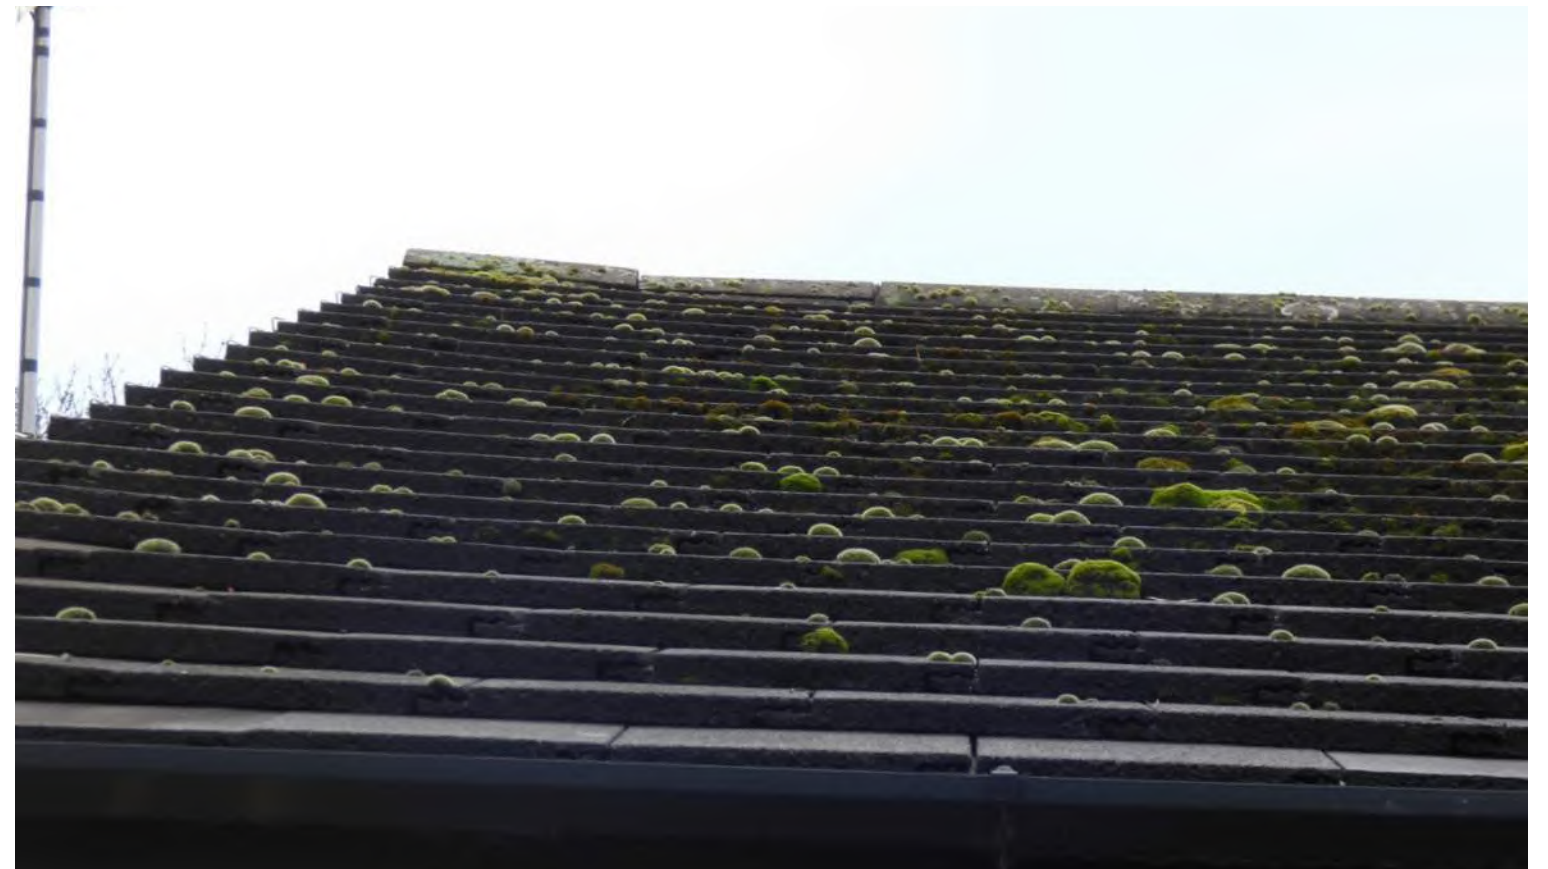
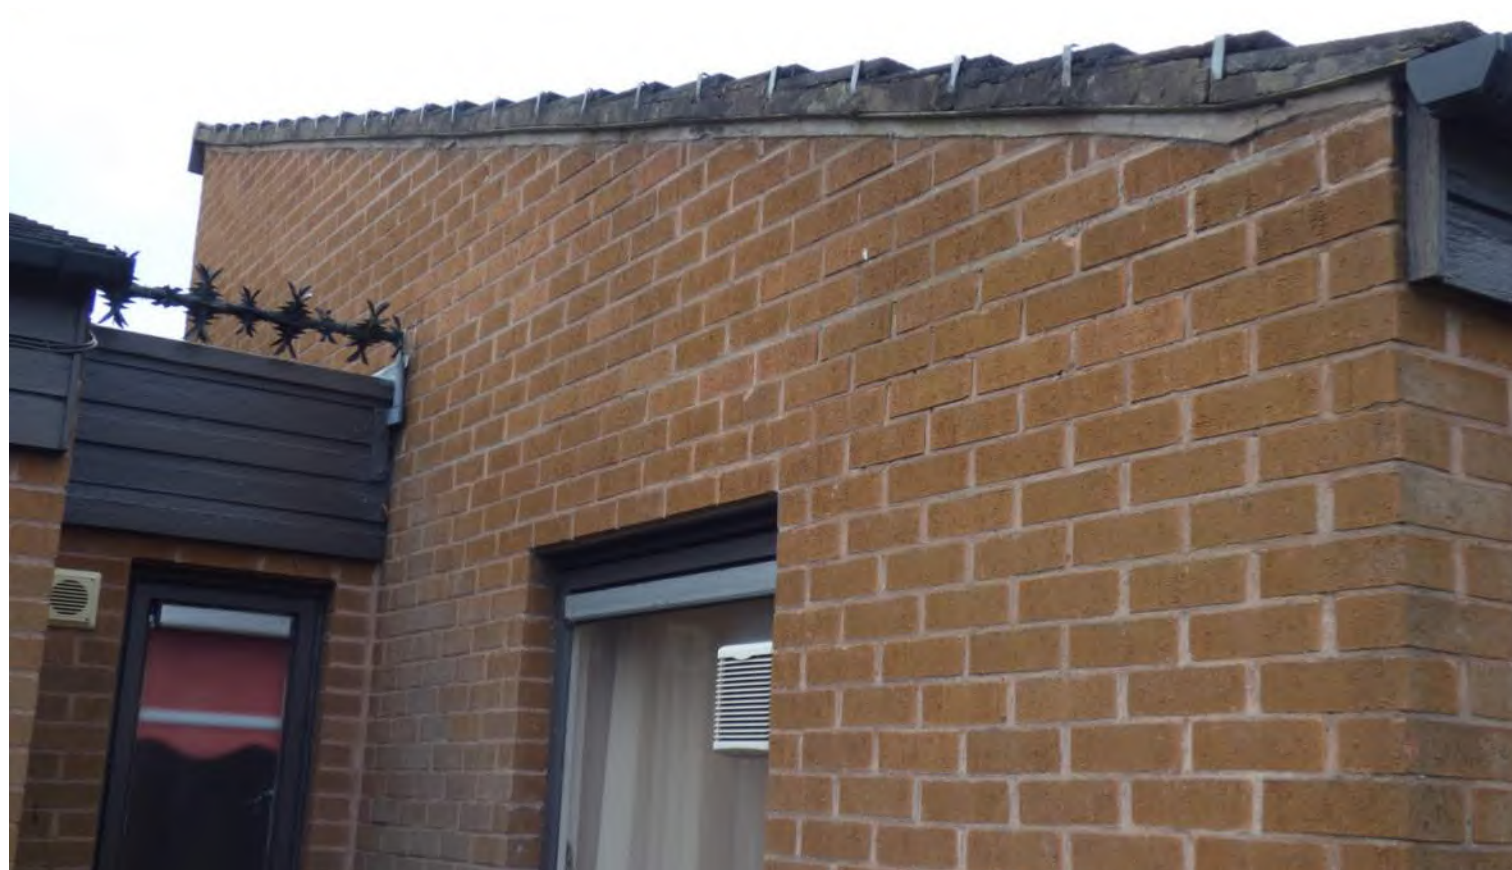
Photo 02

301. The wing comprises duo-pitch, mono-pitch and flat roofs which show no evidence of significant distortion, however they are overgrown with moss and there is a slight distortion of the front most ridge tile on the mono-pitched rear segment of the wing. **(See Photos 02 & 03)**
302. There is no evidence of significant structural distortion to the gables.

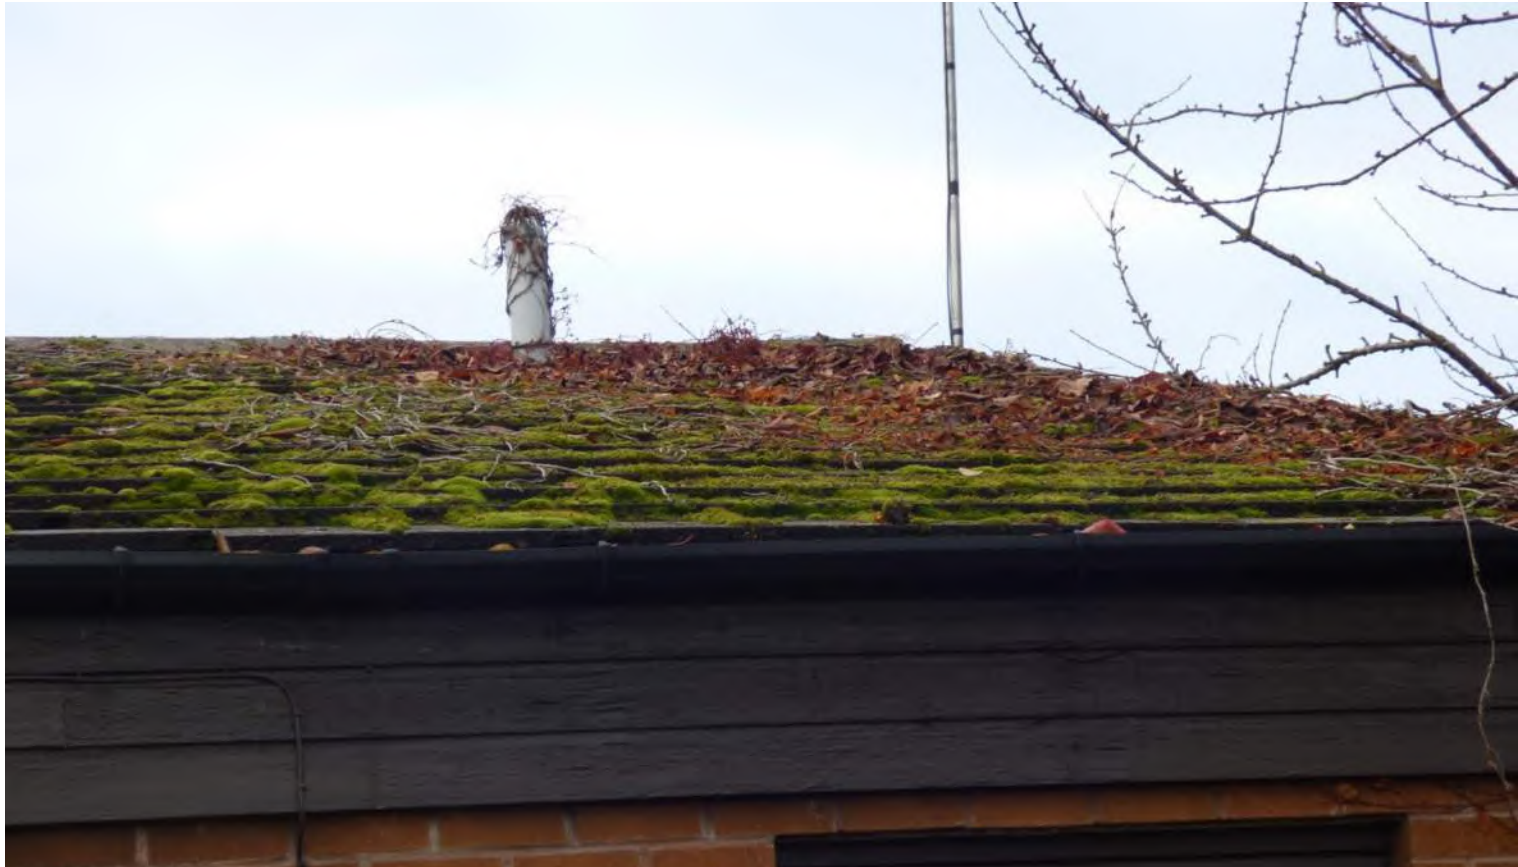
Photo 05

306. The wing comprises duo-pitch, mono-pitch and flat roof sections which show no evidence of significant distortion, however there is moss growing on the covering and tree litter from the large tree growing adjacent to the right hand roof verge. **(See Photo 05)**
307. The climbing plants on the right hand gable have been cut back. **(See Photo 06)**
308. There is no evidence of significant distortion to the gables.

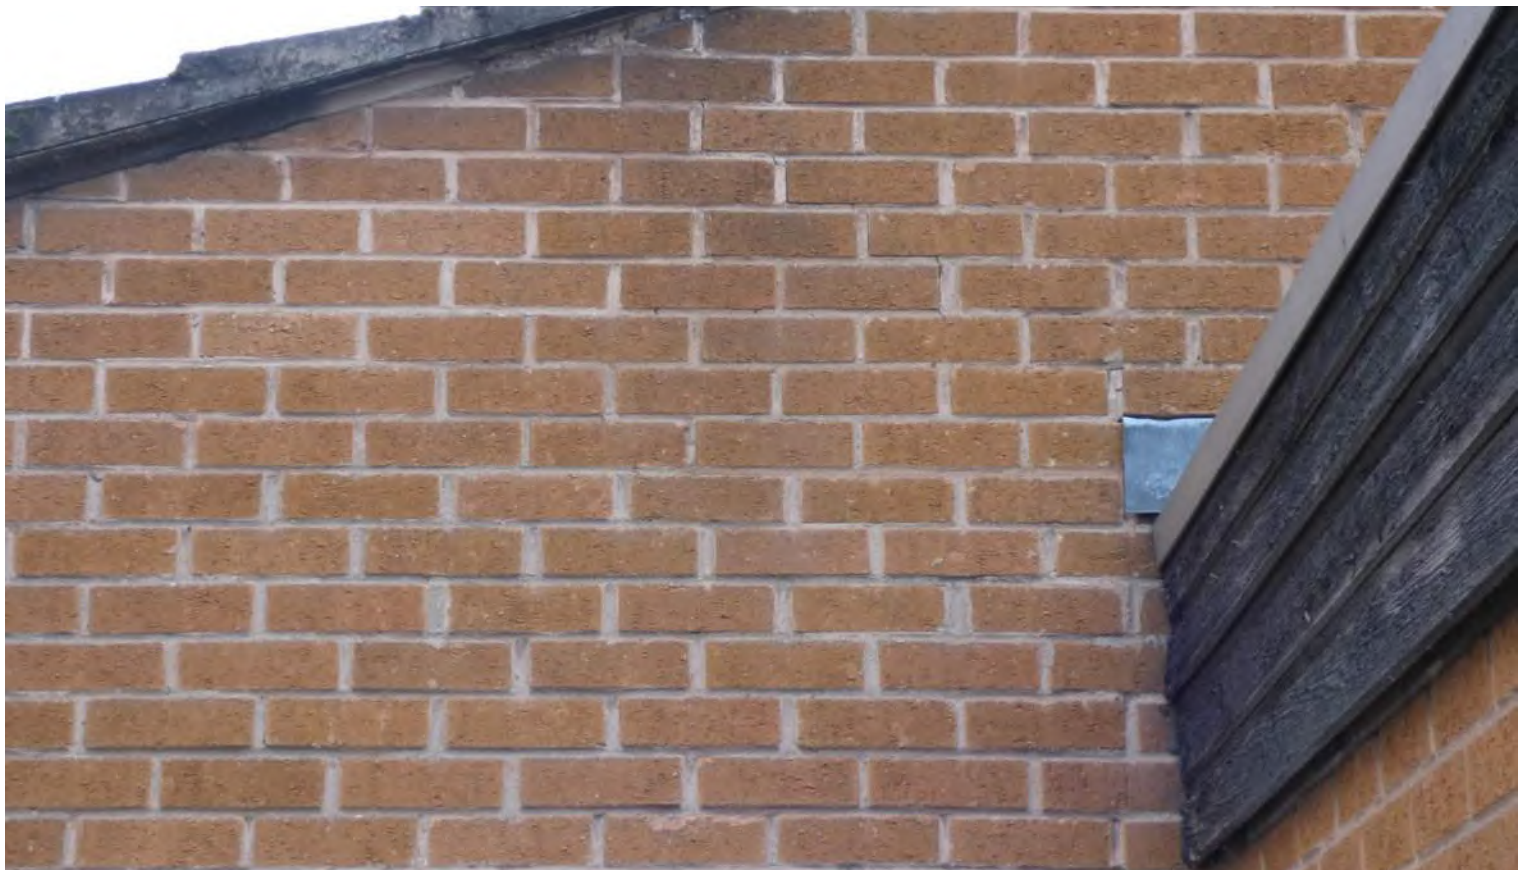
Photo 07

309. The wing comprises mono-pitch and flat roof sections which show no evidence of significant distortion to the pitched roof ridge line.
310. There is no evidence of significant structural movement to the gables, however there is a 0.5mm stepped crack near the frontmost top corner of the right hand gable. **(See Photo 07)**
311. The rainwater gutter at the left hand end of the front elevation is distorted. **(See Photo 08)**

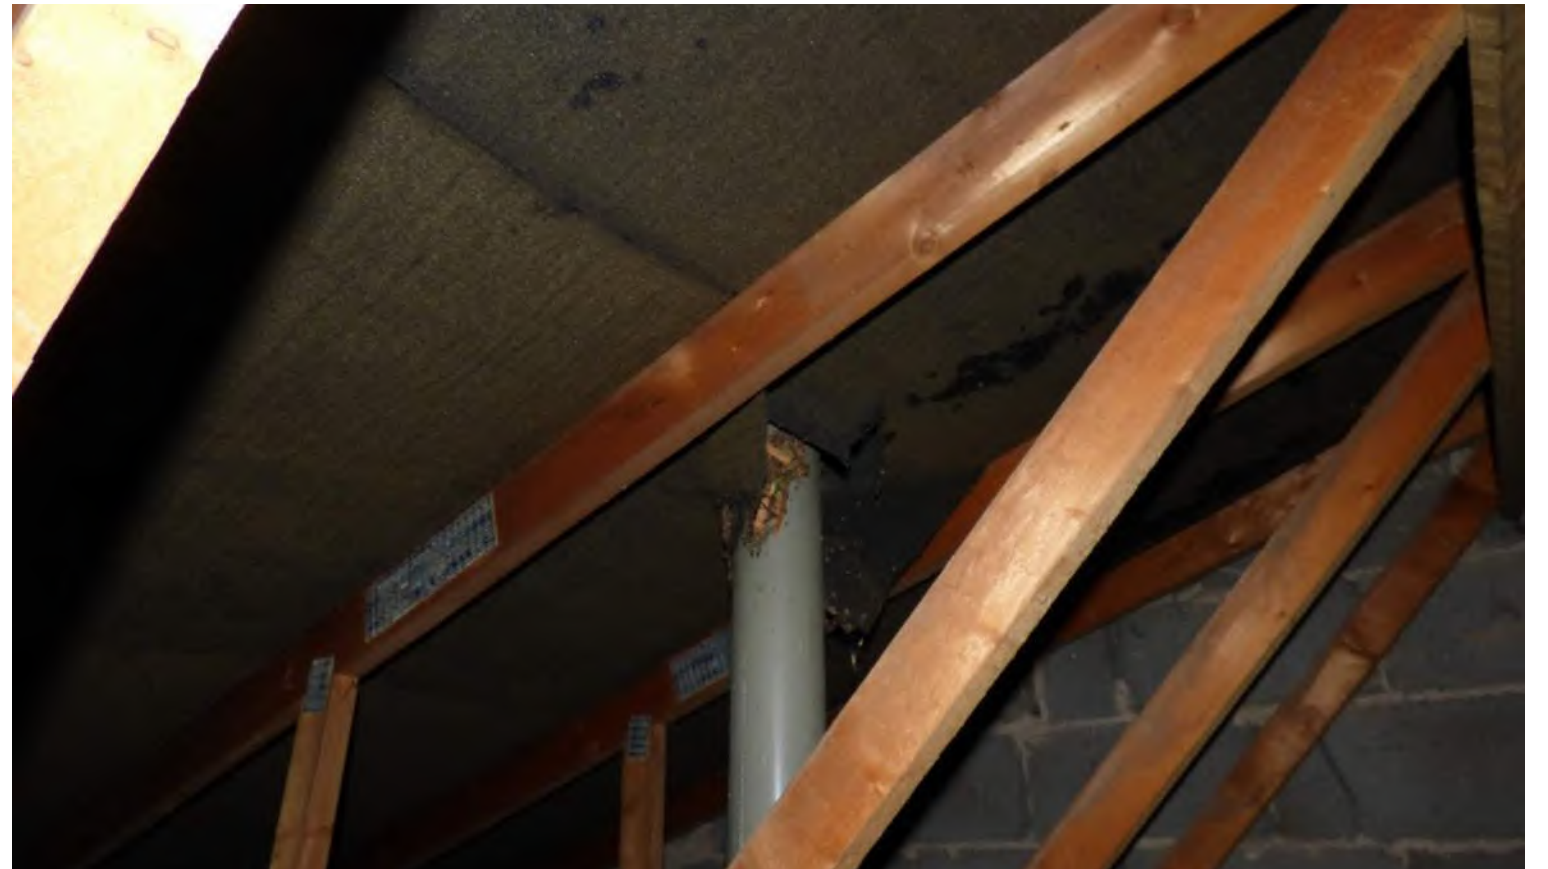
Photo 10

- 412. The roof is of similar construction to the opposite Right Segment.
- 413. There is debris falling through the torn sarking around the flue in the roof space. **(See Photo 10)**
