DERBYSHIRE COUNTY COUNCIL

New Bassett House HOP

Condition Survey

13 November 2018

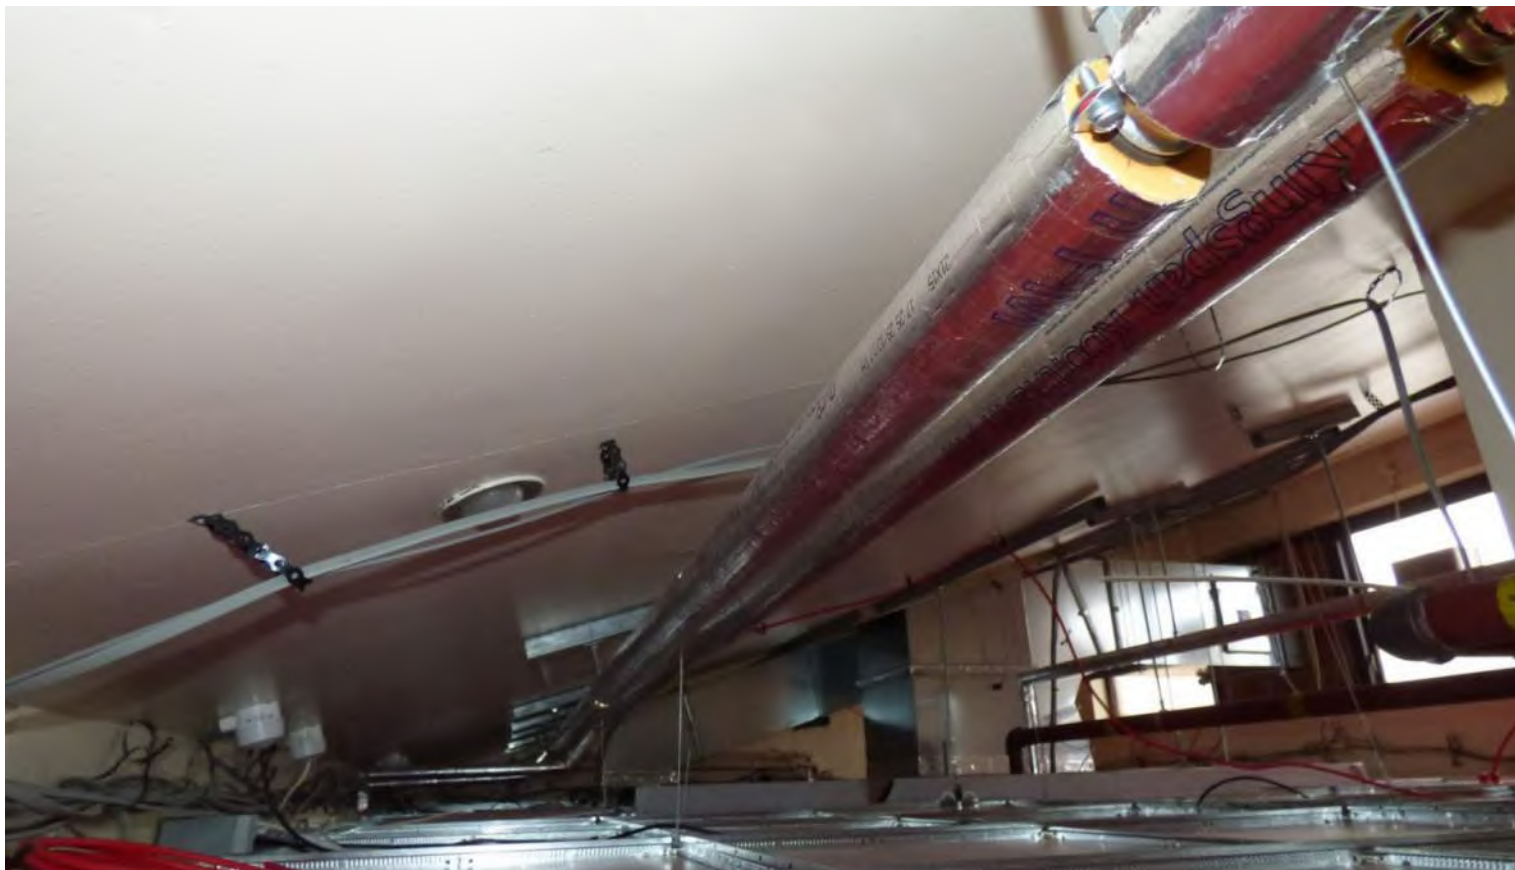
Photo 11

-
414. South Wing - Kitchen
415. The mono-pitched roof over the wing has a secondary light suspended ceiling.
416. The roof space was accessed by removing a suspended ceiling tile revealing an under-boarded primary ceiling which showed no evidence of significant distortion.(**See Photo 11**)
417. We were unable to determine the roof construction.
