DERBYSHIRE COUNTY COUNCIL

Rowthorne HOP

Condition Survey

November 2018

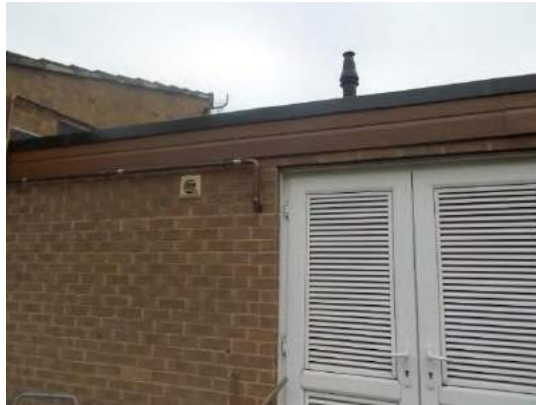
Photograph No 4 – The Gas pipework leaves boiler house to supply the main kitchen.

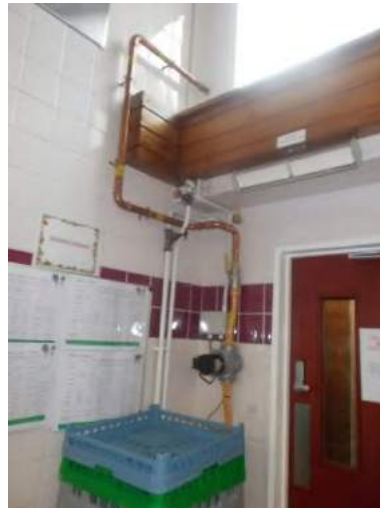
Photograph No 5 – The gas pipework entering the main kitchen from the boiler house.

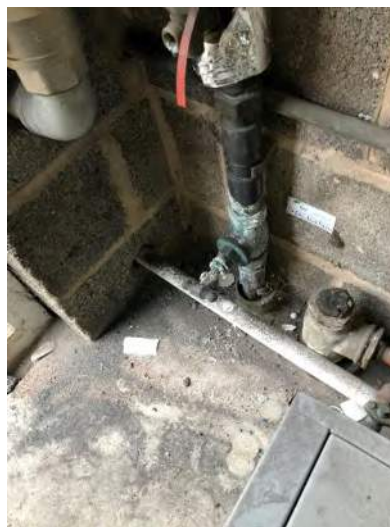
Photograph No 6 – Typical Incoming MCWS appears to enter the building in each boiler house, there was no evidence of a water meter.

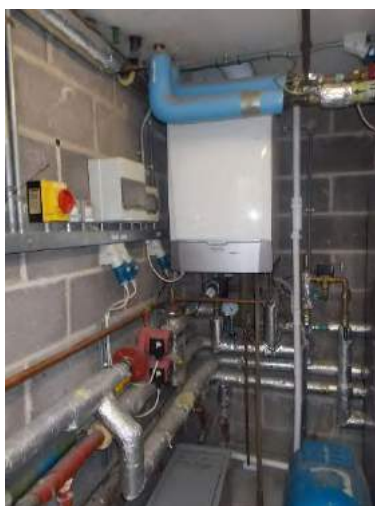
Photograph No 10 – Typical bedroom wing boiler, located in each boiler house.

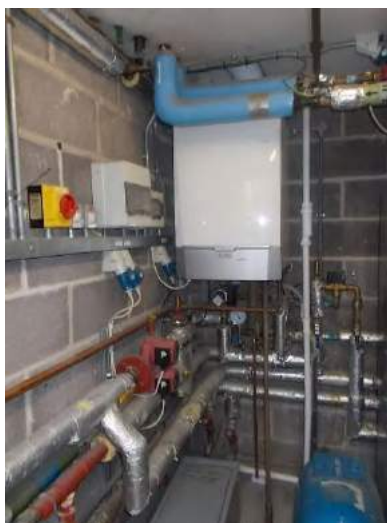
Photograph No 13 – Main boiler house – Pressure relief pipework discharges directly onto the floor.

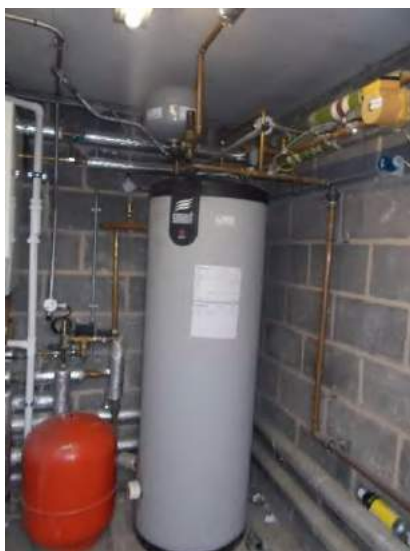
Photograph No 22 –Boiler house (room No 079) – AVC Smart Calorifier for the domestic HWS generation.

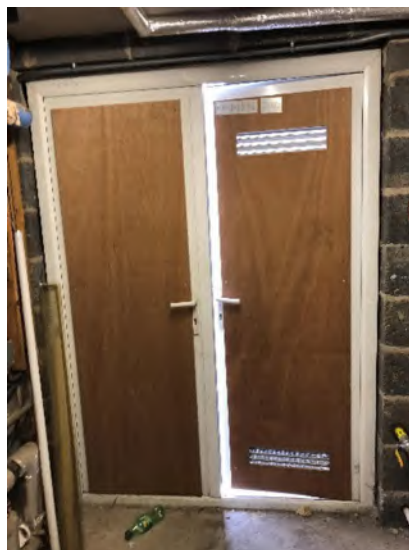
Photograph No 33 – Typical boiler house louvered doors – these have been blanked off, the size of the openings needs to be verified as being correct for this boiler house.

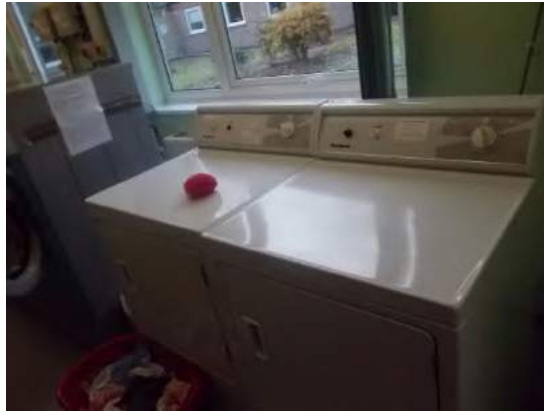
It is not clear if there is any evidence of fibres being deposited on the floor or the back of the grille, it is not clear if the circular ducts have been cleaned to ensure that there is no build-up of lint within the ducts restricting the discharge of air from the dryer.

Photograph No 46 – Laundry gas fired Dryers

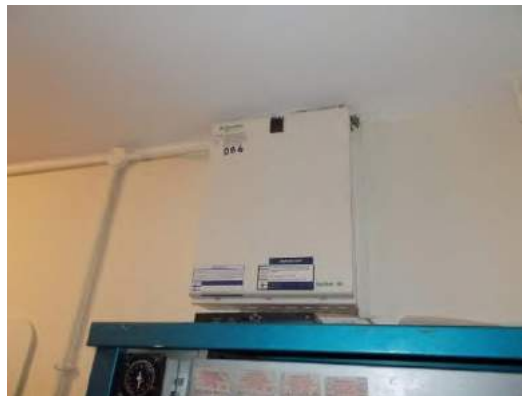
There appears to be a lack of current distribution board schedules fitted to the boards especially as the boards were inspected recently, the boards need to be clearly identified as to the services each breaker supplies.

Photograph No 52 – Typical new distribution board, this panel has an inspection date label fitted but no other warning labels or key lock.

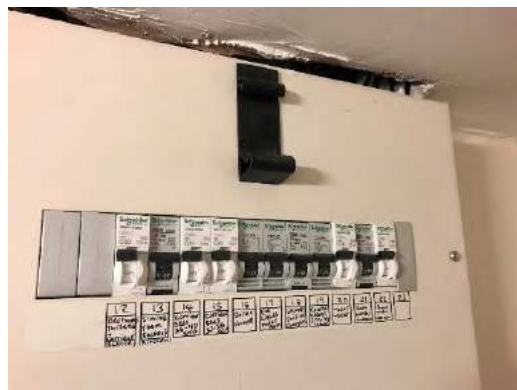
Photograph No 53 – Typical new distribution showing two types of Schneider MCB/RCBO's fitted.

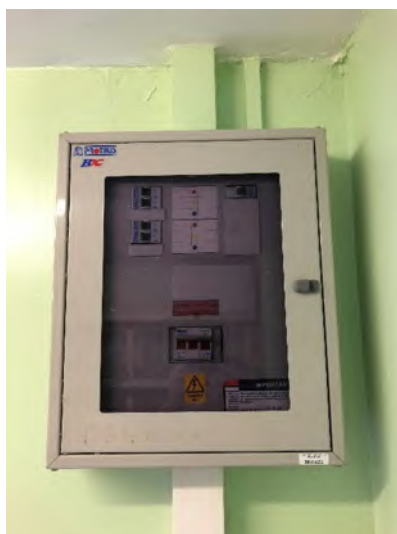
Photograph No 56 – Proteus distribution board located in the laundry.

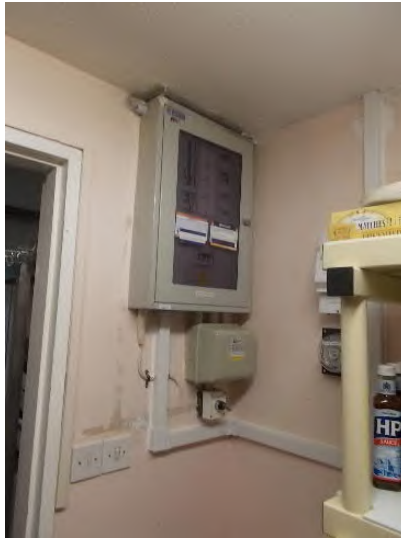
Photograph No 57 – Proteus distribution board located in the kitchen store.

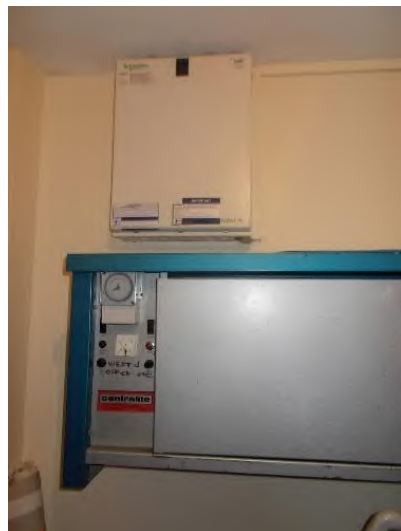
Photograph No 58 – There are a number of old central battery systems per bedroom wing which appear to be switched on and operational. It is not clear what type of fire rated cabling has been utilised.

The central battery units appear to be a lead acid system and their age and battery life is not fully known. Looking at the age of the units they appear to be in a reasonable condition but should be nearing the end of their useful life. The overall system capacity is not known and this may not be sufficient to incorporate bedroom emergency luminaires onto the current 24V system, also the luminaires are limited in the type available for a 24V system, and the system should be replaced with self-contained luminaires off the local lighting circuits.

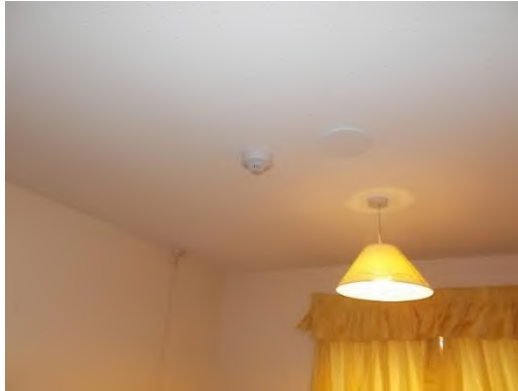
Photograph No 59 – Typical bedroom central pendant luminaire, note the pull cord switch over the bed.

The lighting in the building should be reviewed to ascertain the best options for providing energy efficient luminaires and lighting controls. As the building is provided with primarily circulation spaces and bedrooms the use the correct colour temperature of the lamps should be considered as a warmer light would be more beneficial for the residents. The corridors with natural daylight could be provided with photocell control to make the best use of natural light during the day with artificial lighting being used once the light levels drop to a particular level and would be on during the night. It may also be beneficial to have a series of night lights on manual switches to reduce the corridor lighting to a minimal access level during the night.

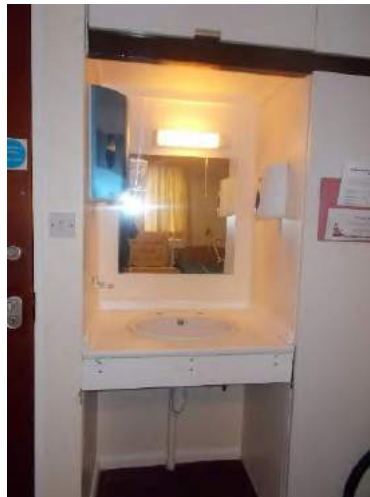
Photograph No 60 – Typical bedroom mirror luminaire.

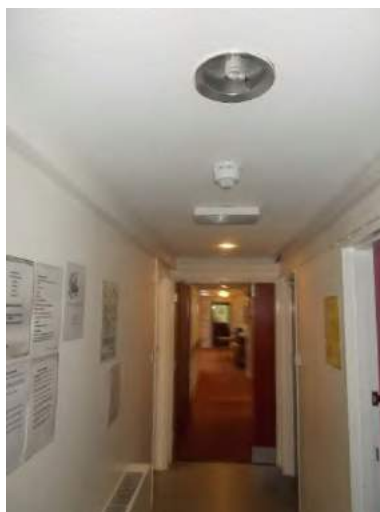
Throughout the amenity areas and corridors the lighting is provided by means of fluorescent luminaires. The lighting was operational although some luminaires are not working and need looking into. The luminaires are generally only manually switched.

Photograph No 61 – Typical corridor lighting, not all of the luminaires were operational.

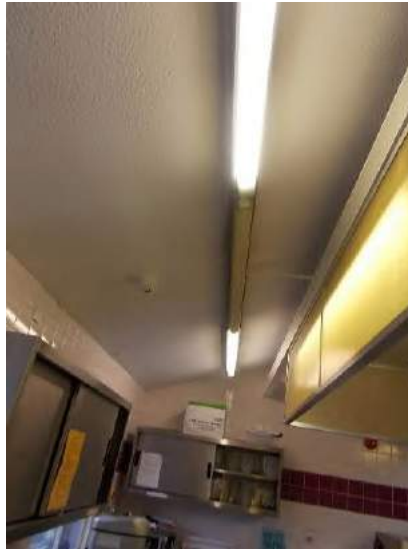
Photograph No 62 – Main Kitchen Lighting

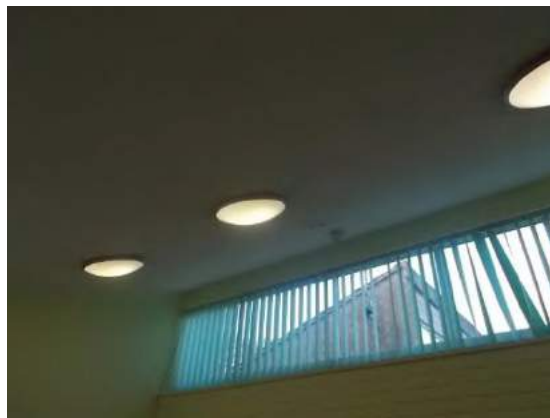
Photograph No 63– Typical common room ceiling lighting.

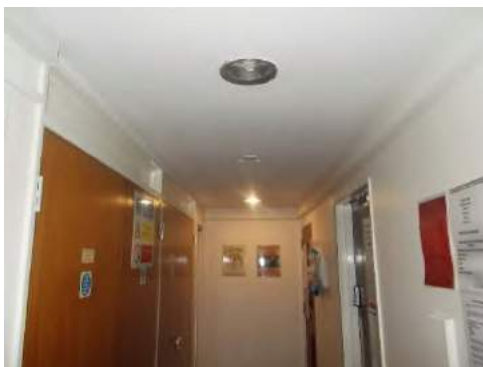
Photograph No 65 – Access corridor to kitchen & laundry with no emergency luminaire over the electrical cupboard doors.

Not all of the bedrooms currently contain emergency luminaires, and it would be beneficial to install emergency luminaires to all bedrooms and rooms where no emergency luminaire has been installed, especially where distribution boards have been installed.

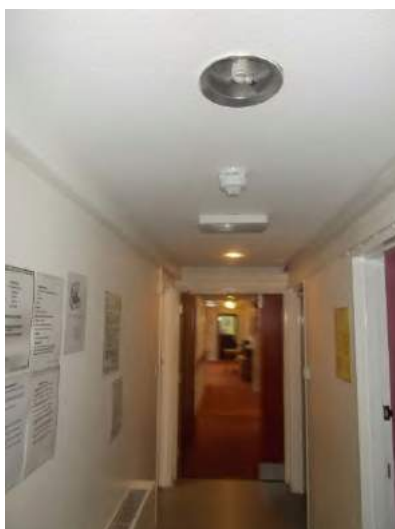
Photograph No 66 – Typical corridor to the main entrance, this is lacking in illuminated exit signage to direct persons to an escape door.

The building is lacking the correct number of illuminated exit signs to ensure that the escape routes are clearly identified. It is not clear if this building should be classified as a public building as visitors for the residents may be within the building and need directing to an emergency exit, again this should be reviewed with the Fire Officer to ensure the correct illuminated signage is installed.

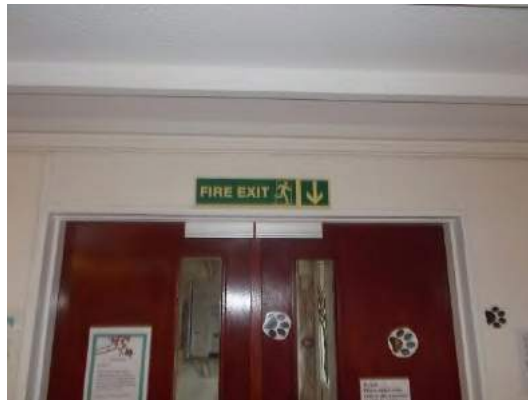
Photograph No 68 – Door to main entrance with a non-illuminated exit sign or no local emergency luminaire by the door sign.

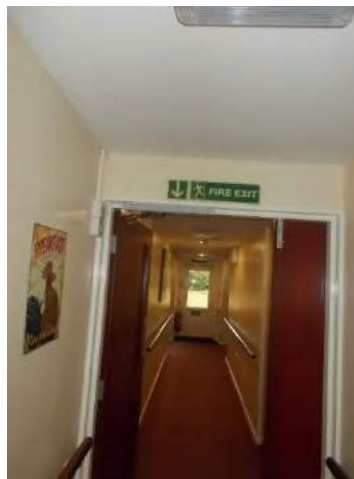
Photograph No 69 – Some external doors have been provided with emergency luminaires over the door exit sign, note when the fire doors are closed the door is not seen, the non-illuminated sign does not have an emergency luminaire close enough to make it easily seen.

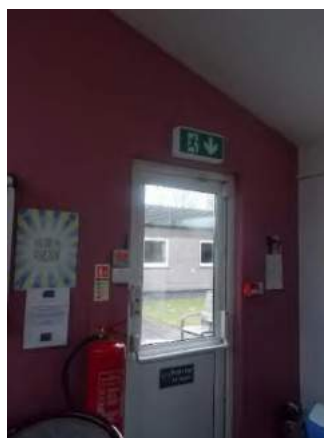
Photograph No 70 – Some external doors have been provided with non-maintained exit signs.

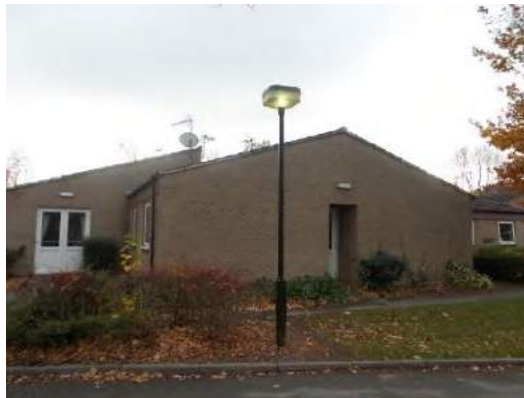
Photograph No 71 – Externally in the driveway/car park there are a number of column luminaires illuminating the area.

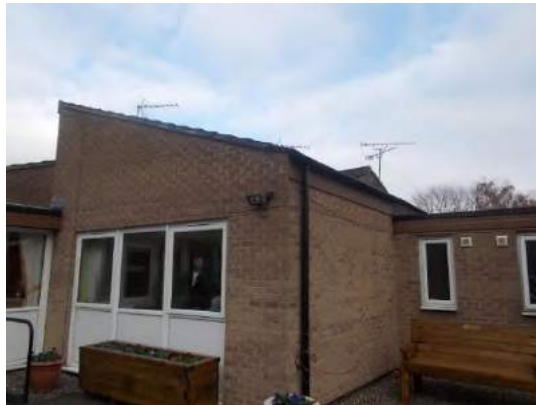
Externally there are a number of column luminaires to illuminate the main driveway and car park route into the building. However, generally around the building there are a number of emergency luminaires located over the escape doors but there are no general luminaires to allow a person to move around the building after dark. The external lighting should be reviewed with the Fire Officer to ensure the correct lighting is installed.

Photograph No 72 – Generally the perimeter of the building has not been illuminated, but there are some odd flood lights in courtyards installed.

It would be beneficial to install general external lighting (complete with emergency battery back-up) to allow the residents to escape or to be evacuated from the exits behind the building to the front of the building and the muster point.

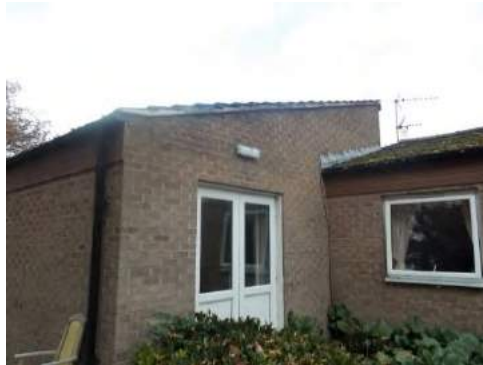
Photograph No 73 – Typical wall mounted bulkhead luminaire over the fire exit doors.

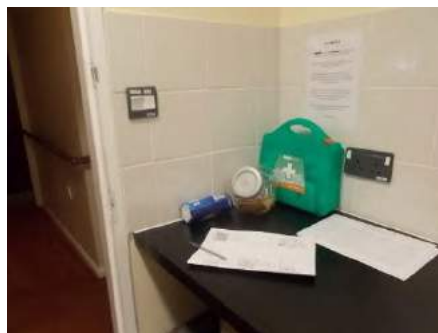
Photograph No 75 – Refurbished kitchenettes with contrast colour accessories.

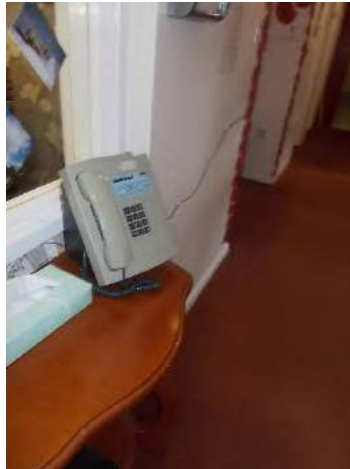
Photograph No 81 – Residents telephone in main entrance area.

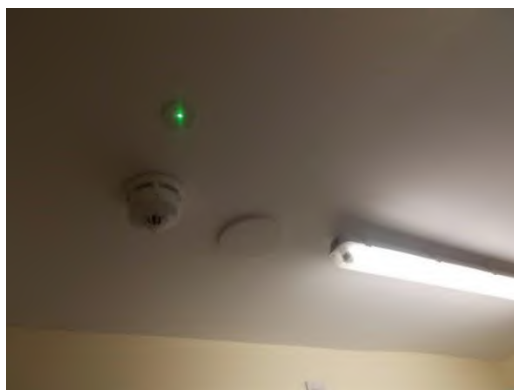
Photograph No 84 – Smoke detection and sounder located within the sluice room.

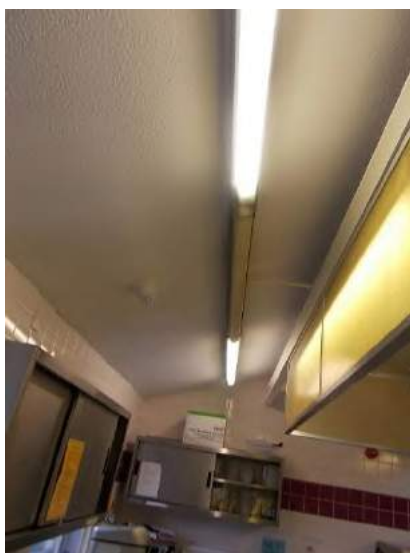
Photograph No 86 – Automatic detection within the main kitchen.

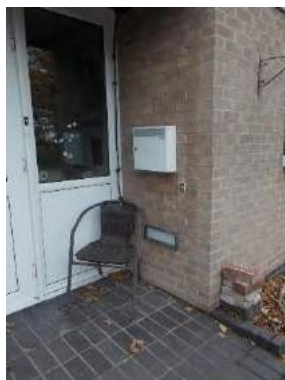
Photograph No 88 – Main entrance door was provided with an access system and key pad on the inside, there was no green emergency break glass unit and it was possible to be locked in the entrance lobby when both doors were closed. No keypad or intercom on the outside of the main entrance.

The main entrance doors require a green break glass unit to exit the building in case of an emergency. The whole of the access arrangements into and out of the building needs to be reviewed for this building.

The building does not have an external intercom system but has an intercom by the lobby door into the building. This needs to be reviewed as this would benefit staff for allowing visitors to enter the building.

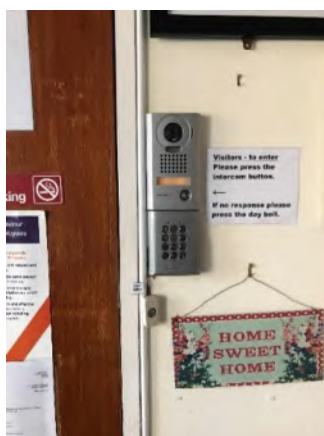
Photograph No 89 – Main door from lobby into the building has been provided with an intercom system to gain access.

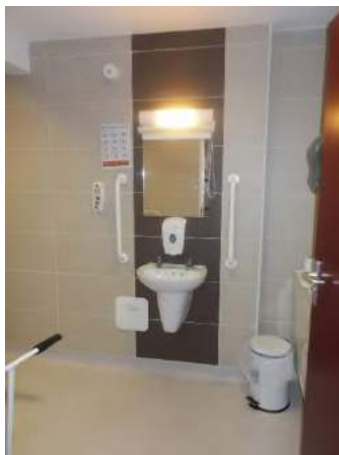
Photograph No 92 – Typical bathroom showing nurse call system, system also includes pull cord switches by baths/showers and toilets.

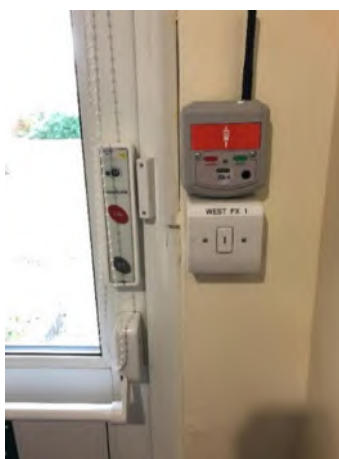
Photograph No 93 – Typical exit door with two nurse call systems attached.

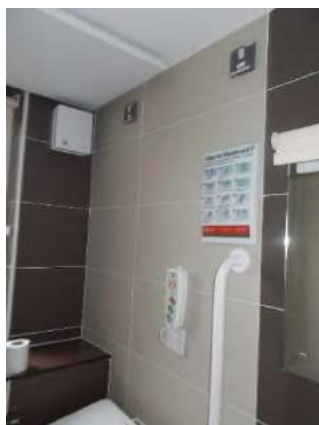
Photograph No 94 – Typical master nurse call panel in refurbished toilets and bathrooms.

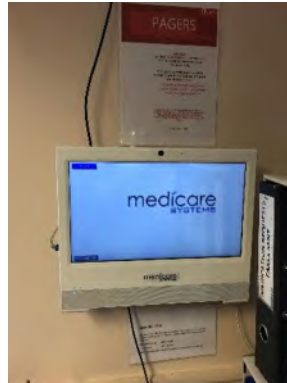
Photograph No 95 – Master Medicare System Nursecall+ system monitor located in the administration office.

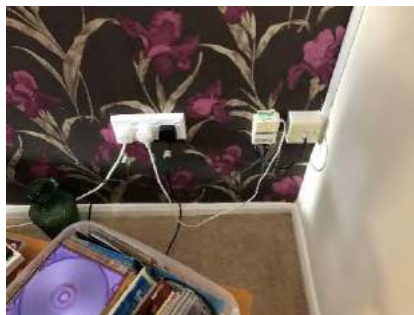
Photograph No 96 –TV aerial with booster system within one of the Common rooms.

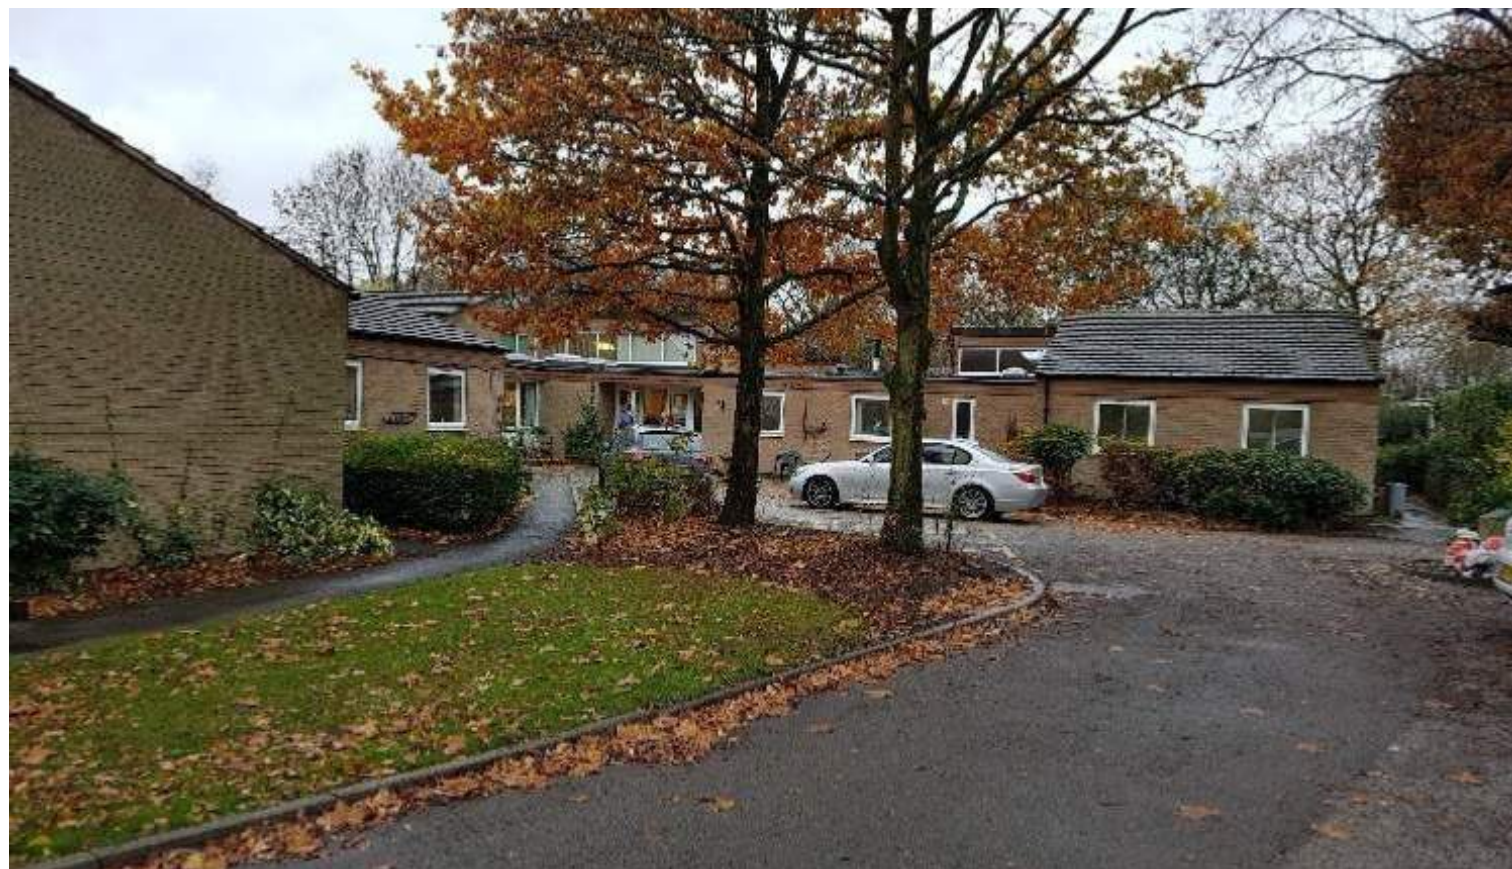
Photo 1

- 202. The premises comprise primarily a single storey building of masonry and timber construction throughout and thought to have been built some 30-40 years ago. (See photo 1)

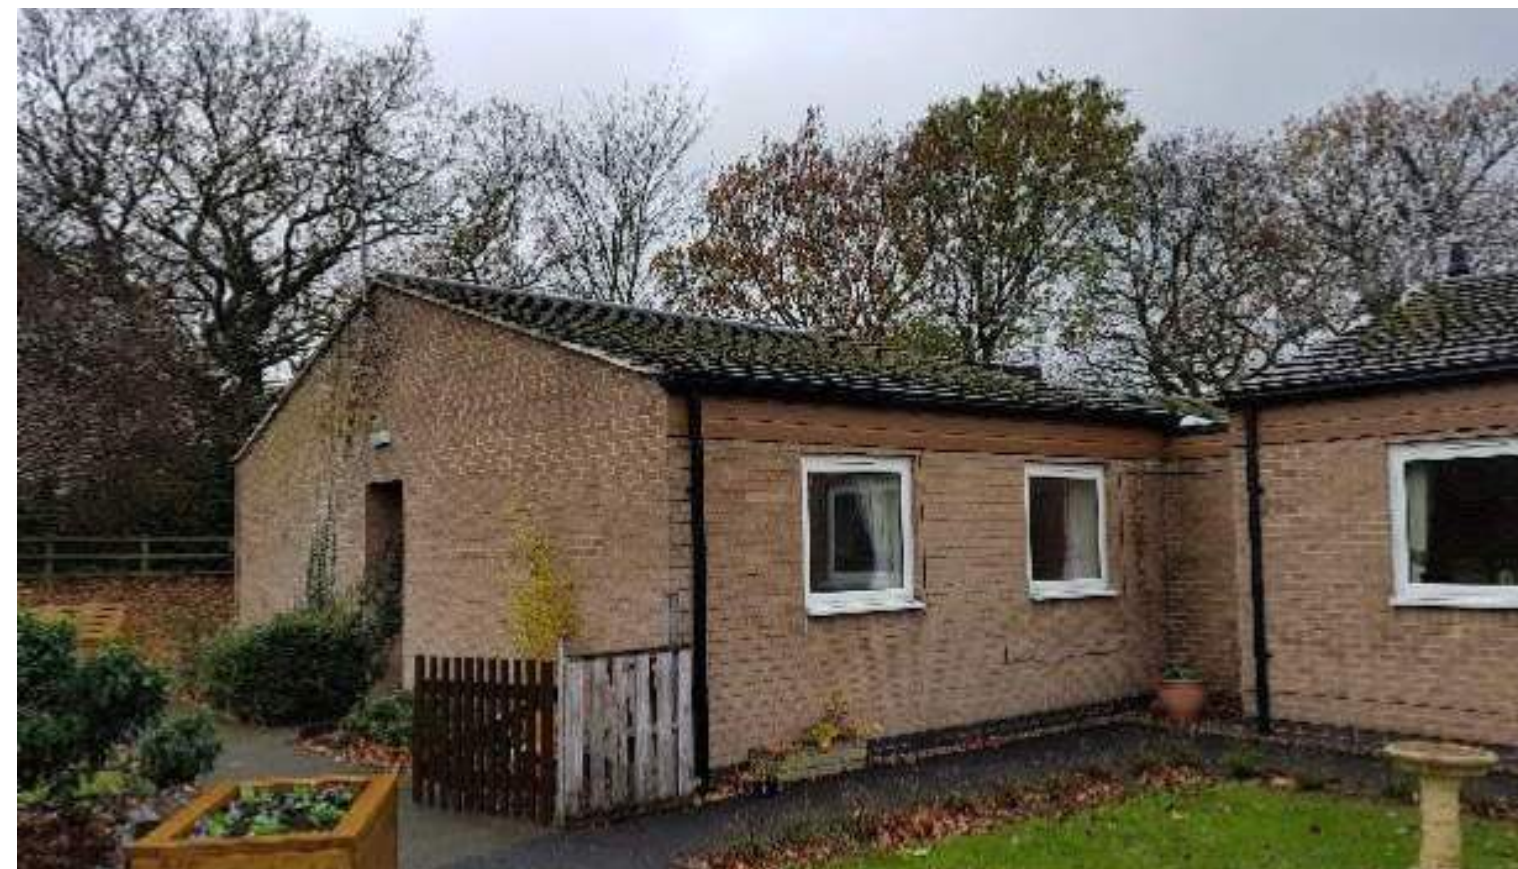
Photo 2

- 301. The roofs primarily consist of a duo pitched roof finished with concrete tiles.
- 302. The condition of the tiles generally looked in reasonable condition. There were no obvious signs of distortion to the ridges and pointing to the gable was in generally reasonable condition. (See photo 2)
- 303. The rainwater goods to the eaves also appeared in serviceable condition throughout.

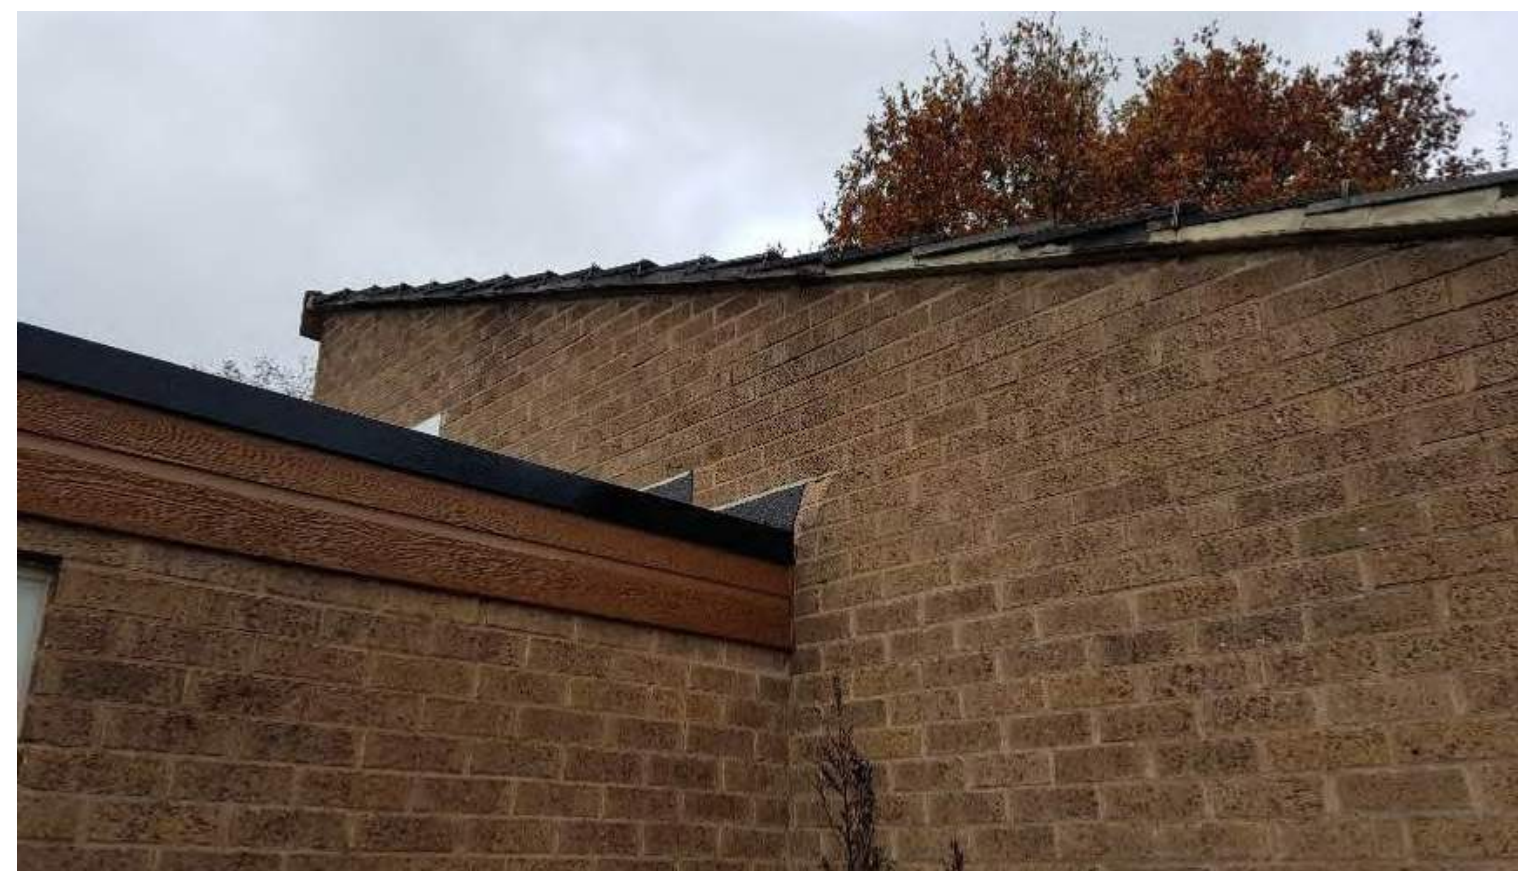
Photo 3

- 306. The roofs primarily consist of a mono pitched roof finished with concrete tiles.
- 307. The condition of the tiles generally looked in reasonable condition. There were no obvious signs of distortion to the ridges and pointing to the gable was in generally reasonable condition. (See photo 3)
- 308. Cracking within the brickwork was noted to the wall dividing rooms 004 (WC) and 005 (Kitchen) at high level. (See Photo 4)
- 309. We also noted that it appears that the flashing between the adjacent flat roof and wall has been once replaced.
- 310. No signs of distortion were noted to the opposite gable.
